FORESHORE AND CLIFF ACTION MANAGEMENT PLAN

COASTAL & CLIFF ACTION MANAGEMENT PLAN

Revision: A (04.10.11)

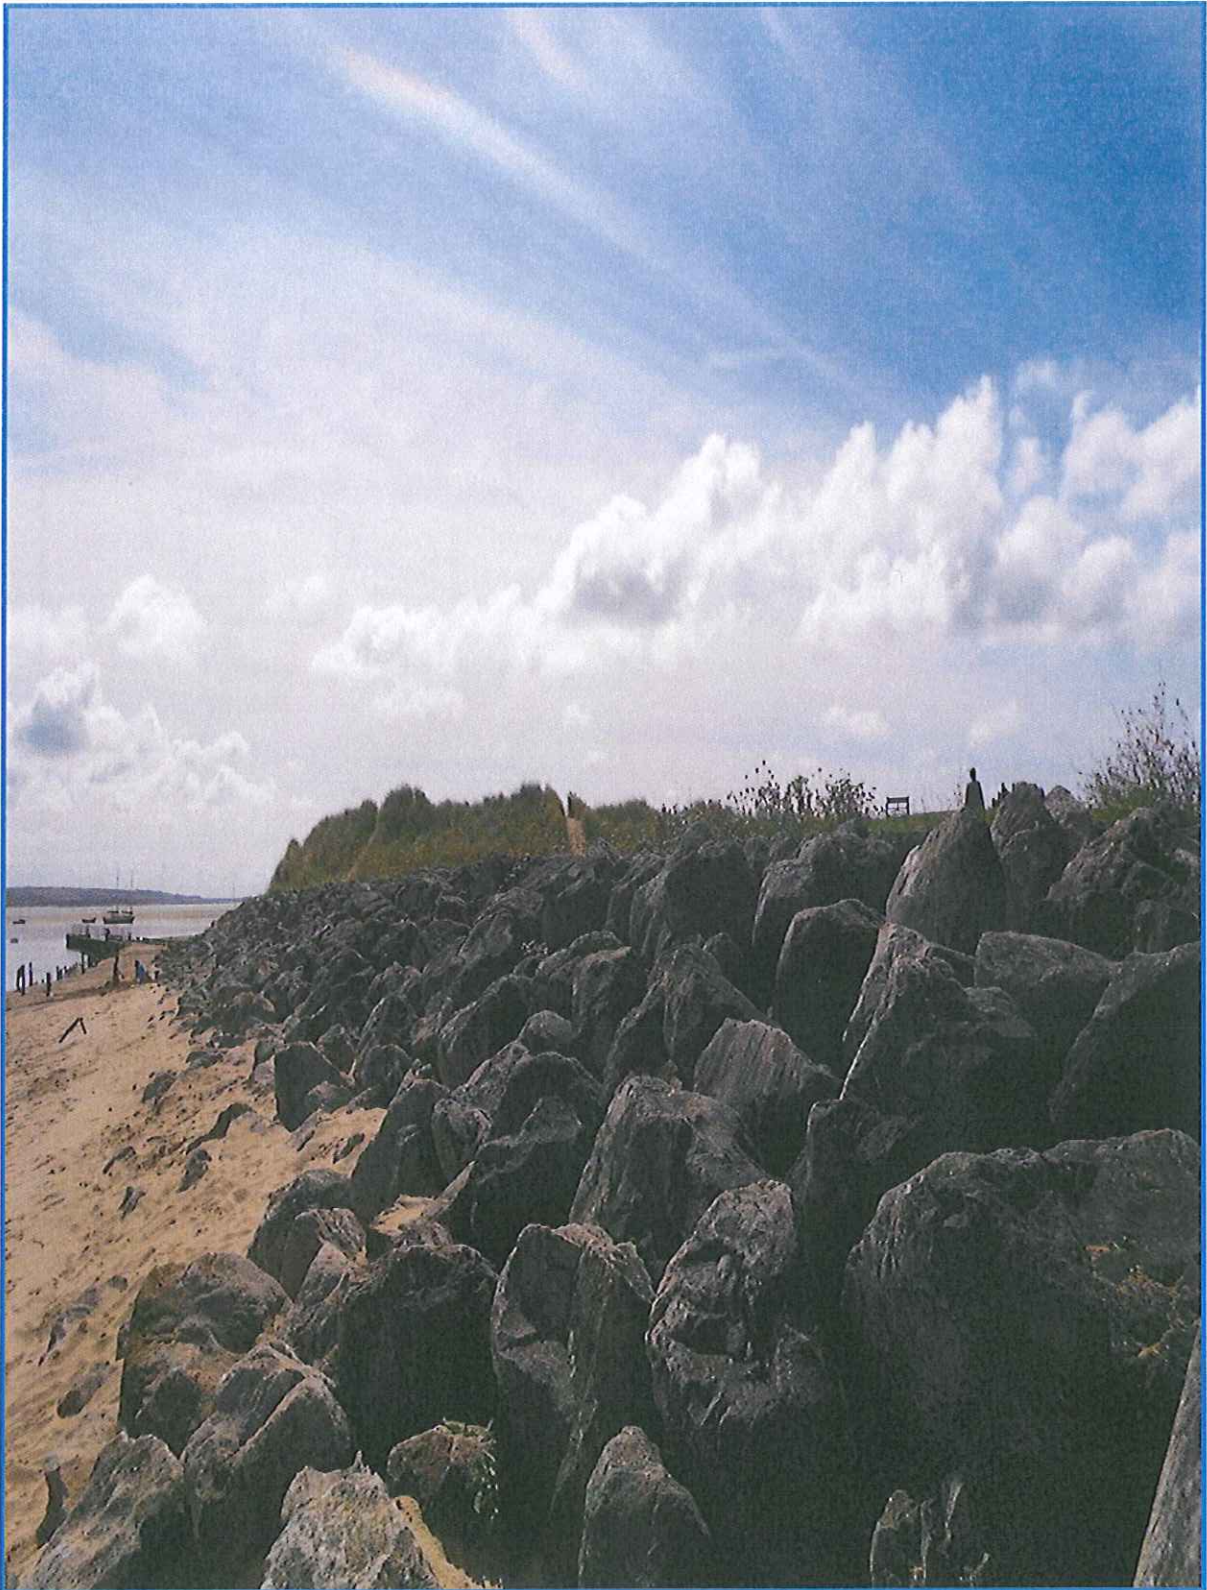
A2 - HAVERIGG PHOTOGRAPH

Rock armour is present to the east and south-east of the site. Along the east boundary the rock armour follows the gradient of the bank and leads to the sandy beach at the base of the protection. The rock armour to this area appeared to be in good condition. The rock armour to the south-east of the site extends onto the beach to protect the land from the river. The condition of this rock armour is also good.

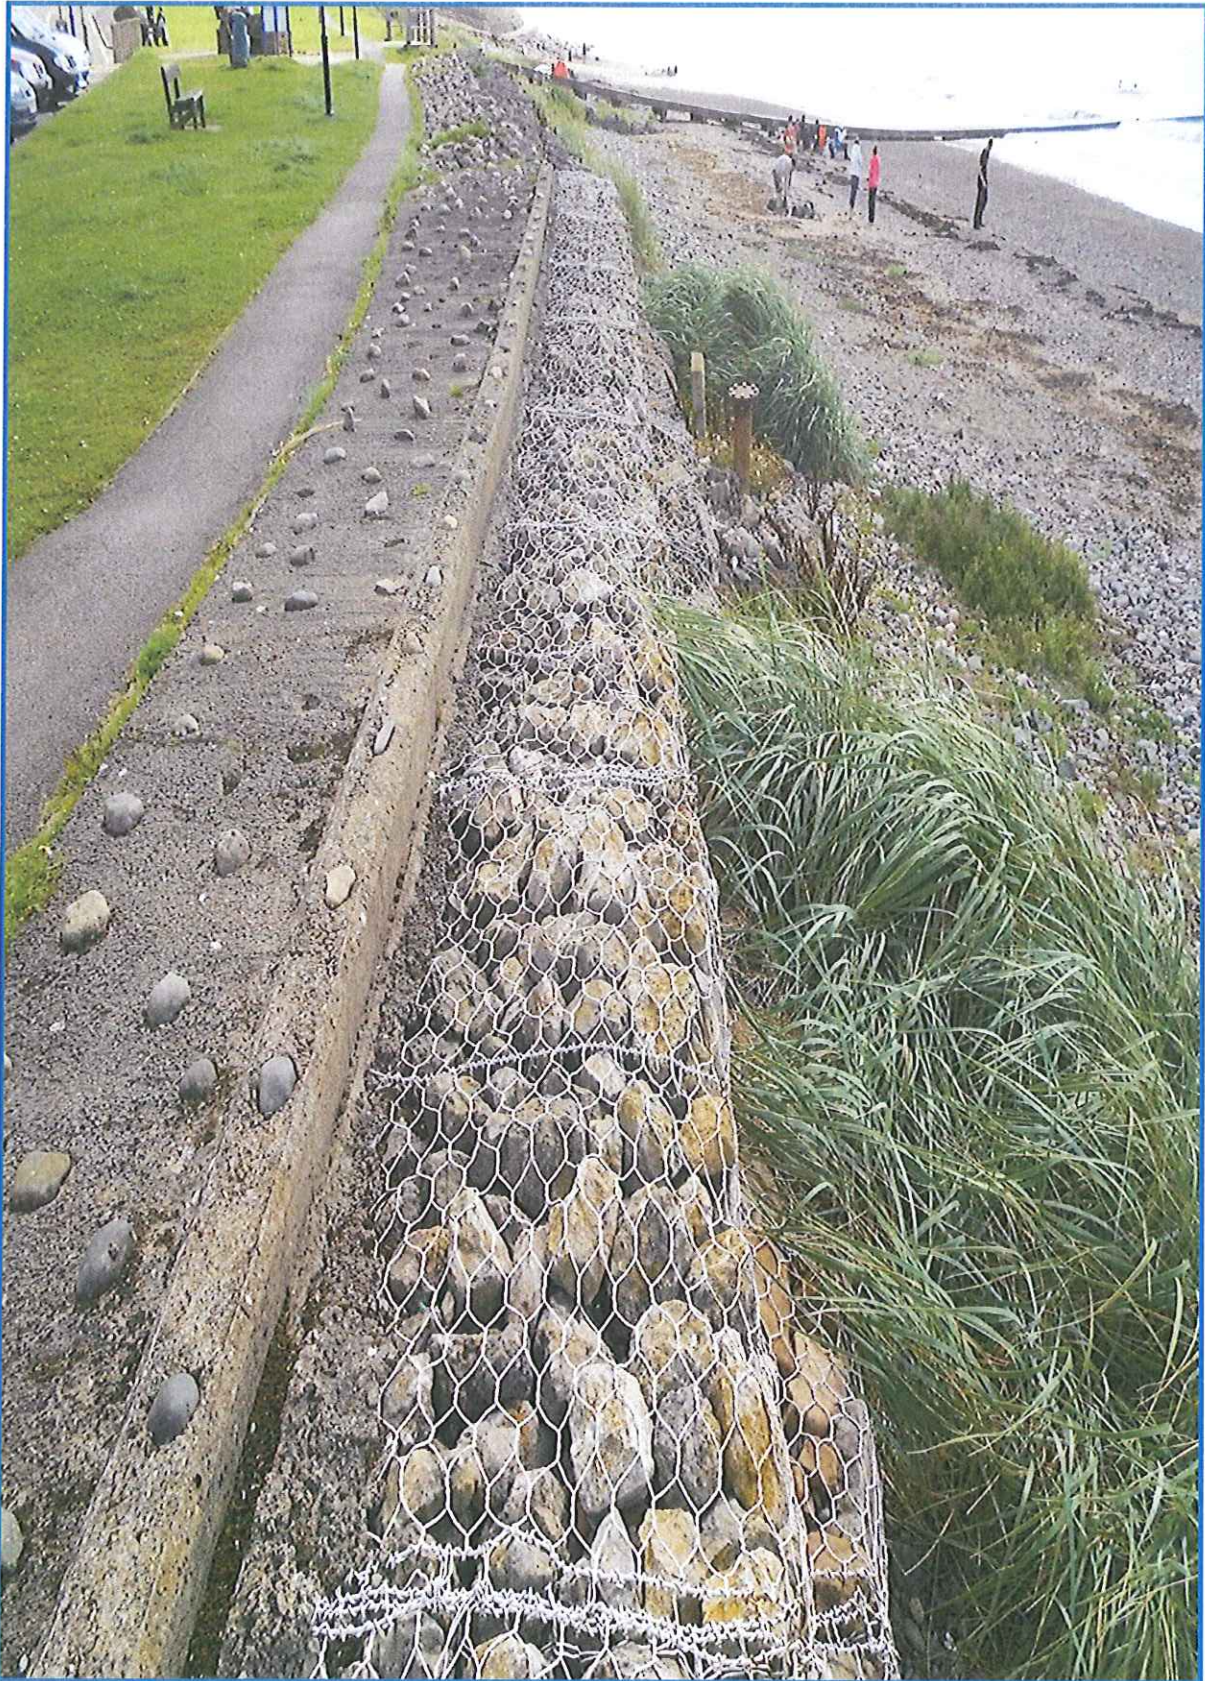
B2 – SEASCALE PHOTOGRAPH

Retaining the land along the beach boundary to the west of the site are gabion baskets. It is understood that these are not within the Copeland Borough Council's boundary. However the Council has been repairing and maintaining these for some time possibly due to an historic agreement. The condition of the gabion baskets is currently fair although remedial work is required to some areas where the gabion netting has failed. Due to the location of the gabion baskets annual inspection is required. It is understood the maintenance of the gabions can be funded from the NWDA Coastal Initiatives Fund. These points are being considered further as part of shoreline management.

Visitors to the site appear to be walking over the stepped gabion baskets to gain access to the site. This should not be used as an access to the beach as there are risks associated with walking on the gabions and from sharp metal wire should the meshing have failed. It is advisable to erect signs requesting that visitors to the site use designated beach access routes.

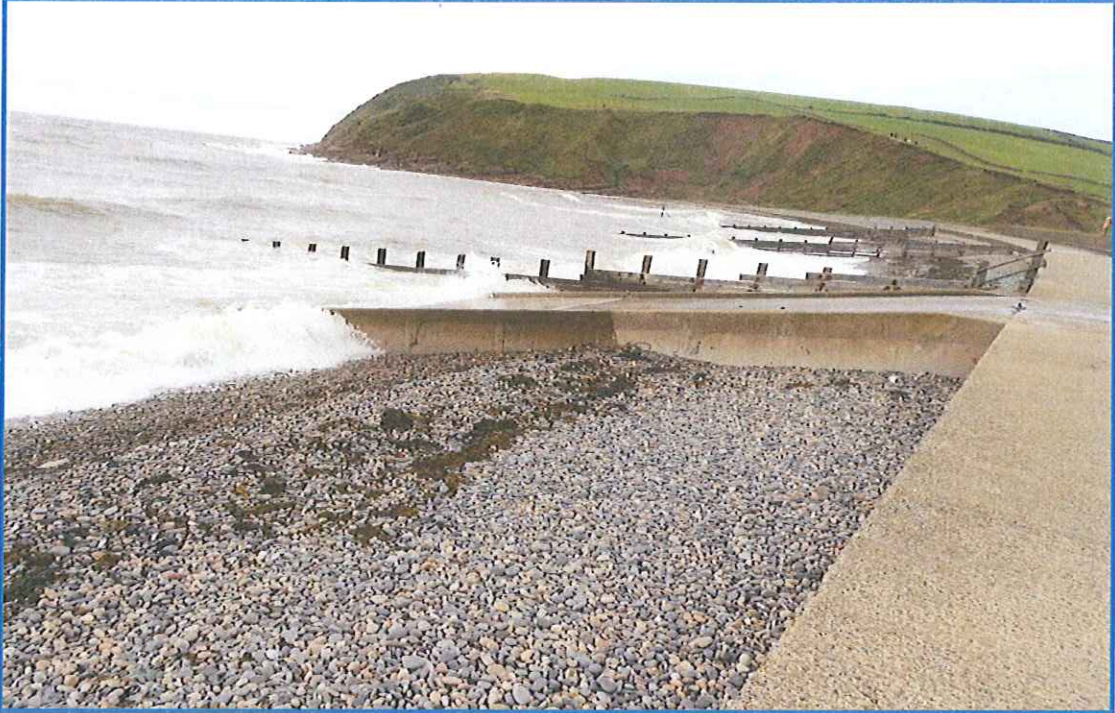
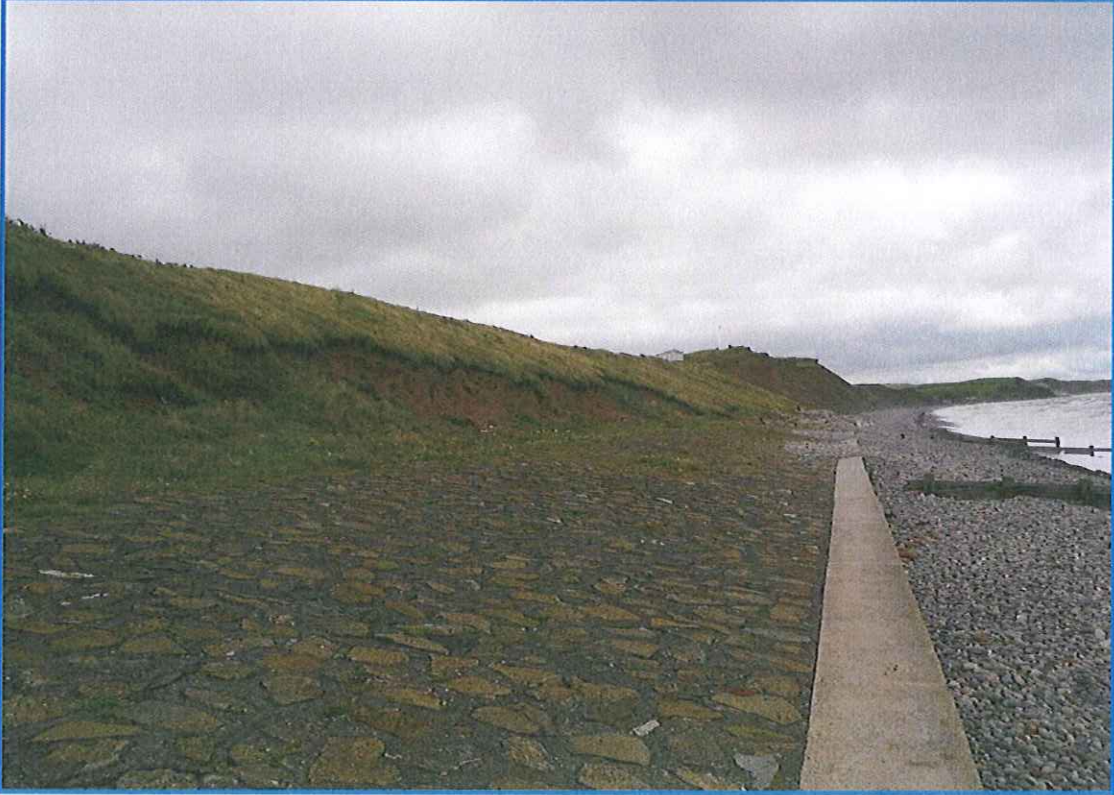
C2 – ST BEES PHOTOGRAPHS

This area currently displays cracking and evidence of loose material and it is expected that further slippage will occur in the future due to the natural erosion of the slope face. There is little that can be done about this other than placing warning signs in the area. Cordoning the foot of the cliff off is not an option as any structure would be damaged/washed away by the sea.

Outstanding actions and cost:	The Council intends putting signage on the public access areas to the beach to advise of the dangers from the coastal slopes. It is anticipated that the cost of this would be initially £1000.00 to install the signage and an annual maintenance sum of £200.00.
Shoreline management plan position:	<p>Hold the line for 0-20 years and 20-50 years; For years 50-100 there should be 'managed realignment'. Key points are:</p> <ul style="list-style-type: none"> (a) the current scheme to protect corroding sheet piling along the north face adjacent to Rottington Beck is underway; (b) the groynes were appraised in 2011 which recommended minimal work for the time being with a further assessment due in 10 years with six monthly safety inspections; (c) the current promenade is around 50 years of age and is

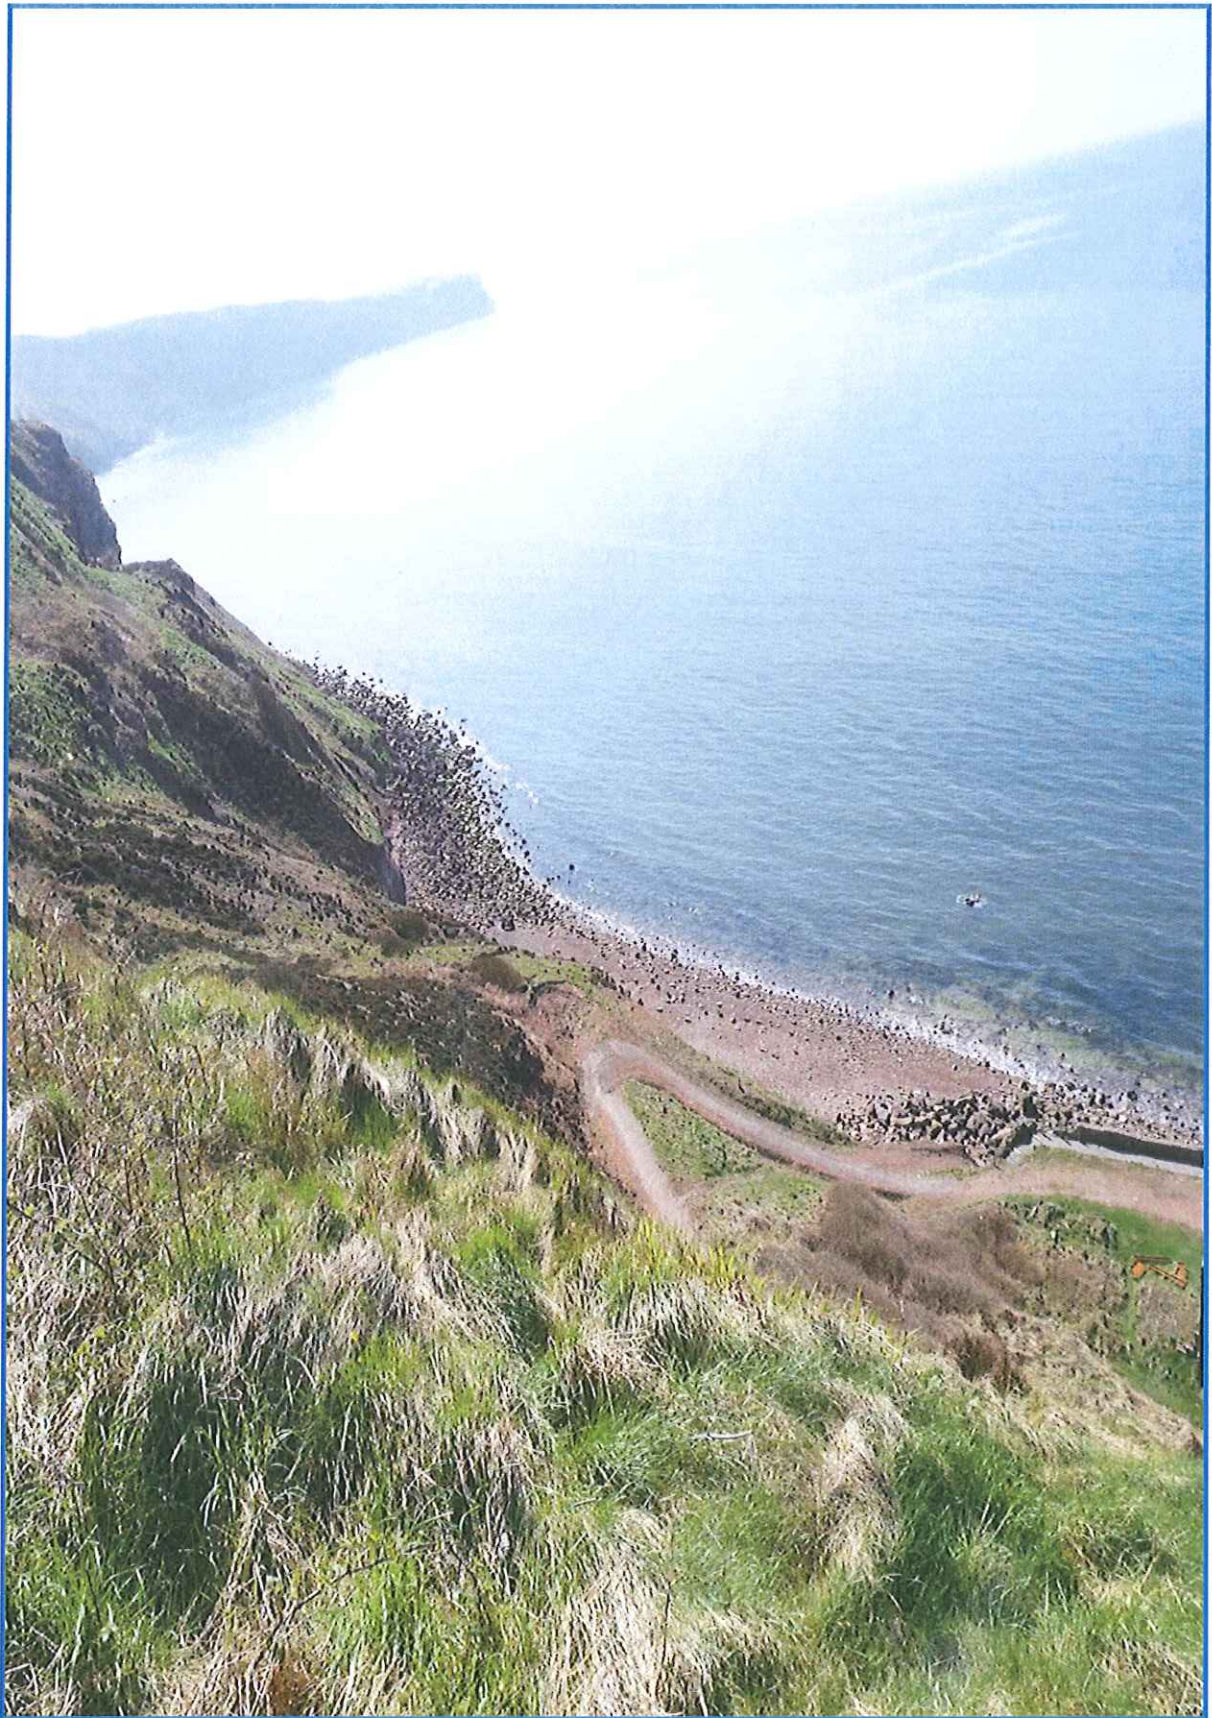
D2 – SALTOM/HAIG PHOTOGRAPH

<p>Current condition:</p>	<p>Area 1 (shown on the Ownership Plan D1) shows constant signs of degradation largely caused by the constant slippage of colliery spoil with sandstone from the Fairy Rocks continuing to move west threatening to engulf the former Saltom Pit Head building. The beach access path requires constant remediation work to remain open. The condition of this area is considered unstable and this impinges on day to day safety. If English Heritage accept the impending demise of this ancient monument then a dialogue needs to take place with the Cumbria County Council on the closure of the beach access footpath until the spoil has stopped moving and the land settled.</p> <p>Areas 2 and 3 (shown on the Ownership Plan D1) shows signs of degradation caused by the upper sandstone cliff receding under natural erosion with the colliery spoil beneath continuing to slip over the lower cliff. This causes progressive fractures and slope failures. The public footpaths and access has been closed in this area on a temporary basis due to the instability of the area. The condition of this area is unsafe.</p> <p>Area 4 (shown on the Ownership Plan D1) comprises of the area at the head of the cliffs known as Jonathon Swift's House and east of this point. It shows signs of settlement but little regression of the cliff itself. The toe of the cliff is colliery spoil</p>

<p>with progressive fractures showing on-going signs of failure and continued erosion. There is no access to the public at the foot of this area. The condition of this area is unsafe.</p> <p>(The above areas correspond to the area considered in the Mouchel Parkman report referred to in the detailed findings below).</p>
Outstanding actions and cost:	<p>Permanent stopping up of the public footpath from the headland along the Haig coastline (not foreshore, nor Saltom path) is required. This is being undertaken by the Cumbria County Council who will recharge its costs to this Council and which will be in the region of £4,000.</p>
Shoreline management plan position:	<p>Saltom Pit: Hold the line for 0-20 years and 20-50 years provided this is technically feasible and affordable to do so; for 50-100 years the designation is for no active intervention.</p> <p>Remainder of this area: No active intervention.</p>

The investigation showed movement to the west-north-west (300°) occurring at about 18m depth at the interface between the colliery spoil and the Whitehaven sandstone and the underlying mudstone of the coal measures rocks on a sub-horizontal (8° - 12°) plane. Analysis of this slip, has suggested that it is a block, rather than a rotational failure, with the slip surface having a residual angle of internal friction of between 10° and 13°. Water within the permeable colliery spoil and sandstone has resulted in weathering of the impermeable mudstone to a clay, creating a potential failure surface. Any increase in groundwater levels, for example, during heavy rain, both increases the disturbing force and lubricates the failure surface.

This structure was repaired to prevent structural collapse due to degradation in 2009, At that time the Parkman report suggested that it was expected to be between 10 and 20 years before the spoil would push the structure over. Following progressive walk over inspections over the last 24 months approximately at 6 week intervals following the movement of the spoil it is more likely the building would be overcome within the next 5 to 10 years.

The scarp at the top of the cliff (currently about 2m) will increase in height causing secondary slips within the colliery spoil until the buried rock face is exposed. Once this happens, a situation similar to that prevailing in Area 3 could be expected to develop, that is, toppling failures, resulting in regression at a rate of around 15 metres per century. It is difficult to predict with any accuracy when this process will start, but it could be as soon as 5 years from now.

expensive and it is recommended that instead, a stand-off distance of say 20m (regression is occurring at a rate of 15 to 20 metres a century) from the cliff face is adopted for any new works (e.g. access routes) in this area, with the existing track moved back (eastwards) accordingly, and the cliff top fenced.

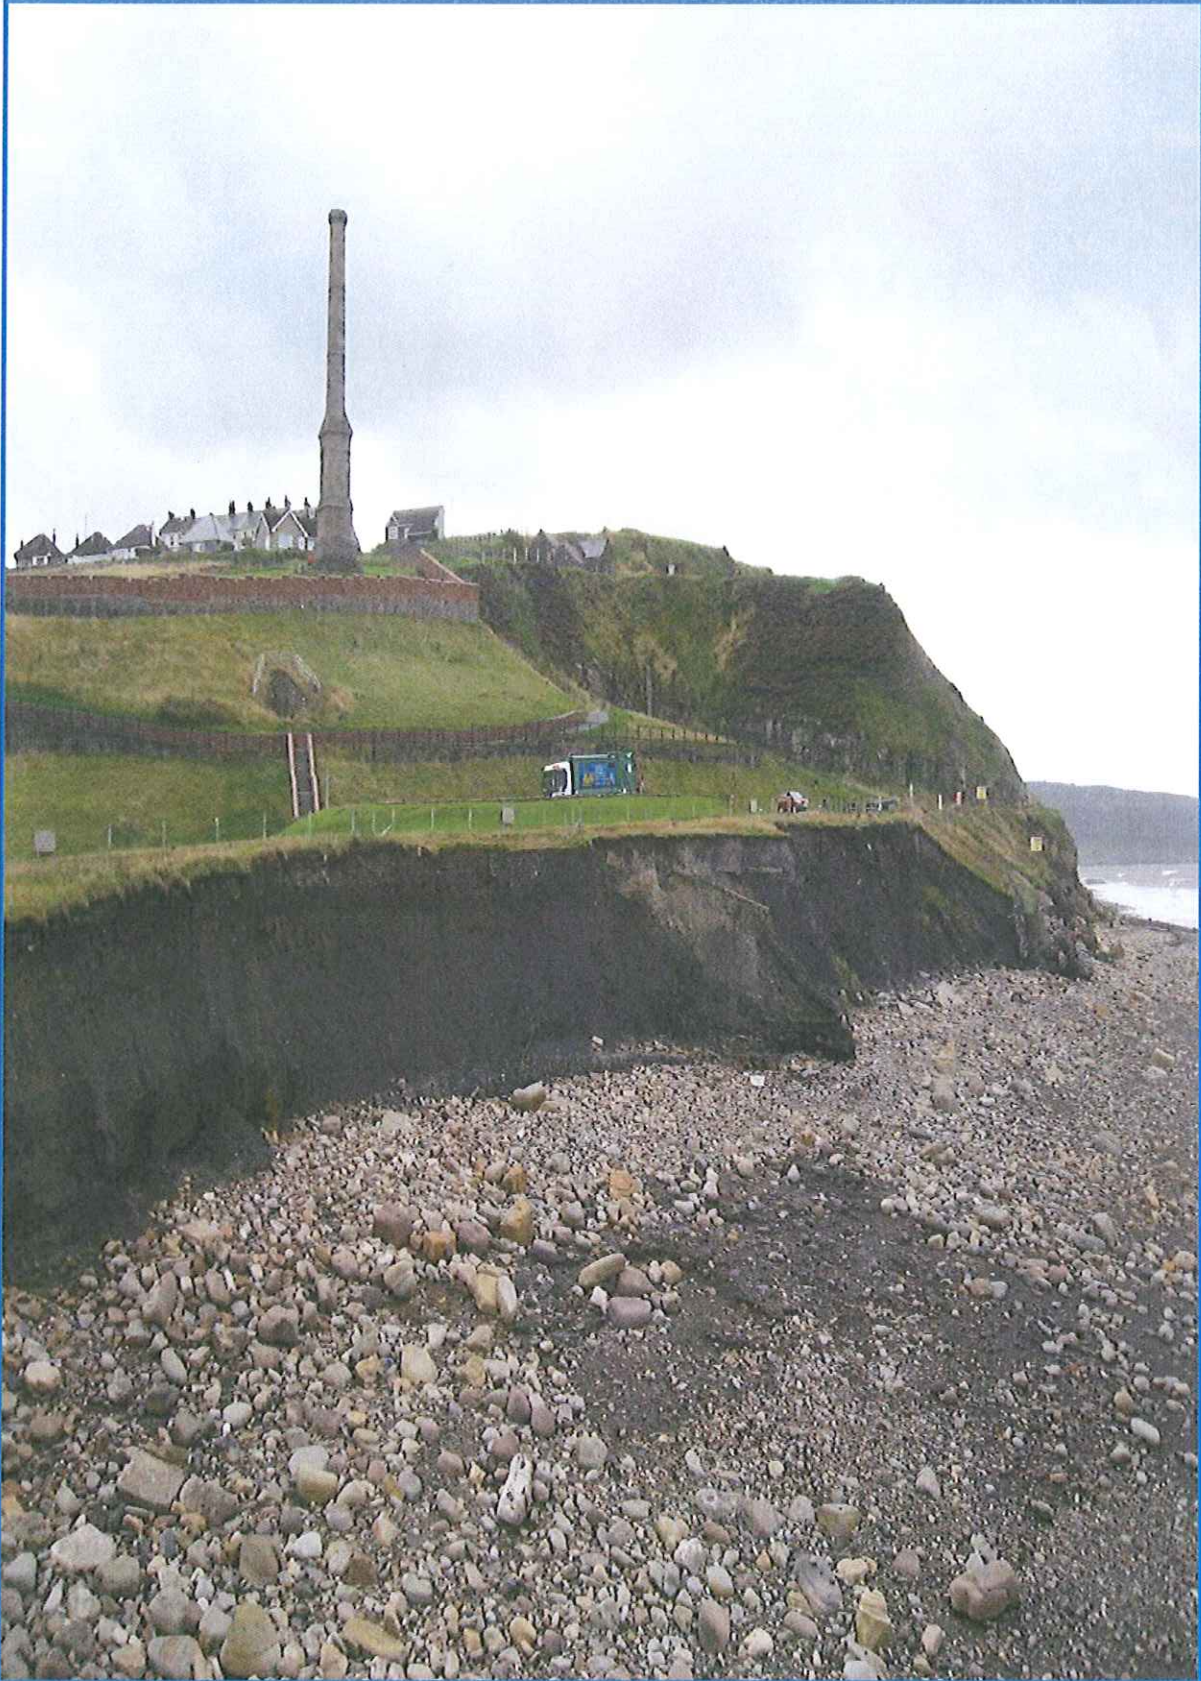
E2 – SOUTH BEACH PHOTOGRAPH

Description of area:	Located at the end of West Strand, Whitehaven the area comprises of a grassed area, with adjacent car park, leading to a pebble and stone beach which is currently closed to public access
Ownership plan: Photograph:	Appendix A, E1 Appendix A, E2
Land ownership position:	The Council owns the freehold having purchased it in two parts on the 28 th June 1961 and 28 th October 1984.
Current condition:	<p>The area is a short Westphalian age consisting of mudstone, siltstone and sandstone with deposits of Flandrian (Quaternary) age, overlain by made ground. The bedrock geology of the site is described as a Pennine Middle Coal Formation of Carboniferous.</p> <p>The grassed area above the cliff was observed to be flat and therefore deemed likely to provide poor drainage. This, coupled with prolonged heavy rainfall may lead to the saturation of the spoil material. In addition, high tides and rough seas have eroded the cliff, and created a slope beyond the angle at which the material is stable.</p> <p>It is likely that this removal of support by wave action, coupled with the saturated ground, has caused the colliery spoil material to become unstable and fail in the past, and will also be the major cause of failure in the future.</p> <p>Due to the unstable nature of the colliery spoil in this area the Council has installed a 15 metre buffer zone by means of a fence at the top of the cliff with no public access being allowed on to the beach below. The public footpath running east to west has been closed</p> <p>Overall the condition of this area is unsafe.</p>

Due to the nature of the material and the mechanism of land sliding the landslide can be classified as a debris fall. Rainfall figures for November and December 2006 were 125 to 150% and 175 to 200% respectively above the 1961-1990 average (Met Office, 2006 & 2007). This high rainfall had saturated the colliery spoil material, increasing the pore water pressure and causing the material to become unstable. The grassed area above the cliff was observed to be flat and therefore deemed likely to provide poor drainage. This, coupled with prolonged heavy rainfall may have lead to the saturation of the spoil

material. In addition, high tides and rough seas have eroded the cliff, and created a slope beyond the angle at which the material is stable (angle of repose). It is likely that this removal of support by wave action, coupled with the saturated ground has caused the colliery spoil material to become unstable and fail.

Due to the unstable nature of the colliery spoil material; access to the area should be prevented. This involves no public access to the beach, and at least a 15 m fenced buffer zone along the cliff top. Based on observations in January 2007, it is likely that any future single cliff failure event will result in no more than 1-2 m recession of the cliff top. Constant monitoring of the cliff top is strongly recommended in order to maintain the 15 metre buffer.

Signage along the cliff top and in the immediate vicinity of the car park should warn the public of the risk posed by the landslide hazard in the area.

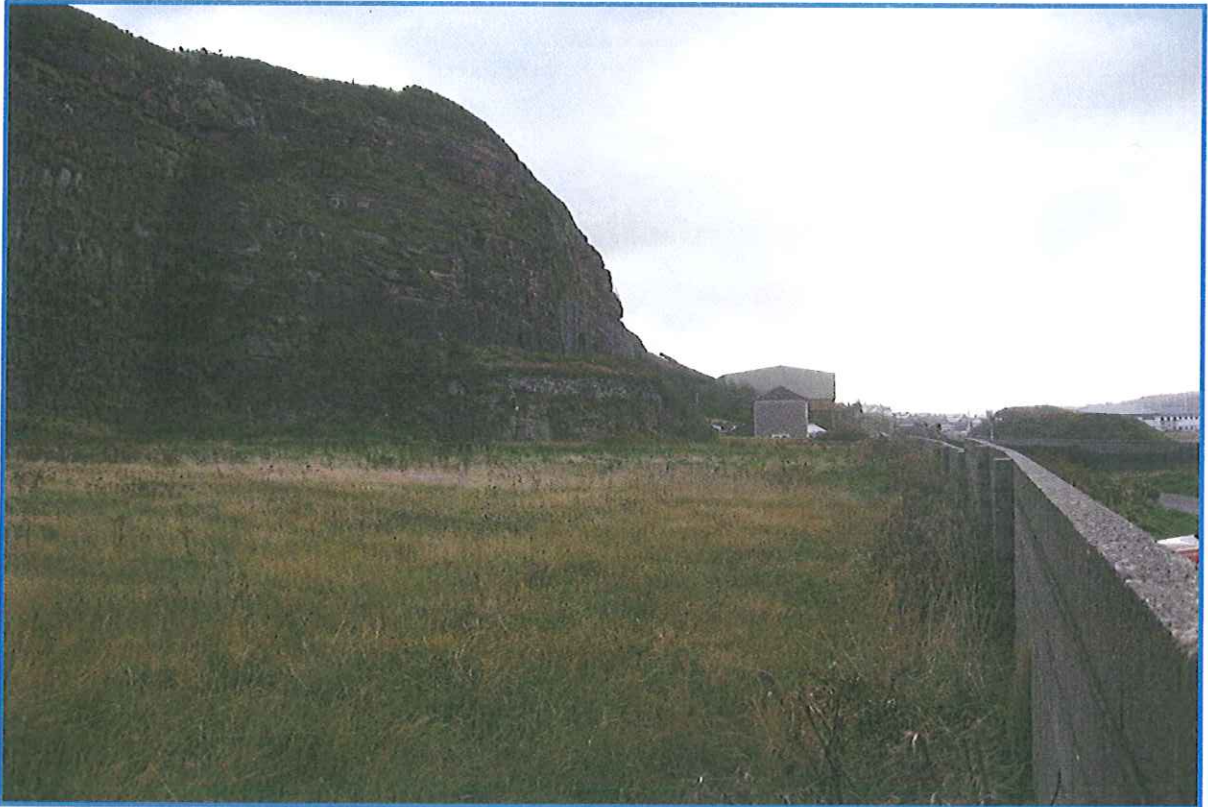
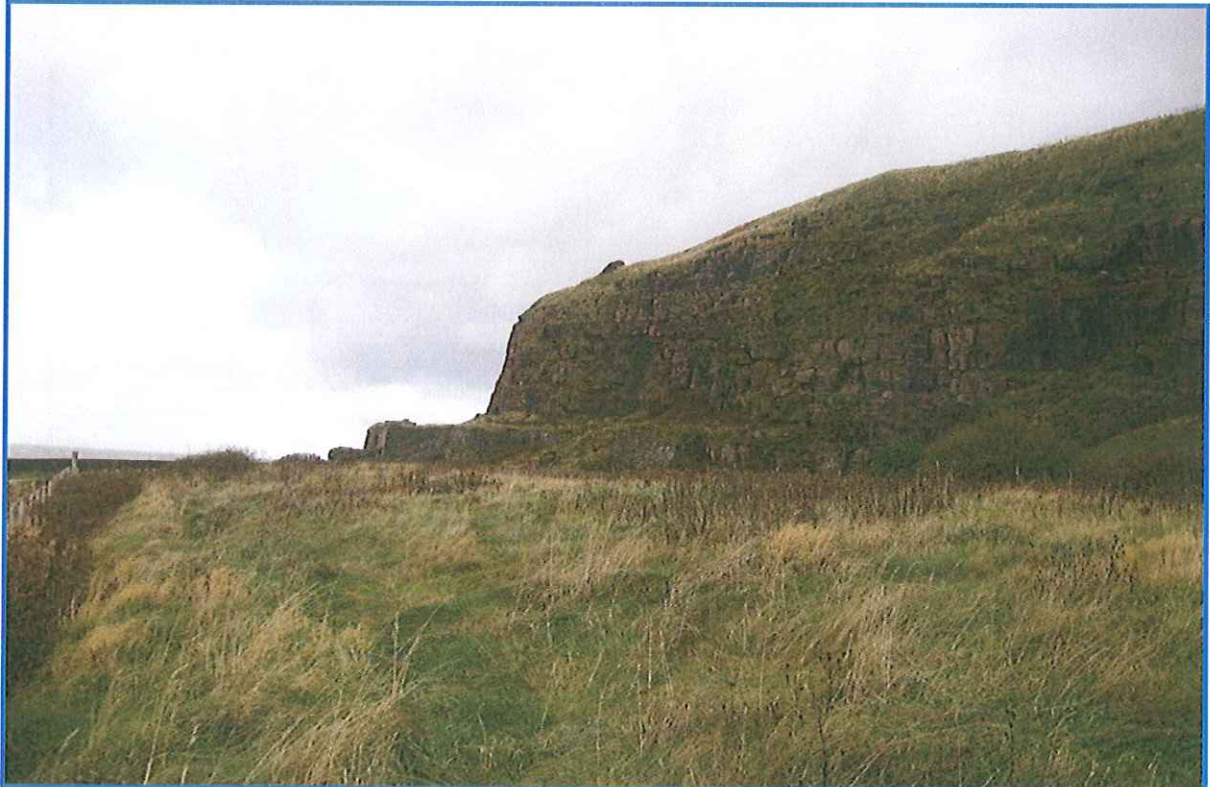
G2 – NORTH SHORE, EAST OF RAILWAY AND BRANSTY, PHOTOGRAPH
East of railway looking south

Area A The most recent of incidents having come to light on the 22nd September 2011. Noticed originally in early 2011 this area has deteriorated quickly with further opening of a tension crack in the slope causing further damage to a wall at the rear of 1 Bransty Road. If the slope was left untreated during the winter of 2011 water infiltration in the tension crack and increased soil saturation is likely to increase the rate of slope deformation and its effects on 1 and 2 Bransty Road. Slope stabilisation measures are now being designed. Works will be carried out late 2011 to provide restraint to the movement and reduce the rate of deterioration to this area. These design and construction works were authorised by an urgent action and decision of the Executive on the 27th September 2011 at a total cost of up to £133,000.

Area B This area is a top of a retaining wall running alongside the U4440 Wagon Road. The embankment between this adopted road and numbers 1-14 Bransty Road has been the subject of slippage. This means that some soil rests on the top of the retaining wall. Further pressure from soil slippage further up the embankment could cause this soil lying on top of the retaining wall to slip onto the road. If this does occur it will only consist of small amounts of soil at any one time. The area needs to be inspected regularly and any soil falling from the wall removed. The wall itself is in poor condition but remains solid. It is expected that this wall will need to be replaced over the next 10-15 years at a cost of around £33,000.

Area C On the 24th December 2009 the embankment in this area suffered a land slip which caused a large amount of soil to slide towards the U4440 Wagon Road. Fortunately it was caught in the trees on the embankment and did not fall onto the road. Permanent soil nailing works are now being undertaken.
