Ref: 10-365-L1
Date: 19th July 2021

COAL MINING RISK ASSESSMENT JEFFERSON PARK, WHITEHAVEN

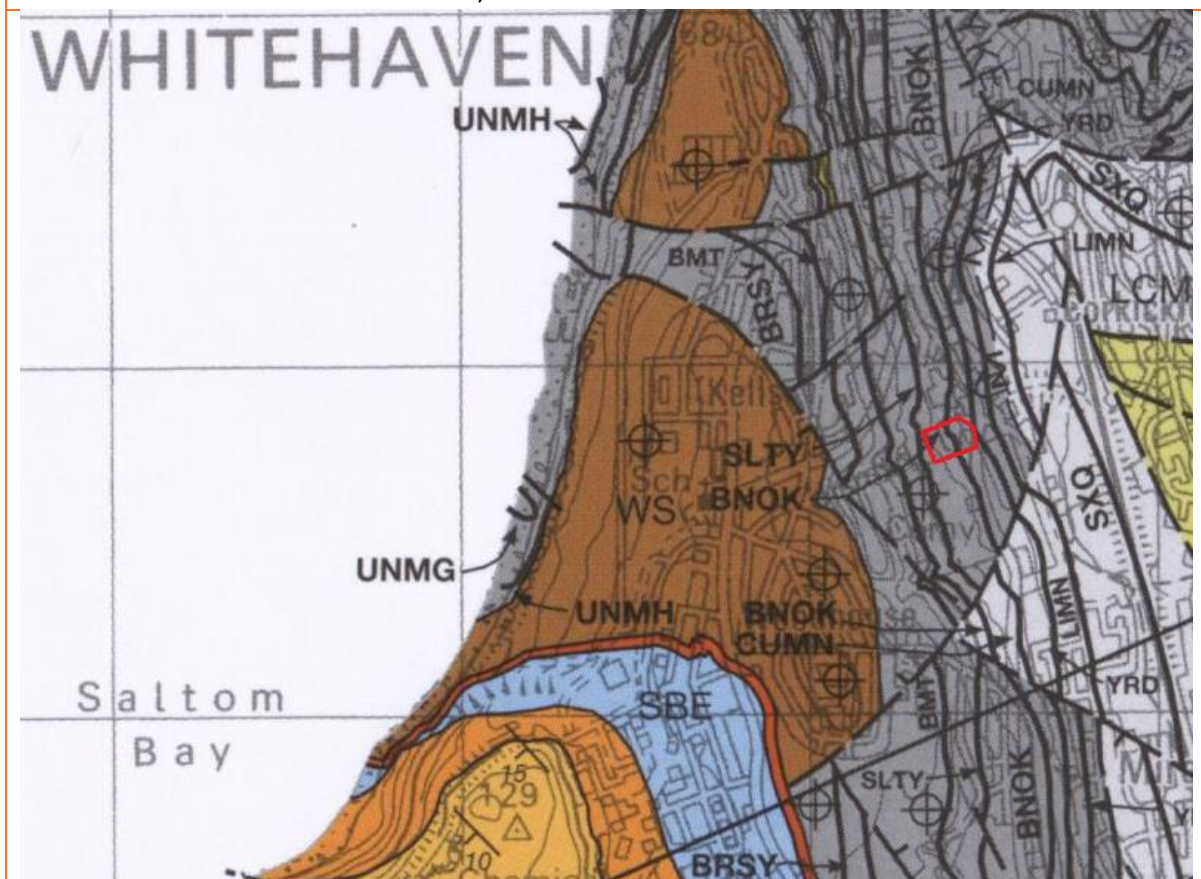
FIGURE 2.1 EXCERPT OF THE 1:10,000 PLAN FOR THE SITE

Figure 2.1 is a excerpt of the 1:10,000 plan for the site which identifies the presence of Bannock Coal underlying the western sector of the site at shallow depth, underlain by Main Coal which outcrops through the eastern profile of the site towards Low Road. This in turn is underlain by Yard Coal which outcrops east of the subject site. The redline denotes the approximate site boundary.

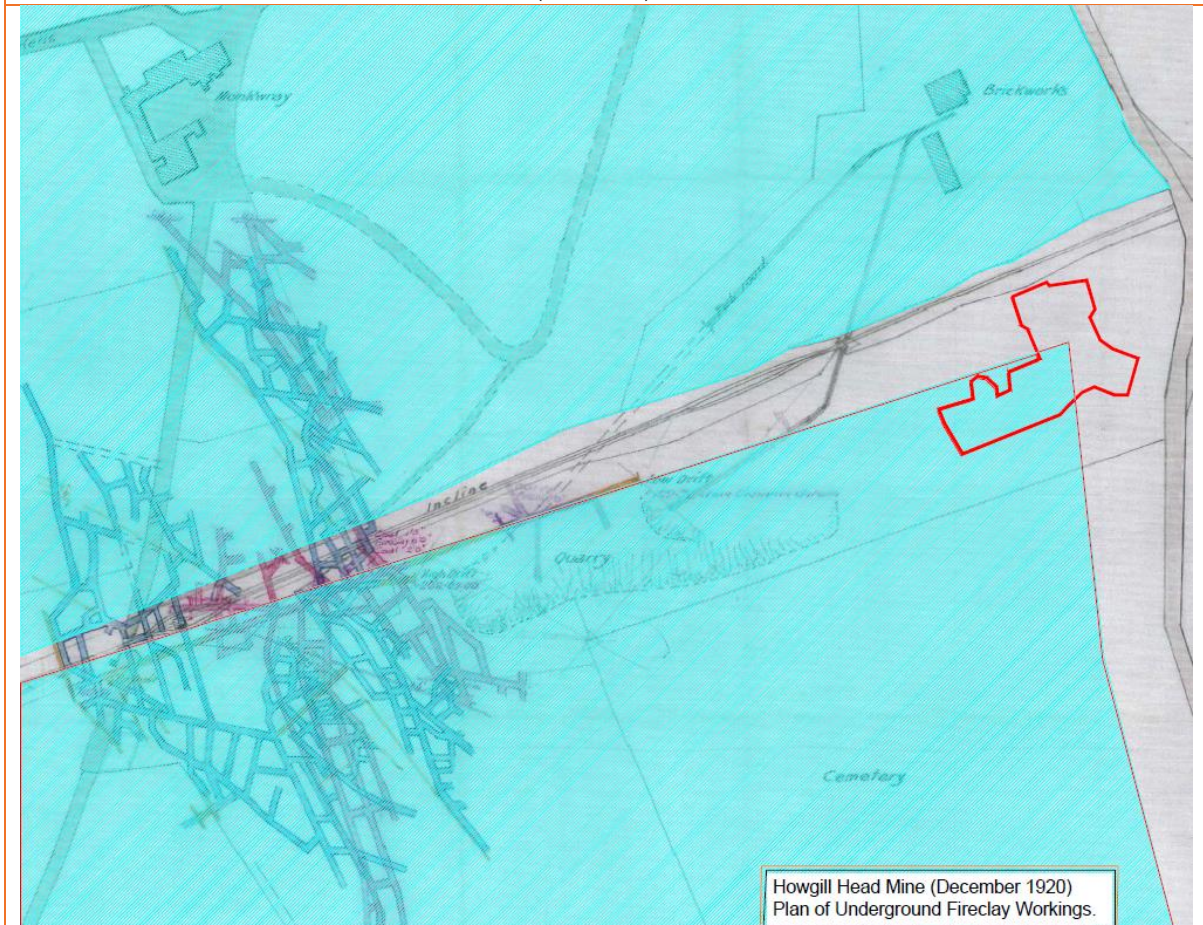
FIGURE 2.3 – MINE ABANDONMENT PLAN (NW1387)

The mine abandonment plan (Ref: NW1387) show the extent of known workings below the site.

The blue denotes the area the area of which the Whitehaven Main Coal seam was either partially or fully extracted. The site lies at the outer extremity of the recorded extraction area.

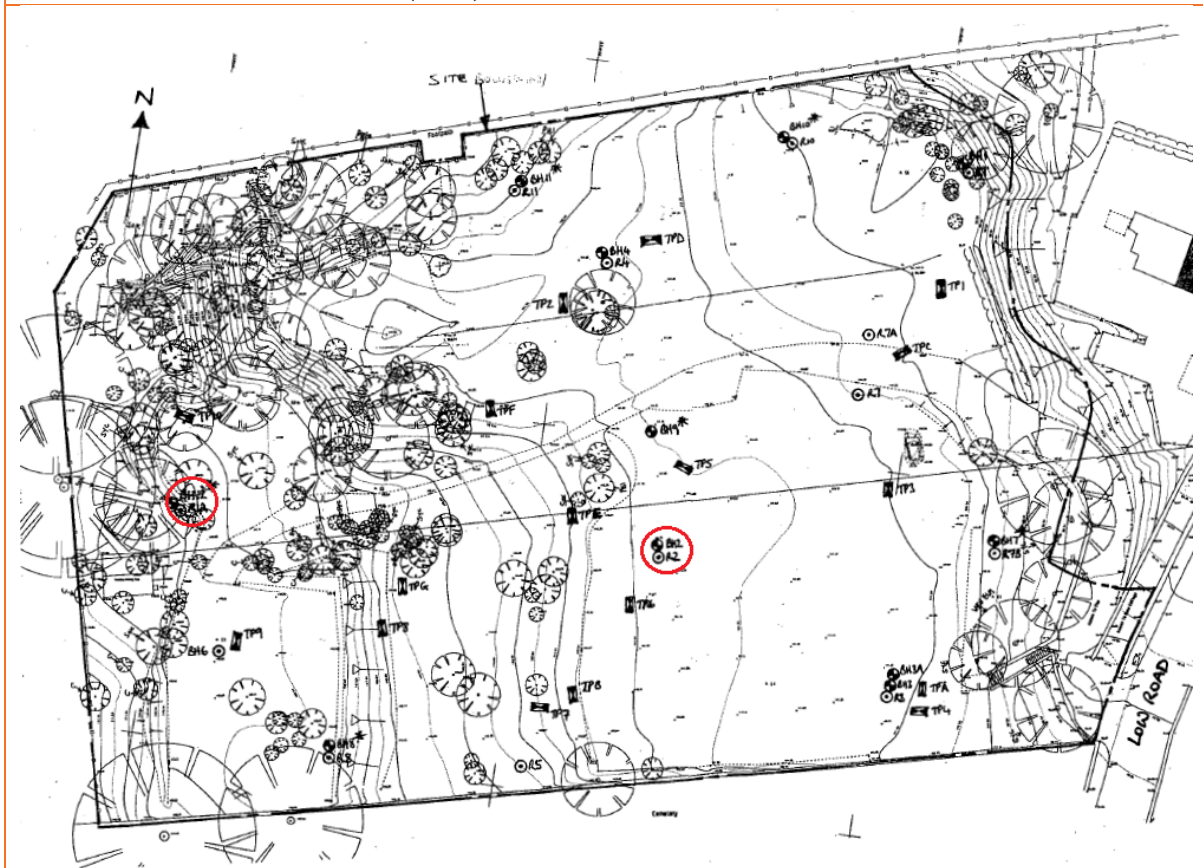
FIGURE 3.1 – SUB SURFACE NW (2007) – BOREHOLE LOCATION PLAN

The Sub Surface (NW) Ltd investigation recorded voids in boreholes R2 and R12. In R2, a 1.20m void was recorded at 22.00m bgl (with loss of flush from 20.80m bgl). R2 is located within the undeveloped grassed area within the central portion of the site. Treatment details for this void are currently awaited from the Coal Authority;

In R12, a 1.00m void was recorded at 18.50m bgl, overlying 1.50m of loose drilling and flush loss recorded from 16.00m bgl. R12 is located c. 30m west of the site boundary. It is unknown if any treatment has been undertaken in this portion of the site and E3P await confirmation from the Coal Authority.

Historic workings / voids are recorded in R2 and a process of proof drilling is required beneath areas of proposed structures and infrastructure with pressure grouting and stabilisation of any workings to ensure adequate consolidation in accordance with CIRIA 758 (subject to confirmation of previous treatment details from the Coal Authority).

Given the presence of thick shallow coal and insufficient rock cover, the site will need to be proof drilled on a 6m grid (beneath structures) and 10m grid beneath roads / infrastructure. Where workings are identified, they will need to be pressure grouted, with possible reduced spacing depending on grout takes.
