DESIGN / HERITAGE IMPACT
ASSESSMENT

HENNERY / PIGGERY AT
BARWICKSTEAD, BECKERMET – 22
March 2022

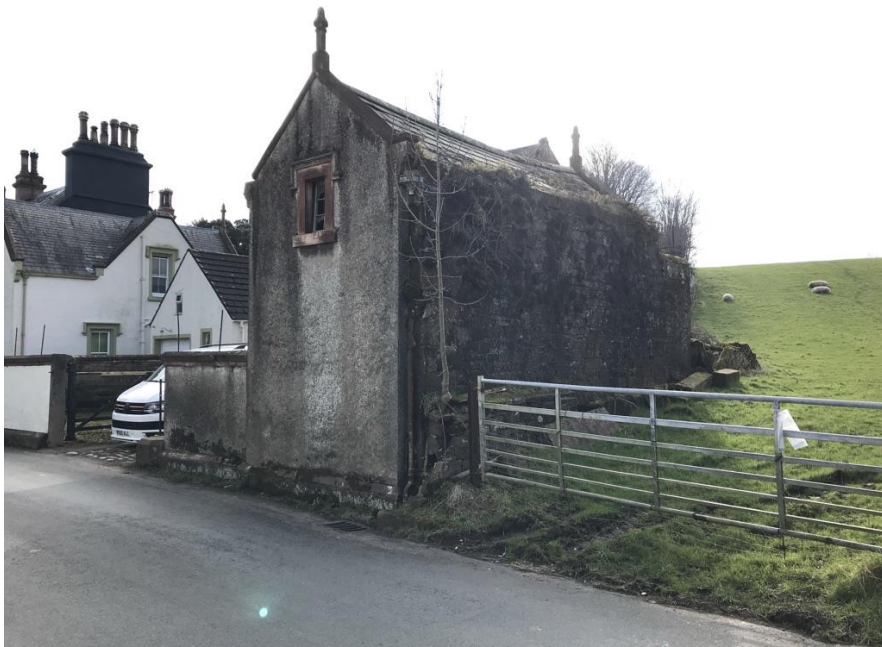
View away from Barwickstead showing barn built into hillside. Vegetation growths to stonework require removal

1. External walls - retained and repaired where required to include re-bedding loose stonework, mouldings etc and bedding with lime mortar. Removal of all vegetation growth from the jointing of the stonework. Elevations to be cleaned off with power washing with option for light sandblast cleaning in areas of lime wash / render. Loose mortar joints to be raked out and re-pointed in lime mortar.
2. Internal walls - these are to be cleaned down and re-pointed with all vegetation growth removed.

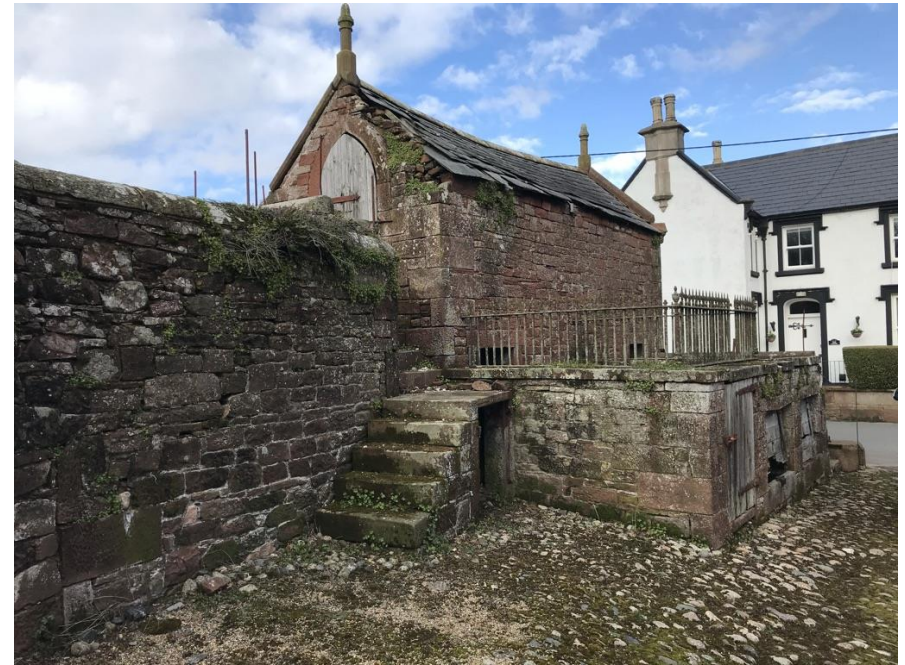
Rear view of Piggery showing decay in stonework (retained on site) and loose / slipped slates as a result of timber failure.

3. Roof Timbers - The existing timbers will be inspected once the floor is made good. Timber repairs will be completed on a like for like basis in cross section and timber sizing, mainly where decay has occurred to the lower edges due to water ingress

4. Roof coverings - the roof will be stripped off and the existing slates removed and re-dressed / re-holed before re-laying with new 25 x 50mm softwood treated graded roof battens. Additional roof slates will be required to make up defective / re-holed slates and this will be sourced as diminishing coursed second hand green slates. A modern breathable roofing felt will be installed to allow flexibility for future use of the building.
