**Visual Structural Inspection  
of  
Ga37 Hight Stret , Cleator Moor  
For  
Mr N Rashid**

Reference - 2025.432 rep001 Rev -  
Date - 15/08/2025  
Author - Paul Crooks BEng CEng MICE  
ICE membership No: 48526190

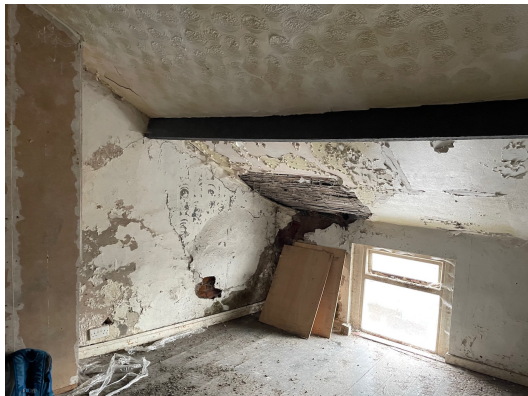
photo 3.1a

Internally, a section of plaster ceiling has detached at the front eaves suggesting water penetration (see photo 3.1a). To the rear damp/water penetration was visible with sections of plasterboard detached (see photo 3.1b).

Given the age of the building the roofs are in reasonable condition. There is the potential for damp penetration (and subsequent damage) to some of the timber rafters. These should be examined as part of the refurbishment works.

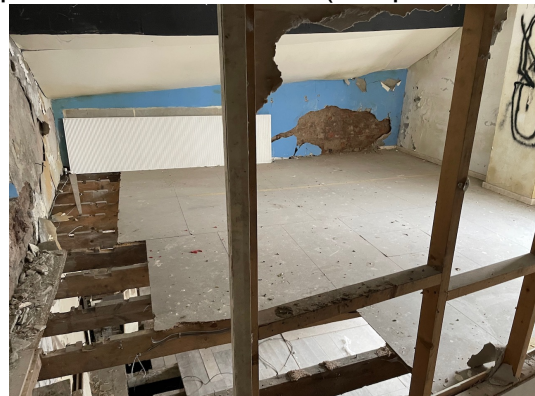
photo 3.1b

The second floor consists of a number of rooms partly within the roof space. The floors consist of timber floor boards or floor panels on timber joists spanning between internal load-bearing masonry walls and the external walls. To the rear rooms sections of the floor panels are missing (see photo 3.1b).

It is likely that a number of the timber members to the 'lean-to' roof will need to be replaced.

In addition to replacing missing floor boards, a number of rotten floor joists will need to be replaced. It is recommended that all timber joists should be checked for damp penetration (particularly where they abut external walls).

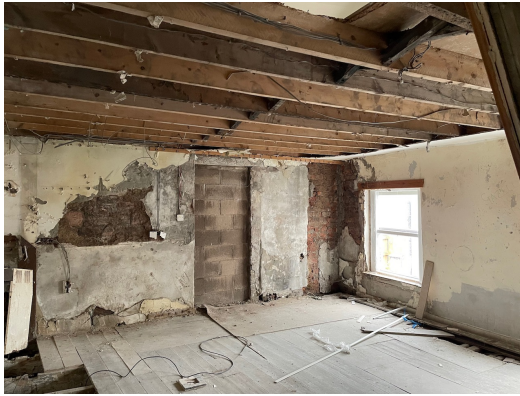
photo 3.3a

The floors consist of timber floor boards on timber joists spanning between internal load-bearing masonry walls and the external walls. To the rear rooms sections of the floor boards are missing and some have been replaced with floor panels (see photo 3.3a). The ceiling has also been removed in this area.

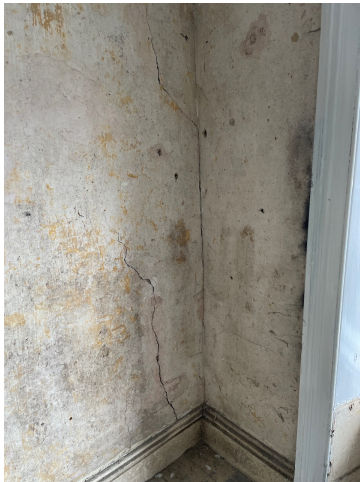
photo 3.3b

Cracking was visible to the plaster to both sides of the central spine wall where it meets the front wall. (see photo 3.3b). It was not possible to ascertain if this cracking extended through the masonry behind.

The spine walls should be examined to ensure they are adequately tied into the external walls.

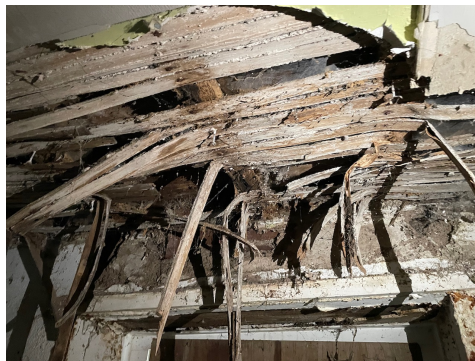
photo 3.3c

The floorboards and joists to the rear room (within the lean-to section) are rotten, the ceiling below has collapsed (see photo 3.3c)

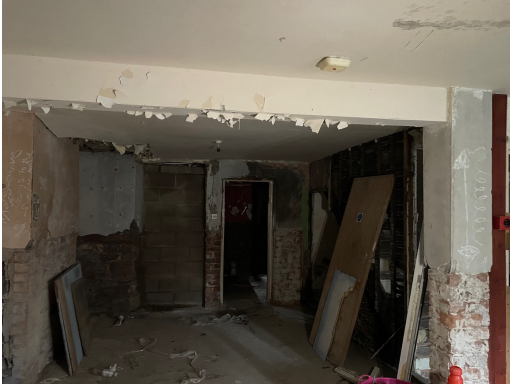
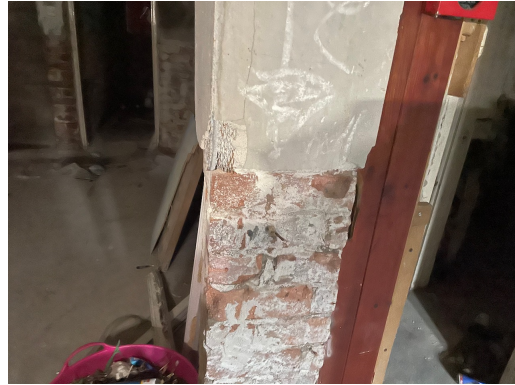
A load-bearing wall has been removed between the front and rear rooms. The walls above are supported on a beam sitting on the external walls and 230 x 250 brickwork pier internally (see photos 3.4a and 3.4b)

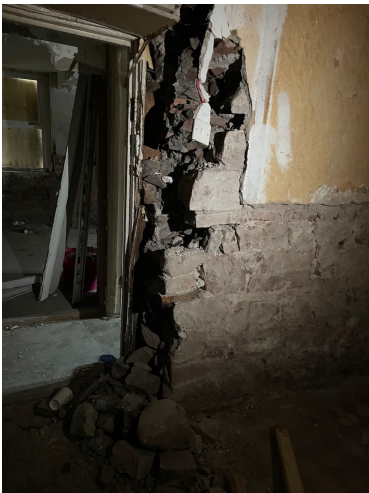
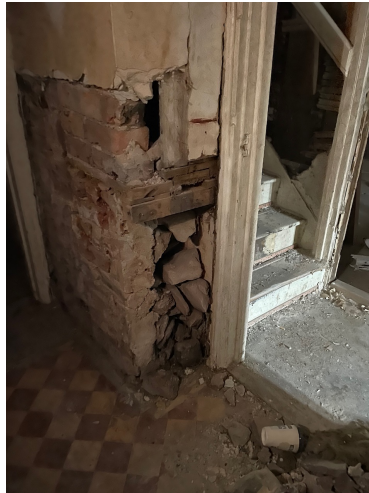
The walls to the opening in the central spine wall have been damaged (see photos 3.4c and 3.4d).

The damaged openings in the walls at ground floor should be repaired as a matter of urgency.

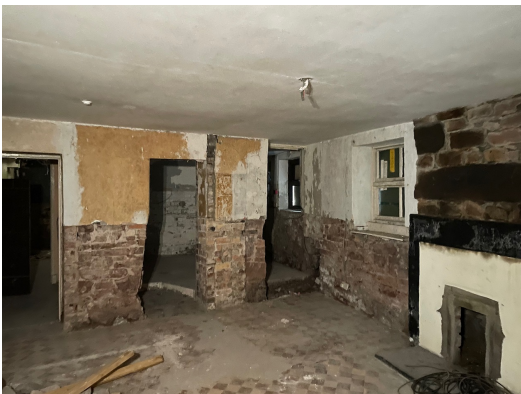
photo 3.4e

Openings have been poorly formed in the walls between front and rear rooms (see photo 3.4e) The masonry to these openings

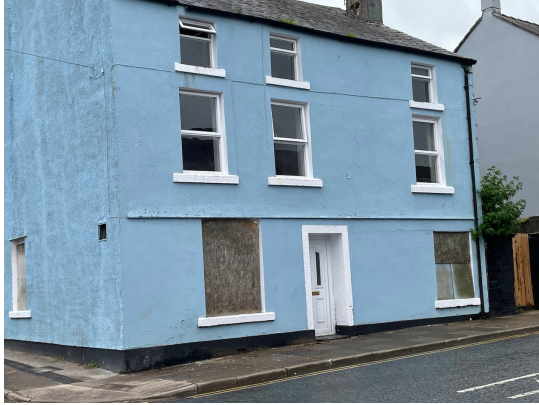
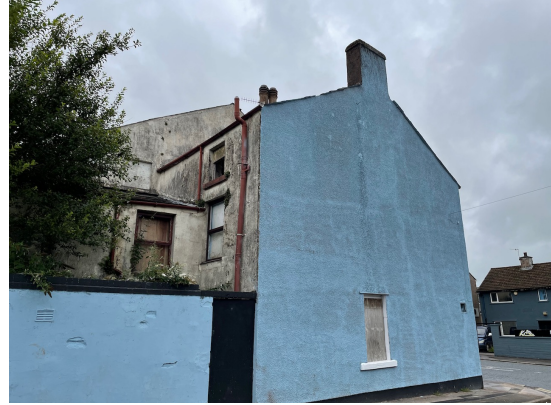
Access to the external elevations was limited to the front and one side at ground level and to the rear from a distance. The front and side walls have been rendered and painted (see photos 3.5a and 3.5b). There is a slight bow to the front elevation. There was no other evidence of movement to these walls.

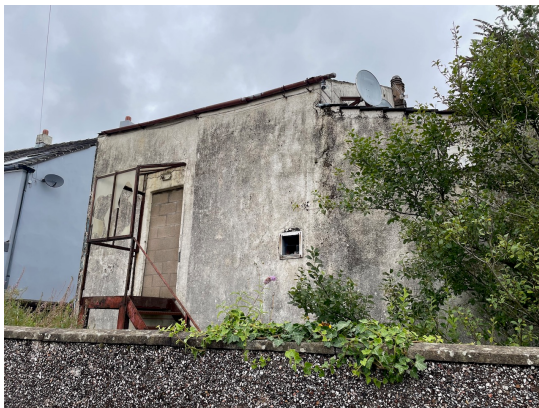
photo 3.5c

The rear walls have been rendered and are showing signs of discolouration due to damp over the entire surface (see photo 3.5c)

The external walls should be inspected for damp penetration.

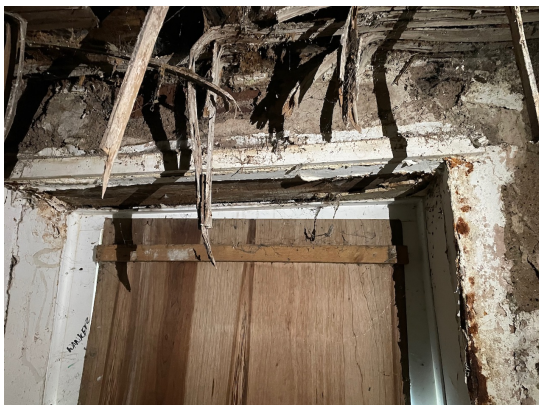
photo 3.6a

The lintels to door and window openings are not generally visible, so the type and condition not be fully ascertained. The limited number visible would appear to be timber to the internal leaf (see photo 3.6a). Given the moisture damage to timber elsewhere there is potential for these to be in poor condition.

All the lintels should be exposed and examined for damage/deterioration. Where necessary these should be replaced.
