STRUCTURAL INSPECTION REPORT

LOCATION: MILL FARM BARNS, THE GREEN, MILLOM,
CUMBRIA, LA18 5HL

CLIENT: MVC DESIGN LTD

JOB No: 25184

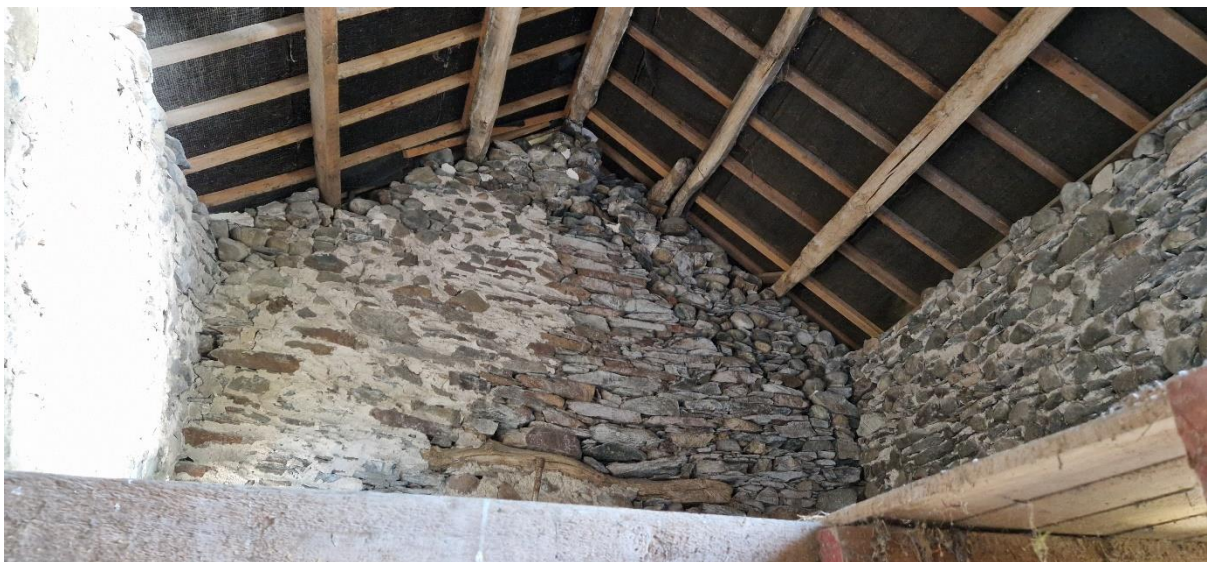
Photo 1 - Gable End and Roof of Barn 1

Barn 1 is located at the southern end and contains a timber first floor. The roof structure consists of an intermediate triangular timber truss with two side purlins each side and a ridge. It has been re-roofed historically with a membrane installed over the rafters. The timber generally appears to be in reasonable condition with no obvious water ingress present.

There is a mixture of timber and stone lintels about openings. The walls are generally straight and true with limited signs of lateral movement. There is some loose stone present towards the peaks of the gable ends. There is render present in part containing several cracks and the lime mortar is old and has deteriorated generally.

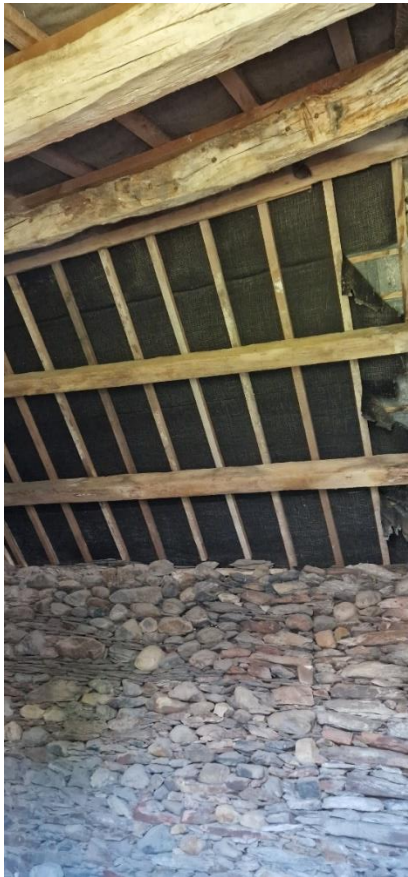
Photo 2 - Roof and Western Wall of Barn 2

Barn 2 was not accessible at ground floor level but ladder access to the first-floor hay barn was available. The roof was again traditional with purlins spanning between gable walls. It had also been re-roofed. The timber generally appears to be in reasonable condition with no obvious water ingress present.

The first floor had severely deflected and needs to be removed during any conversion works

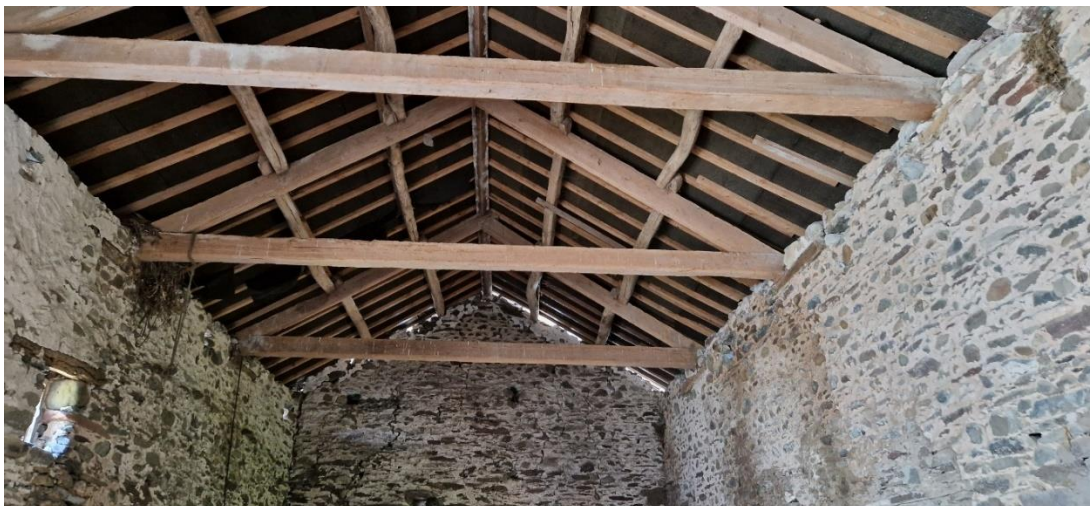
Photo 3 - roof of Barn 3

Large single storey open barn containing 5 intermediate triangular trusses with two side purlins each side. It has again been re-roofed. The timber generally appears to be in reasonable condition with no obvious water ingress present.
