Our Reference: 4046-G-LR031

Date: 15<sup>th</sup> February 2023

**Phase 3A, Edgehill, Whitehaven (Incl. Plots 206-208, 233-235 & 241-308); Verification of Absence of Contamination or Ground Gas Risk**

| JOB TITLE | Phase 3A, Edgehill Park, Whitehaven |

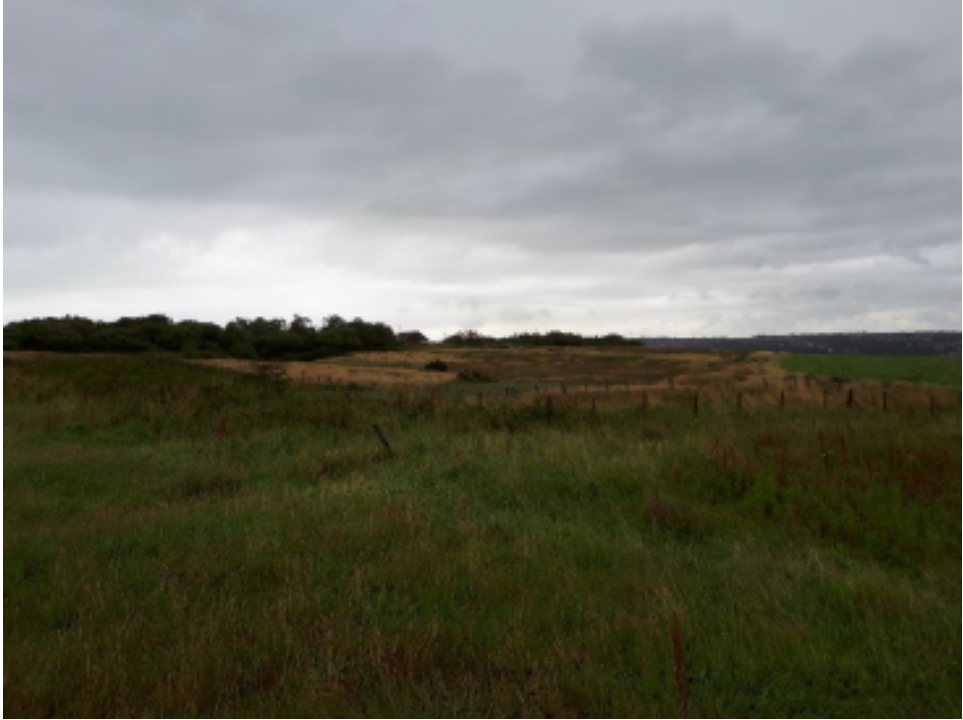
| <b>Photograph 1:</b><br><br>Eastern site corner (foreground) looking northeast from southern boundary, prior to topsoil strip (August 2020) | | | |

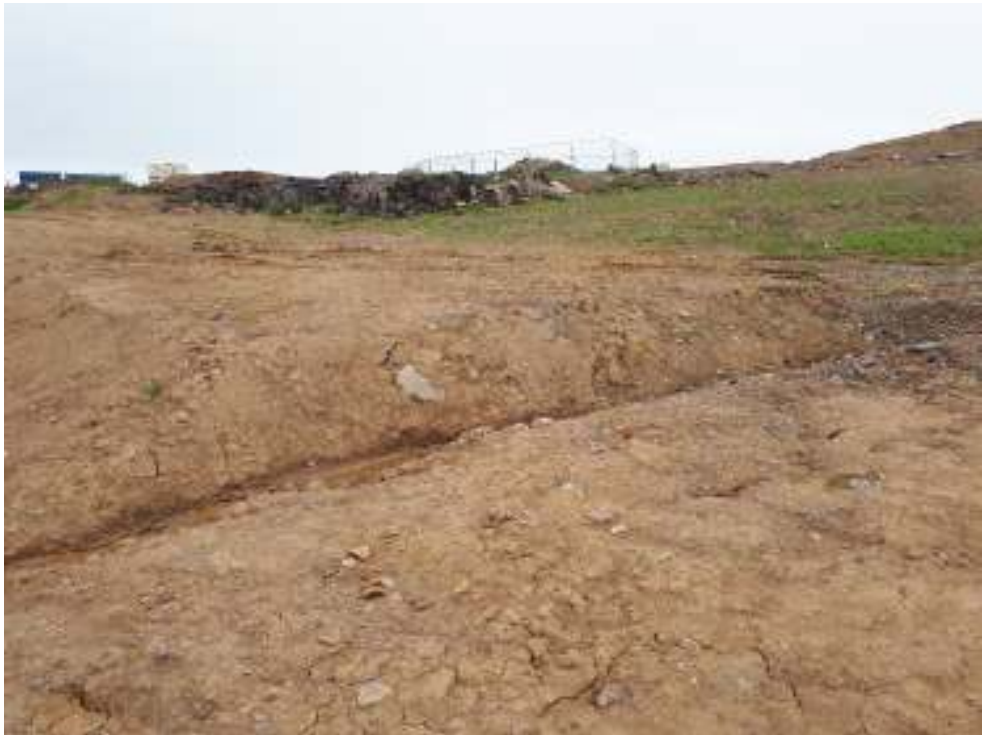
| <b>Photograph 2:</b><br><br>Exposed natural clay deposits on site surface in eastern site corner following topsoil removal. Looking west from south-eastern boundary, (June 2021). | | | |

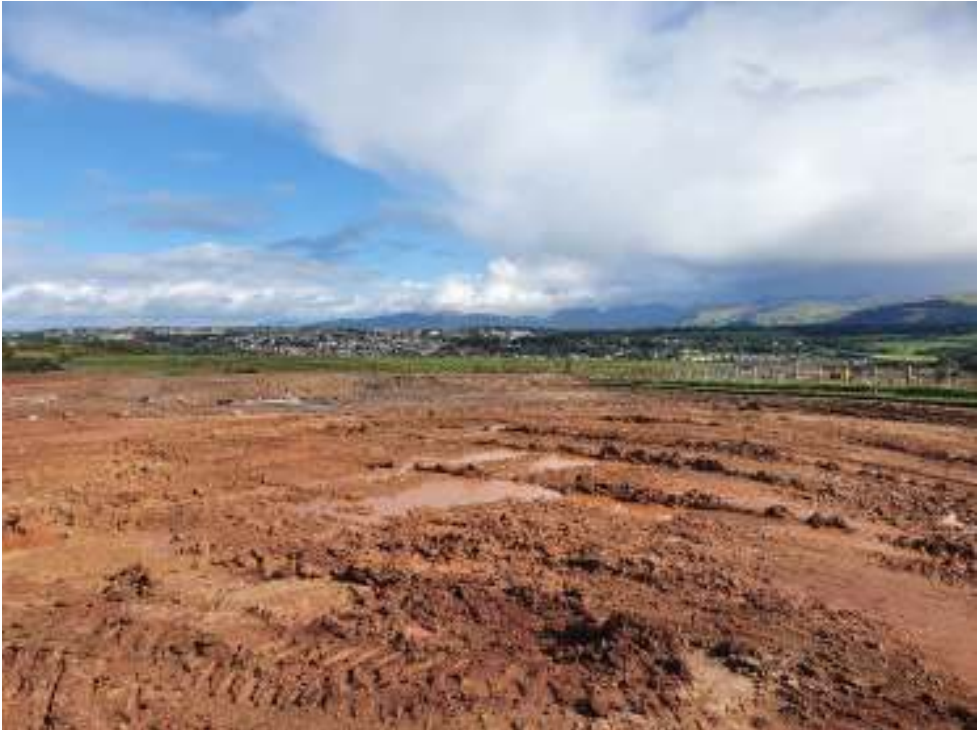
| <b>Photograph 3:</b><br><br>Exposed natural clay deposits on southern site surface following topsoil removal and preparatory earthworks. Viewed from the western boundary. (September 2021). | | | |

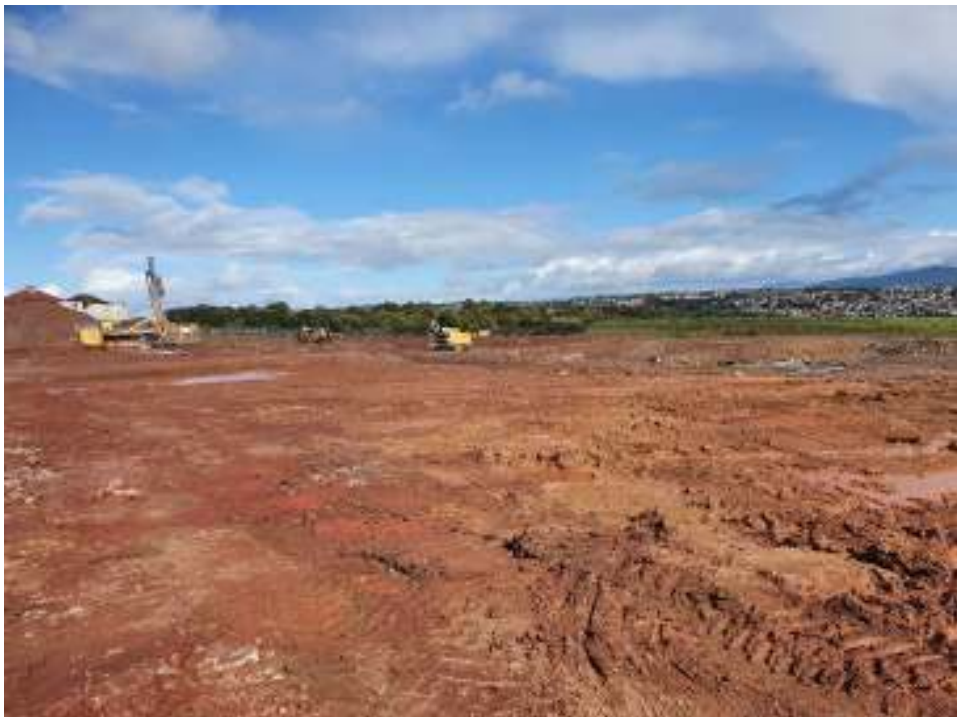
| <b>Photograph 4:</b><br><br>Exposed natural red mudstone & siltstone bedrock on the southern site surface following topsoil removal prior to treatment of shallow mineworkings. Viewed from the southwest site corner. (October 2021). | | | |

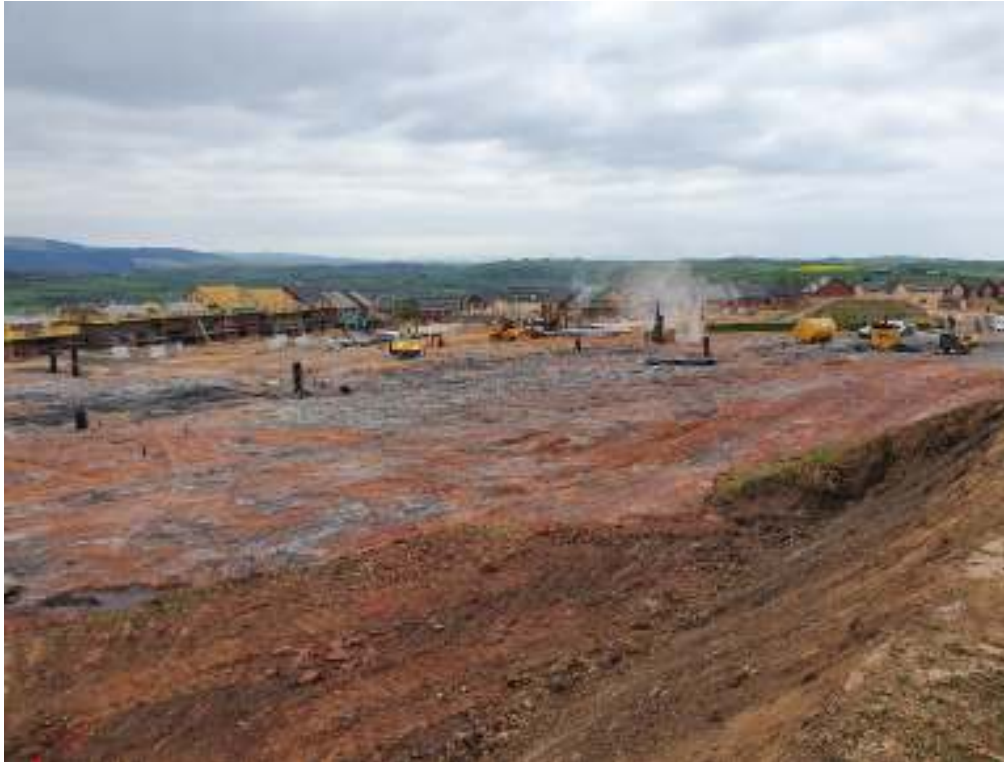
| <p><b>Photograph 5:</b></p> <p>Exposed natural red mudstone &amp; siltstone bedrock on the southern site surface following topsoil removal during treatment of shallow mineworkings. Grey deposits are grout associated with the mine treatment works.</p> <p>Viewed from the north-west. (April 2022).</p> | | | |

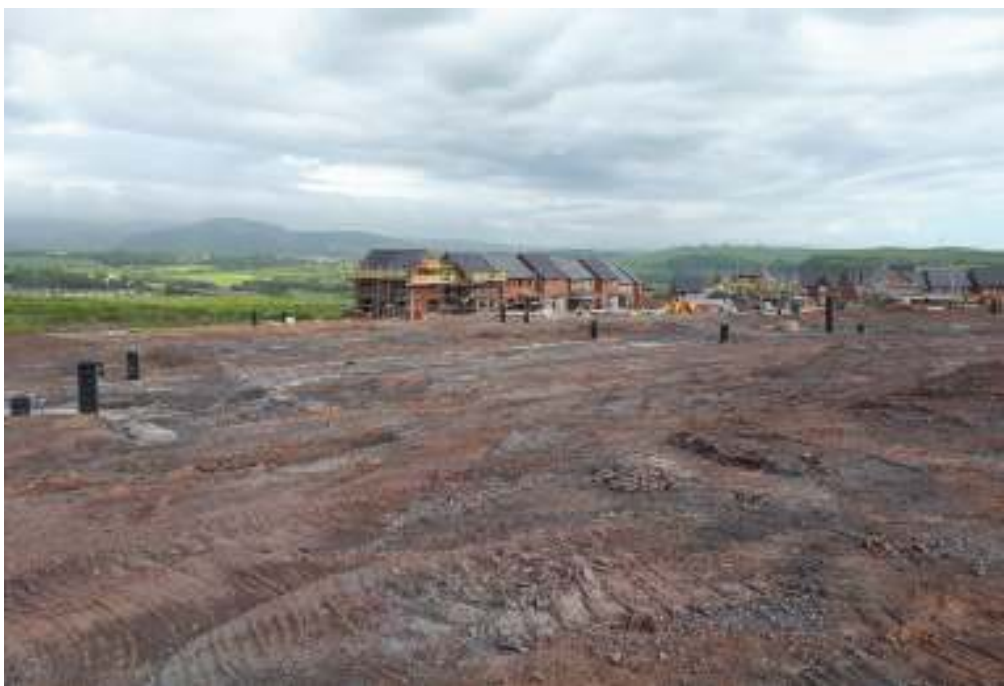
| <p><b>Photograph 6:</b></p> <p>Exposed natural red mudstone &amp; siltstone bedrock on site surface following topsoil removal during treatment of shallow mineworkings. Grey deposits are grout associated with the mine treatment works. Viewed from the northwest boundary (June 2022)</p> | | | |
