# Visual Tree Assessment Survey Report

**Store: 6134 - Millom**

Prepared for: **TESCO**

**Part of the estate wide Tree Survey Programme 2020/21**

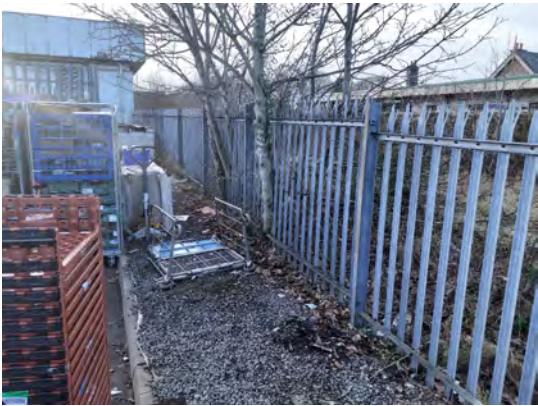
**Tree Ref: GC009389**  
Species: Sycamore

Locality Name	Action Reference Number	Tree Reference	Tag Number	Species	Tree Remarks	Group Number	Inspection Remarks	Action	Action Remarks	Action By	Action Priority	Site Hazard Class
6134 - Millom	AC00002718	GC009389	No tag	Sycamore		5	Growing through the fence.	Fell to Ground Level (Section Fell) & Treat Stump	Fell all trees growing against and through the fence.	Tree Team	Within 3 - 6 Months	High Risk
6134 - Millom	AC00002955	GC009386	3739	Sycamore			Growing against the fence and retaining wall.	Fell to Ground Level (Section Fell) & Treat Stump		Tree Team	Within 3 - 6 Months	High Risk
6134 - Millom	AC00002956	GC009387	No tag	Ash			Growing against the fence and retaining wall.	Fell to Ground Level (Section Fell) & Treat Stump		Tree Team	Within 3 - 6 Months	High Risk

Fell to Ground Level (Section Fell) & Treat  
Stump

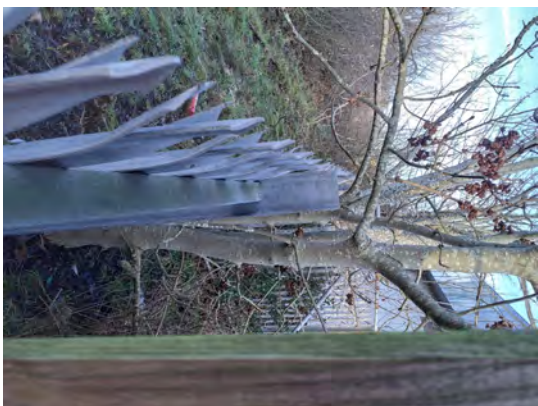
**Tree Ref: GC009387**  
Species: Ash

6134 - Millom	GC009387	IN00009058	No tag	Tree	Ash			Client		6 - 10 Metres	0 - 150 mm	6	Young	Car Park, Railway, Boundary Wall or Fence	No Access - Only Crown Vitality Inspected	Fair	Work Action Required	Growing against the fence and retaining wall.	Multi-Stem
6134 - Millom	GC009388	IN00009059	No tag	Group	Sycamore		2	Client		6 - 10 Metres	0 - 150 mm	5	Young	Building, Railway, Boundary Wall or Fence	No Access - Only Crown Vitality Inspected	Fair	No Works at this Time		Previously Reduced
6134 - Millom	GC009389	IN00009060	No tag	Group	Sycamore		5	Third Party		6 - 10 Metres	150 - 300 mm	5	Young	Car Park, Railway, Boundary Wall or Fence	Limited Access - Only Crown Vitality Inspected	Poor	Work Action Required	Growing through the fence.	No Visible Issues or Defects
6134 - Millom	GC009390	IN00009061	No tag	Tree	Sycamore			Client		6 - 10 Metres	150 - 300 mm	10	Middle Aged	Footpath and Road, Railway	Full Access	Fair	No Works at this Time		No Visible Issues or Defects

Fell to Ground Level (Section Fell) & Treat  
Stump
