## Structural Assessment Report Town Head Farm Nethertown

## Structural Assessment Report

Tweddell and Slater Ltd were appointed by Stuart Woodall, to carry out a structural survey of the barns and cottage at Town Head Farm, Nethertown. We visited the property on 14<sup>th</sup> August 2020 to carry out a visual inspection only. This report is not therefore intended to be a full structural survey, we cannot comment on areas of the structure that were concealed or inaccessible.

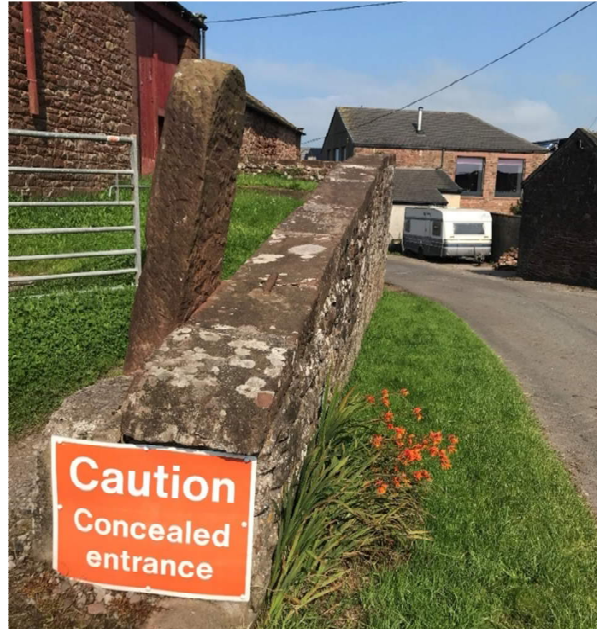
Barn One was located at the south eastern end of the yard. It comprised of two storeys, the ground floor accessed from the yard side and the first floor accessed from a ramp in the road side. The earth ramp was bounded by a stone retaining wall adjacent the road and Barn two behind, which had an outwards lean at the top of the wall.

*Figure 3.0 – Lean in retaining wall to Barn One*

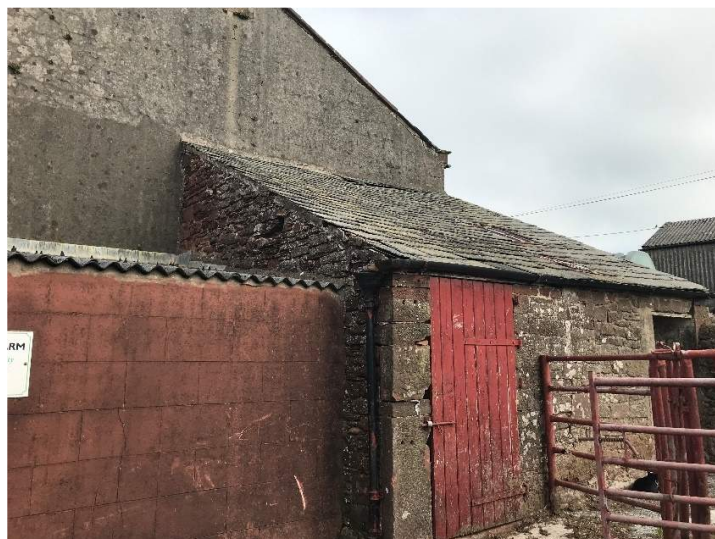
The adjacent road also sloped up from the north western end to the gable and then back down into the yard. There were two lean to extensions on the gable of Barn One, the yard side one constructed in blockwork with render finish and corrugated roof sheeting and the road side one constructed in stone with slate roof. The barn gable above the lean to roofs was also rendered in cement.

*Figure 3.1 – Lean to extensions and rendered gable*

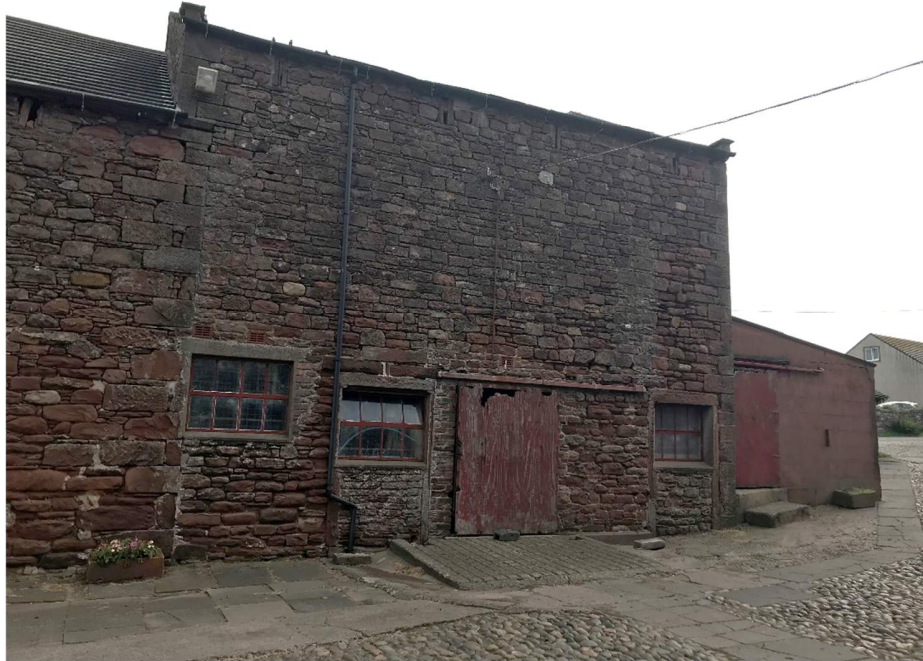
There were some undulations in the yard side wall, with an outwards lean of up to 35mm in a 1.2m length over the barn door. There were areas of missing mortar and heavily weathered stones and some areas of cement pointing were noted, with some spalling off. A straight joint was observed between Barn One and Barn Two.

*Figure 3.2 – Yard side wall of Barn One*

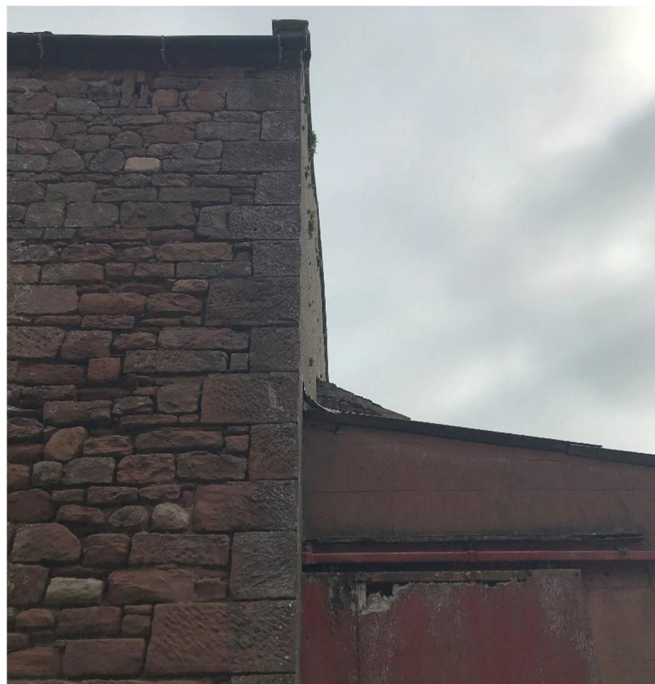
An inwards dish was noted in the gable peak, with an inward lean at the ridge. Loose stonework and cracked render was noted at the yard side eaves. A cast iron downspout was noted to discharge onto the ground behind the blockwork lean to extension.

*Figure 3.3 – Dish in gable*

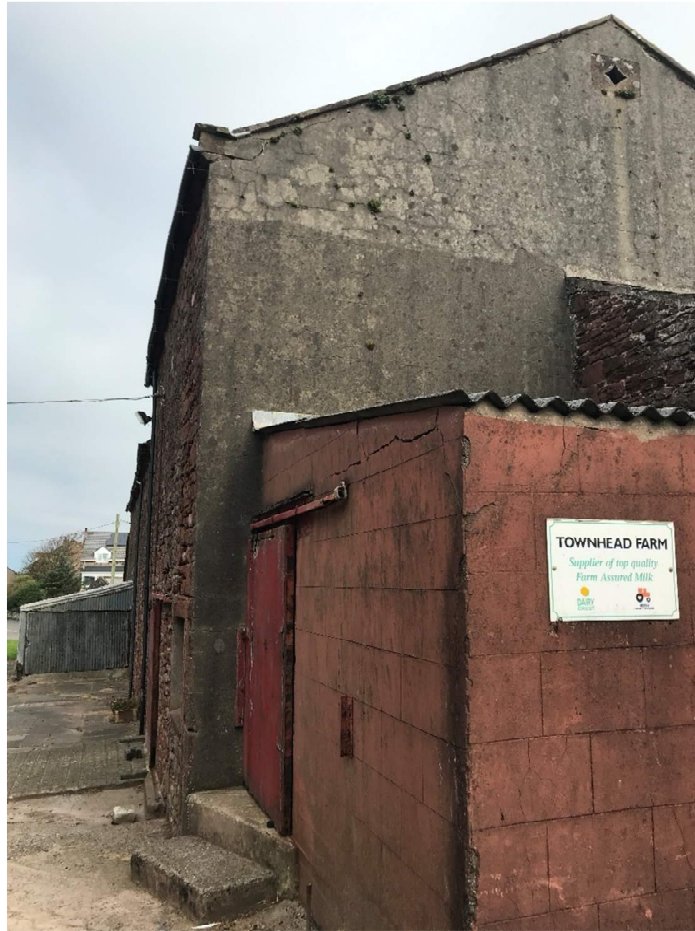
*Figure 3.4 – Loose stones at eaves and cracking to extension*

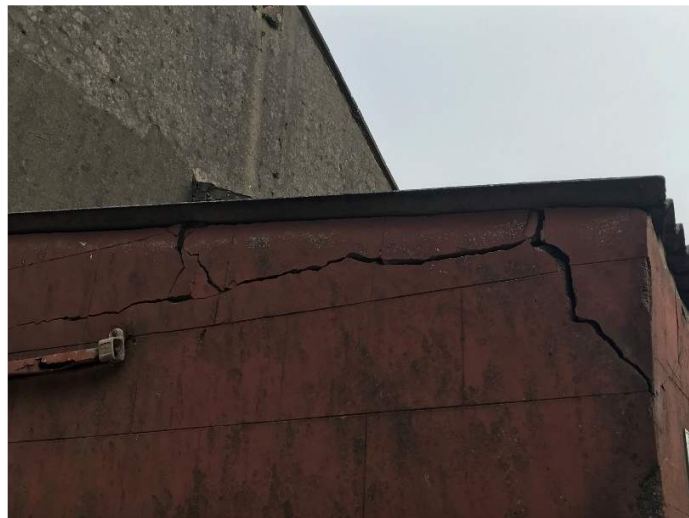
There was cracking to the blockwork along the eaves of the yard side lean to. The steel angle purlins supporting the roof sheeting appeared to have corroded and broken the blockwork at the bearings. Corrosion of the purlins and cracking at bearings was also noted internally, as well as some water staining on the internal wall.

*Figure 3.5 – Cracking at purlin bearings*

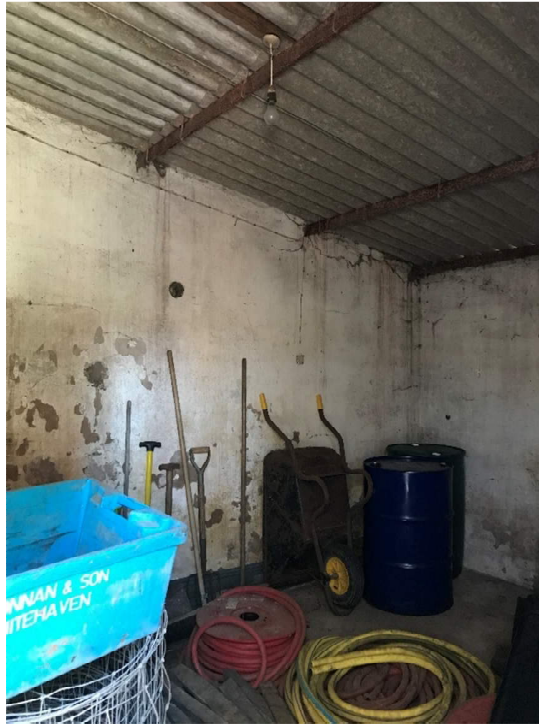
*Figure 3.6 – Water staining and cracking to internal wall*

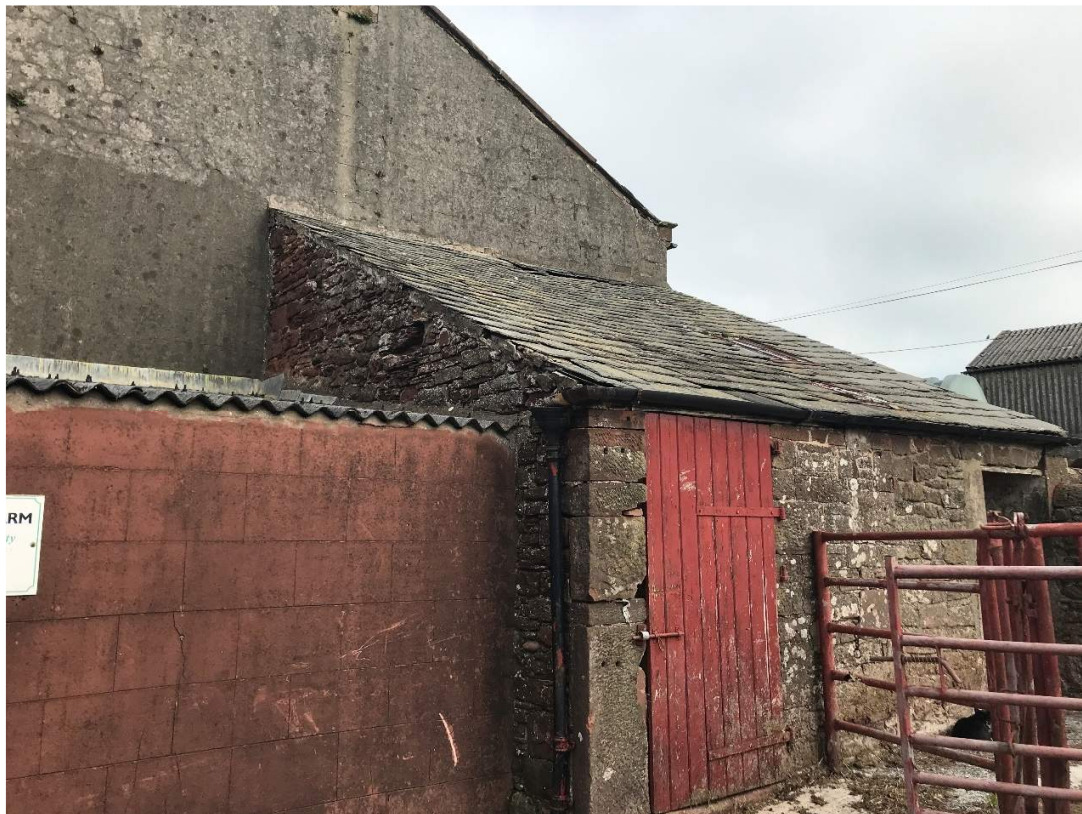
There was a large dip in the roof of the stone lean to, with some separation in the tiles at the junction with the barn gable. There were also two glazed rooflights and some slipped slates.

*Figure 3.7 – Dip in roof of stone lean to extension*

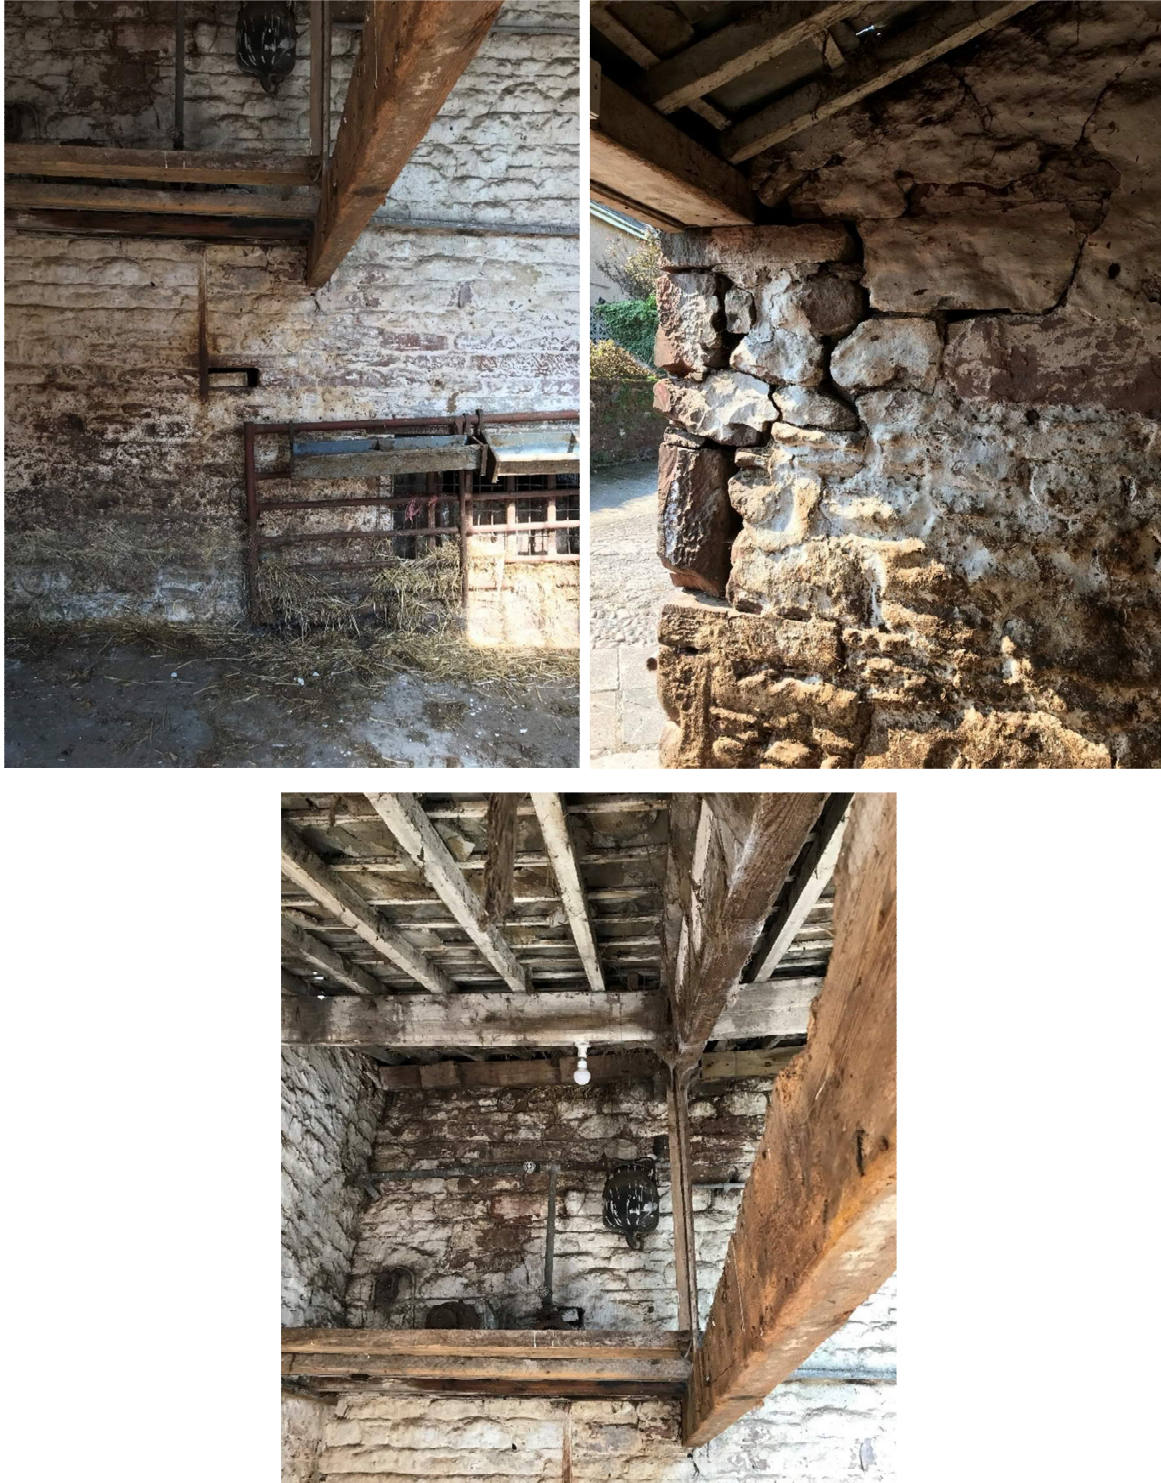
The quoins adjacent to the door were weathered and broken and there was some loose stone and patches of missing mortar on the gable peak facing the yard. Internally, there were timber loose rafters and purlins supported on a timber monopitch truss. There was some cracking under the truss bearings and loose and missing stone around the purlin bearings and the door. A dip in the purlins was also noted, particularly at the bearing onto the truss.

*Figure 3.8 – Cracking at truss bearing, loose stone by door and dip in purlin*

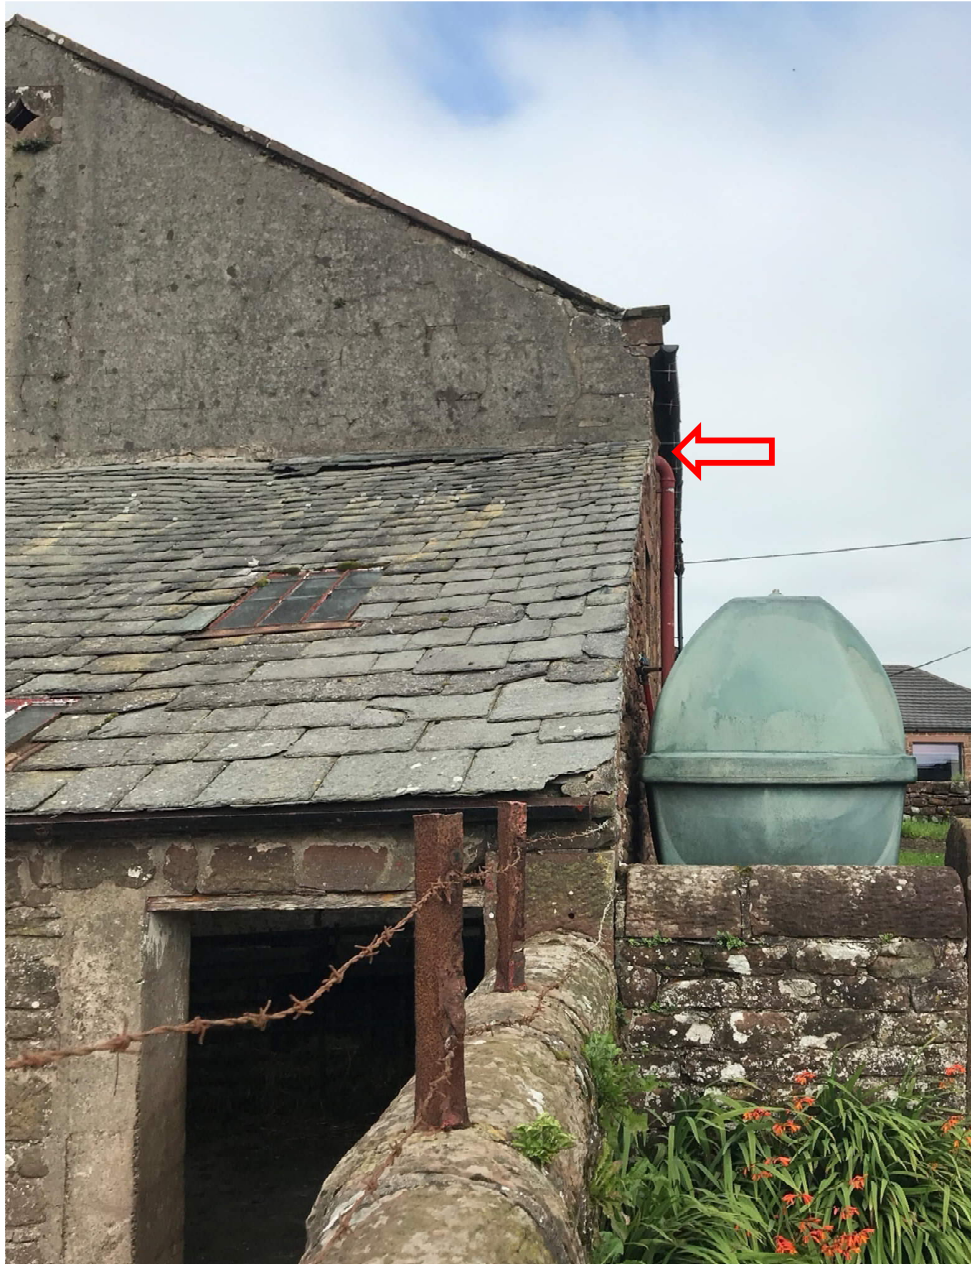
The ground floor section of the road side (front) wall appeared to retain the earth for the ramp up to the first floor entrance. An inwards dish was noted to the left hand side of the barn door.

*Figure 3.9 – Inwards dish in front wall*

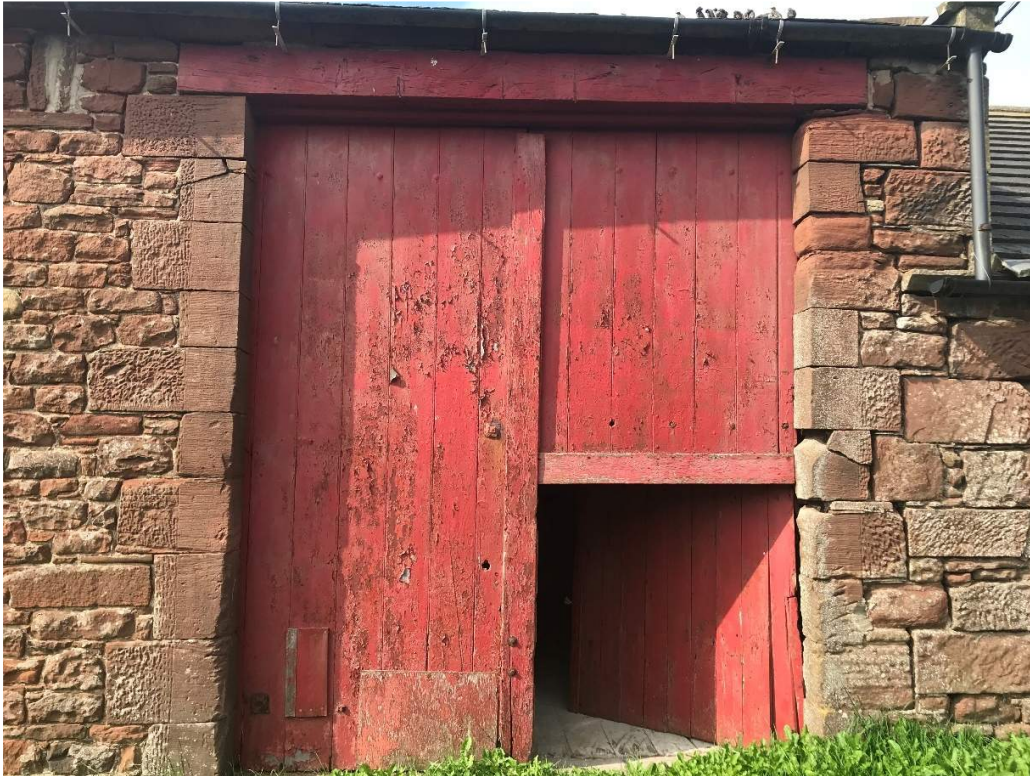
Missing stonework was noted to the gable peak of the lean to extension, along with a straight joint up to the underside of the window. Some patches of cement pointing were observed, particularly around the pipe and at eaves. Otherwise, mortar joints were relatively well filled and only some individual stones appeared well weathered. There was an opening to the lower level with grating over. Cracked stones were noted around the door, particularly where the hinges had corroded and broken the stone. There were also some dry mortar joints to the right hand side of the door.

*Figure 3.10 – Broken stones around door*

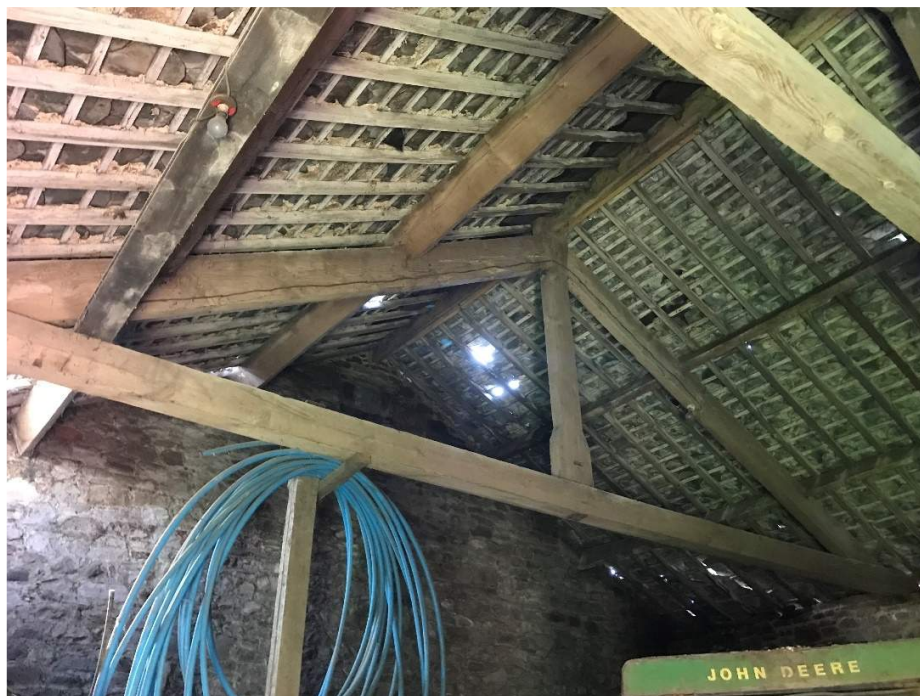
Internally, the floor was suspended timber which appeared relatively stiff under foot but some of the boards were showing signs of rot. The timber loose rafters and purlins were supported on timber principal trusses. The slates and parging were visible from inside, with a couple of slates missing or slipped. The roof timbers generally appeared sound upon visual inspection.

*Figure 3.11 – Barn One roof trusses*

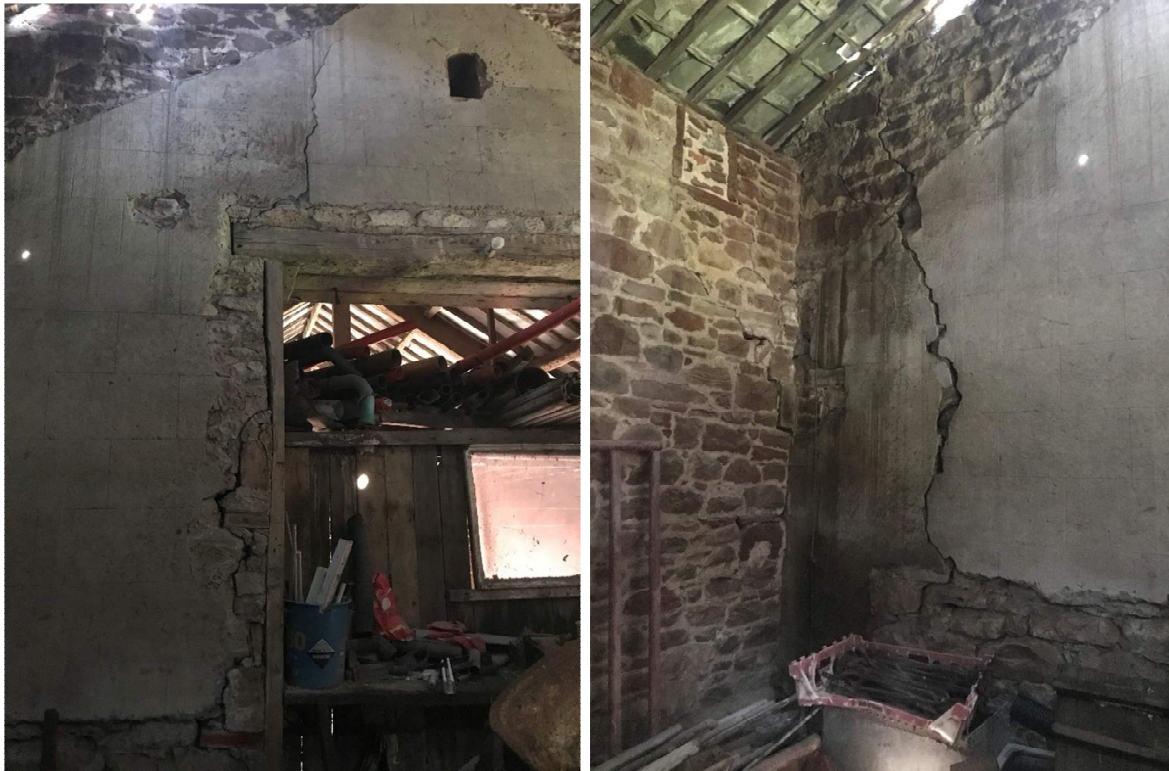
There was a large opening in the internal cross wall with cement render around, that had cracked and spalled. A large diagonal crack was noted at the internal wall/yard wall junction. There was an outwards lean on the yard side wall, measured at approximately 10-15mm in a 1.2m length.

*Figure 3.12 – Cracking in internal wall*

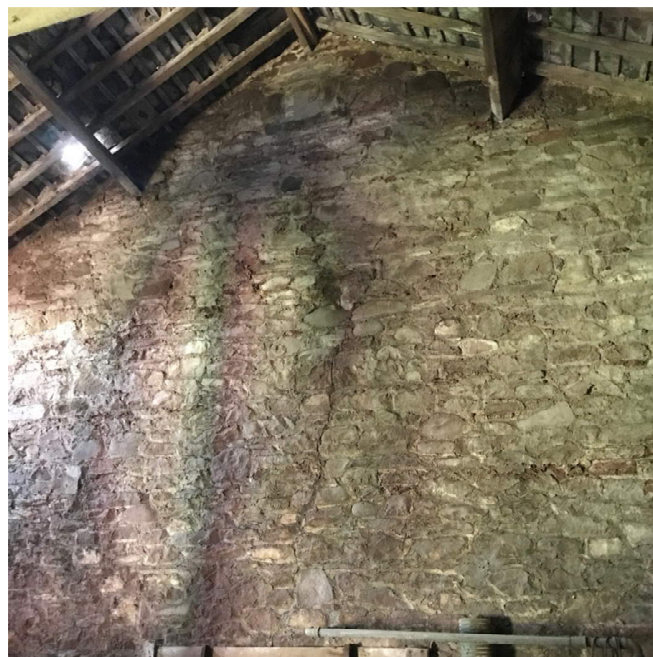
A vertical crack was noted in the gable wall up to the ridge, widening towards the top.

*Figure 3.13 – Vertical crack in gable*

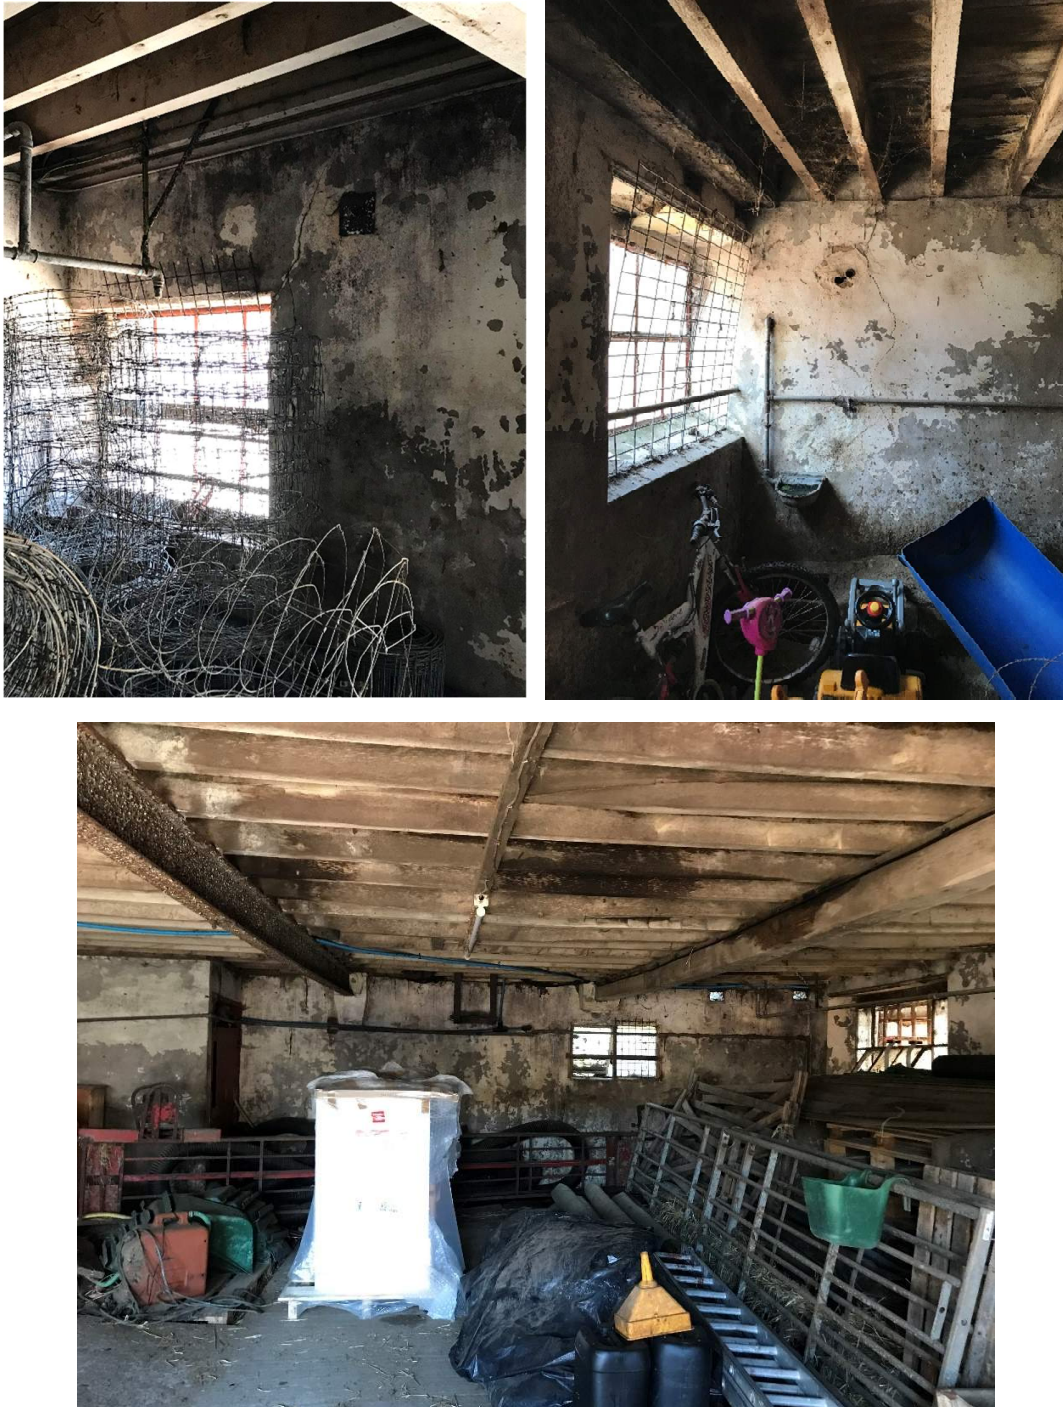
At ground floor level the barn was accessed from the timber sliding door on the yard side. The first floor was supported by one timber beam, measured at approximately 175x225mm, and one steel beam, approximately 230x100mm with an 8mm tapered flange (which could be a 9x3.75x26 RSJ). The steel beam appeared to have replaced an equivalent timber beam at some point and the remaining timber beam appeared to have deflected. Water staining was observed to the floor joists, with corrosion to the steel beam. Corbals were noted at each of the beam bearings. There was some cracking over the yard side window to the left hand side of the door (viewed from inside), as well as some cracking under a joist bearing on the internal wall (near to the yard side).

Figure 3.14 – Cracking in Barn One ground floor and first floor structure

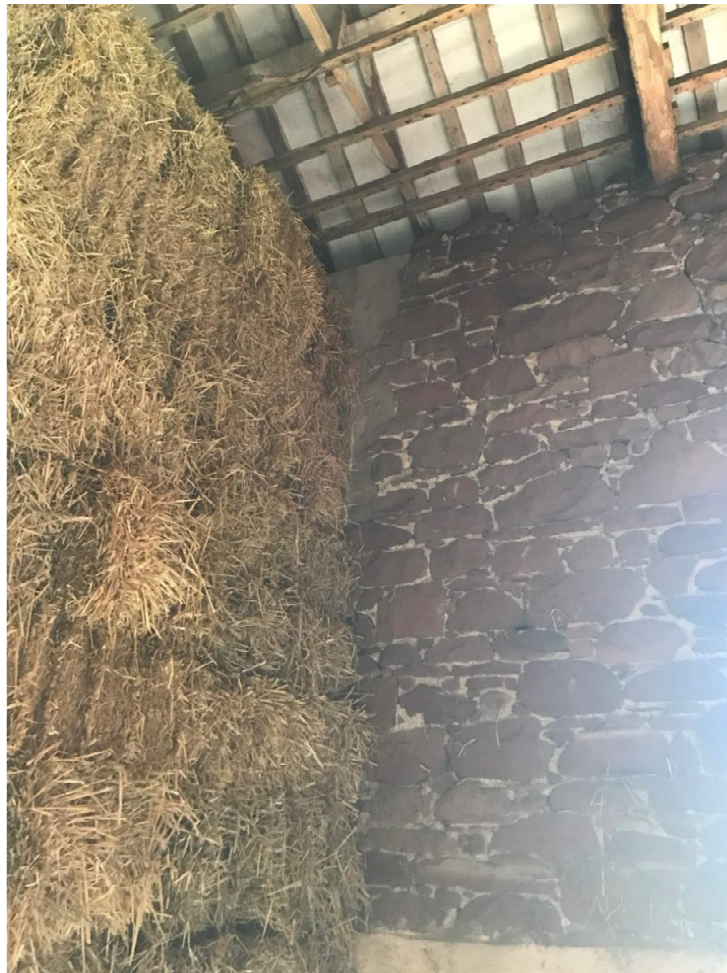
The inspection of Barn Two began at the road side wall. The tenant advised us that the northern end of the roadside wall had been previously rebuilt in blockwork and faced with stone after a collapse (date unknown). The edge of this blockwork could just be viewed internally, but the majority was obstructed by straw bales.

*Figure 3.14 – Edge of blockwork rebuild*
