**VISUAL STRUCTURAL INSPECTION**

**THE PARKHEAD PUB  
THORNHILL  
EGREMONT  
CUMBRIA**

**G&A M LAWSON Ltd**

**Reference - WDS/05/8722/REP01**

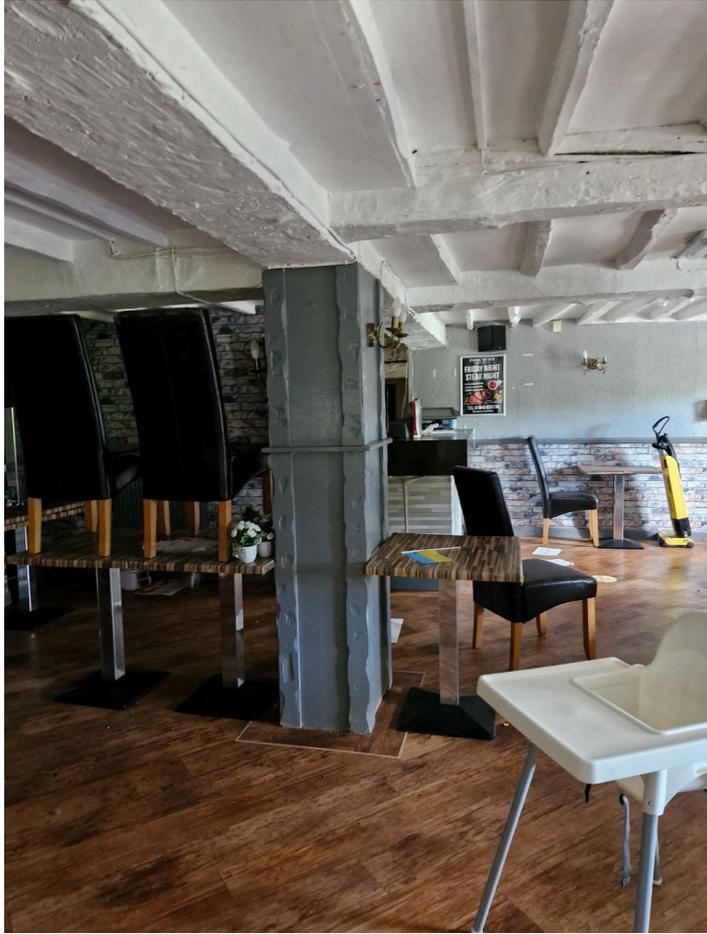
- 2.1 The building appears to have been originally a terrace of 4 cottages which have been knocked through to form the single property apparent today. To achieve this many of the original ground floor walls have been removed and replaced by an array of beams and columns. The beams are mostly timber and are over spanned. The first floor structure deflects excessively when walked upon. See photograph 01 attached.
- 2.2 The front elevation of the property is out of plumb and there are numerous patched cracks apparent suggesting the building has suffered structural movement in the past. It is unlikely that movement is still occurring. See photograph 02 & 03 attached.

PHOTO 01 VIEW ON FLOOR SUPPORT BEAMS (TYPICAL)

- 3.1 We understand that is proposed to convert the property into office space. Considering the condition of the existing building we would expect this to require the entire ground and first floor structures to be replaced, the roof structure strengthened and the external walls retied where out of plumb. In addition the rear retaining walls will need strengthened or replaced. The existing walls foundation will be not adequate to support loading associated with office use and thus the walls will need locally underpinned depending on the revised first floor design. In our opinion the cost of these works will be prohibitive and it will be more cost effective to demolish the existing structure and replace the building with a purpose designed building.

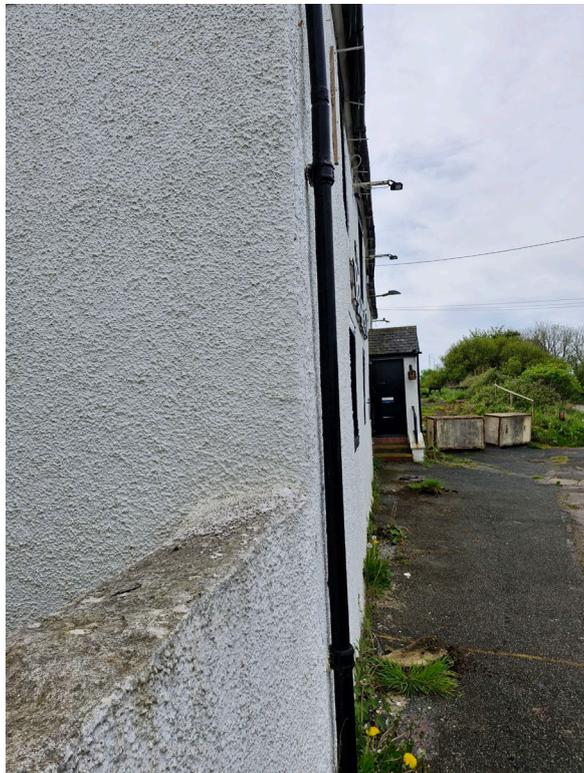
PHOTO 02 VIEW ALONG THE FRONT ELEVATION

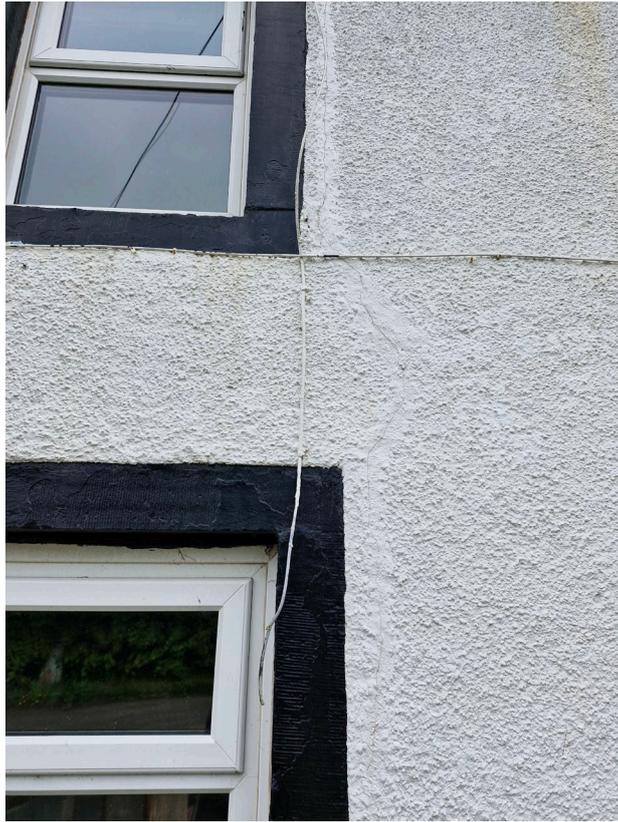
PHOTO 03 VIEW ON TYPICAL PATCHED CRACK

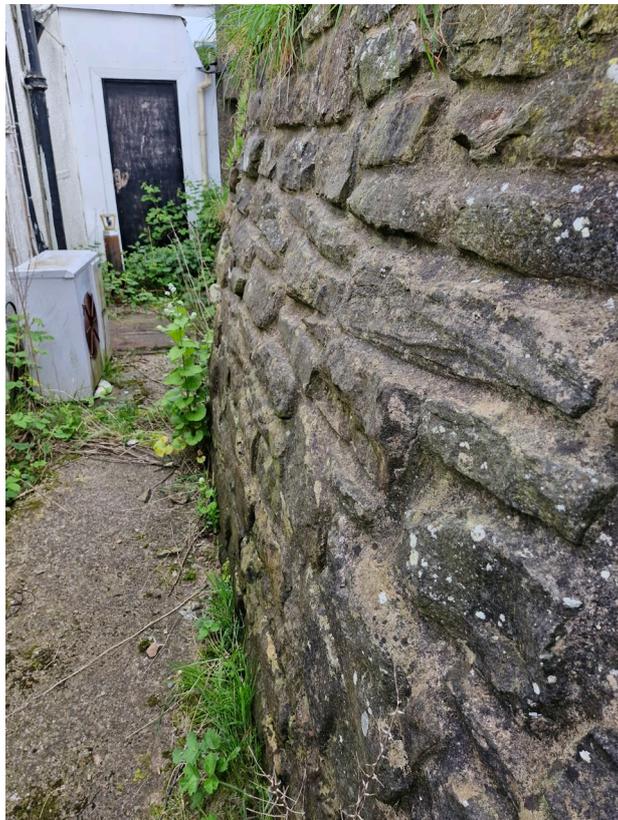
- 2.4 The ground level to the rear of the property is raised by a full storey to form the pub carpark. A retaining wall has been erected which supports the rear carpark level. The retaining walls comprises two structures, an old original stone wall and a more modern block built retaining wall. In both instances the walls are out of plumb having suffered movement. The walls are not structurally adequate and have not been designed to any suitable standard. We cannot confirm the stability of the walls going forward and this is a significant safety hazard to contractors working on the property in the future. See photographs 04 & 05 attached.

- 3.3 The retaining walls to the rear of the property are at risk of collapse and we are concerned that during any future works to the property vibrations could lead to localised collapse. This is a major safety issue as the collapse of the wall will impact on the rear elevation of the property which could lead to the building locally collapsing also. The wall needs made safe prior to any works are carried out on the property. Access to the rear of the wall should be prevented

PHOTO 04 VIEW ON STONE RETAINING WALL

and the carpark cordoned off to at least 3.0m from the rear of the retaining wall.

- 4.2 We recommend that access to the rear of the property within the extensions and in the rear yard are prohibited due to the condition of the retaining walls. In addition the rear carpark needs cordoned off to at least 3.0m from the rear of the retaining walls.

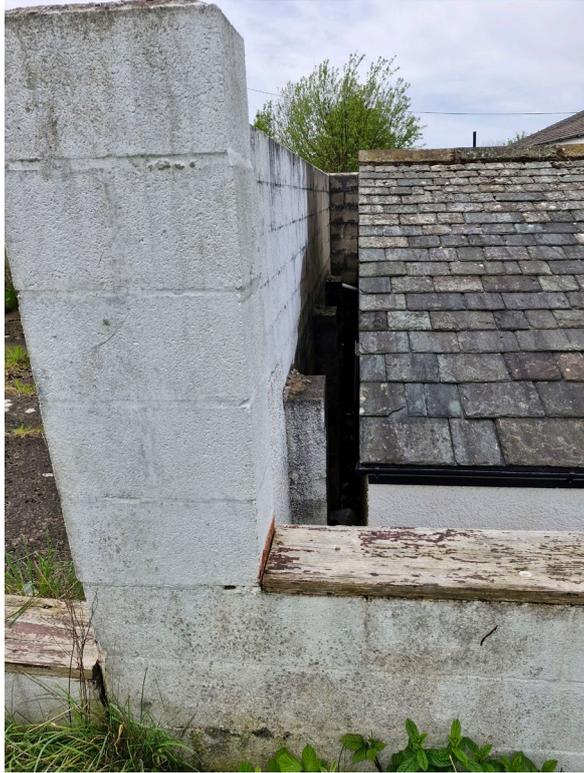
PHOTO 05 VIEW ON BLOCK MASONRY RETAINING WALL
