Arboricultural Impact Assessment

For Trees At
Wyndham Place,
Egremont

For
Aldi Stores Ltd

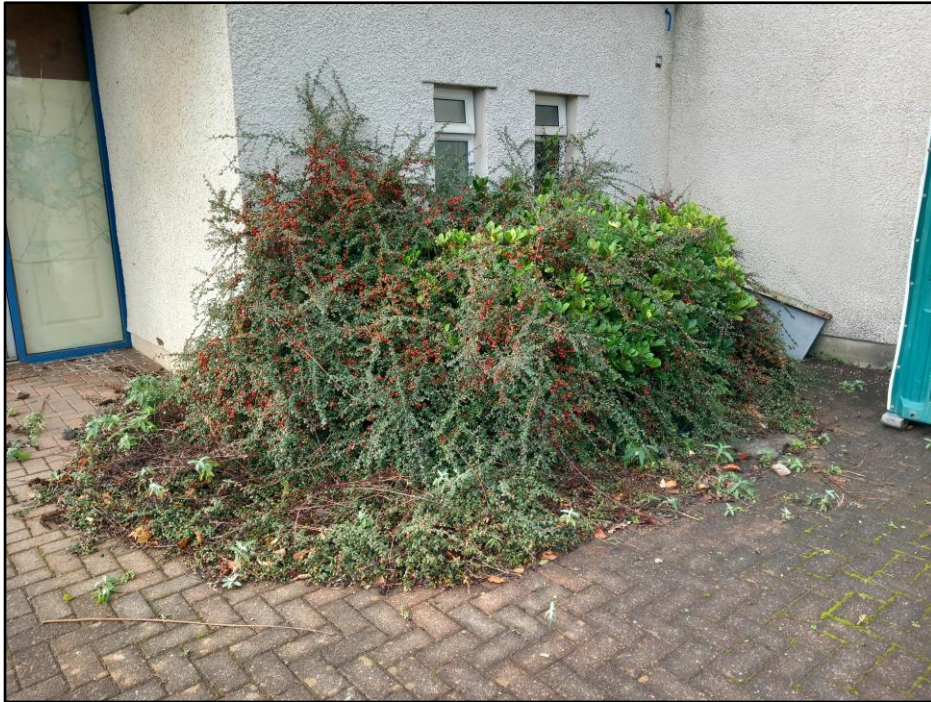
4.4.2 Group 3C will need to be removed due to direct conflict with the scheme – it is within an area identified for disabled parking adjacent to the store front.

Figure 2 – Group 3C, low value shrubs positioned against the existing building
