THE CUSTOMS HOUSE, WHITEHAVEN – Grade II Listed

Job No 1234 –

Change of Use of existing offices to residential

Schedule of Internal Views of the property

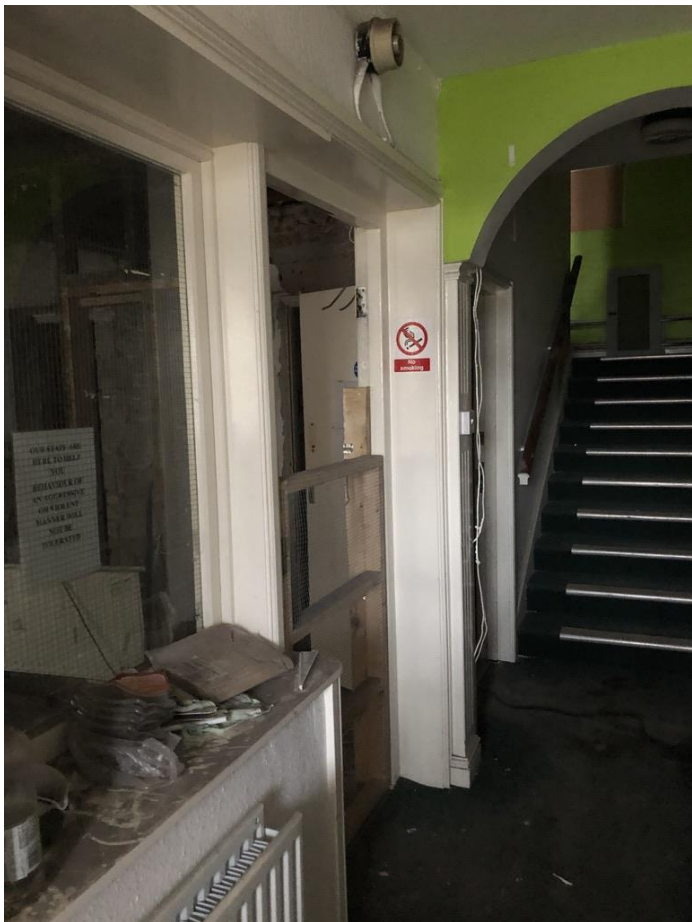
Image 1 - Internal View towards main staircase from new vestibule, proposed Apartment 1 to left hand side – modern glazed screen forming the original reception counter for the previous owners.

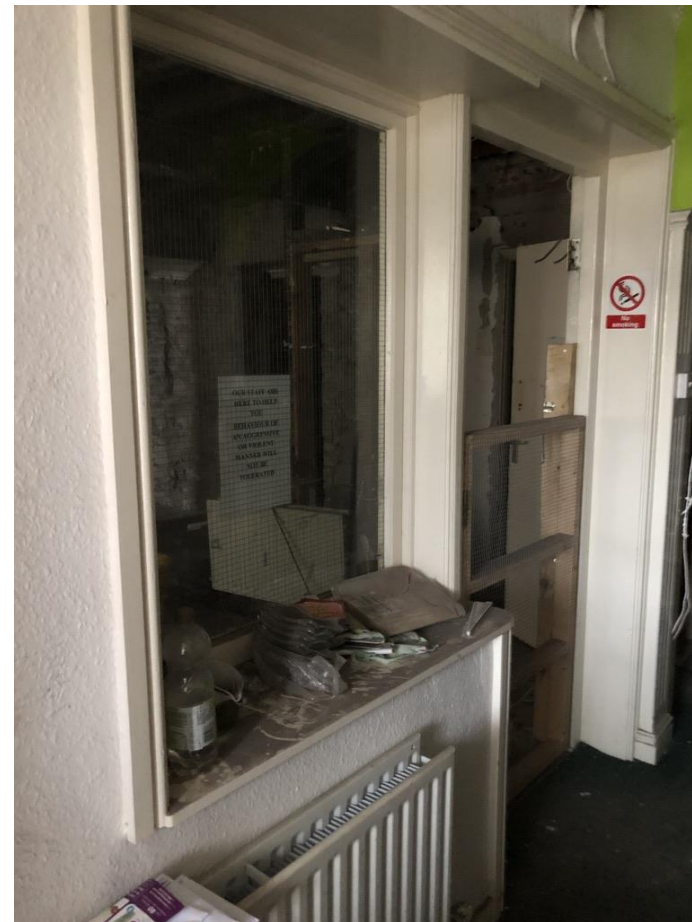
Image 2 - Ground Floor entrance screen into Apartment 1. Screen formed in softwood Torus profile with wired fire glass to provide fire integrity to wall. Screen and door made in modern planed timber. Proposal is to remove the screen and re-instate the wall in new masonry to the full width of the wall, the existing lintol will be retained in-situ to avoid further disturbance to the structure.

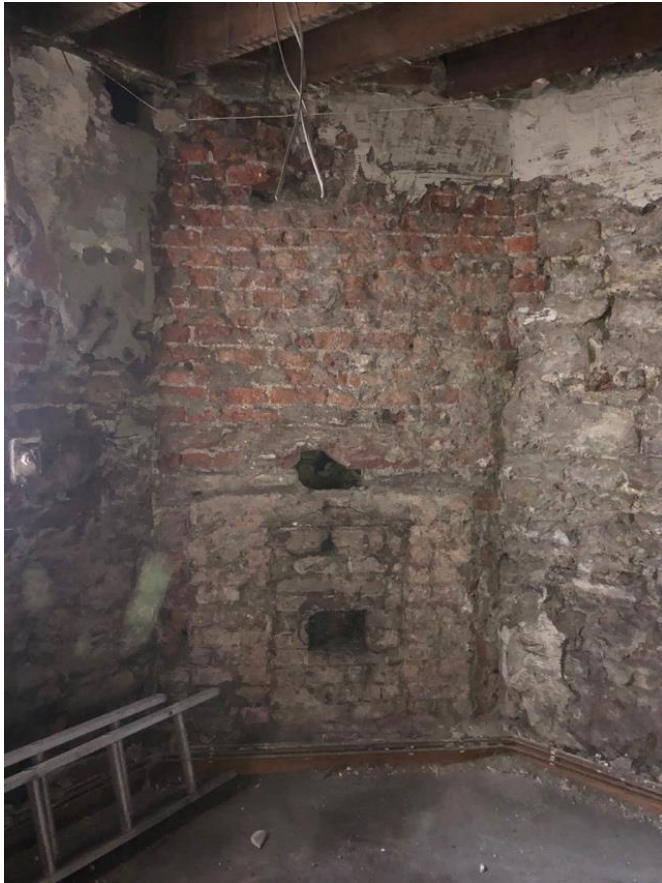
Image 3 - Proposed Cafe area – 45 degree fireplace in corner of room. Mixture of brick and stone, existing fireplace / surround has been removed. Chimney flue not visible in room above at first floor level, location of flue route to chimney stack not identified. Small pocket of similar bricks in gable wall at FF above suggesting flue may be within wall cavity.

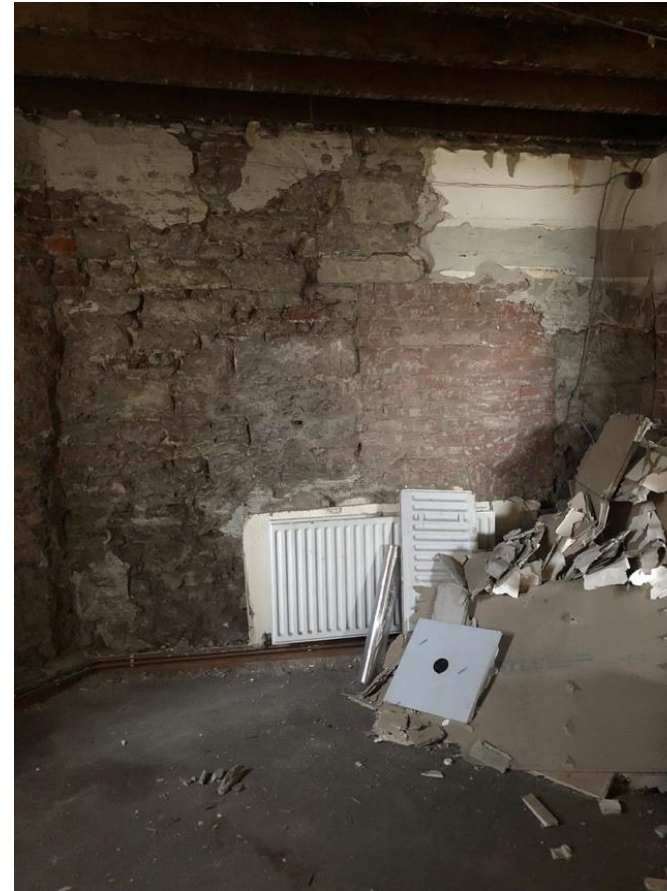
Image 4 - Rear wall in the new café, a former opening in the rear wall indicated (not visible externally) and overlapped by the current external staircase. This window is in the location of the new café toilet and will not be visible internally when works are complete.

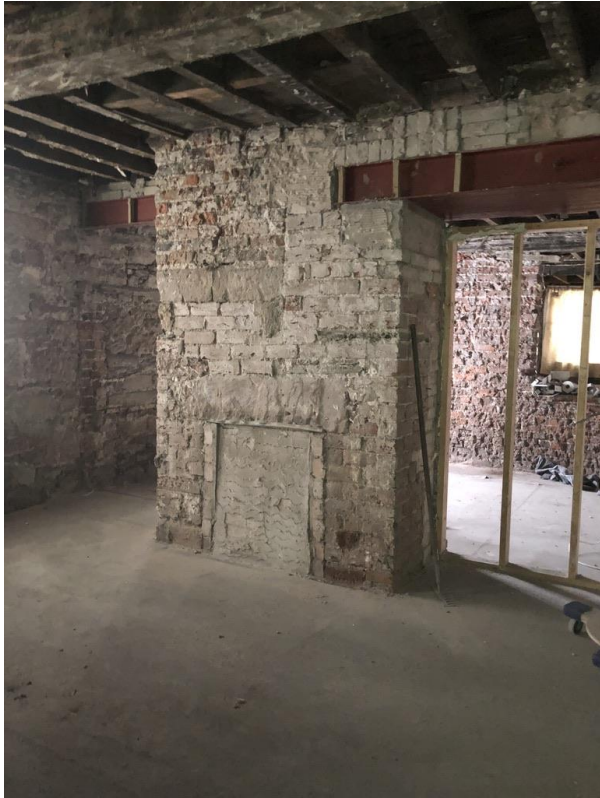
Image 5 - Internal view showing location of fireplace within Apartment 1. An existing sandstone lintol exists in this location, the fireplace has previously been removed. The openings have been strengthened with new steel beams. The window visible to the rear is the serving hatch in the former kitchen looking into the original coaching archway.

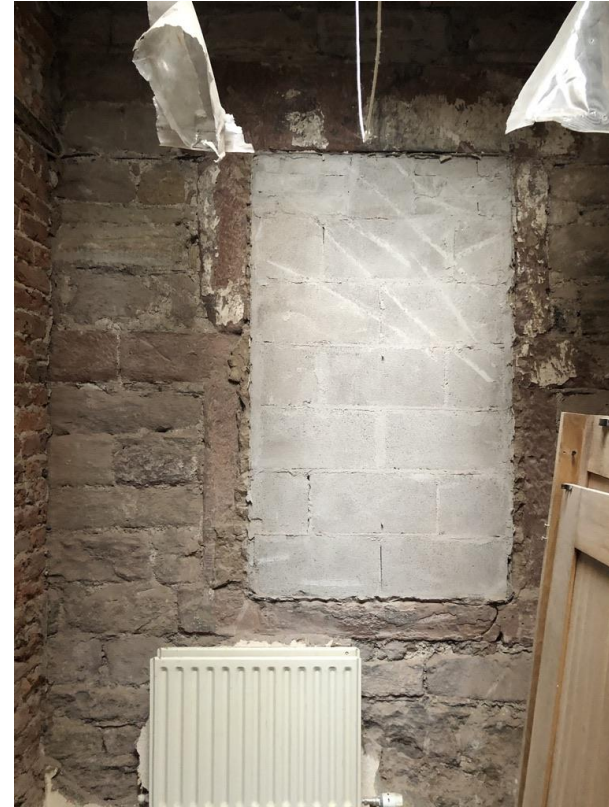
Image 6 - Existing window uncovered in original wall to rear of property, this is the location of the new doorway connecting the bedroom to the hallway in Apartment 2

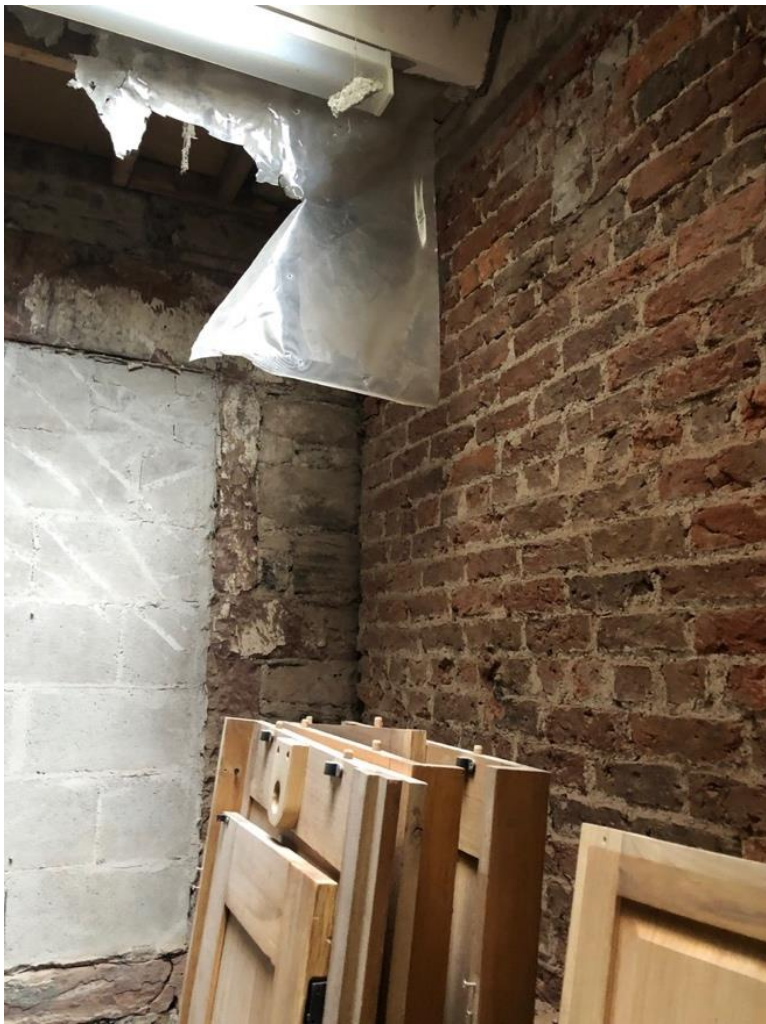
Image 7 – Infilled window as Image 6, the right hand flank wall forms the rear stairwell wall to the property which is paint finished on the upper level of the stairwell

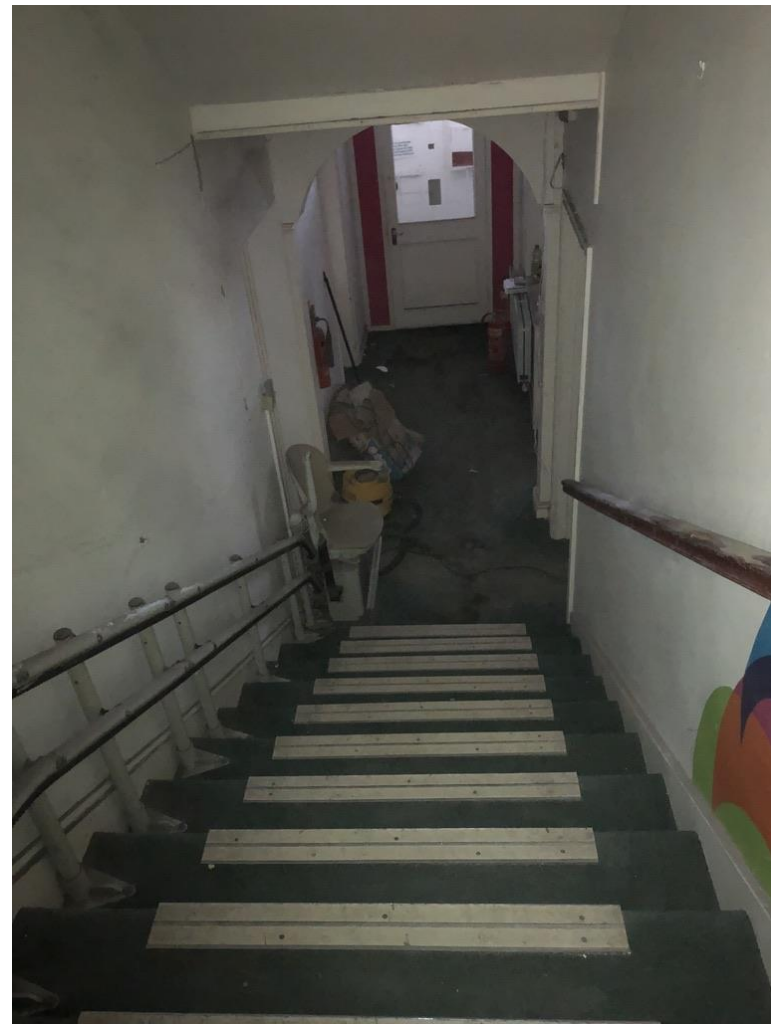
Image 8 - View towards the front door from the first floor half landing, the modern additional vestibule door is to be removed. Modern fittings including stair lift to be removed to de-clutter the stairwell.

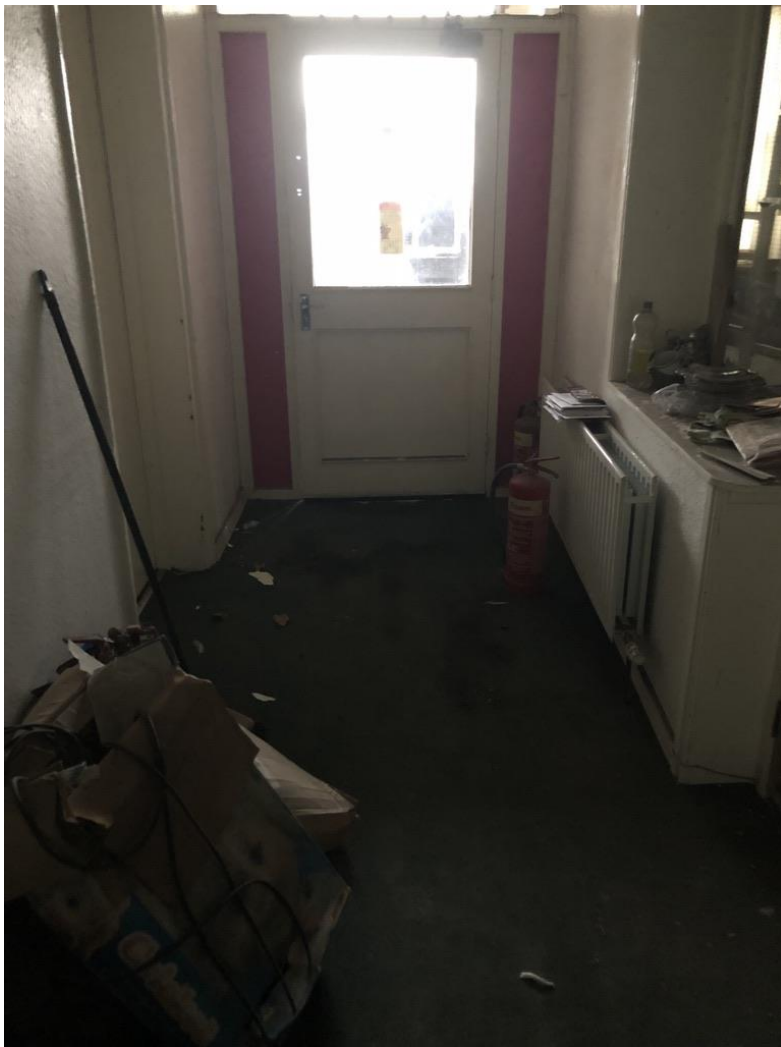
Image 9 - View to front vestibule with modern reception screen on right hand side. Vestibule is to be formed in modern new softwood framework.

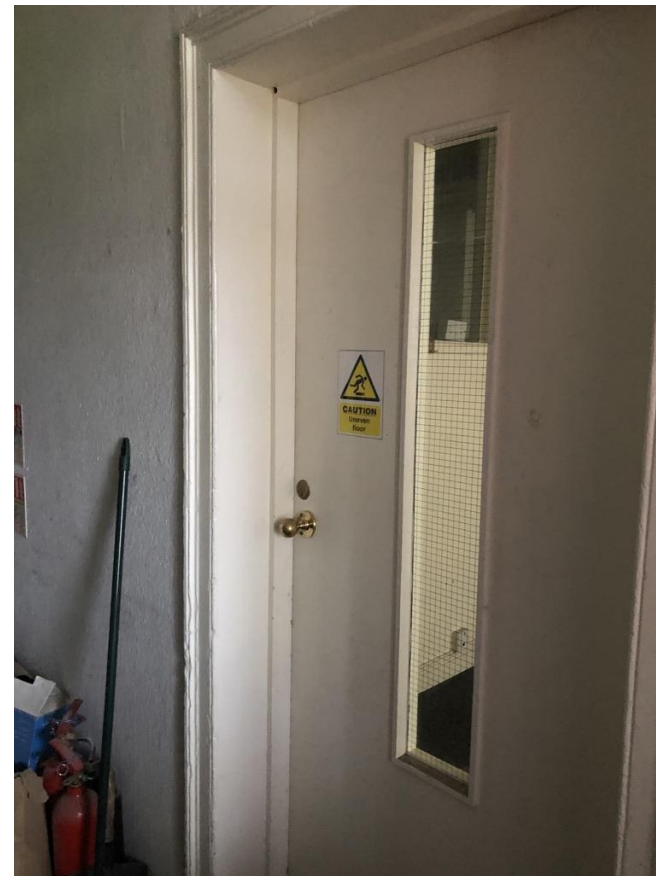
Image 10 - Front entrance door to Apartment 1 – original door lining and architraves through solid wall. Door installed is modern Fire door and wired fire glass. The proposal is to remove this door lining and architrave and make good to the plaster work. The condition of the lintol over (assumed timber) will be assessed when the works are opened up

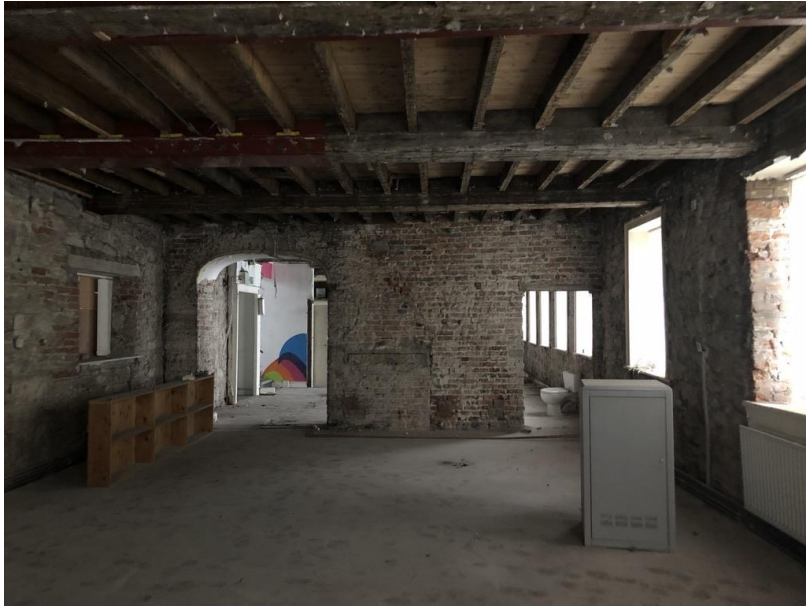
Image 11 - Apartment 3 view across open plan room, installation of bedroom wall to be fitted between the two external windows to frontage . Evidence of former fireplace in central chimney stack – existing timber infill panel to righthand side of door hidden behind plasterboard – Archway to be infilled and finished flush within the apartment. Window to left hand side to be opened up to form window to new bathroom

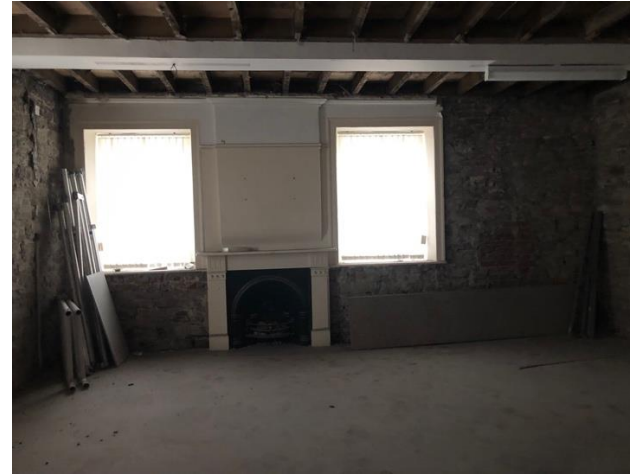
Image 12 – View internally in Apartment 3 to gable wall with fire place centrally between windows. Current fireplace and surround to be retained in situ -see image 13

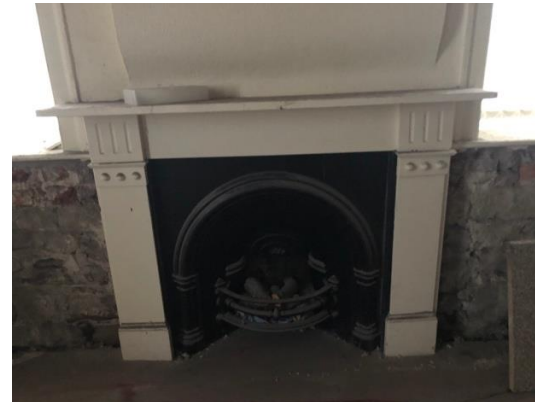
Image 13 – detail of existing fireplace, historic to the building but post dates the original building

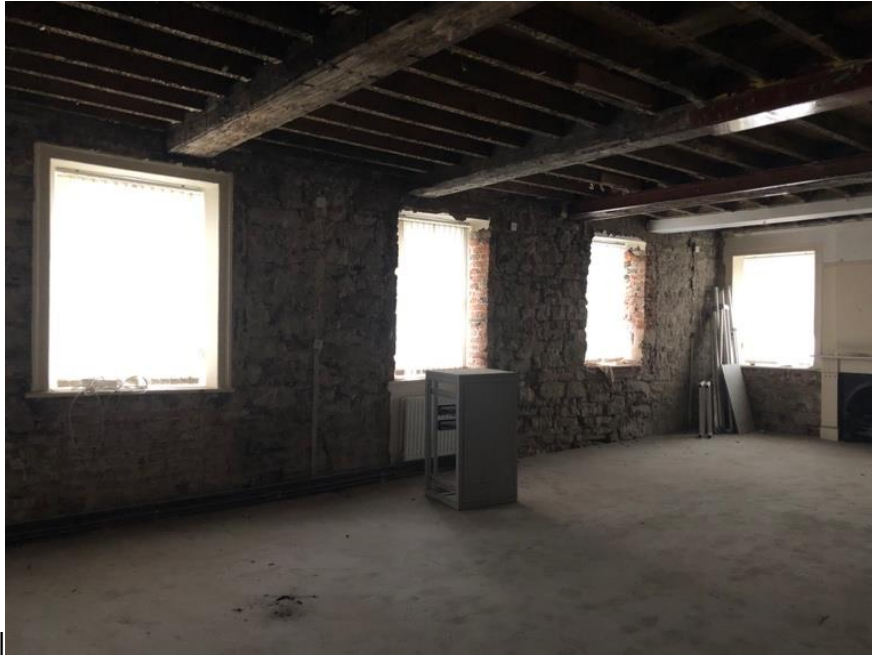
Image 14 – Reverse view of Image 11 across the first floor room. Original timber beams have been strengthened with steel work by previous owner

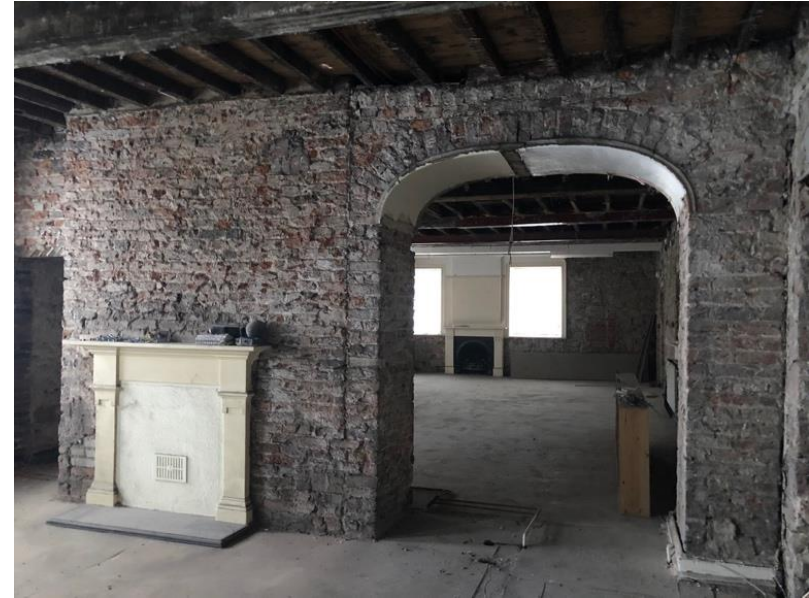
Image 15 - Original arched former on first floor dividing rooms. Note the location of the modern plasterboard stud wall approx 800mm across opening. Previously subdivision created unnatural room division. The new proposal sees inclusion of the whole arch form within the apartment and will be visible within the dressing area of Apartment 4.

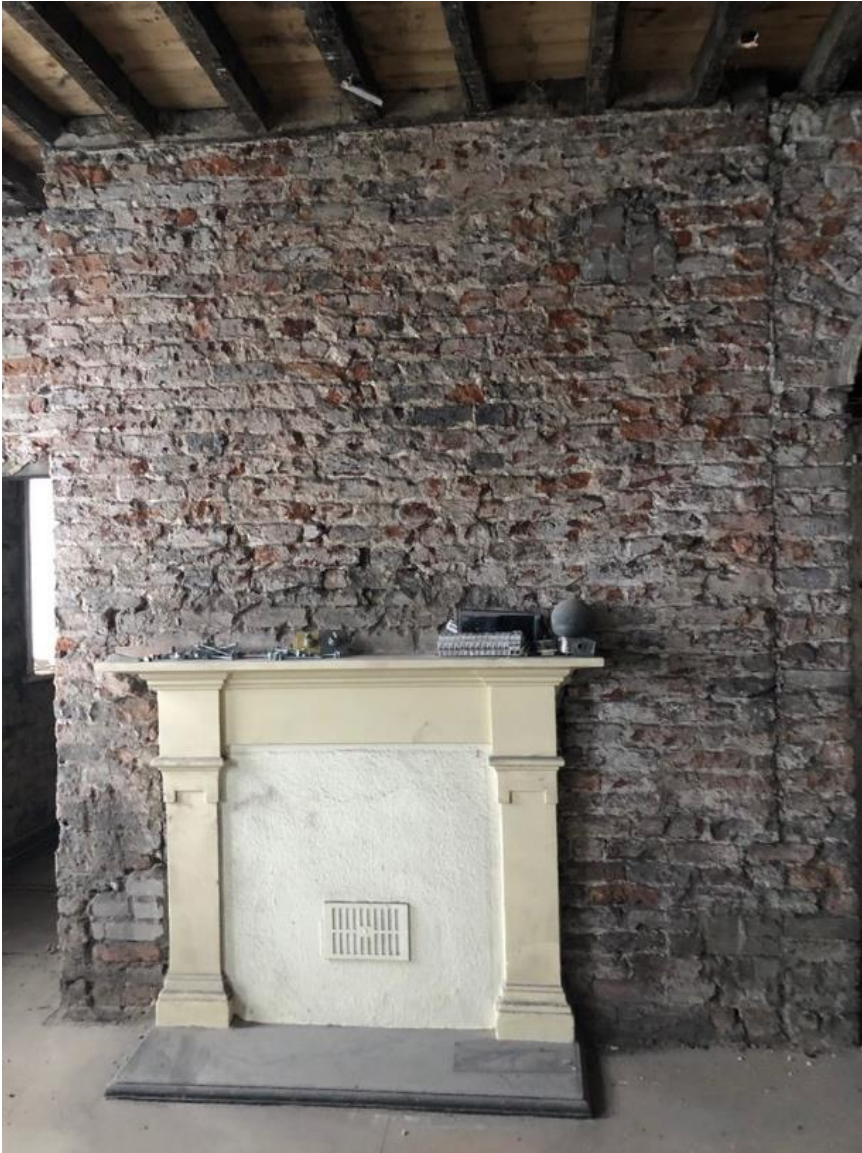
Image 16 – Fireplace to be retained in Apartment 4

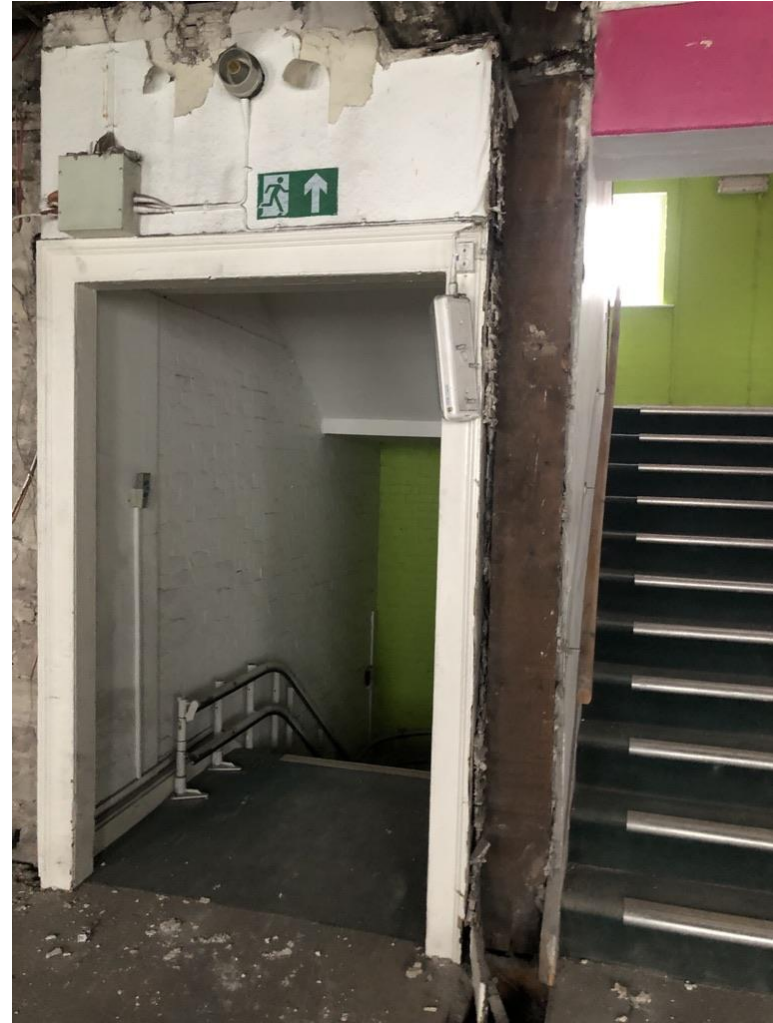
Image 17 – First floor view of staircase, right hand staircase rising to second floor. New staircase lobby re-instated to allow for continuity of 'protected stairwell' to the entrance door.

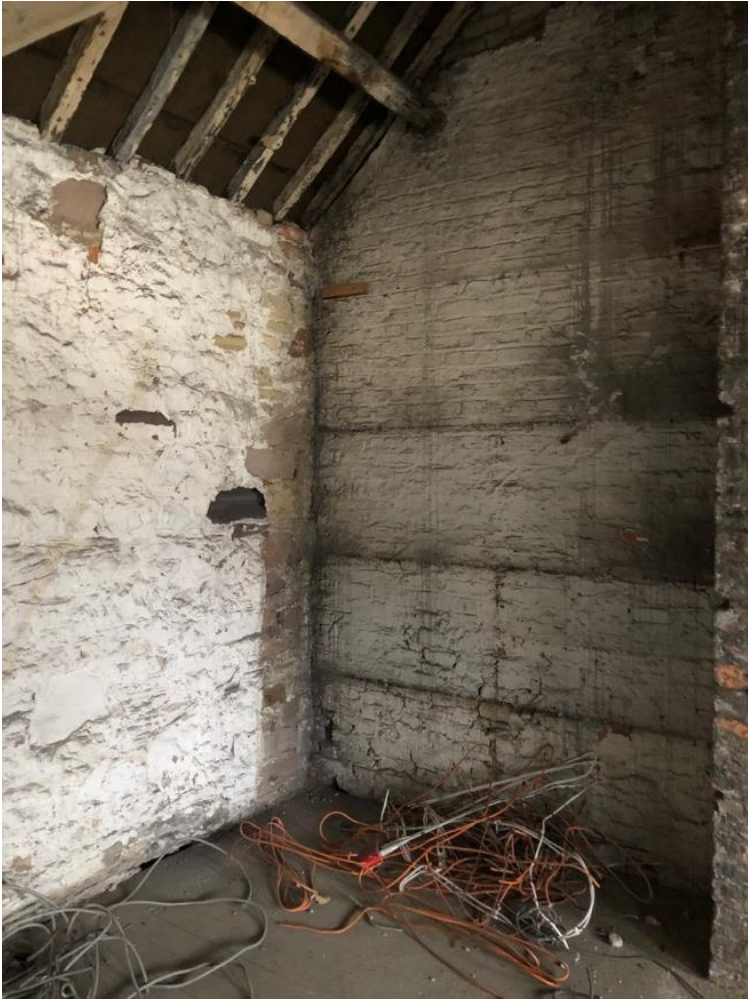
Image 18 - View of roof space to rear Party Wall showing white washed walls prior to the installation of modern dry lining. Roof in areas has been re-felted with traditional 1F felt

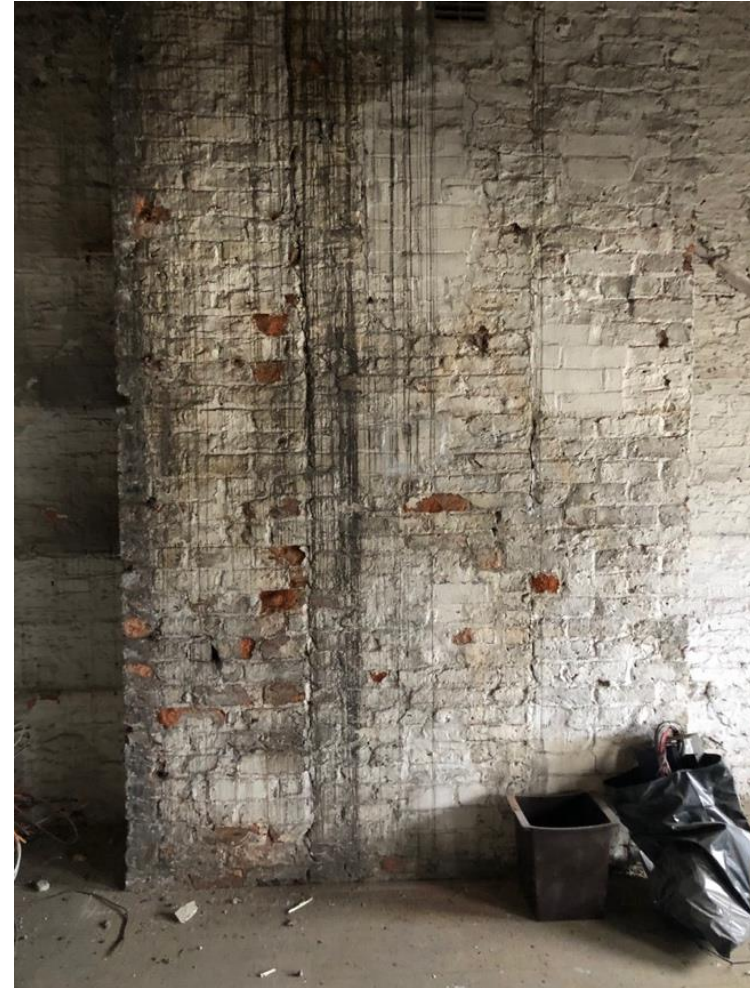
Image 19 - Evidence of staining to the Party Wall chimney stack on the party wall indicating failing in the roof covering or flashing at the abutment, failure assumed to be historic.

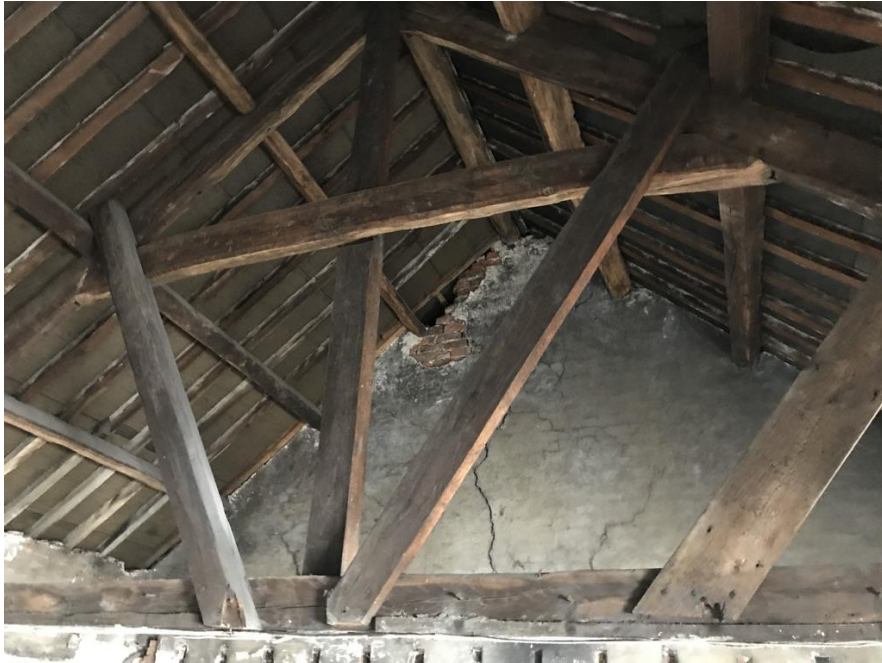
Image 20 - View to attic through existing trusses. Note additional steel strengthening added to trusses and rafter legs installed by previous owner

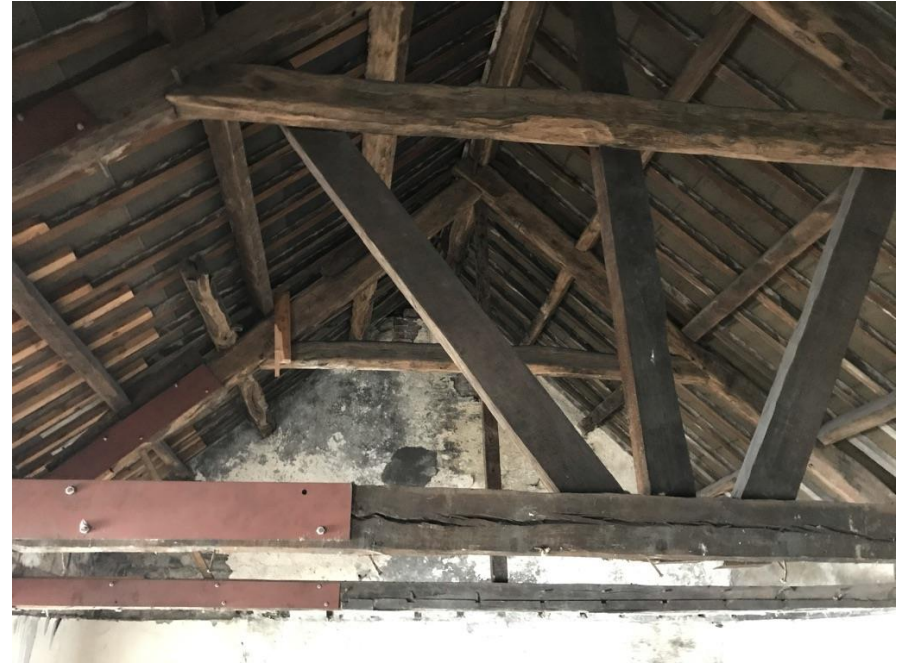
Image 21 – Additional steel strengthening added to trusses and rafter legs installed by previous owner – part replacement roof rafters to rear pitch of roof. The proposal is to insert a mezzanine floor level within this roof zone to provide a bathroom and study to Apartment 5. The works will not require any alteration to the trusses and allow them to be exposed within the finished building rather than hidden behind suspended ceilings. The new staircases are designed to fitted between trusses. New rooflights are fitted between the existing purlin positions

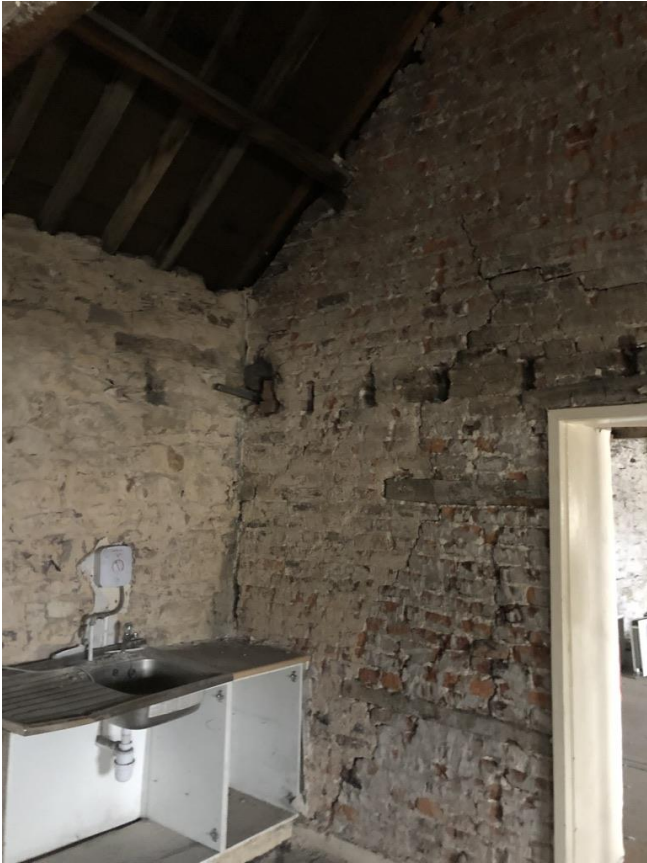
Image 22 - View of existing kitchenette to second floor, joist pockets indicate position of original timber ceiling joists – these had been removed by previous owner to install suspended ceiling throughout second floor.

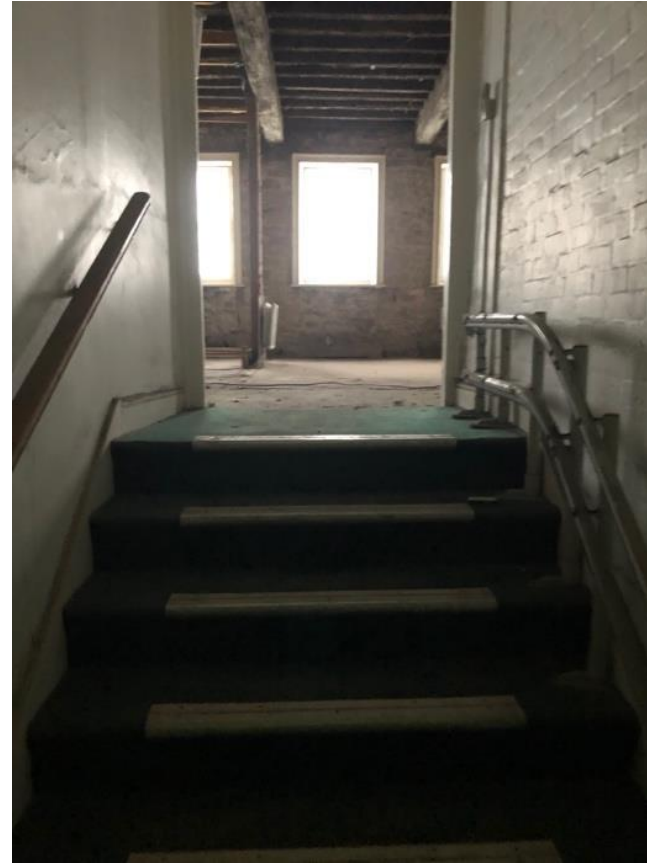
Image 23 - View from existing second floor landing with views directly through the building to the front elevation. Modern stair lift frame work fitted to right hand side of stair to be removed. No finish to existing stairwell walls currently painted brickwork
