## **Appendices for the Discharge of Pre- Commencement Conditions**

Land Adjacent to School House with Access from the  
B5345, St Bees

Application Ref: 4/22/2315/0F1

CCTV Inspection Report

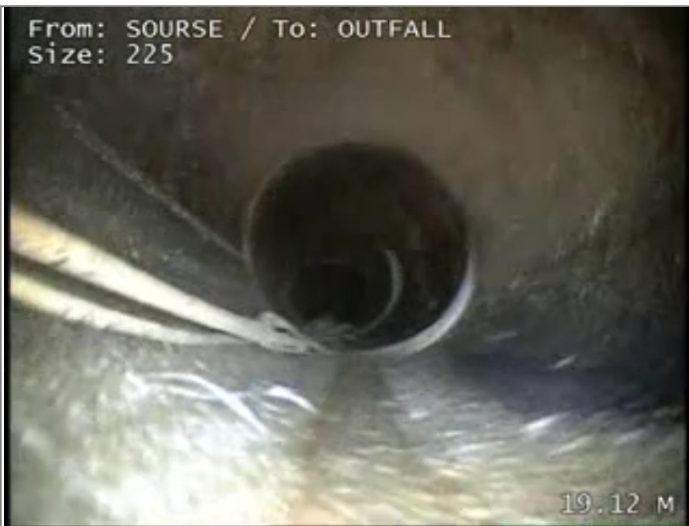
Push rod camera had to be used due to the restricted access with the main line system.  
 Numerous slight displaced joints throughout.  
 Tap roots noted at 19.12m and 25.10. Pipe is fractured at 20.79m. There is a connection at 32.60m but the origins of which are unknown.

Roots tap at joint

- The proposal for rectification would be to:
- Remove the trash screen to allow access.
  - Use Jet/Vac Recycler to clean the culvert and remove any debris.
  - Use a robotic cutting machine to remove the roots.
  - Install Localised Structural Repair Liners at 19.12m and 25.1m (to seal joints after root removal).
  - Install a Localised Structural Repair Liner at 20.79m where the pipe is fractured.
  - Survey on completion.

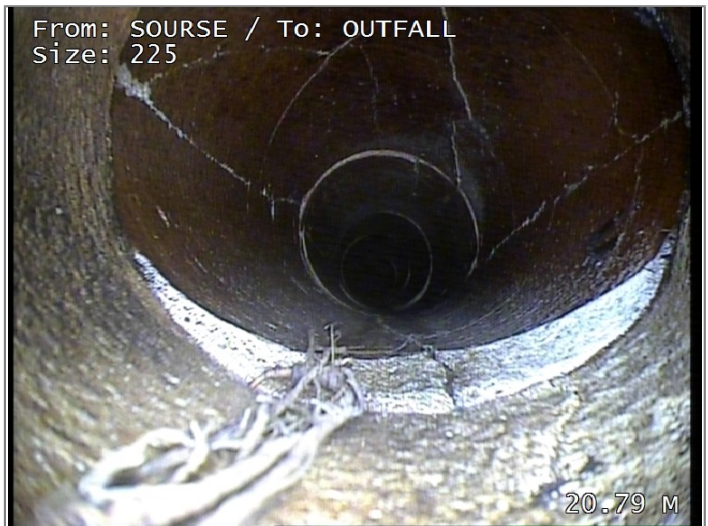
Fracture multiple from 9 to 3 o'clock

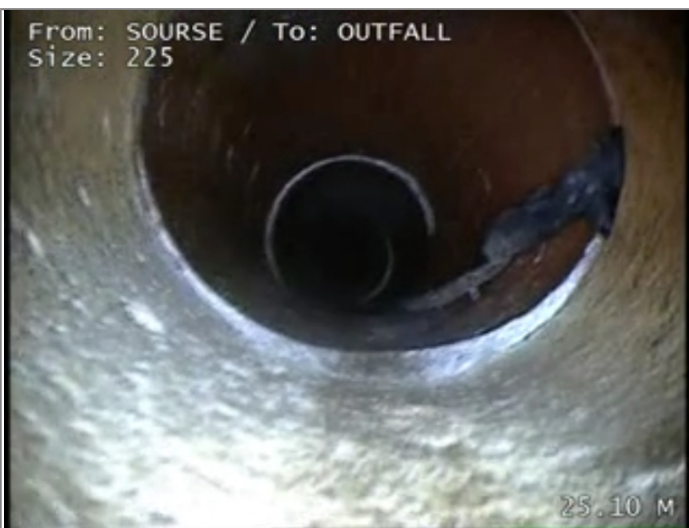
Roots tap at joint

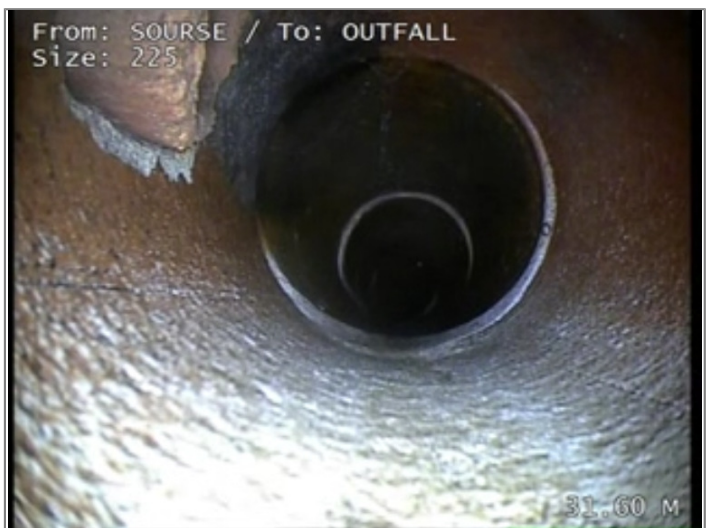
Connection other than junction at 9 o'clock, diameter 100mm

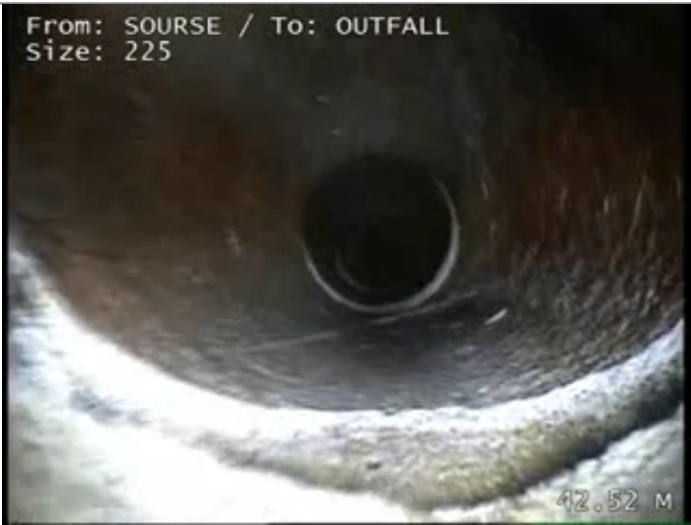
Joint displaced 10mm

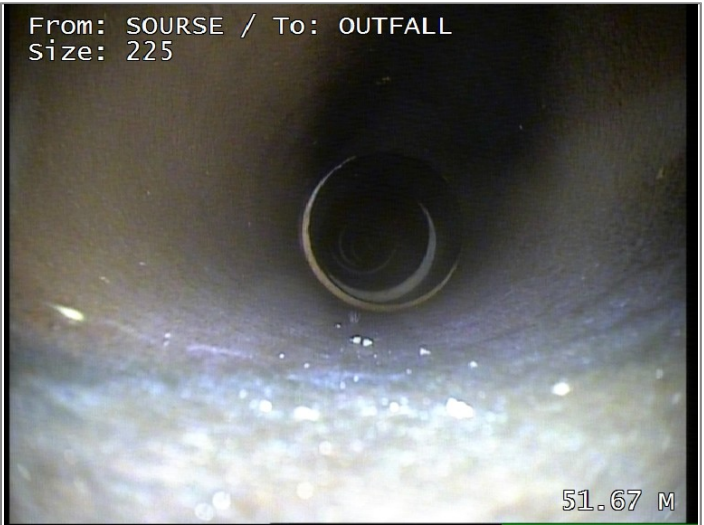
Finish node type, major connection without manhole, reference CCTV  
Has gone past site boundary
