former Whittles furniture store,
Duke Street, Whitehaven,
CA28 7ER

Visual building feature and fabric assessment

AS21.35 Rev 01
July 2021

Applicant: BEC

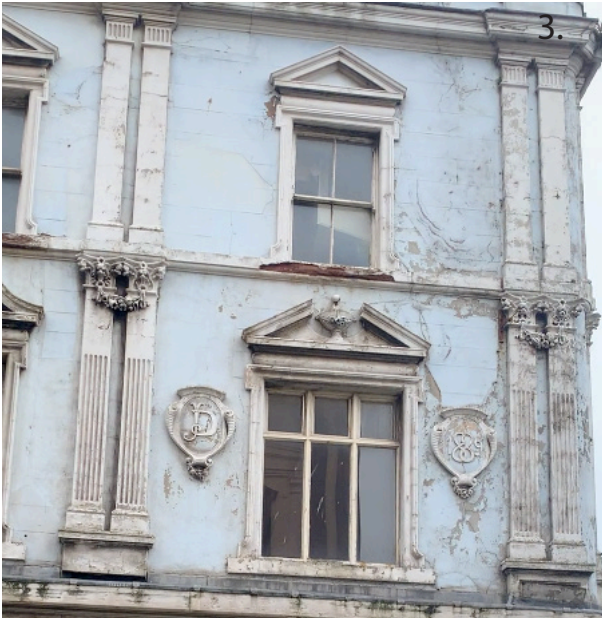
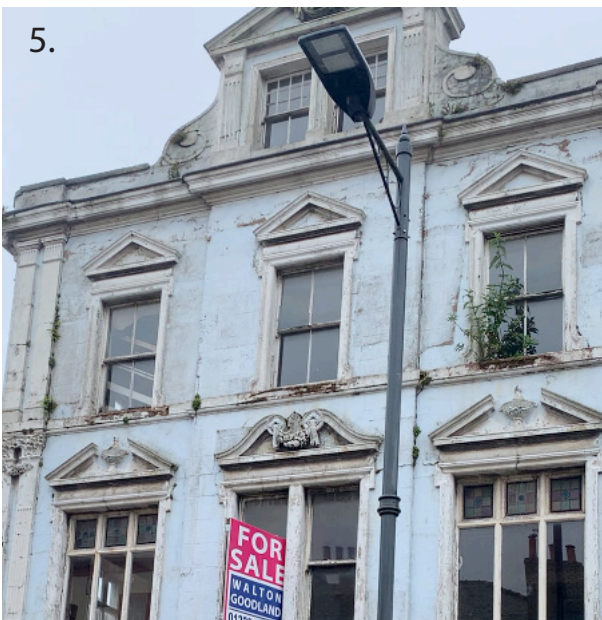
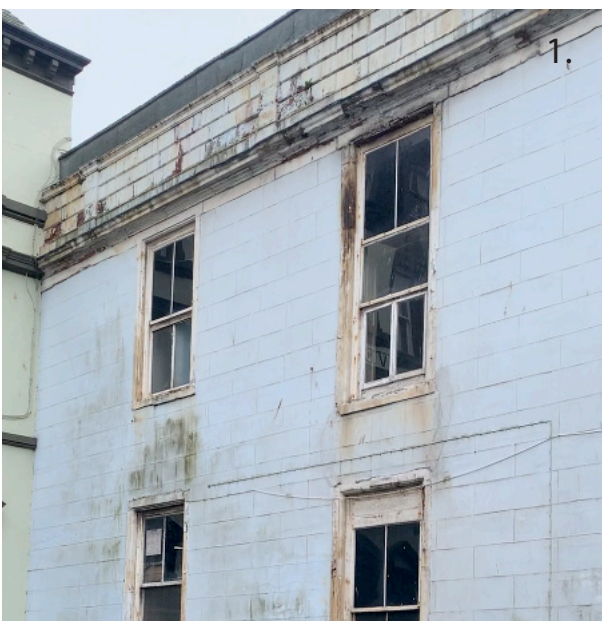
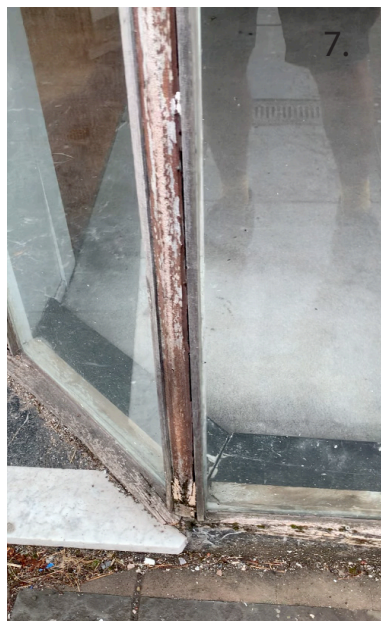
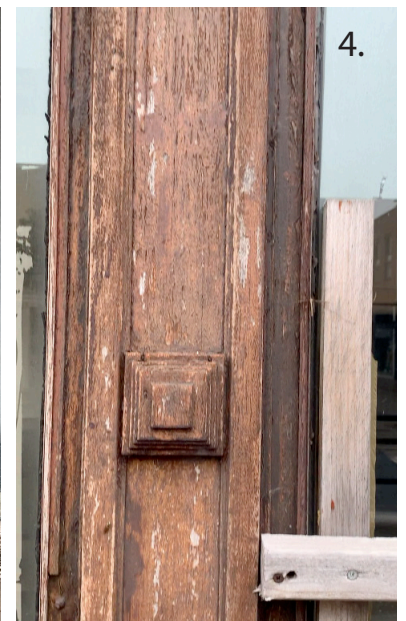
1. Building has been adapted over time to create retail open plan floor space. Architecture elevation, a simple form. Existing windows blocked up facing neighbouring property.

2. Elevation adsorbed into retail unit as retail use extended and adapted over time to create retail open plan floor space. Simple form and elevation palette when compared to the original buildings feature corner. Evidence of shop awning support zone mid level.

3. Building dressed in retained feature stucco columns, window dressing and plaques.

4. Existing balustrade feature, internally that appears also to be picked up in shopfront glazing framing.

5. Existing facade failing, and unmaintained. Vegetation growing out of feature bands noted.

6. Existing shop front glazing in poor state of repair. Smashed panes currently boarded up, or are being temporary braced due to being inadequately supported.

7. Evidence of water penetration at window heads. Potentially showing water egress either running through render facade, head of windows or cills above.

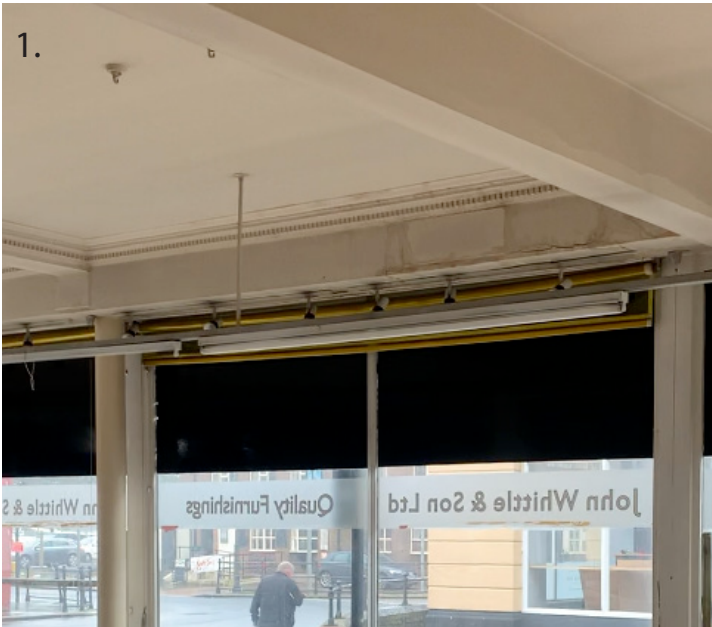
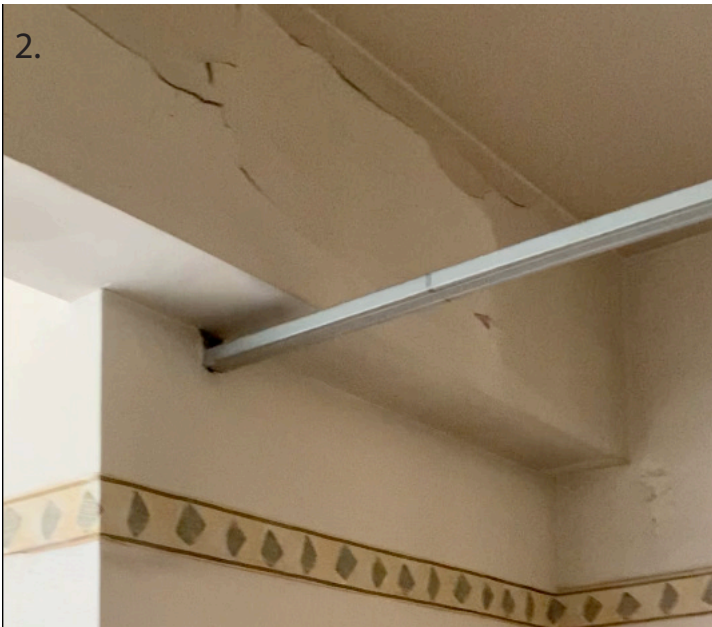
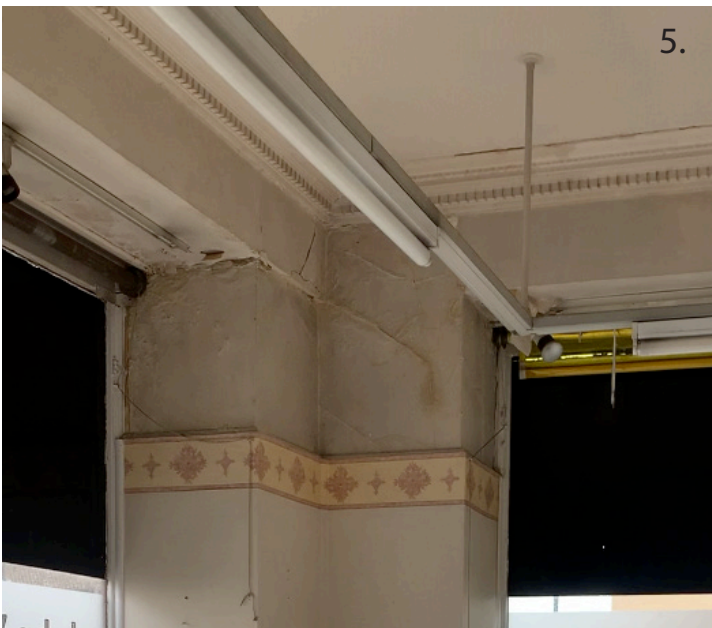
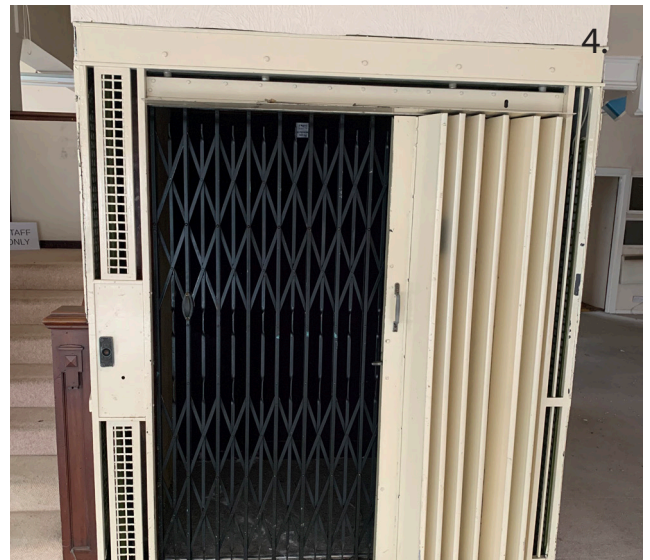
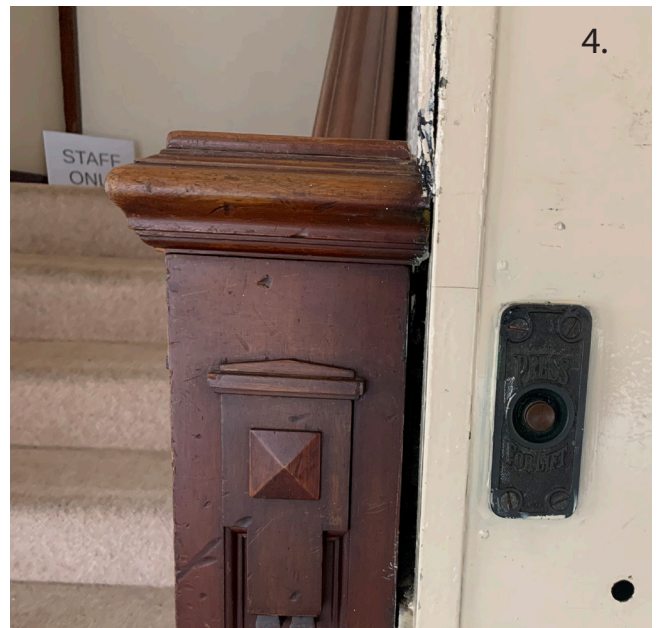
1. Building has been adapted over time to create retail open plan floor space. Photo shows typical arrangement with downstand beams cutting across floor plate, with evidence of damp and plaster failure.
2. As above, but in certain bays cornice feature in play, dressed around downstand beams. Evidence of solar overheating with blanking film being introduced at high level on retail frontage.
3. Existing back of house partitions, full height.
4. Existing goods lift with cage gate way. Existing balustrade feature, that appears also to be picked up in shopfront glazing framing.
5. Evidence of water penetration at window heads. Potentially showing water egress either running through render facade, head of windows or cills above.

6. Existing shop front glazing in poor state of repair. Smashed panes currently boarded up, or are being temporary braced due to being inadequately supported.

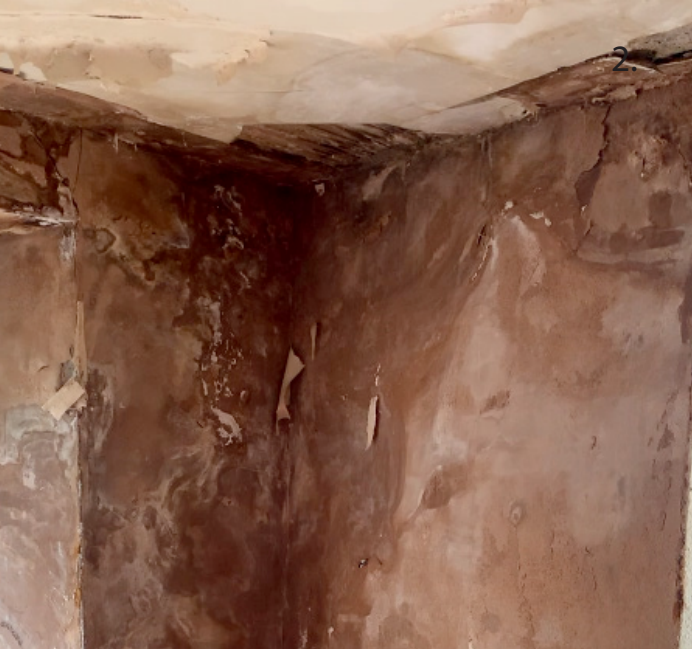
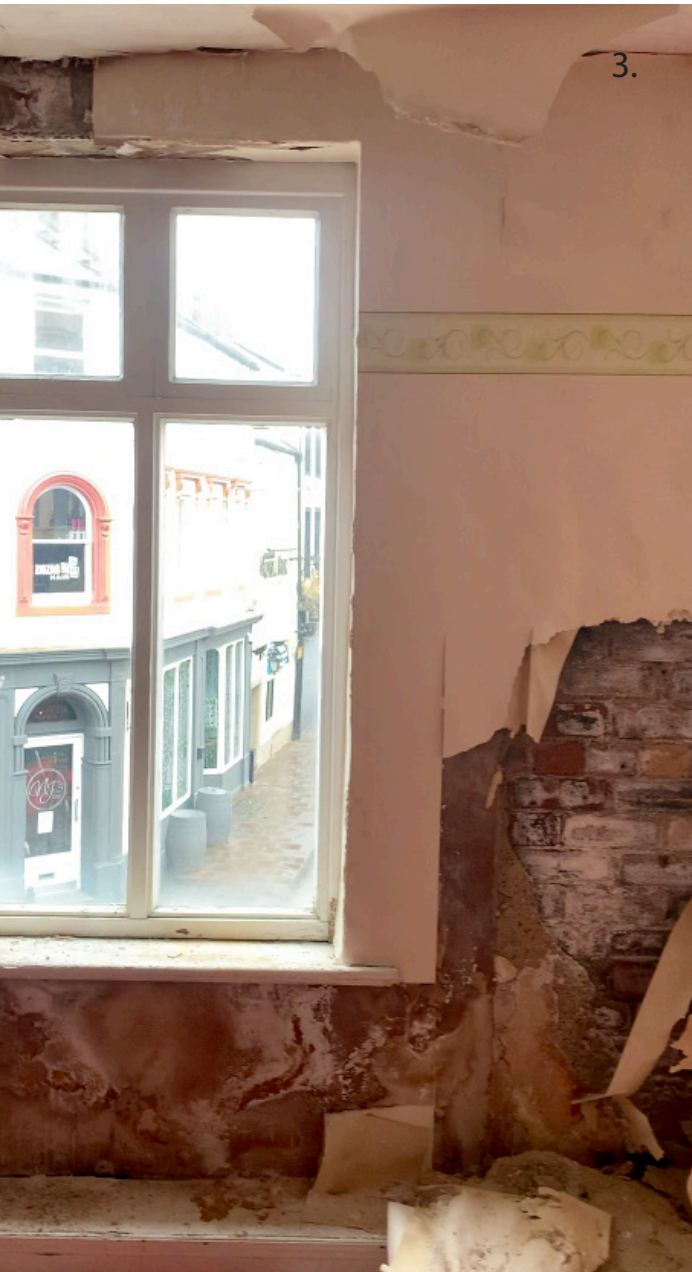
1. Existing back of house partitions, full height.
2. Existing external wall and ceilings failing and in poor state of repair, showing water egress either running through render facade.
3. Evidence of water penetration at window heads. Potentially showing water egress either running through render facade, head of windows or cills above.
4. Building has been adapted over time to create retail open plan floor space. Photo shows typical arrangement with downstand beams cutting across floor plate.

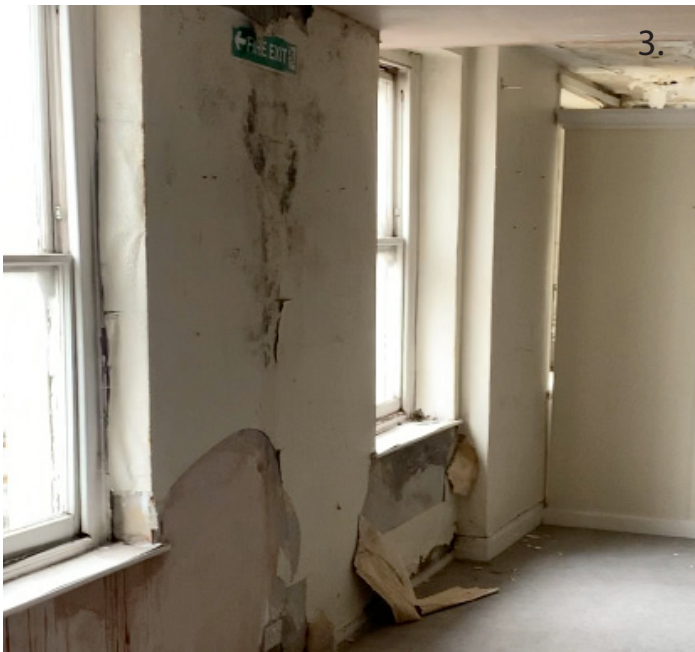
1. Evidence of water penetration at window heads. Potentially showing water egress either running through render facade, head of windows or cills above. Noted retained spiral stair feature, dressed in front of existing windows

2. Building has been adapted over time to create retail open plan floor space. Photo shows typical arrangement with downstand beams cutting across floor plate.

Remedial ceiling works in certain areas of the floor plan, dressed around downstand beams.

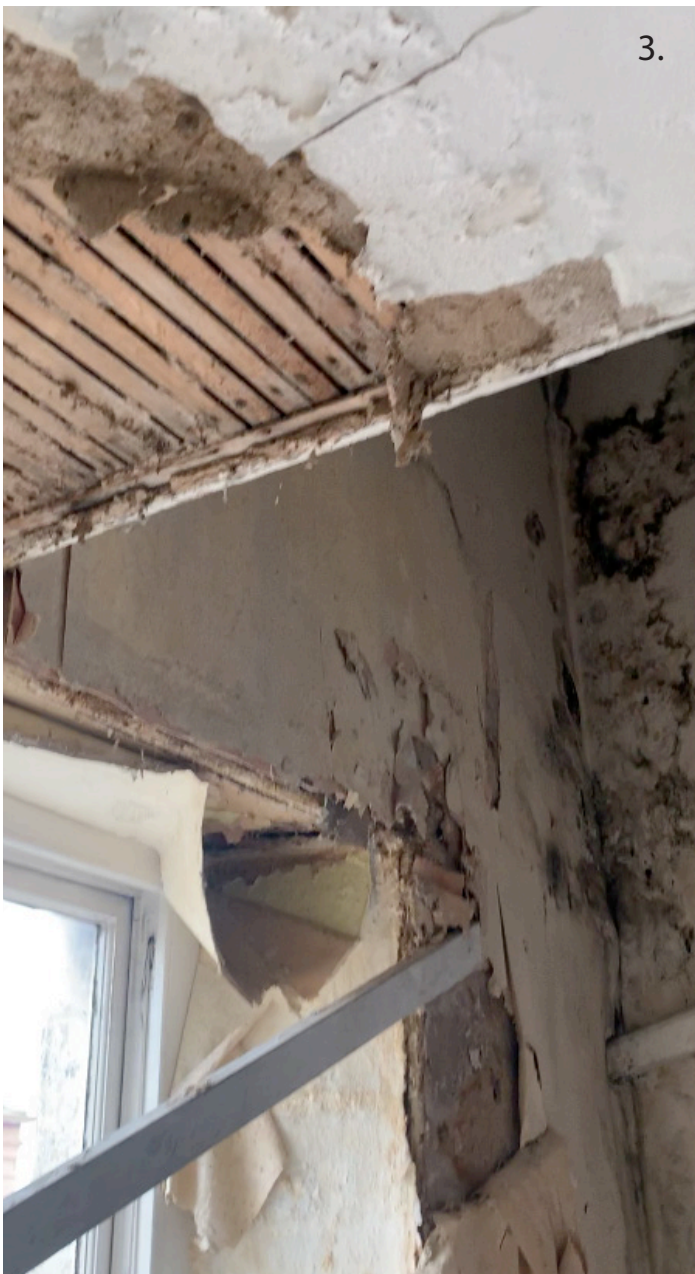
3. Existing external wall and ceilings failing and in poor state of repair, showing water egress either running through render facade, head of windows or cills above. Noted evidence of lath and plaster in ceiling / floor zones.

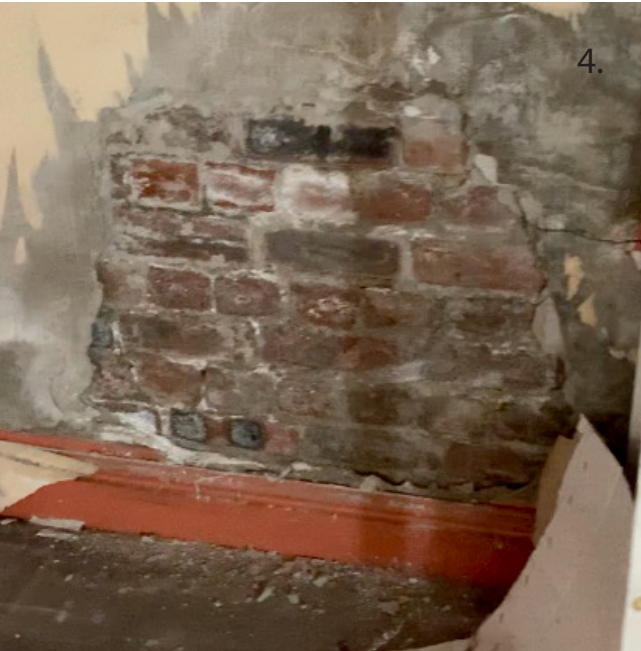
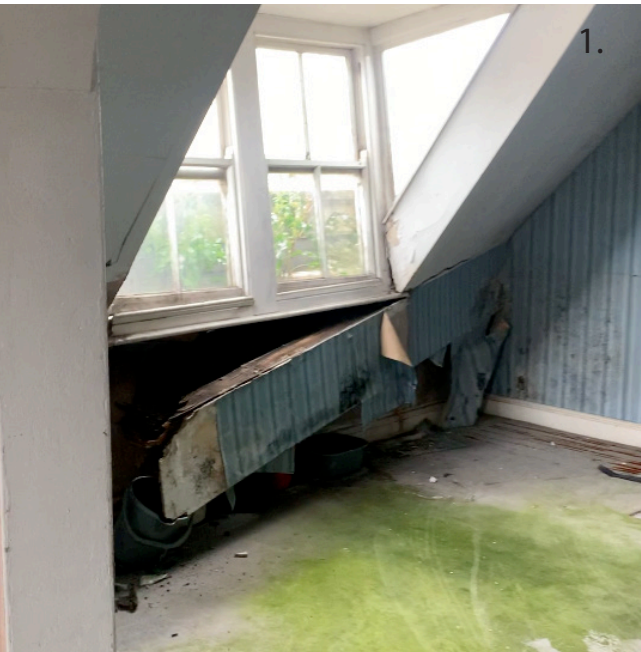
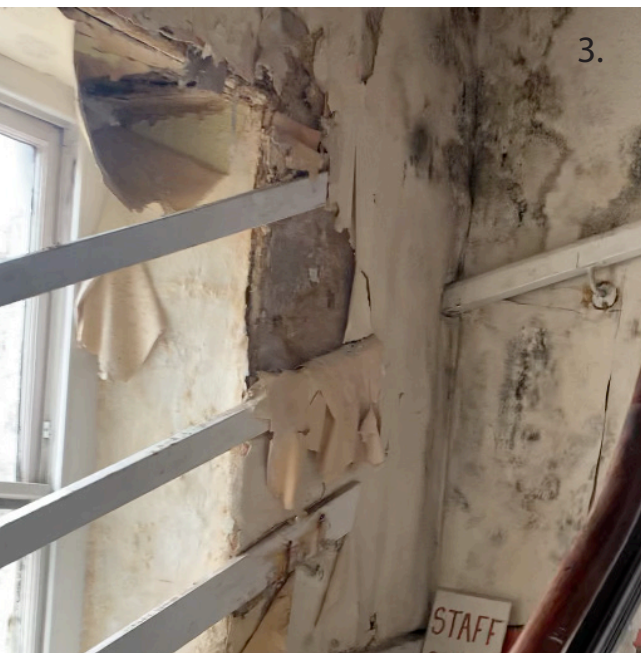
- 1. Dormer window failure. Main cause of below floor water damage.
- 2. Inadequate positive surface water connection to drainage system.
- 3. Existing external wall and ceilings failing and in poor state of repair, showing water egress either running through render facade, head of windows or cills above.
- 4. Existing external wall failing and in poor state of repair.

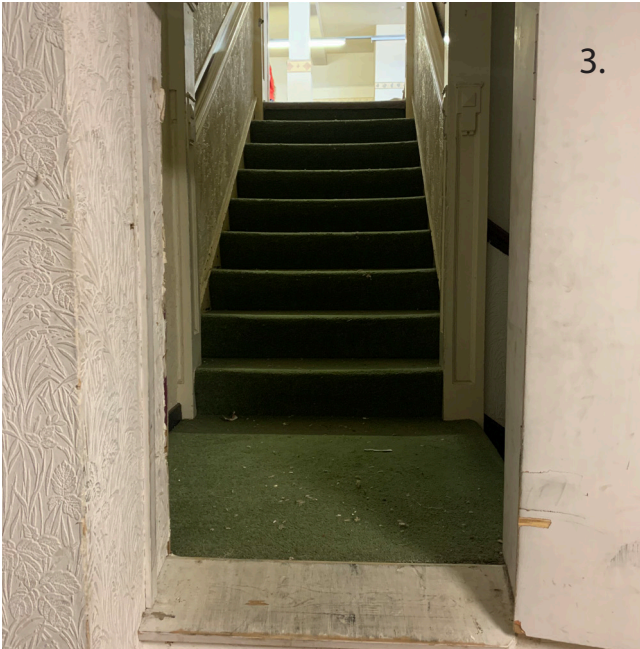
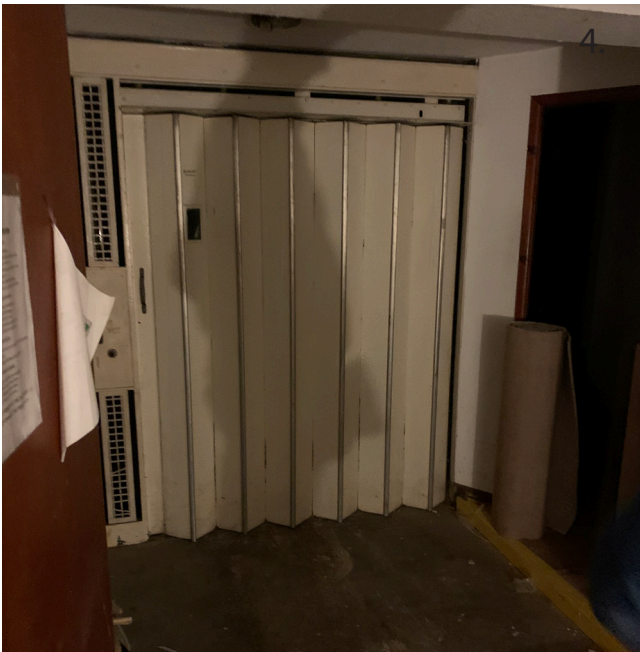
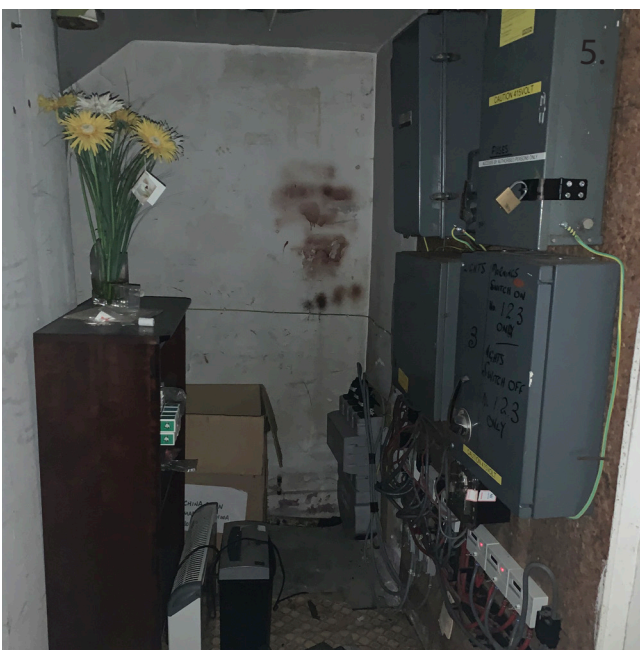
1. Existing fire escape route to ground floor.
2. Low ceiling height storage room. Wall panels potentially blocking void space under retail unit containing drainage termination points.
3. Loading hatch positioned off main stair.
4. Existing lift car to basement.
5. Location of incoming main services cup'd.
6. Evidence of ceiling zone failing, showing water egress from floor above. Tanked basement walls look in good repair.
