Refurbishment Survey (with MA + PA)

10-11 South Parade
Seascale
CA20 1PZ

**West Coast Surveys
Unit 2
Derwent Building
40 Lakes Road
Derwent Howe
Workington
Cumbria CA14 3YP**

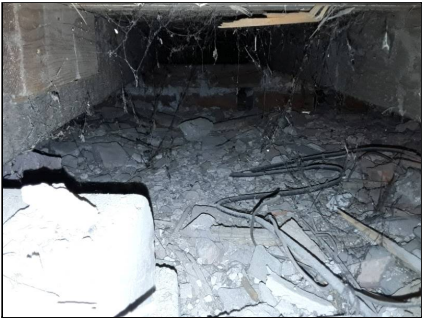
Survey Date:	Lead Surveyor	Survey Type	Floor	Analysis
	4 Apr 2023	Paul Agnew	Refurbishment Survey	Ground Floor	N/A
	Building	Room	Item	Quantity	
	Commercial property	Floor cavities G02	No suspect materials found	N/A	
	Sample No (S,SP,P,As)	Product Type	Surface Treatment	Condition	Accessibility
	Visual (P)	N/A	N/A	N/A	N/A

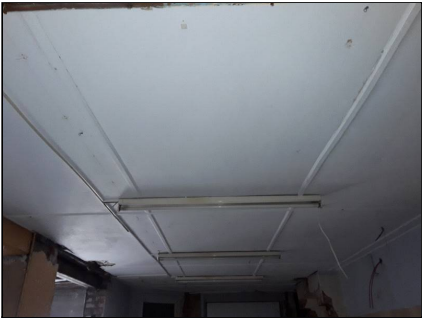
Survey Date:	Lead Surveyor	Survey Type	Floor	Analysis
	4 Apr 2023	Paul Agnew	Refurbishment Survey	Ground Floor	
	Building	Room	Item	Quantity	
	Commercial property	Room 1 G01	White material over fibreboard ceiling Part ceiling	36m ²	
	Sample No (S,SP,P,As)	Product Type	Surface Treatment	Condition	Accessibility
	PA002955 (S)	N/A	N/A	N/A	N/A

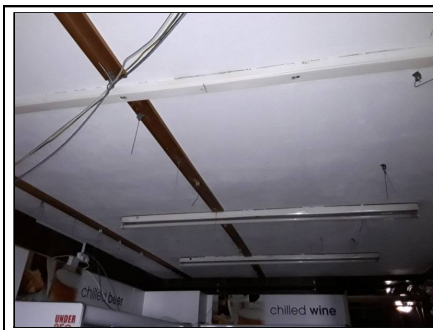
Survey Date:	Lead Surveyor	Survey Type	Floor	Analysis
4 Apr 2023	Paul Agnew	Refurbishment Survey	Ground Floor	No Asbestos Detected
Building	Room	Item	Quantity	
Commercial property	Room 1 G01	Textured coating Over plastered ceiling, Lower area	28m ²	
Sample No (S,SP,P,As)	Product Type	Surface Treatment	Condition	Accessibility
PA002957 (S)	N/A	N/A	N/A	N/A

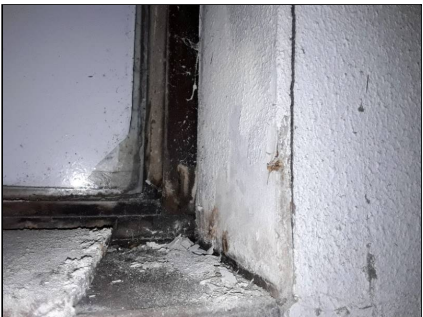
Survey Date:	Lead Surveyor	Survey Type	Floor	Analysis
	4 Apr 2023	Paul Agnew	Refurbishment Survey	Ground Floor	N/A
	Building	Room	Item	Quantity	
	Commercial property	Room 1 G01	Wooden panelling to window reveals	N/A	
	Sample No (S,SP,P,As)	Product Type	Surface Treatment	Condition	Accessibility
Visual (P)	N/A	N/A	N/A	N/A

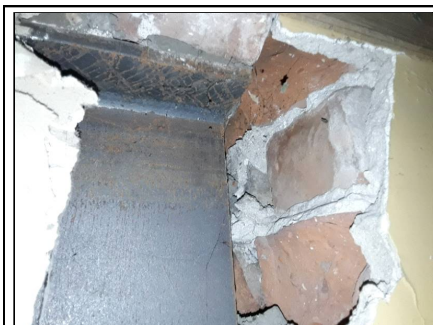
Survey Date:	Lead Surveyor	Survey Type	Floor	Analysis
4 Apr 2023	Paul Agnew	Refurbishment Survey	Ground Floor	N/A
Building	Room	Item	Quantity	
Commercial property	Wall cavities G03	No suspect materials found	N/A	
Sample No (S,SP,P,As)	Product Type	Surface Treatment	Condition	Accessibility
Visual (P)	N/A	N/A	N/A	N/A

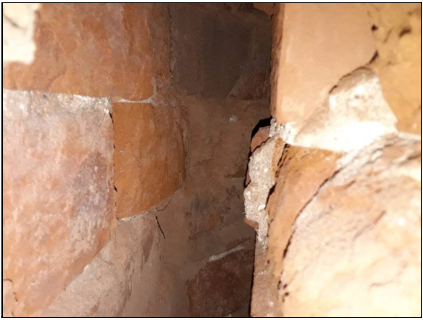
Survey Date:	Lead Surveyor	Survey Type	Floor	Analysis
	4 Apr 2023	Paul Agnew	Refurbishment Survey	Ground Floor	N/A
	Building	Room	Item	Quantity	
	Commercial property	Wall cavities G03	No suspect materials	N/A	
	Sample No (S,SP,P,As)	Product Type	Surface Treatment	Condition	Accessibility
	Visual (P)	N/A	N/A	N/A	N/A

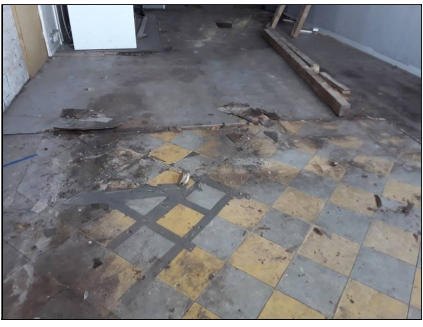
Survey Date:	Lead Surveyor	Survey Type	Floor	Analysis
	4 Apr 2023	Paul Agnew	Refurbishment Survey	Ground Floor	No Asbestos Detected
	Building	Room	Item	Quantity	
	Commercial property	Room 2 G04	Yellow/grey floor tiles and adhesive To wooden flooring part beneath grey linoleum material	28m ²	
	Sample No (S,SP,P,As)	Product Type	Surface Treatment	Condition	Accessibility
PA002959 (S)	N/A	N/A	N/A	N/A

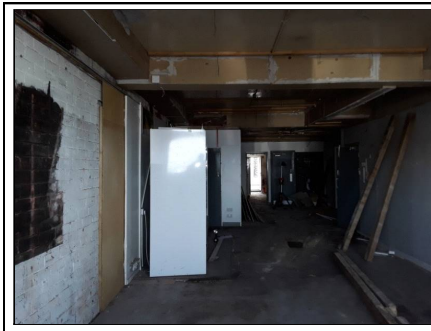
Survey Date:	Lead Surveyor	Survey Type	Floor	Analysis
4 Apr 2023	Paul Agnew	Refurbishment Survey	Ground Floor	N/A
Building	Room	Item	Quantity	
Commercial property	Room 2 G04	Walls are brick beneath part covering of plasterboard, Plastered ceiling	N/A	
Sample No (S,SP,P,As)	Product Type	Surface Treatment	Condition	Accessibility
Visual (P)	N/A	N/A	N/A	N/A

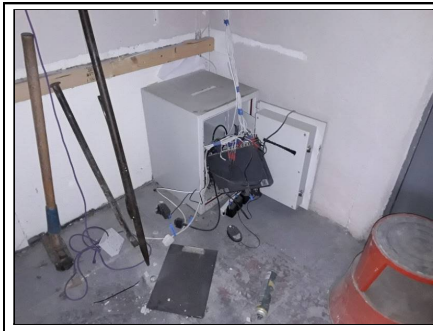
Survey Date:	Lead Surveyor	Survey Type	Floor	Analysis
4 Apr 2023	Paul Agnew	Refurbishment Survey	Ground Floor	N/A
Building	Room	Item	Quantity	
Commercial property	Room 3 G05	Modern safe	N/A	
Sample No (S,SP,P,As)	Product Type	Surface Treatment	Condition	Accessibility
Visual (P)	N/A	N/A	N/A	N/A

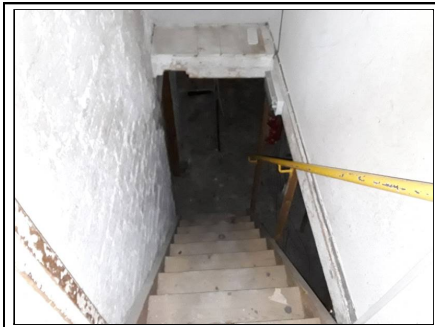
Survey Date:	Lead Surveyor	Survey Type	Floor	Analysis
4 Apr 2023	Paul Agnew	Refurbishment Survey	Z-Sub Level 1	N/A
Building	Room	Item	Quantity	
Commercial property	Staircase Z101	No suspect materials	N/A	
Sample No (S,SP,P,As)	Product Type	Surface Treatment	Condition	Accessibility
Visual (P)	N/A	N/A	N/A	N/A

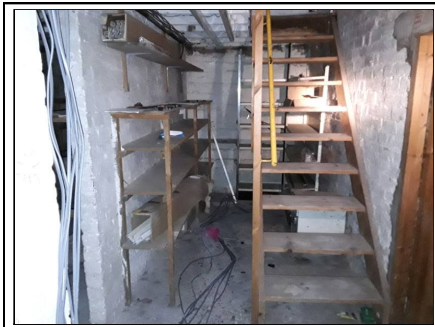
Survey Date:	Lead Surveyor	Survey Type	Floor	Analysis
4 Apr 2023	Paul Agnew	Refurbishment Survey	Z-Sub Level 1	N/A
Building	Room	Item	Quantity	
Commercial property	Stairwell Z102	No suspect materials found	N/A	
Sample No (S,SP,P,As)	Product Type	Surface Treatment	Condition	Accessibility
Visual (P)	N/A	N/A	N/A	N/A

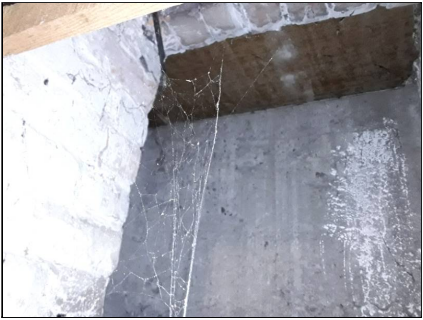
Survey Date:	Lead Surveyor	Survey Type	Floor	Analysis
	4 Apr 2023	Paul Agnew	Refurbishment Survey	Z-Sub Level 1	N/A
	Building	Room	Item	Quantity	
	Commercial property	Room 1 Z103	No suspect materials Void in wall	N/A	
	Sample No (S,SP,P,As)	Product Type	Surface Treatment	Condition	Accessibility
	Visual (P)	N/A	N/A	N/A	N/A

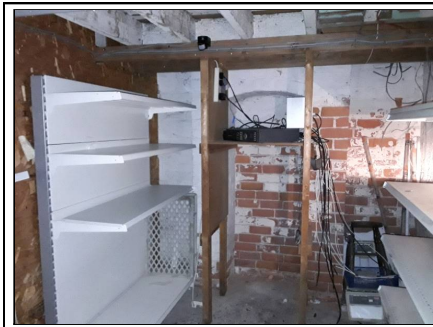
Survey Date:	Lead Surveyor	Survey Type	Floor	Analysis
4 Apr 2023	Paul Agnew	Refurbishment Survey	Z-Sub Level 1	N/A
Building	Room	Item	Quantity	
Commercial property	Room 1 Z103	Concrete flooring, Bricked walls and wooden ceiling, Part wooden panelling to walls	N/A	
Sample No (S,SP,P,As)	Product Type	Surface Treatment	Condition	Accessibility
Visual (P)	N/A	N/A	N/A	N/A

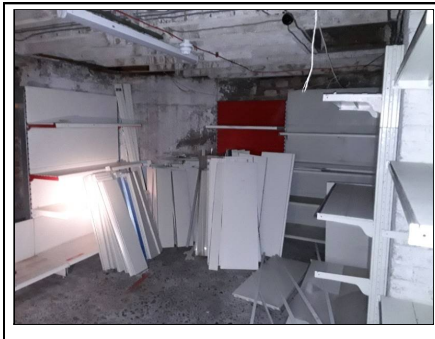
Survey Date:	Lead Surveyor	Survey Type	Floor	Analysis
4 Apr 2023	Paul Agnew	Refurbishment Survey	Z-Sub Level 1	N/A
Building	Room	Item	Quantity	
Commercial property	Room 2 Z104	Walls are brick beneath part covering of wooden panelling, Concrete floor, Wooden ceiling	N/A	
Sample No (S,SP,P,As)	Product Type	Surface Treatment	Condition	Accessibility
Visual (P)	N/A	N/A	N/A	N/A

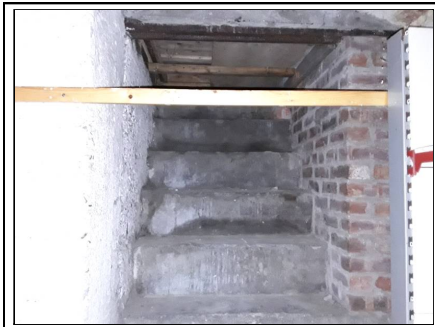
Survey Date:	Lead Surveyor	Survey Type	Floor	Analysis
4 Apr 2023	Paul Agnew	Refurbishment Survey	Z-Sub Level 1	N/A
Building	Room	Item	Quantity	
Commercial property	Room 2 Z104	No suspect materials Redundant concrete staircase section	N/A	
Sample No (S,SP,P,As)	Product Type	Surface Treatment	Condition	Accessibility
Visual (P)	N/A	N/A	N/A	N/A

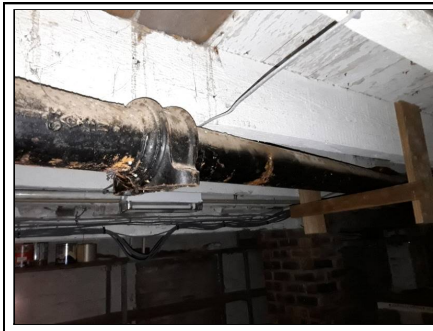
Survey Date:	Lead Surveyor	Survey Type	Floor	Analysis
4 Apr 2023	Paul Agnew	Refurbishment Survey	Z-Sub Level 1	N/A
Building	Room	Item	Quantity	
Commercial property	Room 3 Z105	Metal waste pipes across ceiling area	N/A	
Sample No (S,SP,P,As)	Product Type	Surface Treatment	Condition	Accessibility
Visual (P)	N/A	N/A	N/A	N/A

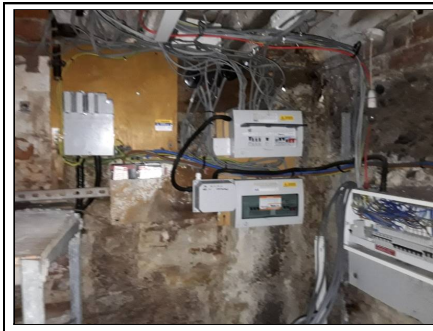
Survey Date:	Lead Surveyor	Survey Type	Floor	Analysis
4 Apr 2023	Paul Agnew	Refurbishment Survey	Z-Sub Level 1	N/A
Building	Room	Item	Quantity	
Commercial property	Room 3 Z105	Modern electrics	N/A	
Sample No (S,SP,P,As)	Product Type	Surface Treatment	Condition	Accessibility
Visual (P)	N/A	N/A	N/A	N/A

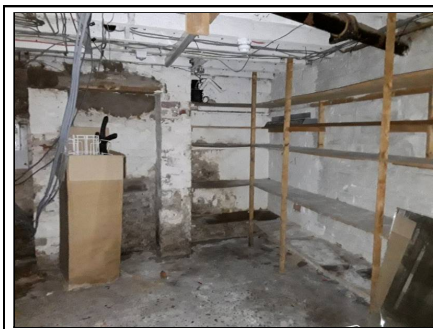
Survey Date:	Lead Surveyor	Survey Type	Floor	Analysis
4 Apr 2023	Paul Agnew	Refurbishment Survey	Z-Sub Level 1	N/A
Building	Room	Item	Quantity	
Commercial property	Room 3 Z105	Walls are brick, Concrete floor, Wooden ceiling	N/A	
Sample No (S,SP,P,As)	Product Type	Surface Treatment	Condition	Accessibility
Visual (P)	N/A	N/A	N/A	N/A

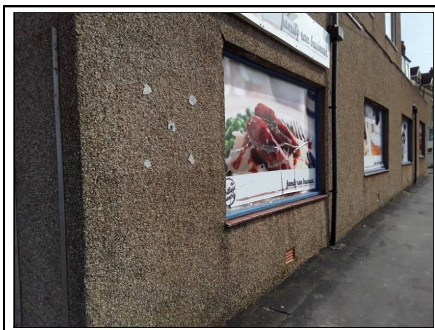
Survey Date:	Lead Surveyor	Survey Type	Floor	Analysis
4 Apr 2023	Paul Agnew	Refurbishment Survey	External	No Asbestos Detected
Building	Room	Item	Quantity	
Commercial property	Walls E01	Render material All external wall areas	Throughout	
Sample No (S,SP,P,As)	Product Type	Surface Treatment	Condition	Accessibility
PA002962 (S)	N/A	N/A	N/A	N/A

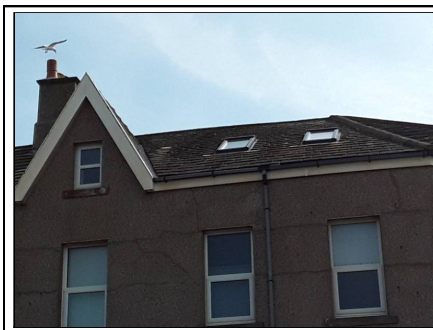
Survey Date:	Lead Surveyor	Survey Type	Floor	Analysis
4 Apr 2023	Paul Agnew	Refurbishment Survey	External	N/A
Building	Room	Item	Quantity	
Commercial property	Roof E02	Roof tiles are slate	N/A	
Sample No (S,SP,P,As)	Product Type	Surface Treatment	Condition	Accessibility
Visual (P)	N/A	N/A	N/A	N/A

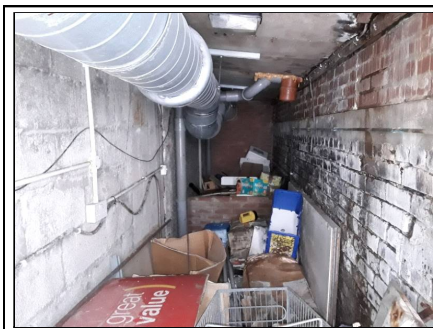
Survey Date:	Lead Surveyor	Survey Type	Floor	Analysis
4 Apr 2023	Paul Agnew	Refurbishment Survey	External	N/A
Building	Room	Item	Quantity	
Commercial property	Outhouse E03	No suspect materials found	N/A	
Sample No (S,SP,P,As)	Product Type	Surface Treatment	Condition	Accessibility
Visual (P)	N/A	N/A	N/A	N/A

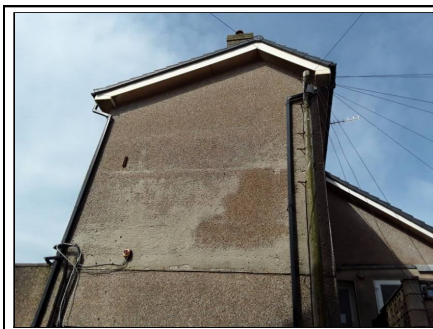
Survey Date:	Lead Surveyor	Survey Type	Floor	Analysis
4 Apr 2023	Paul Agnew	Refurbishment Survey	External	N/A
Building	Room	Item	Quantity	
Commercial property	Rainwater goods E04	Guttering and downpipes are plastic	N/A	
Sample No (S,SP,P,As)	Product Type	Surface Treatment	Condition	Accessibility
Visual (P)	N/A	N/A	N/A	N/A
