## APPENDIX D – PREVIOUS DRAINAGE INVESTIGATIONS

## Former Rhodia Site Sea Outfall Investigation

Week Commencing 11<sup>th</sup> December 2017

**Purpose:** To gather as much information as possible about the sea outfall and its associated underground physical assets upstream to the leachate plant sampling point.

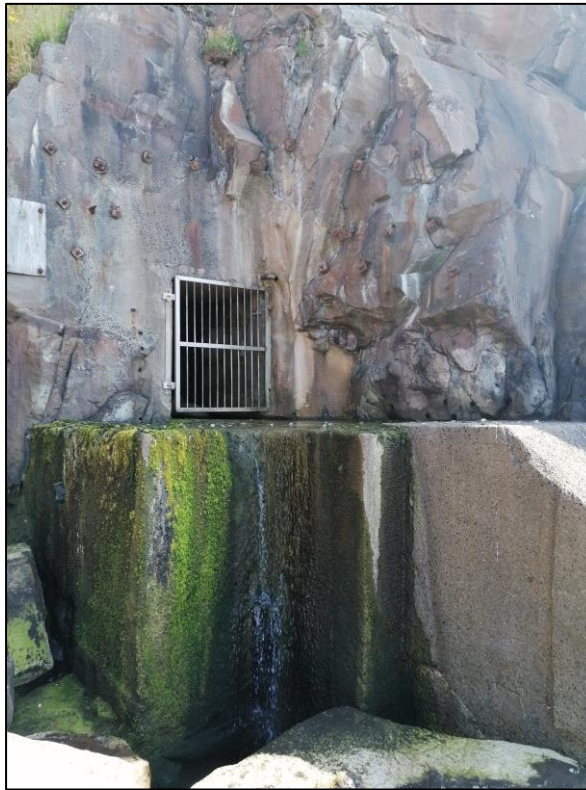
**Photo 3 – Northern Discharge Pipe – Sea Outfall (I)**

Video footage of the Greenpeace activities on this outfall in 1991 shows a swan's neck outfall, with the top of the neck at the high-water mark. This swan's neck has been washed away in the intervening period, the horizontal section to the low water mark has been open to the elements for several years.

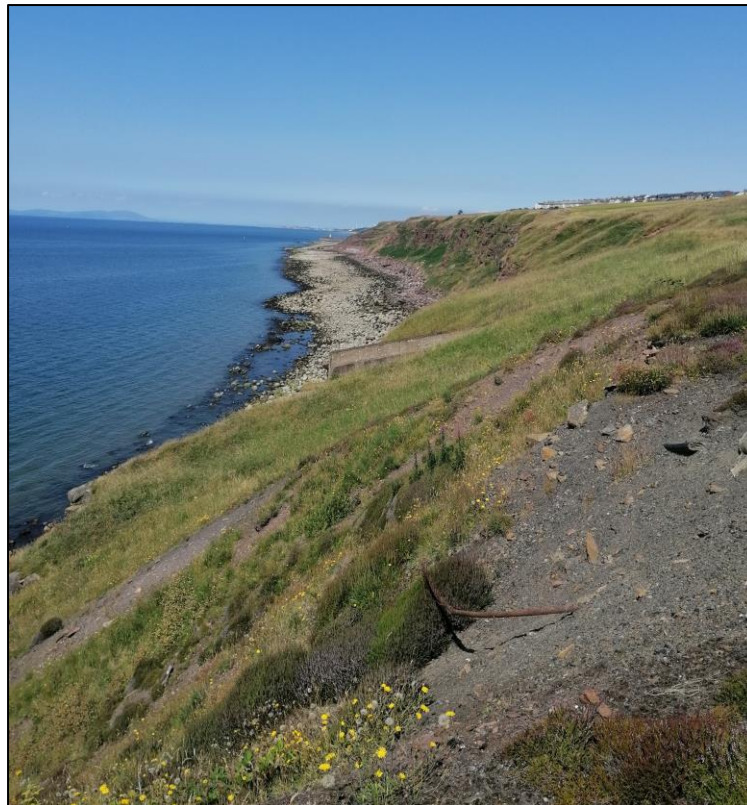
**Photo 6 – Cliff Outfall (I)**

There is a second sea outfall pipe; this runs down the cliff from MH17, through the southern side of MH17C to MH15 which is a Y manhole. This connects across to MH5. The other leg of the Y is stopped off but it runs down to MH14 then to MH13, then to MH12 and finally it drops into a box section culvert called MH11 on the plan before discharging over the cliff. We have footage of this drain – it's a combination of 600 and 450mm diameter pipe and is in good condition. Access to the vertical section is poor and unsafe. There's no access at MH11 other than by dangling over the cliff.
