Bingham Yates Limited

FORMER CASTLE CINEMA SITE, EGREMONT

We confirm the investigation at the above site, relating to the attempted completion of BRE Digest 365 percolation tests, on Wednesday 26 and Thursday 27 September 2018, and we are pleased to advise you as follows.

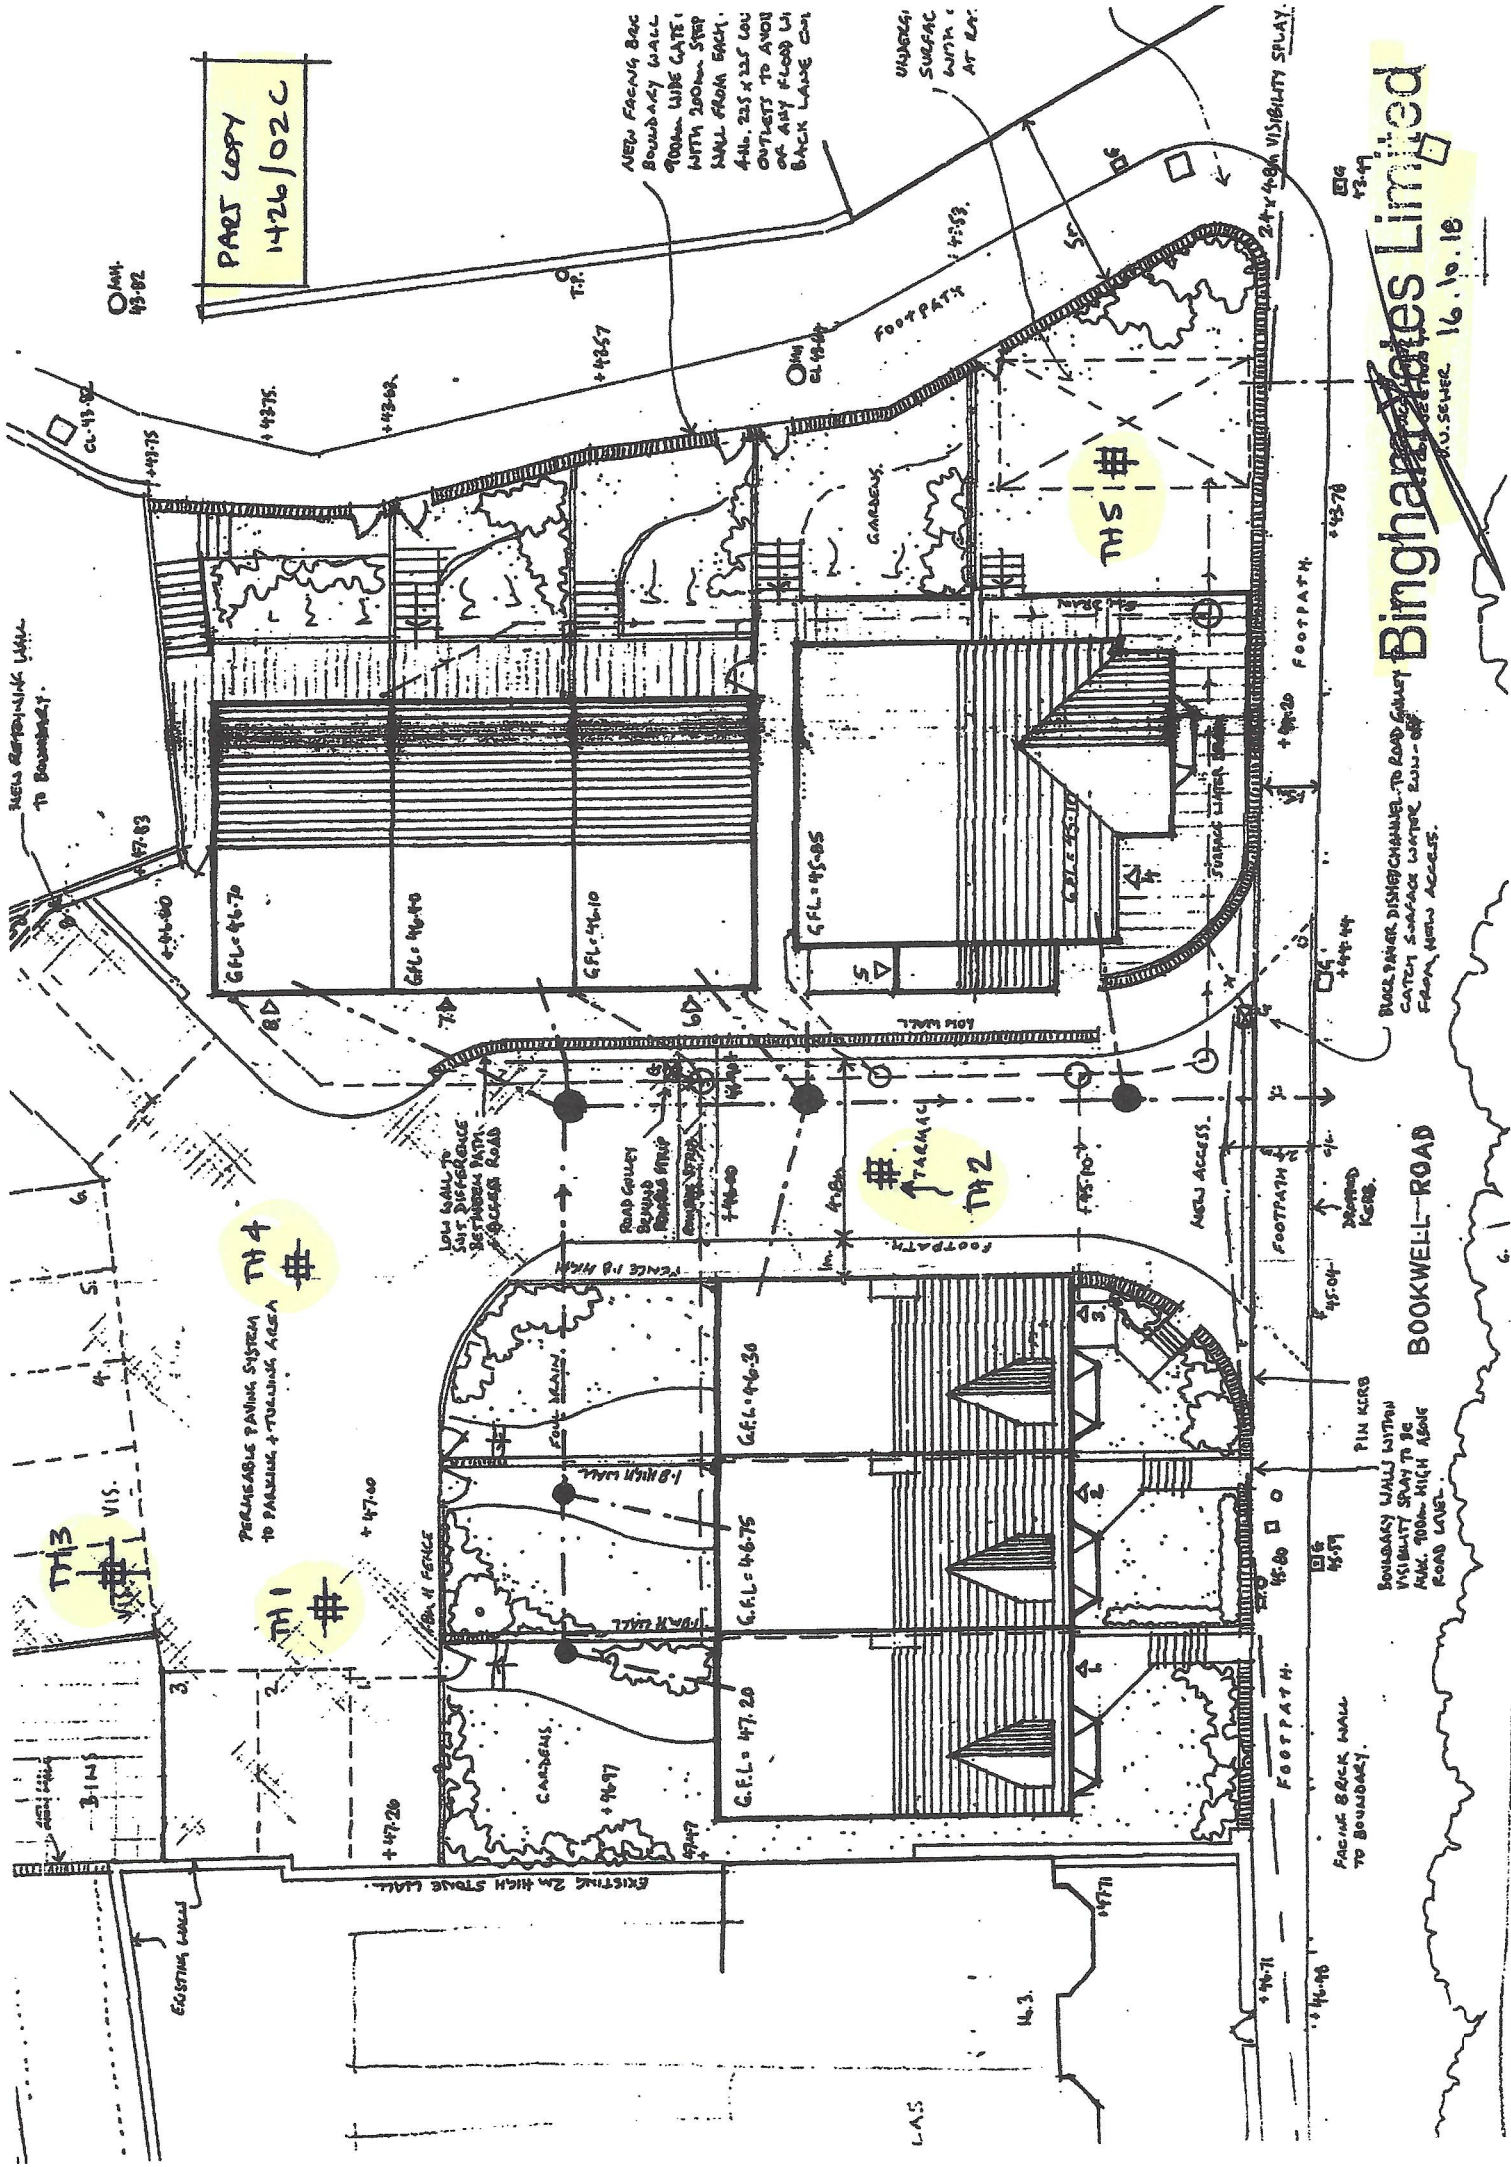
PARIS COPY
1426/02C

We attach a marked up part copy of your drawing 1426/02C, indicating the 5No excavation positions which were completed to initial depths of 1.5m/2.5m deep below existing ground level on the afternoon of Wednesday 26 September 2018. A return visit was made early the following morning to observe the situation, in each instance.
