Bat Survey - Former Public Toilets, Chapel Street, Egremont, Cumbria, CA22 2DU

This brief report outlines the findings of a site inspection for bats at Former Public Toilets, Chapel Street, Egremont, Cumbria, CA22 2DU (Nat Grid Ref. NY 01191 10767).

Our Ref. No.: CBC20BAT012
 Date: 02 July 2020
 Your Ref. No.: N/A

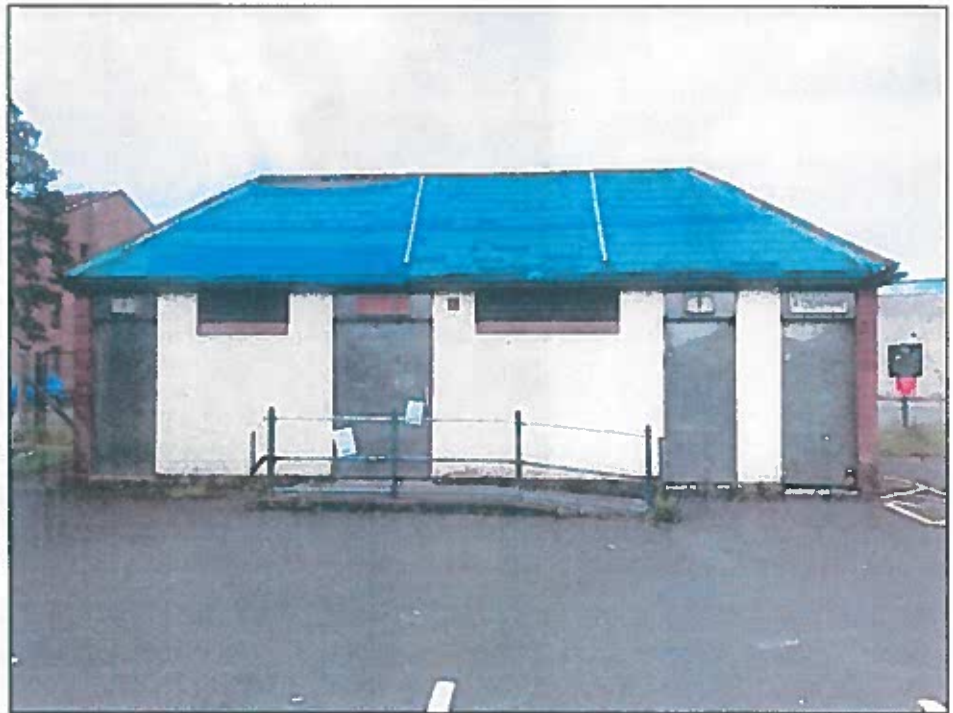
The former public toilet building itself is constructed of brick, with a timber framed roof which is hipped at the northern and southern ends. The roof is internally lined with a bituminous roofing felt and externally clad in a manufactured tile. The roof is in a very poor state of repair having apparently suffered from vandalism and a large number of tiles are broken and holes exist through the internal roof lining. To mitigate the risk of broken tiles falling or

blowing off the roof, debris netting has been secured on the eastern pitch of the hipped roof. The external walls are rendered and the eaves are enclosed within plastic soffits and fascias which are in a good state of repair and do not offer any gaps. Internally the male, female and disabled toilet facilities are enclosed within pre-fabricated stainless steel cubicles with a glass false ceiling. The attendant area is without this internal cubicle, allows access to the rear of the toilet facilities and contains the cisterns and cleaning facilities. From the attendants area it is possible to access the roof space, which is generally unenclosed, but does lie above the internal cubicle unit.

Figure 3: Showing the eastern elevation of Chapel Street Toilets with debris netting attached to the eastern pitch of the hipped roof to prevent broken tiles falling off.

The eastern pitch of the roof - being completely covered with debris netting - is inaccessible to bats. Although many broken and missing tiles exist on this pitch, offering theoretical access to gaps between the cladding and the lining (and to the internal void), the debris netting comprehensively prevents access via the eastern pitch. Broken tiles also exist on the northern and western pitches; these are limited to a small number of tiles but do allow theoretical access to the roof structure and void to birds and bats. All gaps created by broken tiles were accessible during the site inspection and could be inspected in detail.

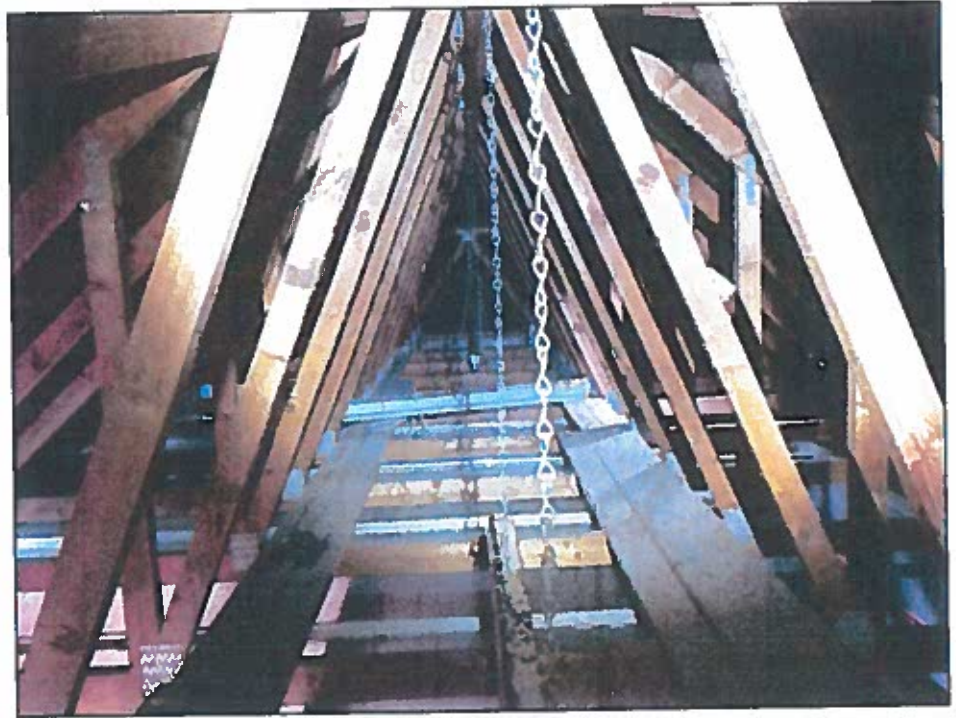
The identified gaps were inspected with a high powered torch and video endoscope and no evidence of bats having used these locations was identified. No droppings were discovered anywhere on or within the roof structure and no scratches or other evidence of bats was identified in or around the features

deemed to offer potential for bats to roost. Furthermore, no evidence of bats or birds was identified within the roof void. Rat droppings were discovered within the roof void on timber walkways above the glass false ceiling and on the glass itself.

Figure 4: Showing the internal void within the building.
