Project Name: 2019_09_24 Whiehaven Bus Station
Project Description: Culvert Inspection
Project Date: 24/09/2019
Project Standard: MSCC5 Sewers & Drainage GB (SRM5 Scoring)

Culvert inspection Whitehaven Bus Station.

Section Inspection - 24/09/2019 - Y junctionX

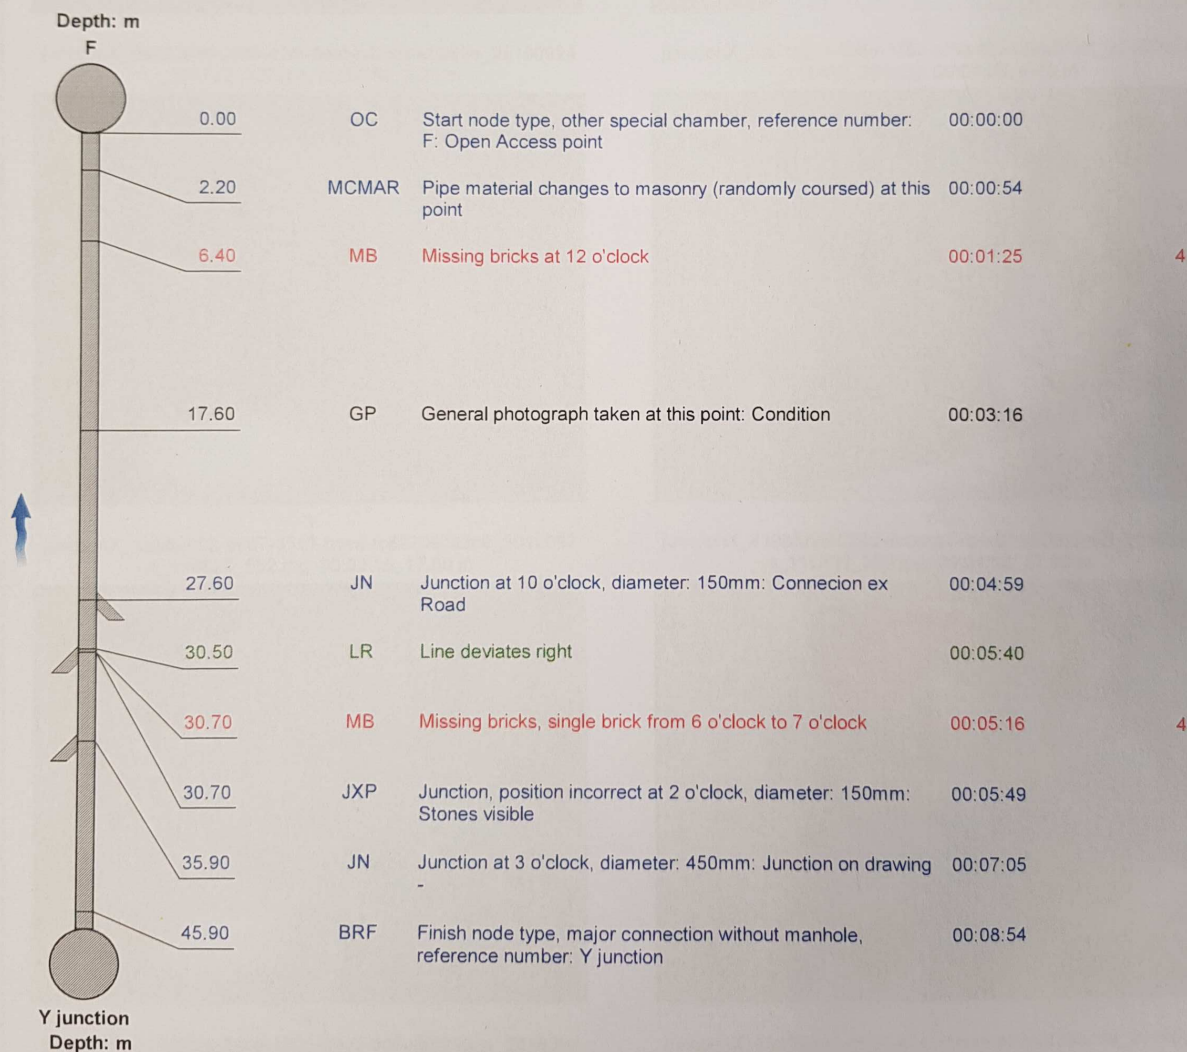
Scale: 1:408 Position [m] Code Observation MPEG Photo Grade

Construction Features					Miscellaneous Features				
Structural Defects					Service & Operational Observations				
STR No. Def	STR Peak	STR Mean	STR Total	STR Grade	SER No. Def	SER Peak	SER Mean	SER Total	SER Grade
2	80.0	3.4	160.0	4.0	0	0.0	0.0	0.0	1.0

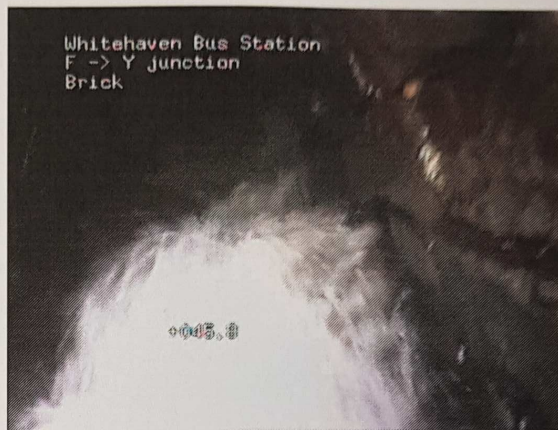
junctionX_9b080ac4-1ac6-4fb1-b7f8-de179b015cca_20190924_120332_220.jpg, 00:08:54, 45.90 m

At the 46m mark upstream of F the culvert appears to come in at high level. The inspector could not climb the "waterfall" so the survey was abandoned at this point. This is most likely the culvert passing over the railway tunnel.
