CCTV Inspection Report

JEFFERSON PARK ADDITIONAL SURVEYS LOW ROAD WHITEHAVEN

22/11/2021
Approved By: S. OAKES
Job Number: SK-S 256/2021

SK Drainage Solutions

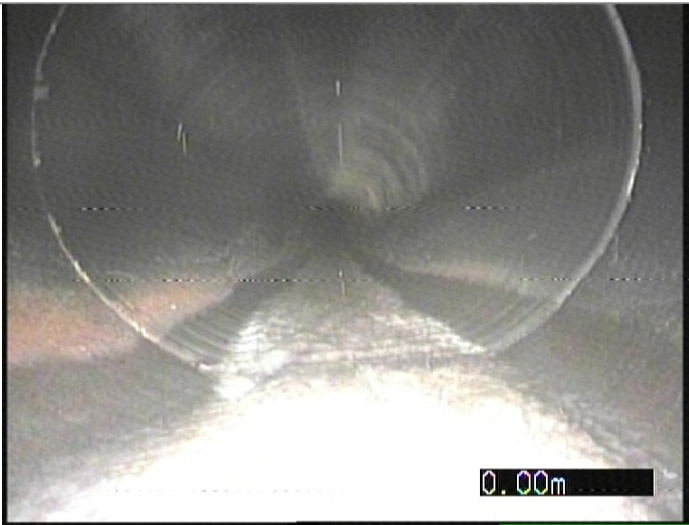
<p>Start node type, manhole, reference SW15</p>

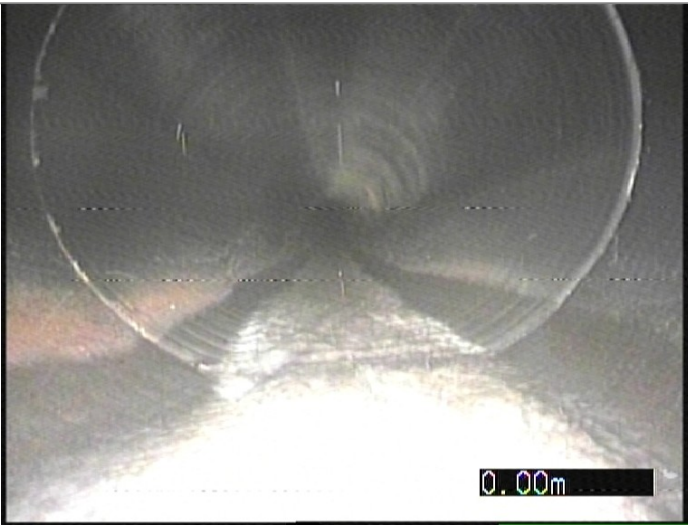
<p>Water level 5% height/diameter</p>

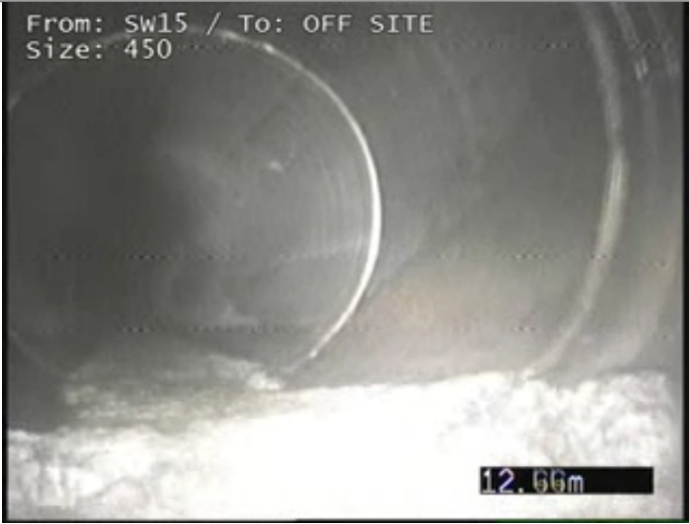
DISPLACED JOINT AT 12.66M HOLDING A SMALL AMOUNT OF FLOW.

<p>Joint displaced 10mm</p>

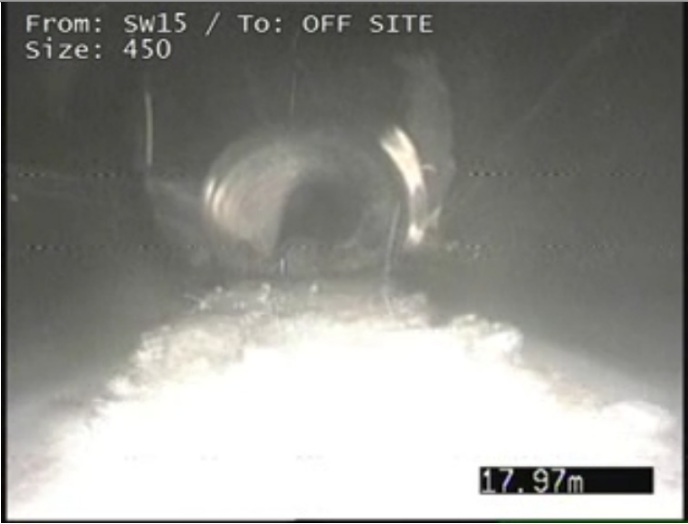
<p>Water level 10% height/diameter, Start</p>

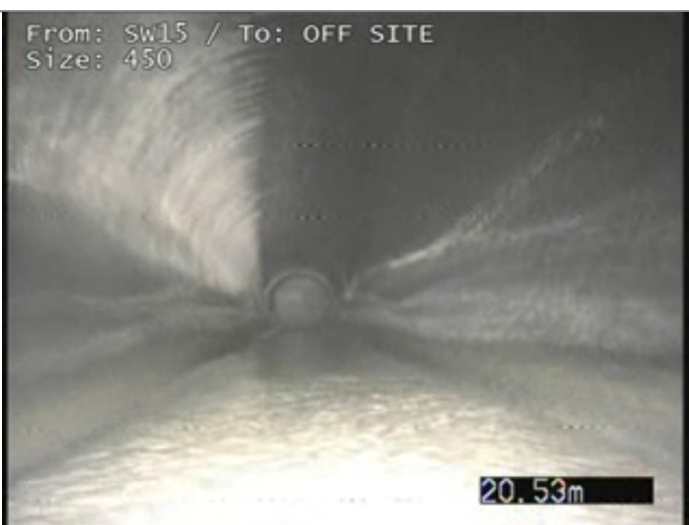
<p>Water level 10% height/diameter, Finished</p>

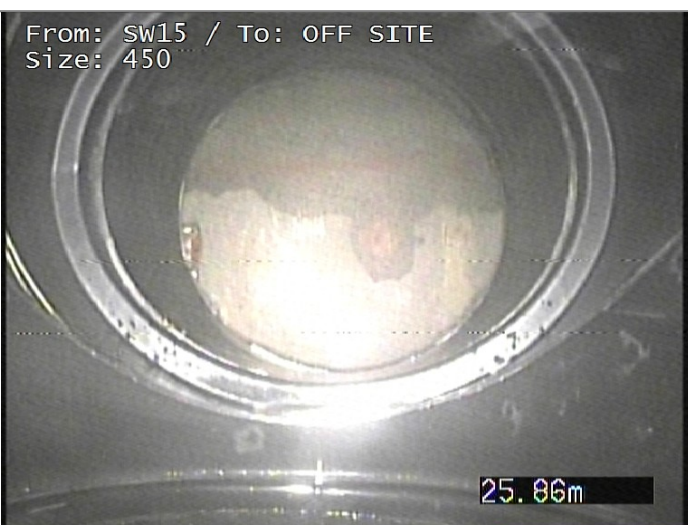
The survey downstream towards Pow Beck could not not be completed as the pipe enters the manhole on Low Road via a back drop connection.

<p>Finish node type, manhole, reference OFF SITE BACKDROP FINISH</p>

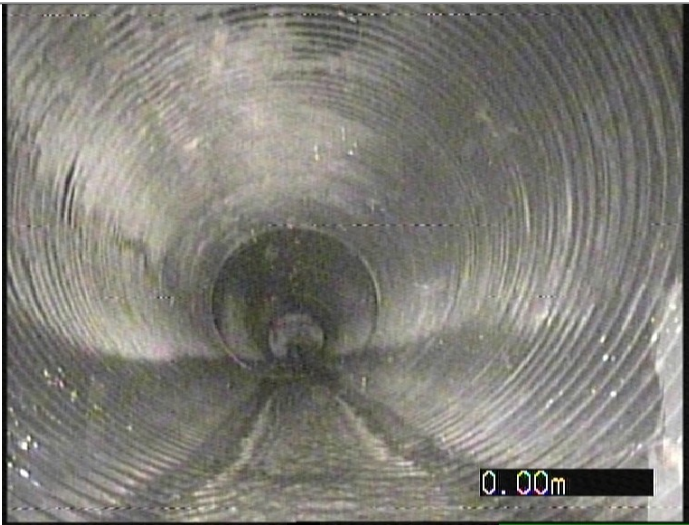
<p>Start node type, manhole, reference SW20</p>

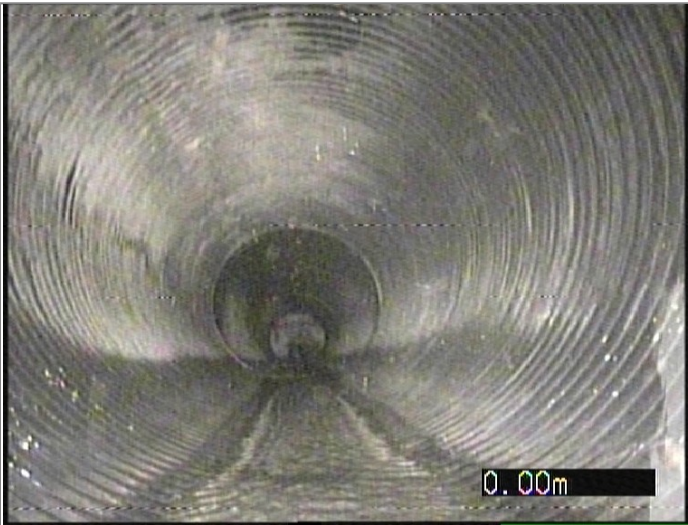
<p>Water level 00% height/diameter</p>			
<p>From: Sw20 / To: Sw15 Size: 1200</p>

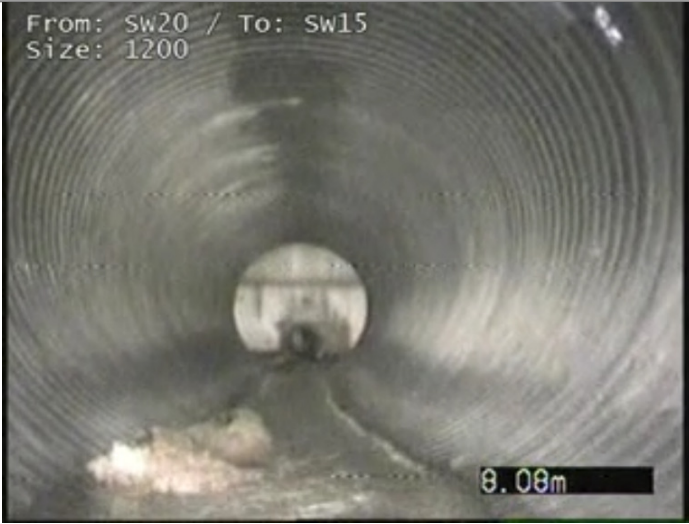
<p>Settled deposits hard or compacted 5% cross-sectional area loss</p>			
<p>From: Sw20 / To: Sw15 Size: 1200</p>

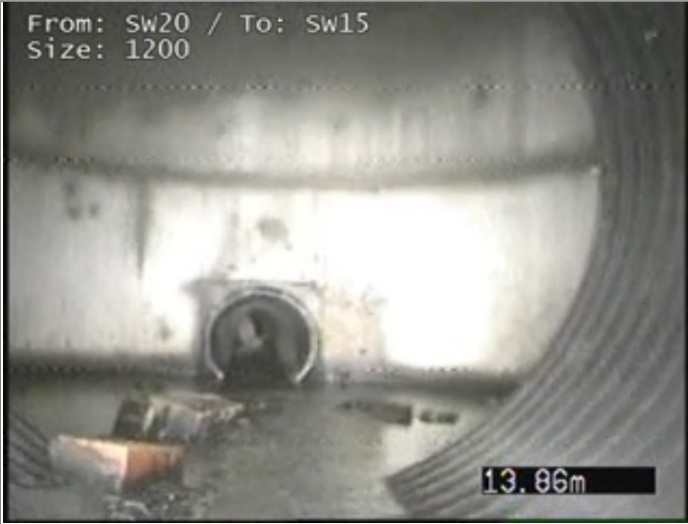
DEBRIS NOTED IN MH SW15.

<p>Settled deposits coarse 20% cross-sectional area loss - Remark: DEBRIS IN MANHOLE.</p>			
<p>From: Sw20 / To: Sw15 Size: 1200</p>

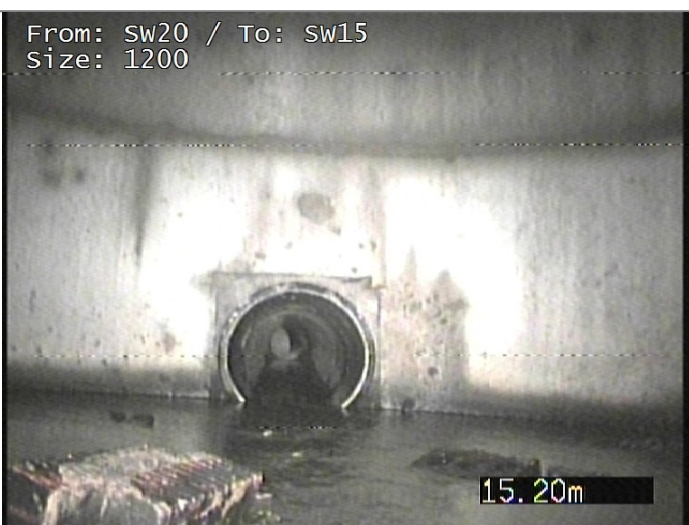
<p>Finish node type, manhole, reference SW15/A</p>

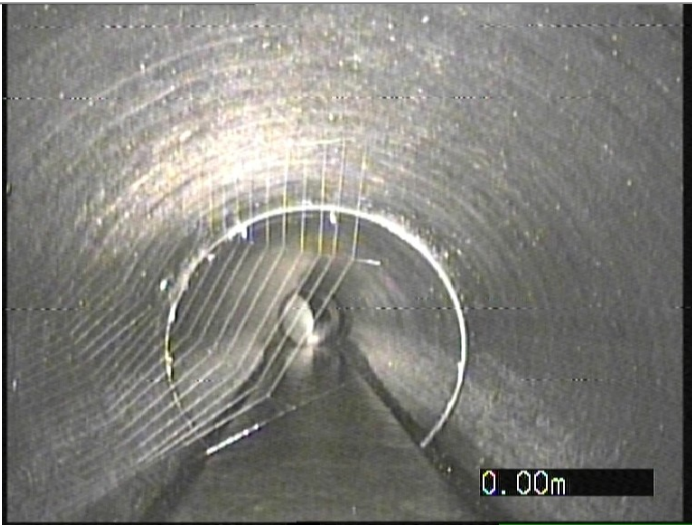
<p>Start node type, manhole, reference SW15/A</p>

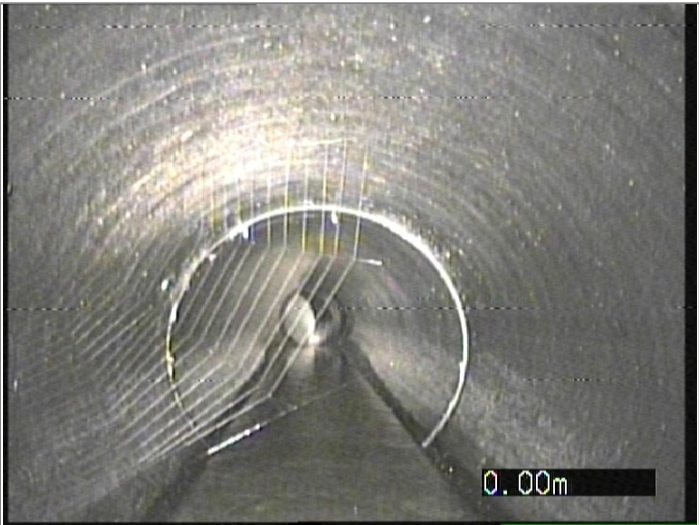
<p>Water level 5% height/diameter</p>			
<p>From: Sw15/A / To: Sw15 Size: 525</p>

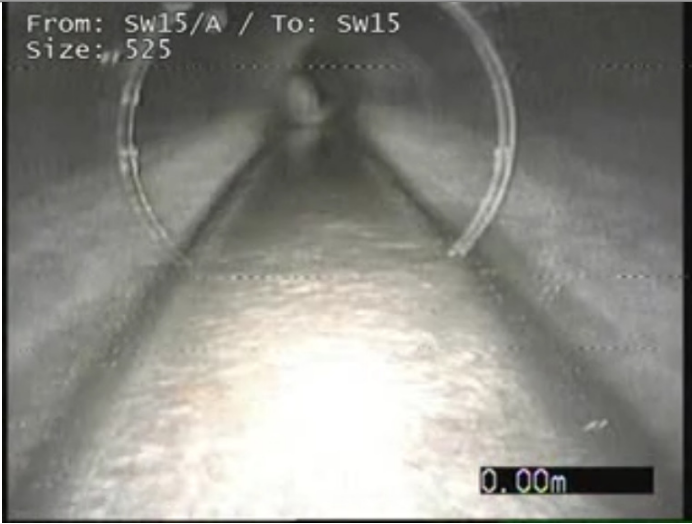
SMALL AMOUNT OF DEBRIS THROUGHOUT.

<p>Settled deposits fine 5% cross-sectional area loss, Start</p>			
<p>From: Sw15/A / To: Sw15 Size: 525</p>

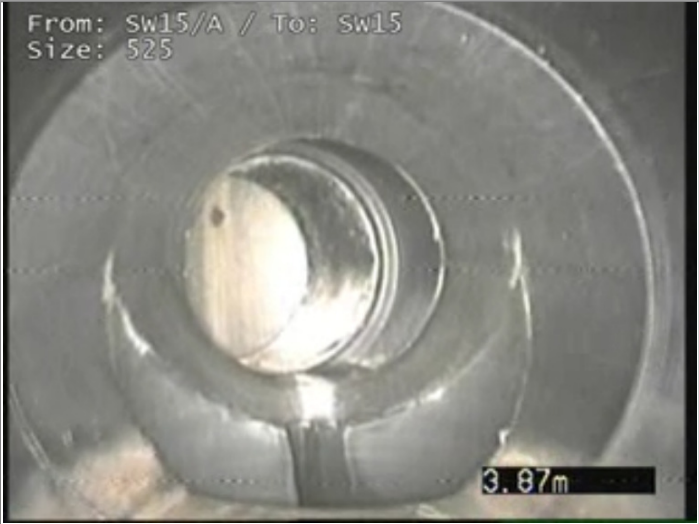
<p>Settled deposits fine 5% cross-sectional area loss, Finished</p>			
<p>From: Sw15/A / To: Sw15 Size: 525</p>

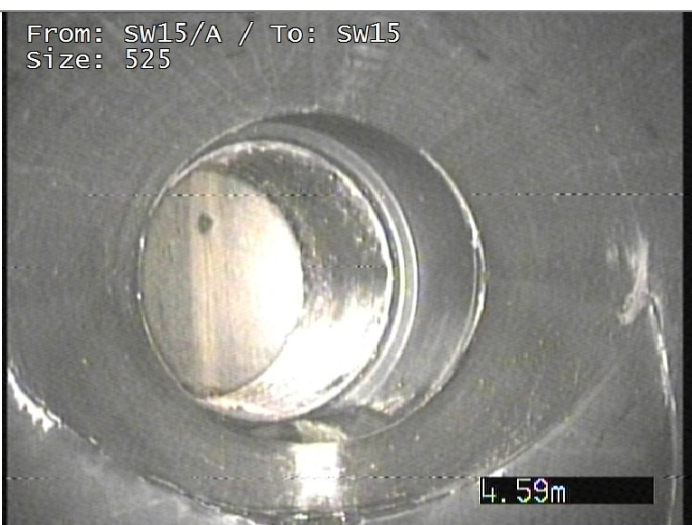
<p>Finish node type, manhole, reference SW15</p>
