# Phase II GeoEnvironmental Investigation

Old Ironworks

Devonshire Road

**Report Ref: A1287/17**

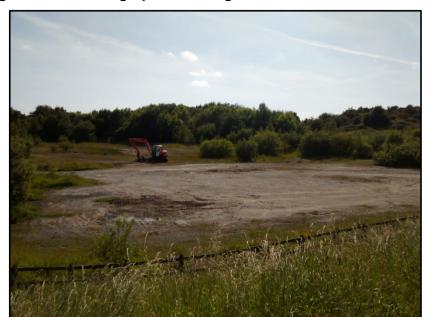
Figure 2 Site Photograph - Looking SW towards Devonshire Road

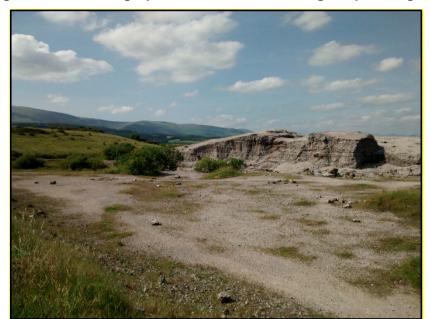
A photograph of a residual slag heap just north of the site boundary is shown in Figure 4 overleaf.

Figure 4 Site Photograph - View of residual slag heap, facing NW
