Project Name: Whitehaven Academy - Hensingham - 2022_06_20

Project Description: CCTV

Project Number: JC 27466

Inspection Standard: MSCC5 Sewers & Drainage GB (SRM5 Scoring)

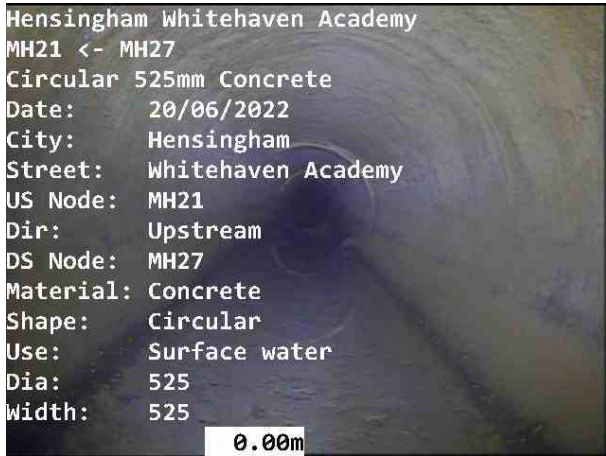
MH21X_ce390d49-0f25-447a-8f10-d813b35b3e71_20220622_153449_770.jpg, 00:00:00, 0.00 m
 Start node, manhole, reference: MH27

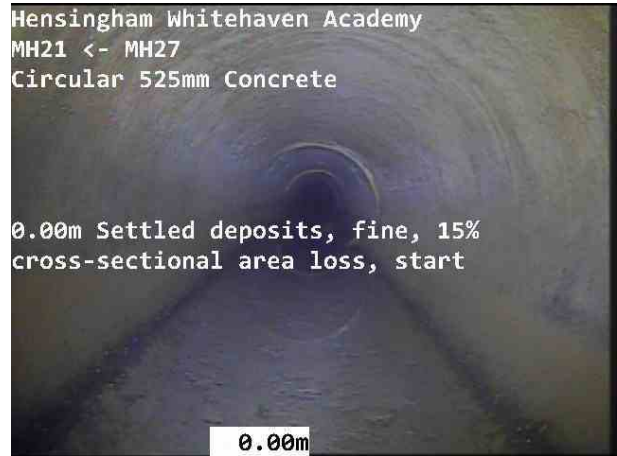
MH21X_0134eacd-9871-4a78-9401-57dceaa3e30f_20220622_153452_952.jpg, 00:00:06, 0.00 m
 Settled deposits, fine, 15% cross-sectional area loss, start

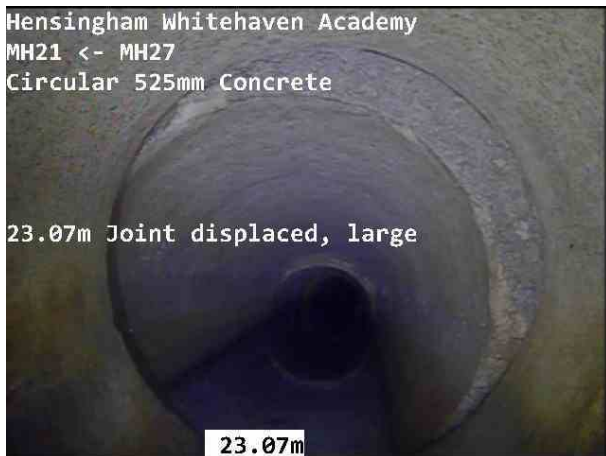
MH21X_57a3cae3-a014-41c0-bd47-c7d6fe2c8a72_20220622_153612_461.jpg, 00:03:14, 23.07 m
 Joint displaced, large

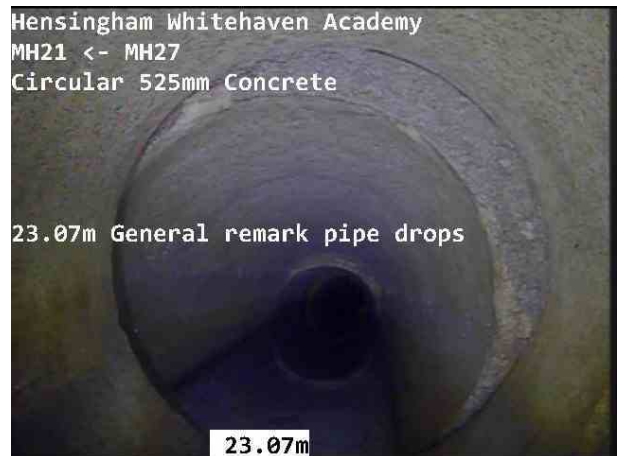
MH21X_7e59d3ce-88e2-4efb-8494-19a2d08cb071_20220622_153616_513.jpg, 00:03:18, 23.07 m
 General remark, pipe drops

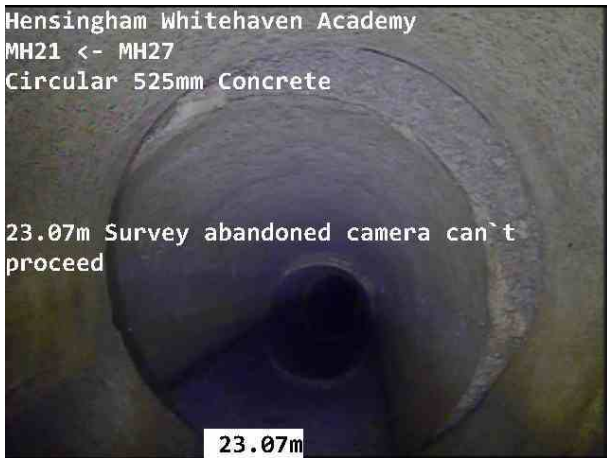
MH21X_54dc5fb6-c5f6-47f9-b311-cc86b9df179a_20220622_1
 53619_944.jpg, 00:03:23, 23.07 m
 Survey abandoned, camera can't proceed

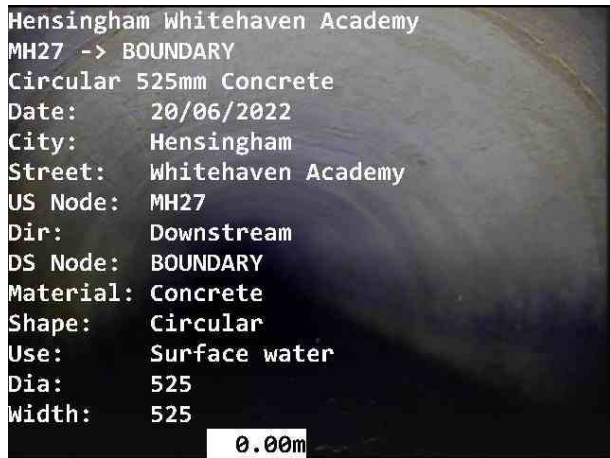
MH27X_28783338-b581-433b-a55a-7c08c969d744_20220622_153632_831.jpg, 00:00:00, 0.00 m
 Start node, manhole, reference: MH27

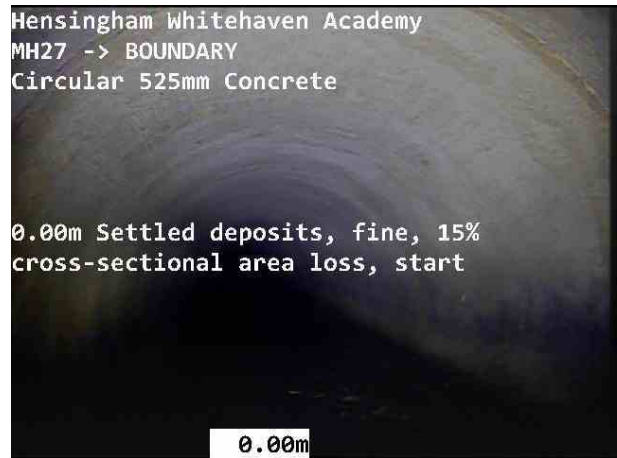
MH27X_a80f1b9b-6c60-4078-964a-66cebda942e3_20220622_153635_520.jpg, 00:00:03, 0.00 m
 Settled deposits, fine, 15% cross-sectional area loss, start

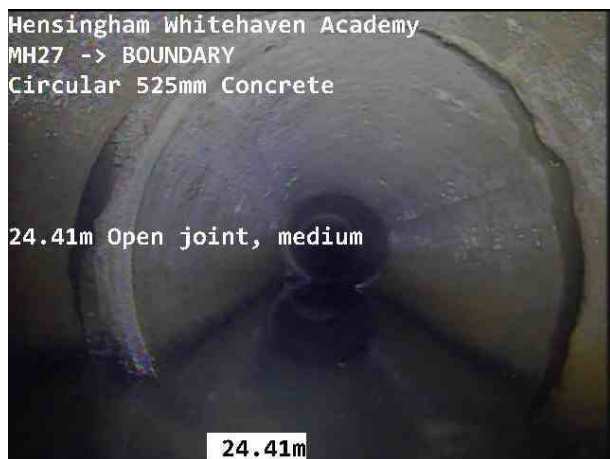
MH27X_7e87f2c5-7157-4a47-8fbf-ca90e7f55776_20220622_153645_124.jpg, 00:05:15, 24.41 m
 Open joint, medium

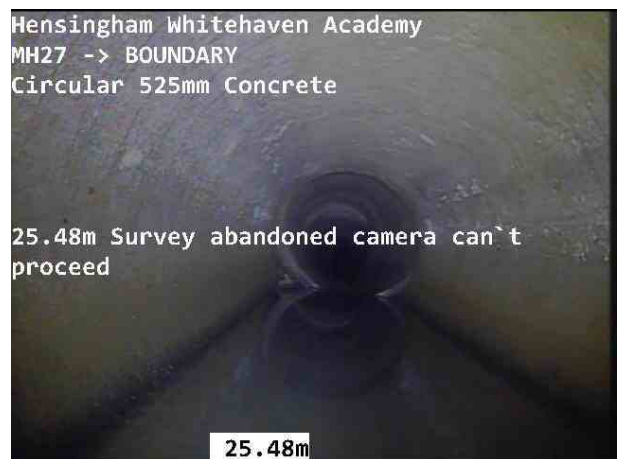
MH27X_4f03049a-f610-45bb-9be5-e3e9442fb05a_20220622_153652_852.jpg, 00:05:40, 25.48 m
 Survey abandoned, camera can't proceed

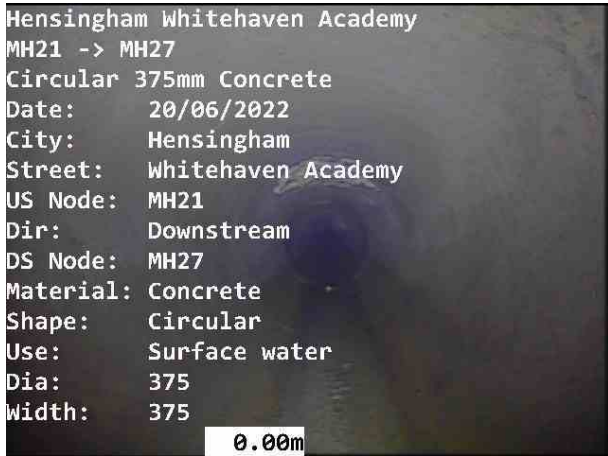
MH21X_a6486355-cf25-403d-a166-47ba39500958_20220622_153706_376.jpg, 00:00:00, 0.00 m
 Start node, manhole, reference: MH21

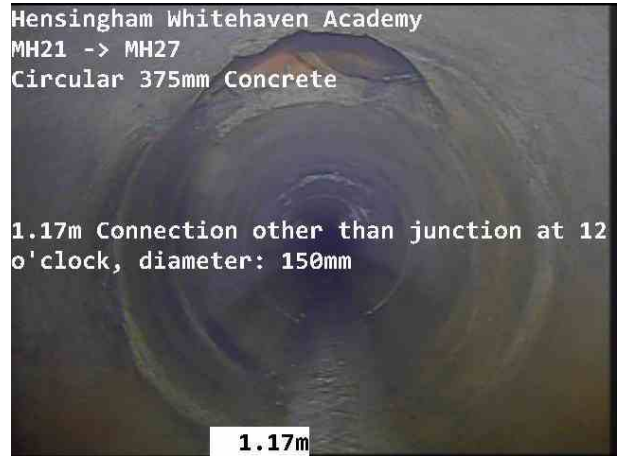
MH21X_c68098c1-bfbb-473b-8cbf-57522af5e8dd_20220622_153709_281.jpg, 00:00:25, 1.17 m
 Connection other than junction at 12 o'clock, diameter: 150mm

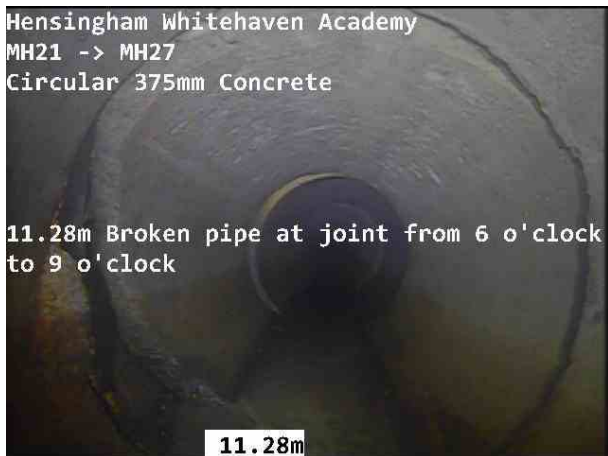
MH21X_1ef3ecfa-3af1-44f4-ad44-7e9d1b8603e4_20220622_153716_635.jpg, 00:01:11, 11.28 m
 Broken pipe at joint from 6 o'clock to 9 o'clock

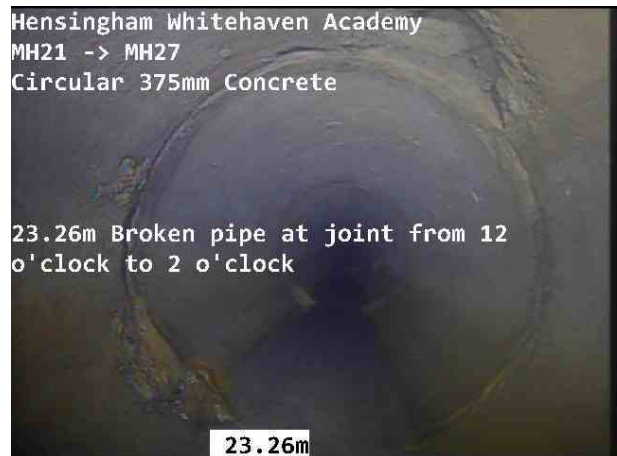
MH21X_bd9c0086-9608-4a43-b255-08ca5241b232_20220622_153724_203.jpg, 00:01:59, 23.26 m
 Broken pipe at joint from 12 o'clock to 2 o'clock

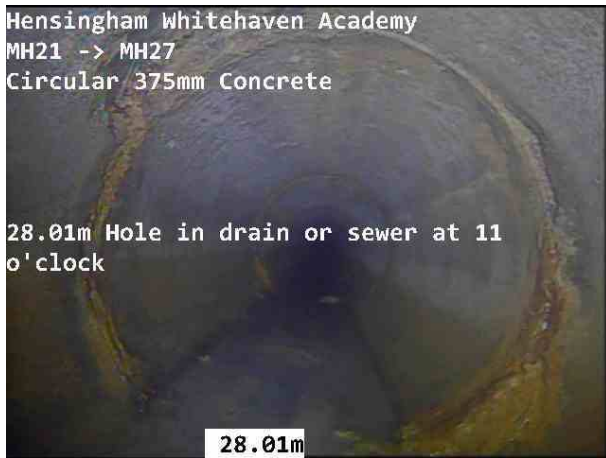
MH21X_93253561-1162-4ec8-9cdb-99992a037ac8_20220622_153731_878.jpg, 00:02:24, 28.01 m
 Hole in drain or sewer at 11 o'clock

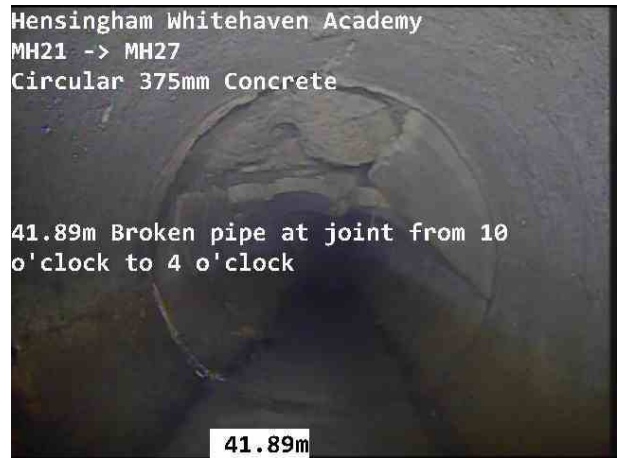
MH21X_06554e84-0b61-4b9d-8768-af657374f4f4_20220622_153739_665.jpg, 00:03:23, 41.89 m
 Broken pipe at joint from 10 o'clock to 4 o'clock

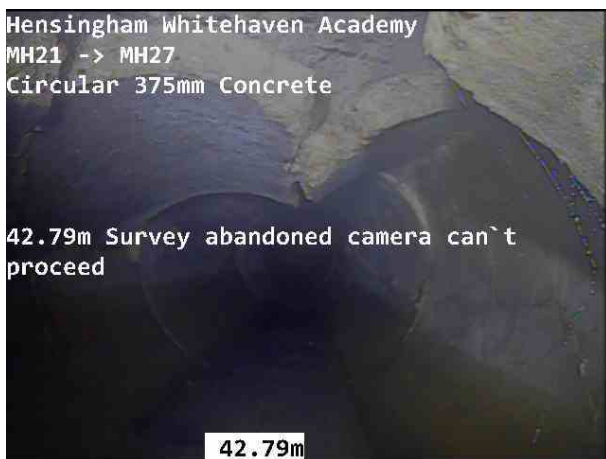
MH21X_80d960ff-47ed-4f22-8eda-4a437f3f5452_20220622_153742_938.jpg, 00:03:33, 42.79 m
 Survey abandoned, camera can't proceed
