<h2 style="margin: 0;">Tree Inspection</h2>	Ref No:	ARB-TEM-6
		Issue No:	V1
		Page Number:	Page 1 of 10
		Date of Issue:	14/11/2025

Ennerdale Country House Hotel Tree Inspection

Sam Pagett *mHort* [Arborscape Environmental Services Ltd] sam@arborscape.uk

12/04/2026

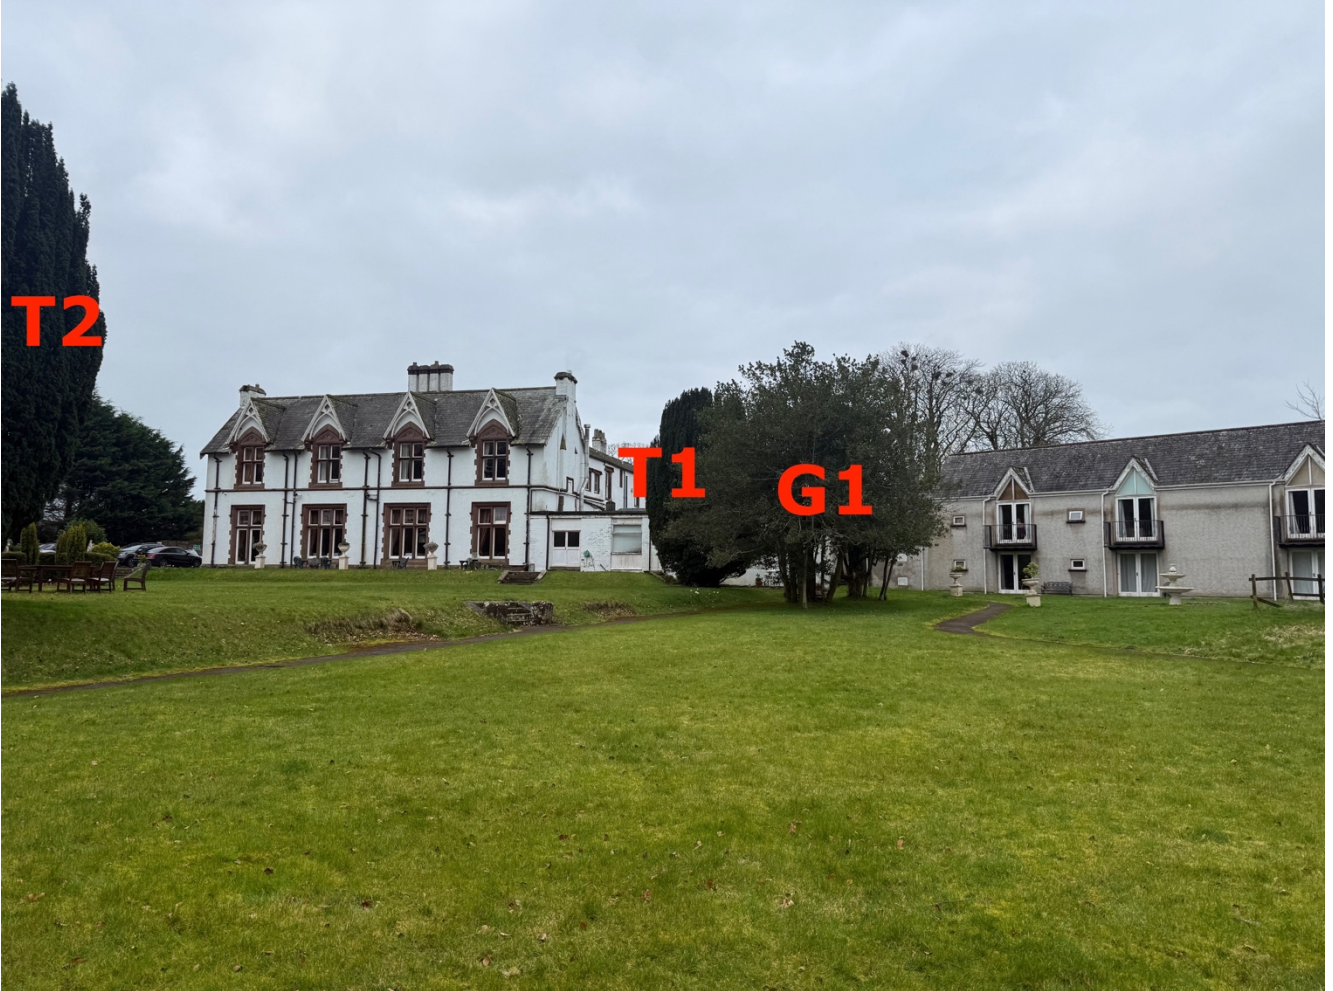
Num	Species	Age Class	Structural Condition	Physiological Condition	Recommendations
T1	<i>Taxus baccata</i>	Mature	Good	Fair; Vigour reducing, regrowth from centre	Regeneration prune back to 5-foot structure
T2	<i>Taxus baccata</i>	Mature	Fair; Some minor tear outs on unions	Fair; Vigour reducing, regrowth from centre	Regeneration prune back to 5-foot structure
T3	<i>Acer pseudo-platanus</i>	Mature	Good	Good; Vigorous growth	Remove due to proximity to surfaced path [lifting] (self-seeded tree)
T4	<i>Taxus baccata</i>	Mature	Fair; Some minor tear outs on unions	Fair; Vigour reducing, regrowth from centre	Regeneration prune back to 5-foot structure
T5	<i>Taxus baccata</i>	Mature	Good	Fair; Vigour reducing, regrowth from centre	Regeneration prune back to 5-foot structure
T6	<i>Fagus sylvatica</i>	Mature	Poor; Extensive decay in main stem with loss of several large limbs	Fair; Reasonable canopy growth density	Remove to eliminate risk of falling branches or tree

G1	<i>Ilex aquifolium</i>	Mature	Poor; Basal decay	Moderate; Some dead, lacking vigour	Remove
G2	<i>Acer pseudo-platanus</i>	Juvenile	Good	Good	Remove self-seeded trees upgrowing through mature Pine
G3	<i>Cupressus x leylandii</i>	Semi-Mature	Failed	n/a	Four half fallen trees above pathway removed as emergency works.

Image 1: Tree 1 & 2 multi-stemmed Yews and G1 Hollies (authors image).

Num	Species	Recommendation	Justification
T1	<i>Taxus baccata</i>	Reduce to 5-foot structural framework to regenerate	Regenerate into traditional shaped topiary balls as per historic design
T2	<i>Taxus baccata</i>	Reduce to 5-foot structural framework to regenerate	Regenerate into traditional shaped topiary balls as per historic design
T3	<i>Acer pseudo-platanus</i>	Remove due to prevent further pathway damage and regain original design balance in garden	Self-seeded specimen non-conforming with garden layout
T4	<i>Taxus baccata</i>	Reduce to 5-foot structural framework to regenerate	Regenerate into traditional shaped topiary balls as per historic design
T5	<i>Taxus baccata</i>	Reduce to 5-foot structural framework to regenerate	Regenerate into traditional shaped topiary balls as per historic design
T6	<i>Fagus sylvatica</i>	Remove due to extensive decay	Reduce risk in main garden area and open space for replanting

G1	<i>Ilex aquifolium</i>	Remove due to poor condition and proximity to pathway	Poor specimens seemingly remnants of a previous hedge, removed to allow for garden improvements and replanting
G2	<i>Acer pseudo-platanus</i>	Remove due to damage to surfaced walkway creating accessibility issues & trip hazard	Young self-seeded specimens will deform retained large Pine
G3	<i>Cupressus x leylandii</i>	Remove failed line of specimens lifted in wind posing risk to adjacent walkway	Removed due to immediate hazard

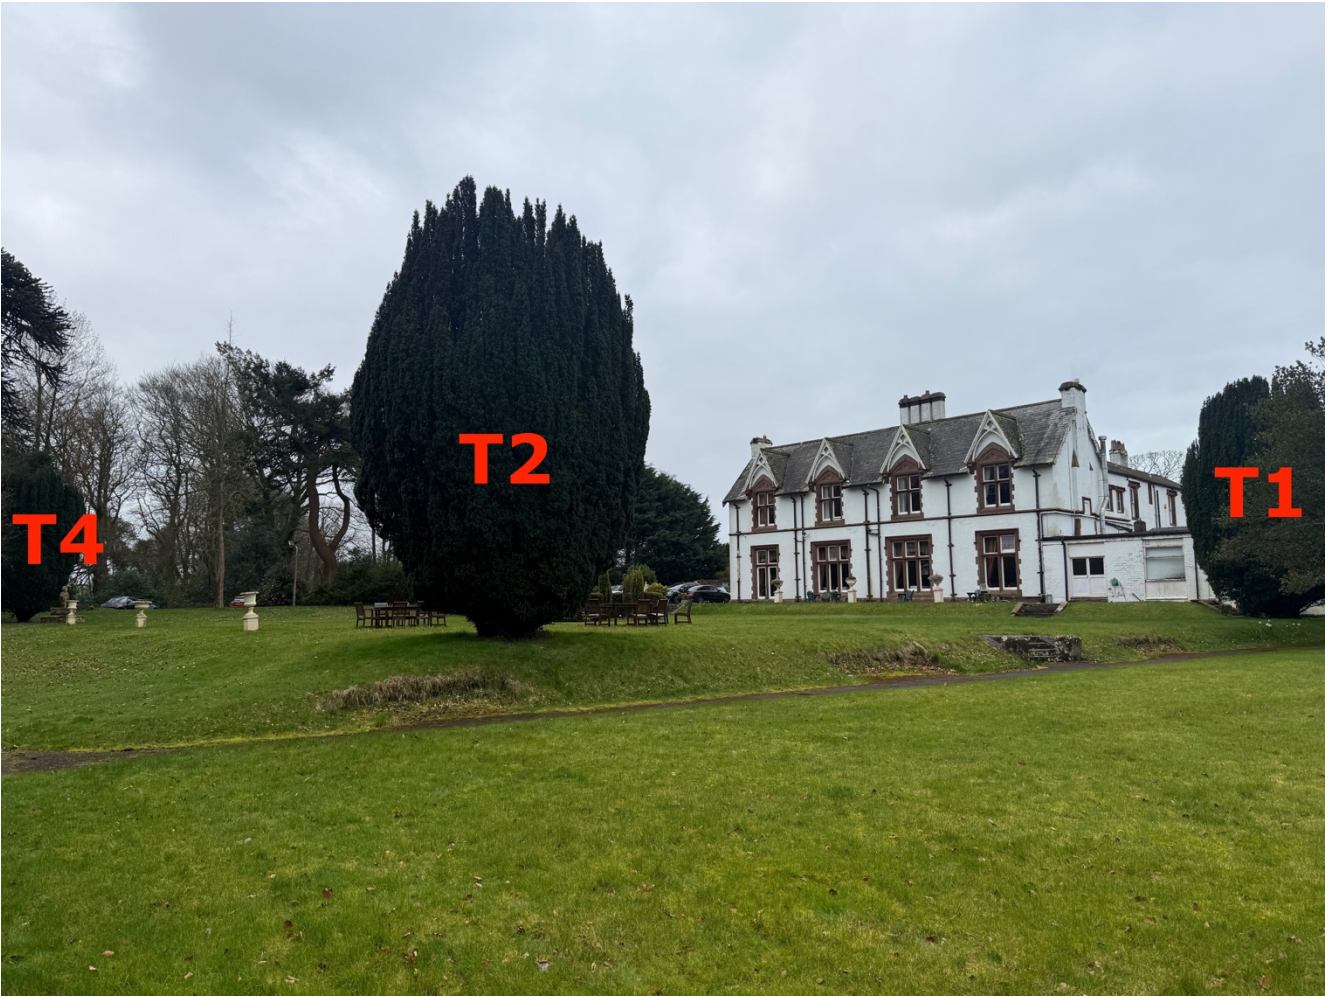
Image 2: Tree 1, 2, & 4 multi-stemmed Yews (authors image).

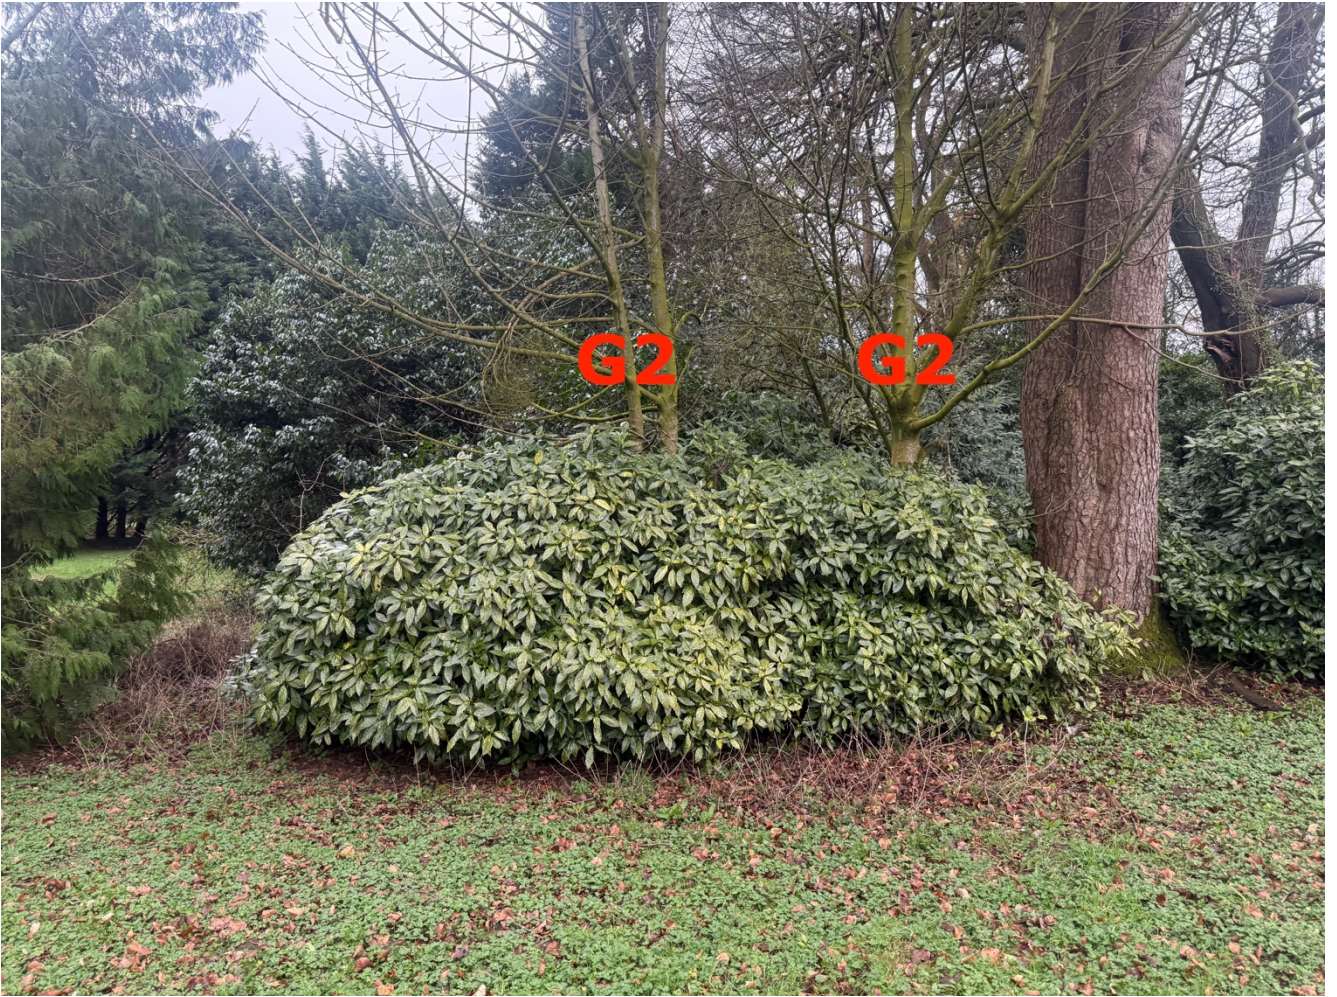
Image 3: Group 2 self-seeded Sycamores (authors image).

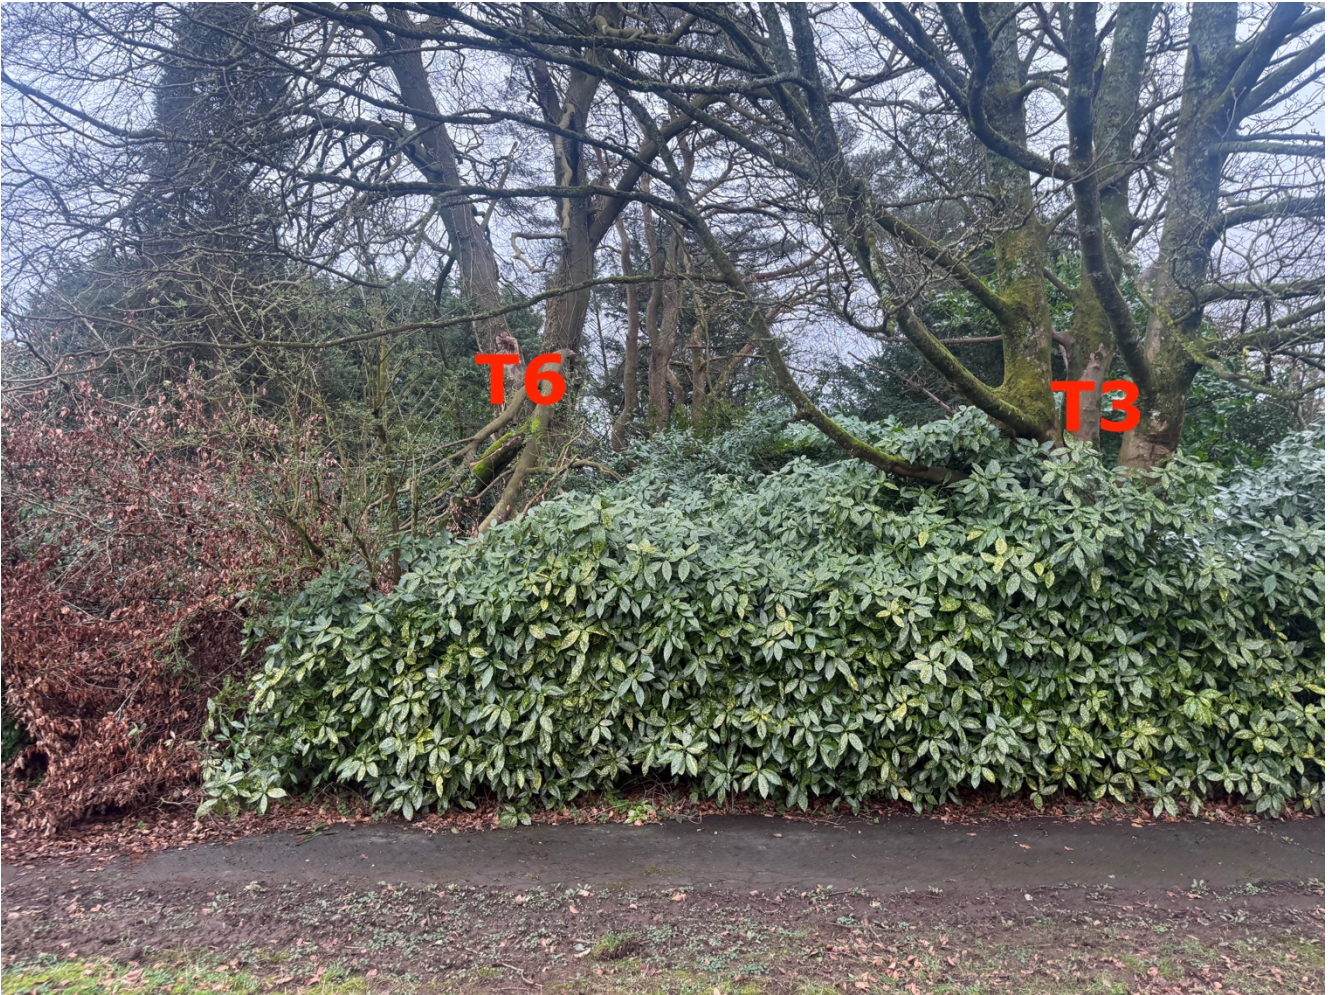
Image 4: Tree 3 Sycamore lifting pathway and Tree 6 Beech with decay (authors image).

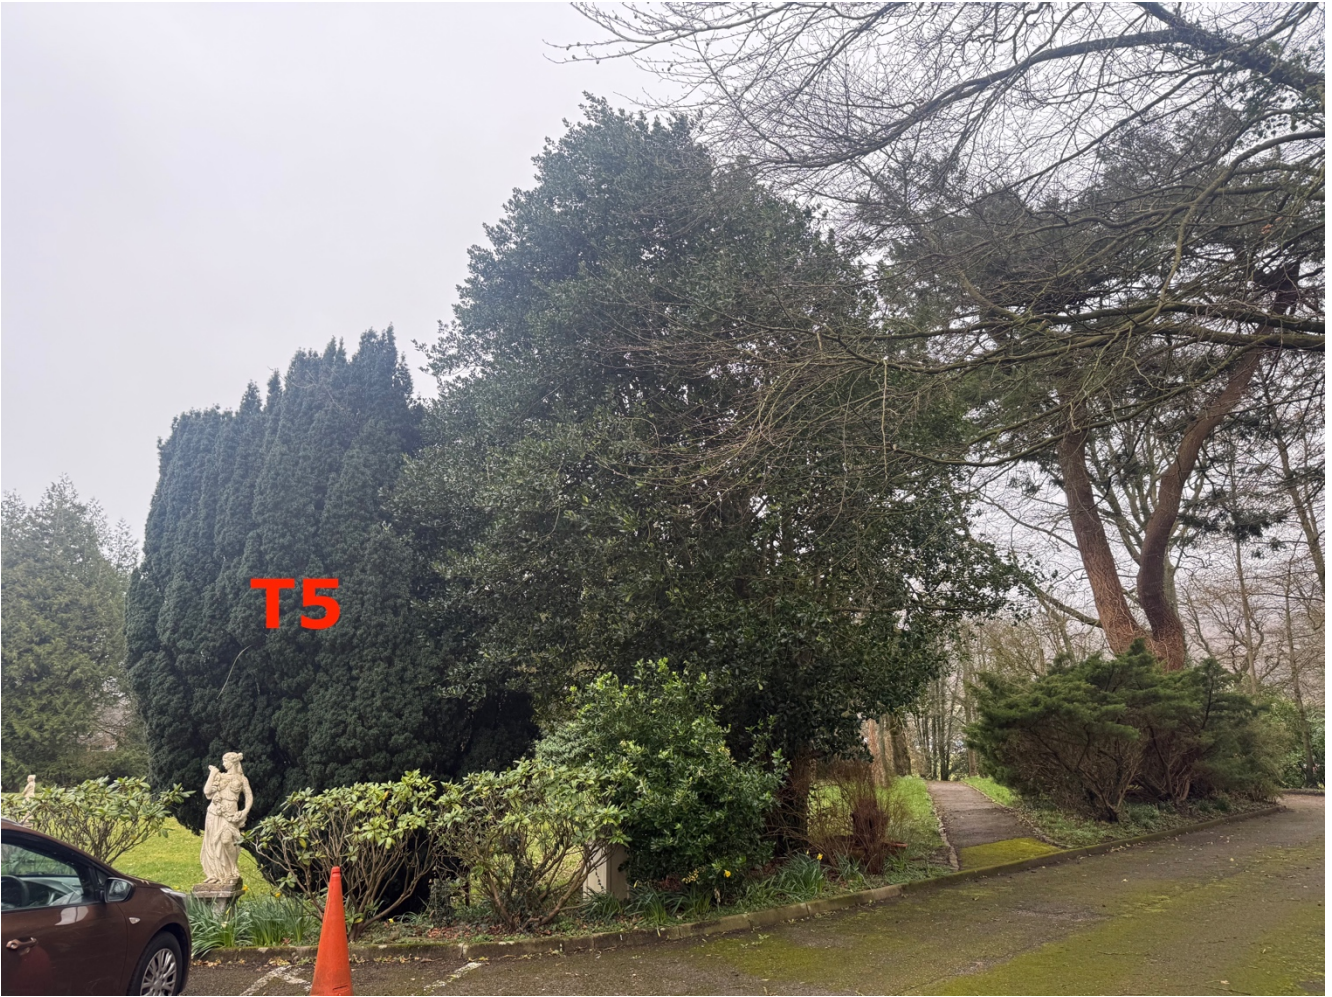
Image 5: Tree 5 multi-stemmed Yew (authors image).

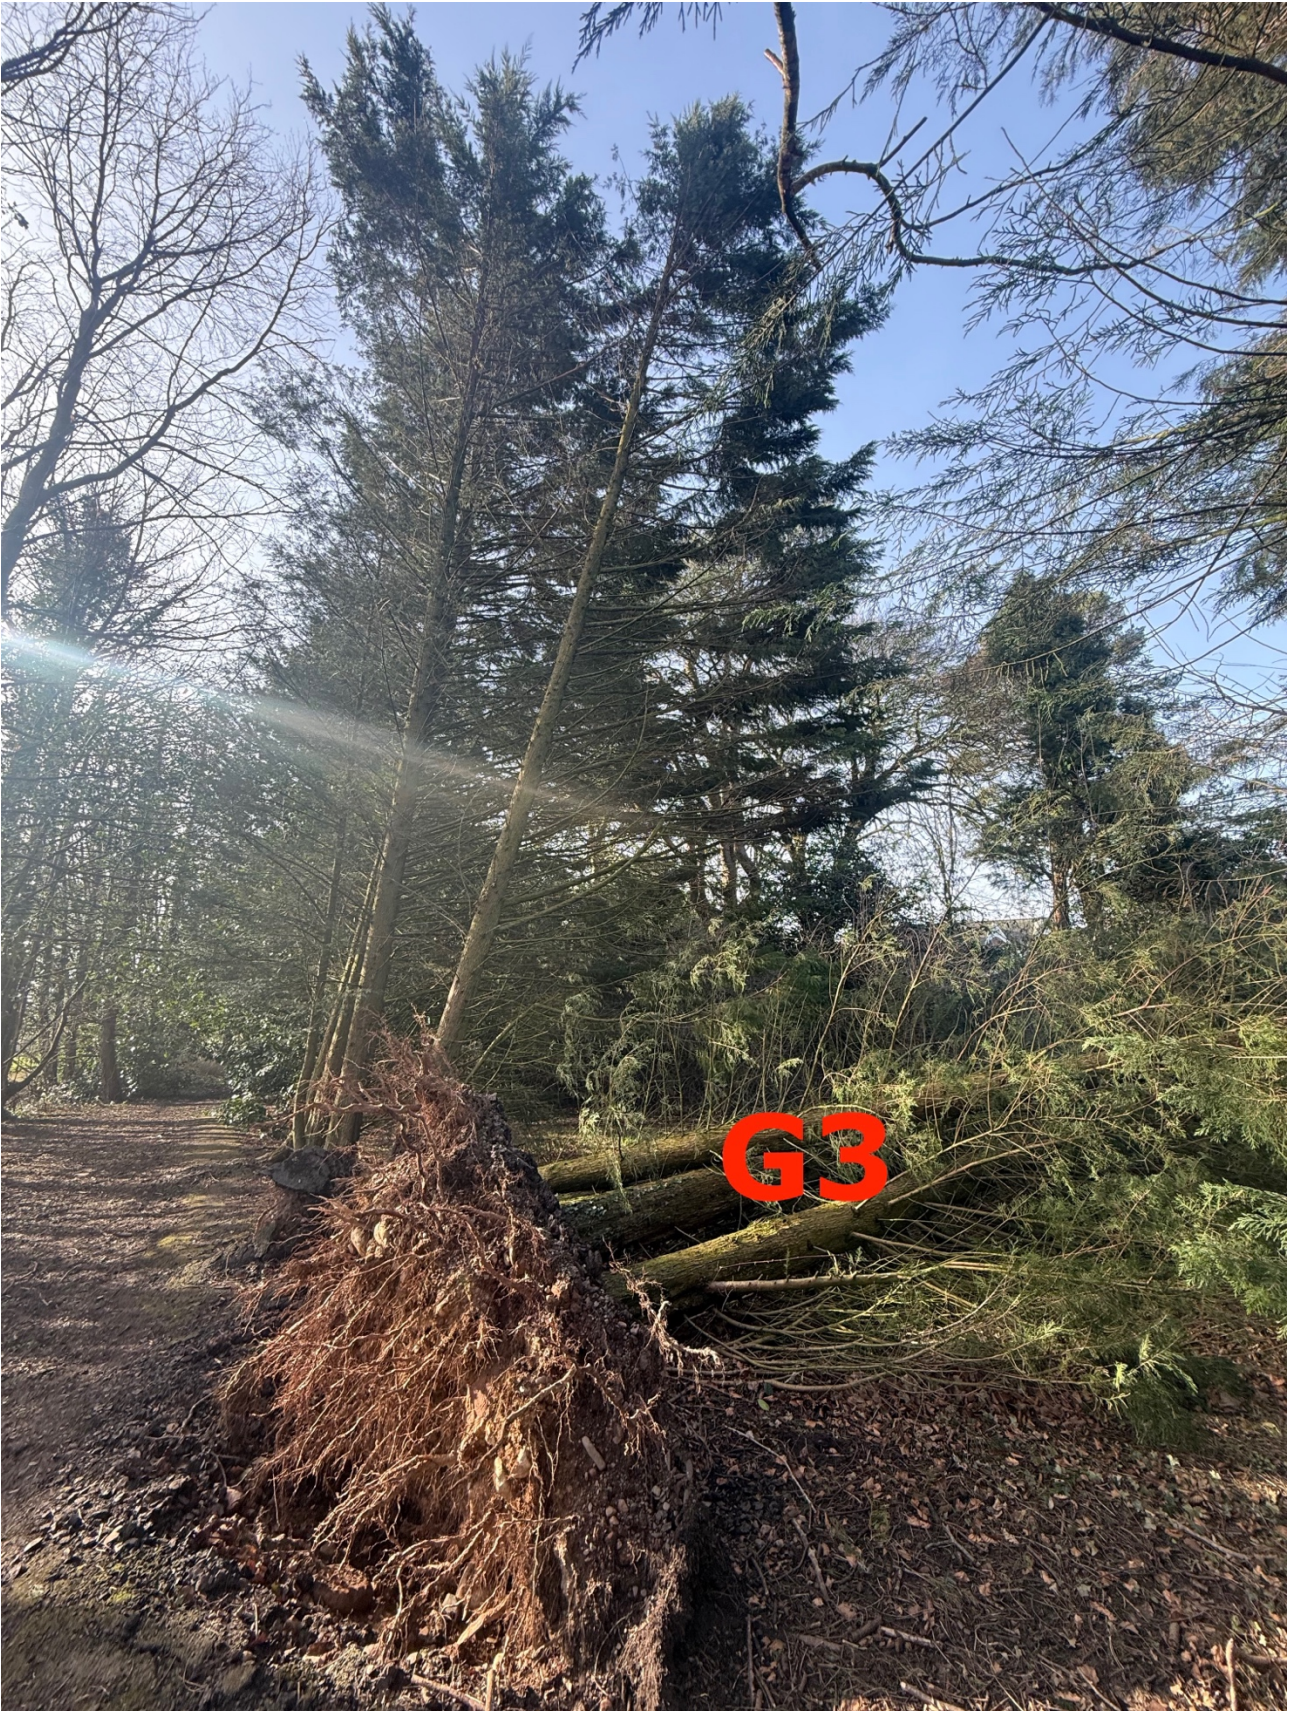
Image 6: Fallen and part lifted Leylandii (authors image).
