Project No: GEO2026-7124

Project: Jacktrees Road, Cleator Moor

Report Title: Field Investigation – Drainage and Pond (Draft for Design Team Review)

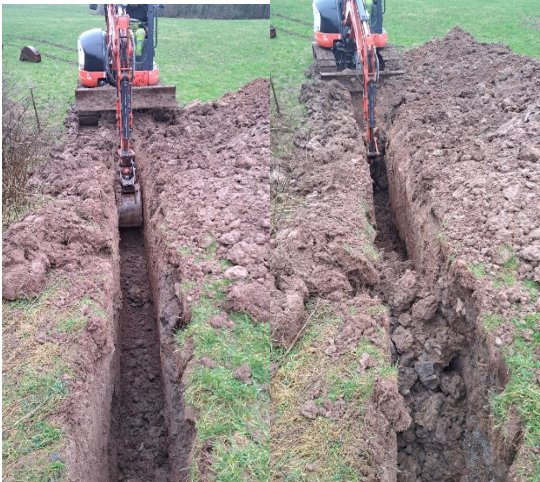
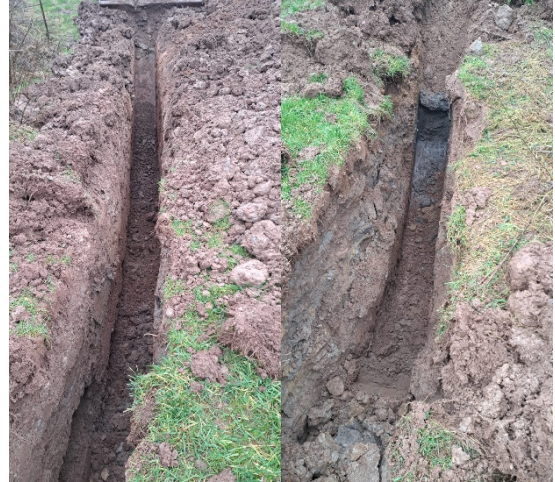
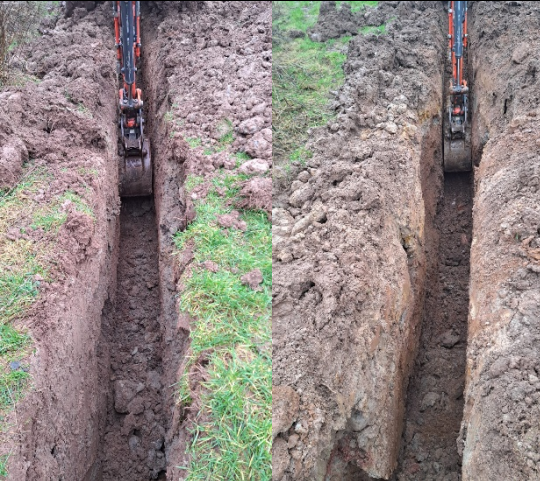
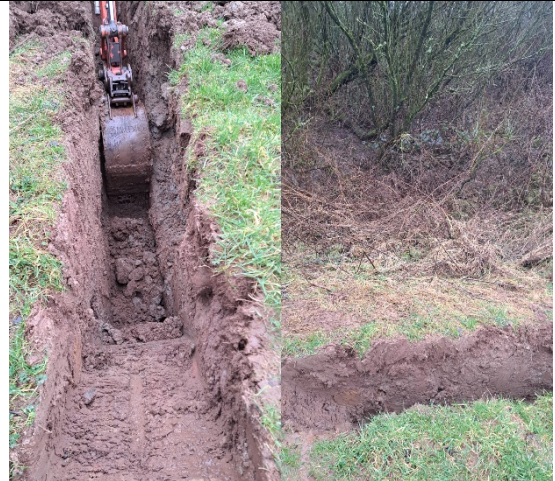
Trial Trench

GEO attended the site on the 26th February 2026. The weather conditions on the day comprised heavy rain and light to moderate winds. Temperatures were around c.8 degrees Celsius. A single linear trench was excavated as per the enclosed plan. The trench was excavated to consistent depths of c.2.30m below ground levels and identified topsoil over natural appearing sandy silty gravelly clay soils. There was no visual evidence of made ground or buried utilities (e.g., pipes, drains etc.). The excavation was predominantly dry but did become unstable.

There was a slight opening in the cobbles, where it was possible to insert a tape measure that extended c.4m in a west-north-west direction. The trial trench included this location and nothing of note was identified (e.g. no evidence of a pipe or drain). A sonde was inserted into the opening, however due to the debris and cobbles it inserted less than c.0.5m.

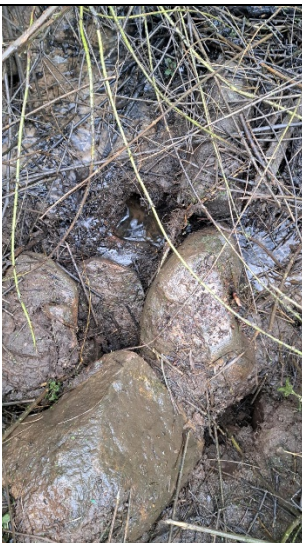
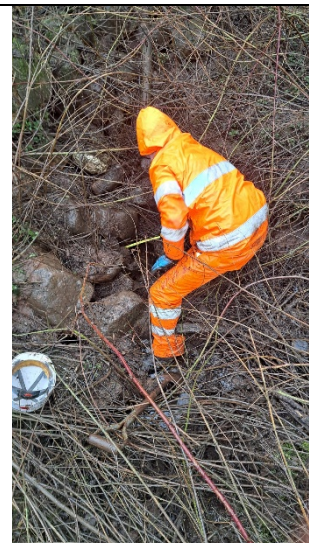
Within the western most extent of the pond was a collection of large cobbles. They were subrounded to rounded and appeared to be of natural materials. It is possible that this collection of cobbles was a result of agricultural activities and the cobbles being removed from the field (e.g., to aid ploughing). There was no visual evidence of building materials to suggest it was a former structure. It was at this location that the water in the pond appeared to flow downwards. Some of the cobbles were removed, but there was no evidence of an outfall or a pipe.

Public sewer plans indicate a surface water sewer entering the pond at its northern point. Excavations have not indicated any pipes or drains exiting the pond on its lowest lying (western) edge. However, water does visibly leave the pond along its western edge and water was noted descending vertically into the ground at the location of a collection of cobbles.

Cobbles and descending water

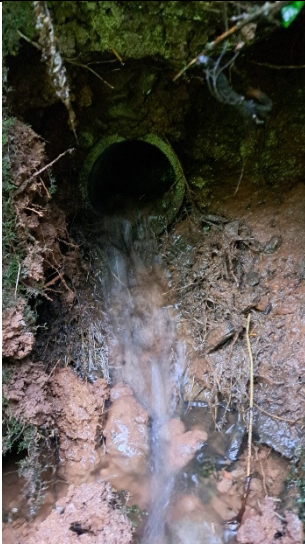
Slightly north of the pond, within the gully, was a c.150mm diameter clay pipe emerging into a circular pond. A sonde was inserted into the pipe, however after c.2m the pipe was blocked with debris (although water was still flowing). The direction of the pipe was toward the manhole in the field to the north of the pond, shown on existing utility plans.

**Pipe into cutting upslope of site
(thought to connect to existing sewer)**

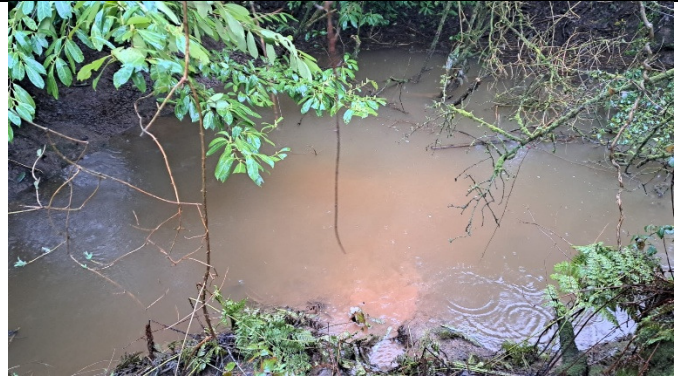
**Circular pond in the cutting in which the pipe
enters**
