VISUAL STRUCTURAL INSPECTION

**STEEL FRAMED BARN BUILDING
FLEMING HALL FARM
SEASCALE**

Reference - WDS/05/5332/REP02

Date - 05/11/2021

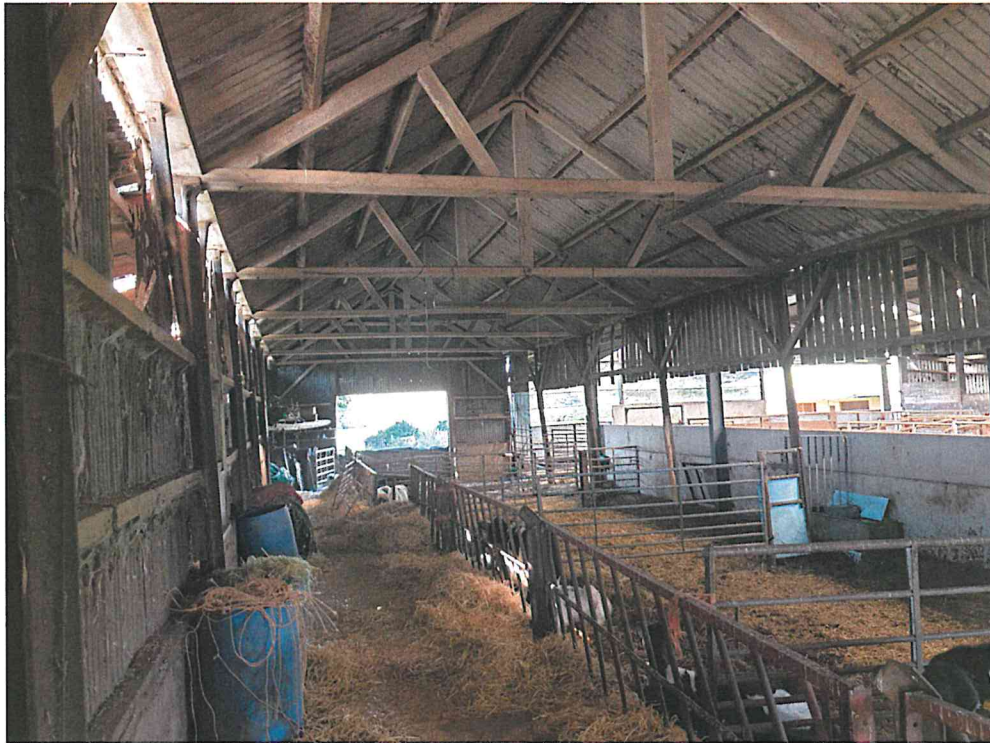
PHOTO 01 GENERAL VIEW INSIDE THE MAIN BARN

- 2.1** The steel columns to the main barn are considerably out of plumb with the building leaning towards the front. The columns are probably in excess of 150mm out of plumb over their height (See photograph 01, 02 & 03 attached). The columns are also excessively rusted.

- 4.1** The barn and lean-to structure are structurally inadequate and need demolished. We suggest the barns are vacated and cordoned off to prevent access. In addition we recommend that the cladding to the buildings is removed as soon as possible as the sheets are at risk of becoming detached in high wind conditions which is a serious safety issue to the farm workers and the public.

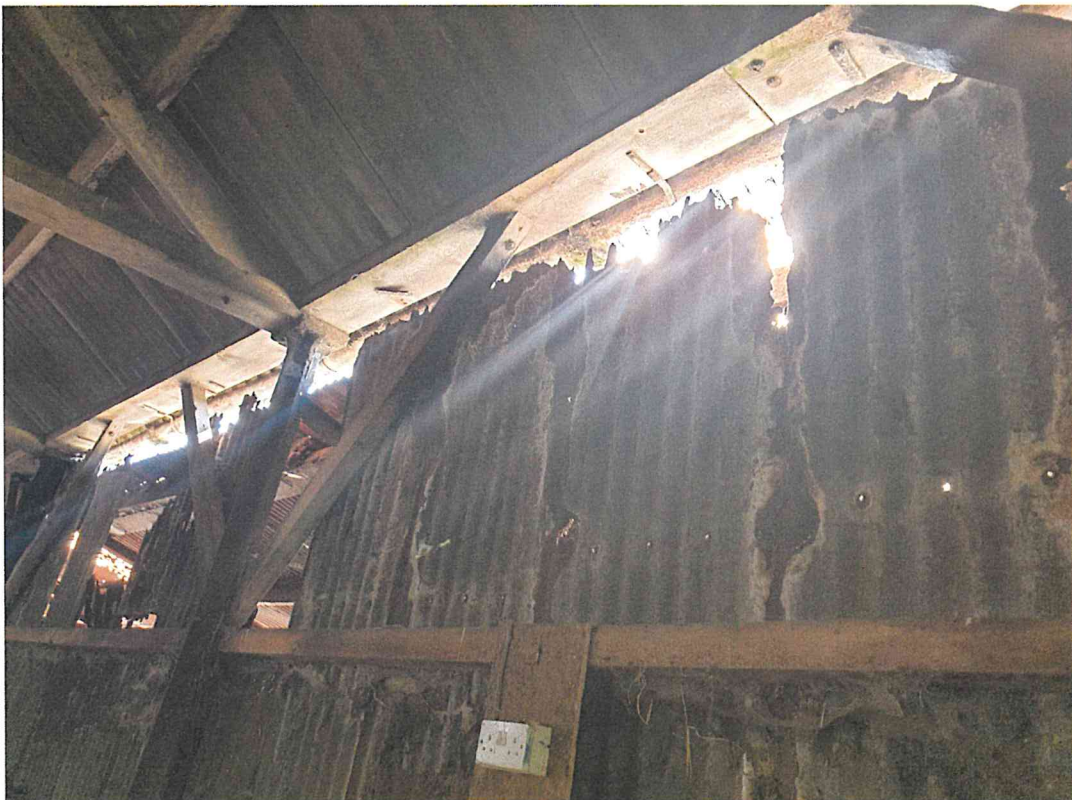
PHOTO 04 TYPICAL VIEW ON THE WALL CLADDING

- 2.2** The side rails are in a poor condition with many having rotted and some have failed. The timber cladding is damaged in numerous locations and is poorly supported. The Steel sheeting to the walls is also excessively corroded and inadequately supported. A support post in the right hand extent of the barn has snapped and is hanging (see photographs 04 & 05 attached)

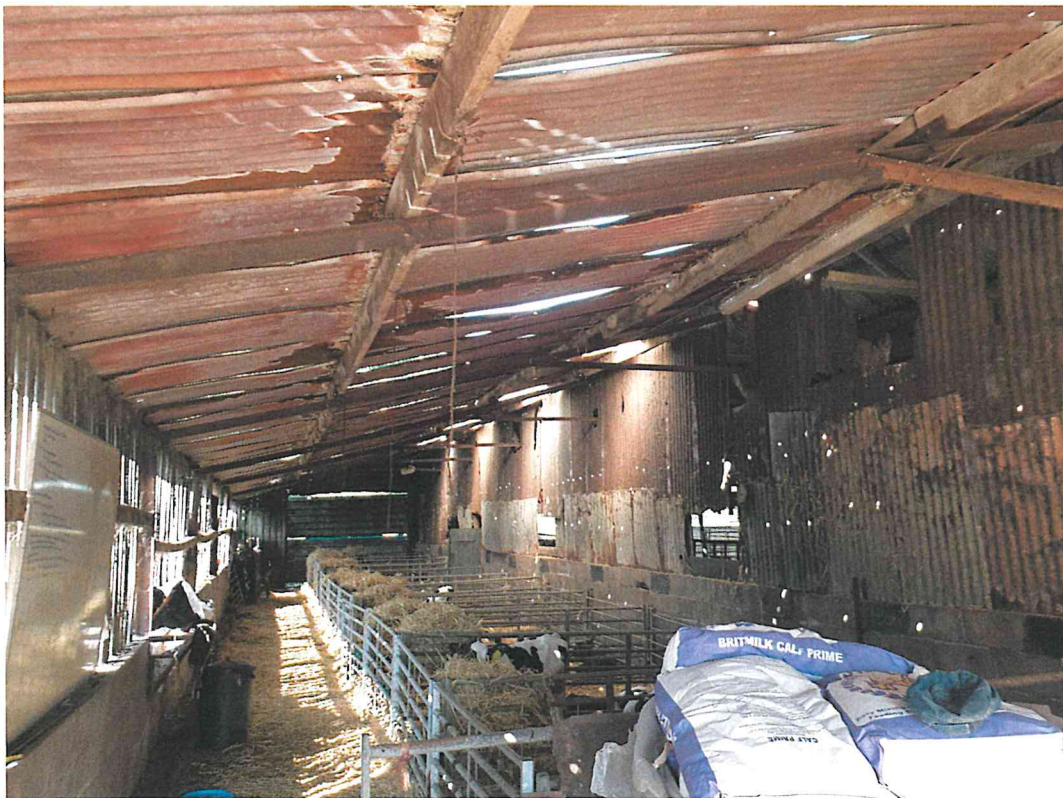
PHOTO 06 VIEW ON THE LEAN-TO STRUCTURE GENERALLY

- 2.4** The lean-to comprises a light weight steel frame supported off the main building columns which supports the timber purlins and side rails. The steelwork is undersized and heavily corroded. The timber purlins and side rails have also excessively deflected and are in a poor condition. The steel sheeting is heavily corroded with many fixings missing or having failed. (See photographs 06 & 07 attached)
