Project No: GEO2024-6348

Project: Scurgill Terrace, Egremont, Cumbria

Report Title: Supplementary Controlled Waters Risk Assessment

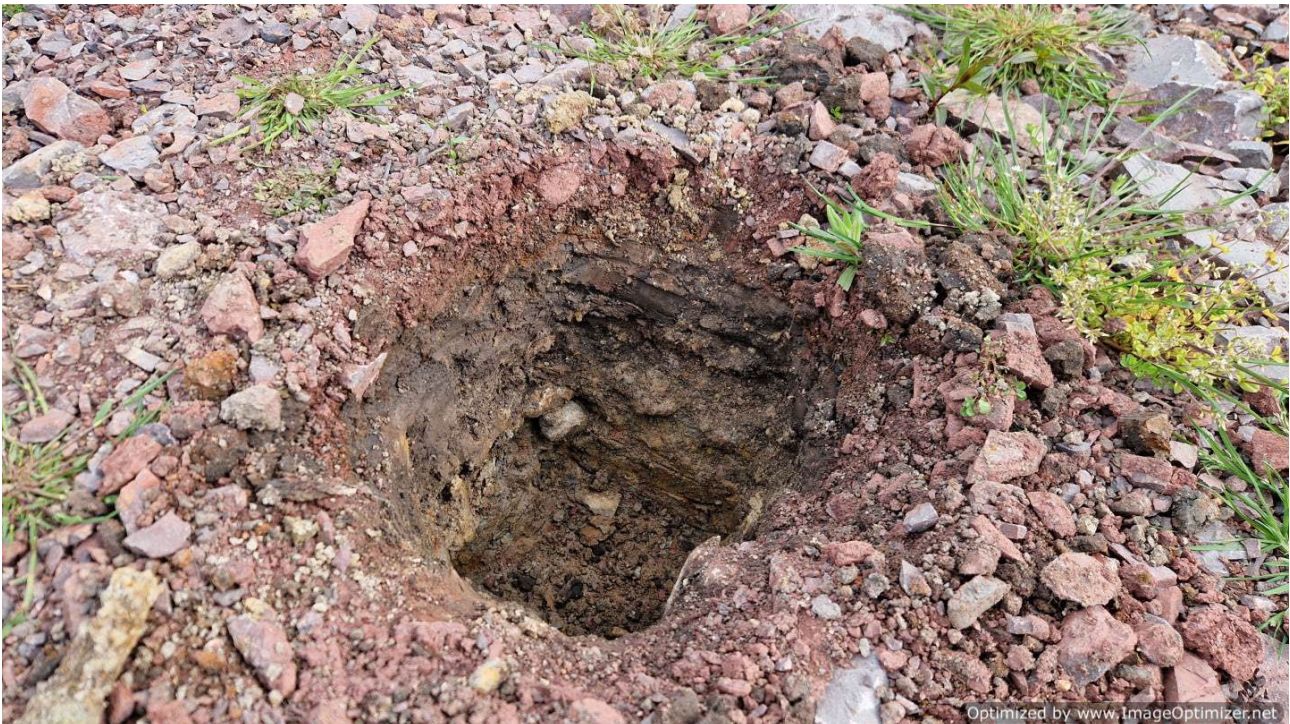
GEO2024-6348: Scurgill Terrace, Egremont – TP-A

Depth From (m)	Depth To (m)	Strata Description	Legend	Testing / Samples
0.00	0.10	MADE GROUND: Dark grey brown silty sandy angular GRAVEL of aggregate (ironstone spoil).

0.10	0.30	MADE GROUND: Firm dark grey sandy gravelly SILT with occasional roots. Occasional cobbles.

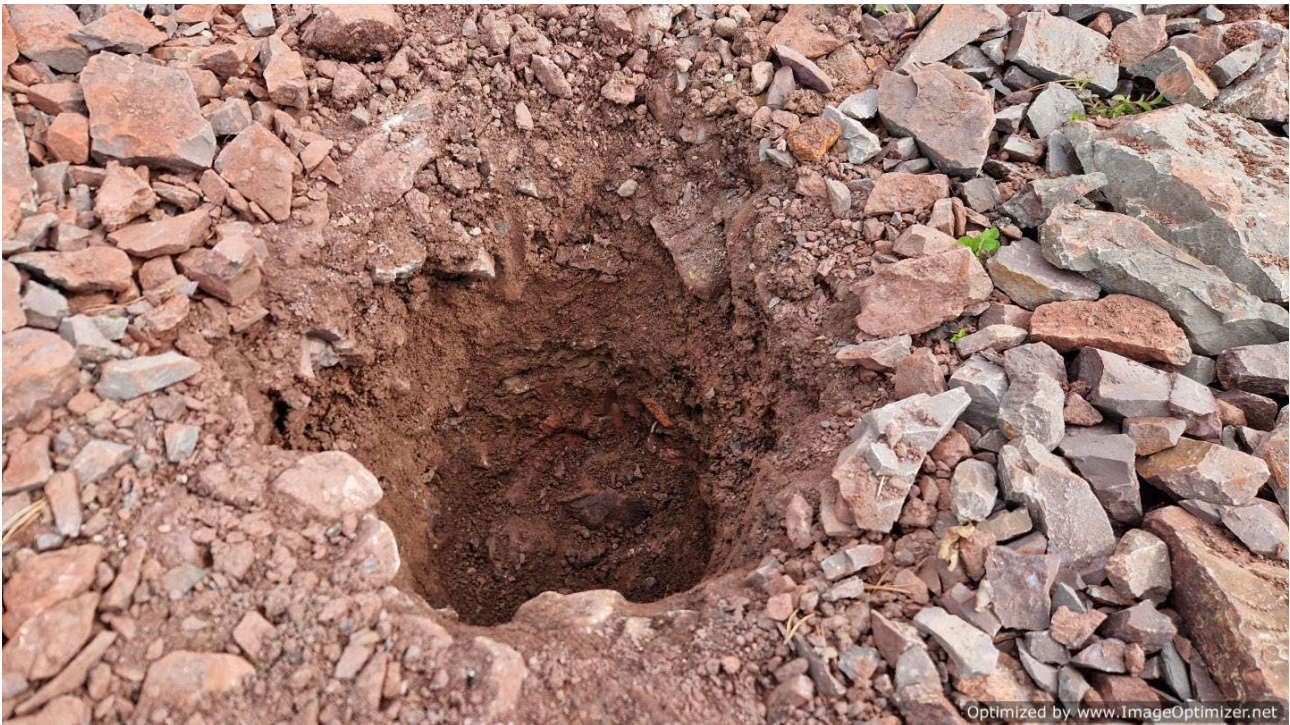
GEO2024-6348: Scurgill Terrace, Egremont – TP-B

The results of the leachate analysis indicate marginally elevated concentrations of PAH compounds within the sample of made ground from trial pit TP-B at c.0.30m bgl only. The results slightly exceed the assessment criteria values for stringent UK Drinking Water Standards (DWS) only. The concentrations of metals were below the GAC values in this sample, and the results from the other samples were all below the assessment criteria values.

The made ground in trial pit TP-B comprised aggregate with occasional clinker, brick, metal and shale.

Depth From (m)	Depth To (m)	Strata Description	Legend	Testing / Samples
0.00	0.45	MADE GROUND: Dark grey brown very silty sandy fine to coarse angular GRAVEL of aggregate (ironstone spoil) with occasional brick, clinker, metal and shale. Refusal on boulder at 0.45m bgl.

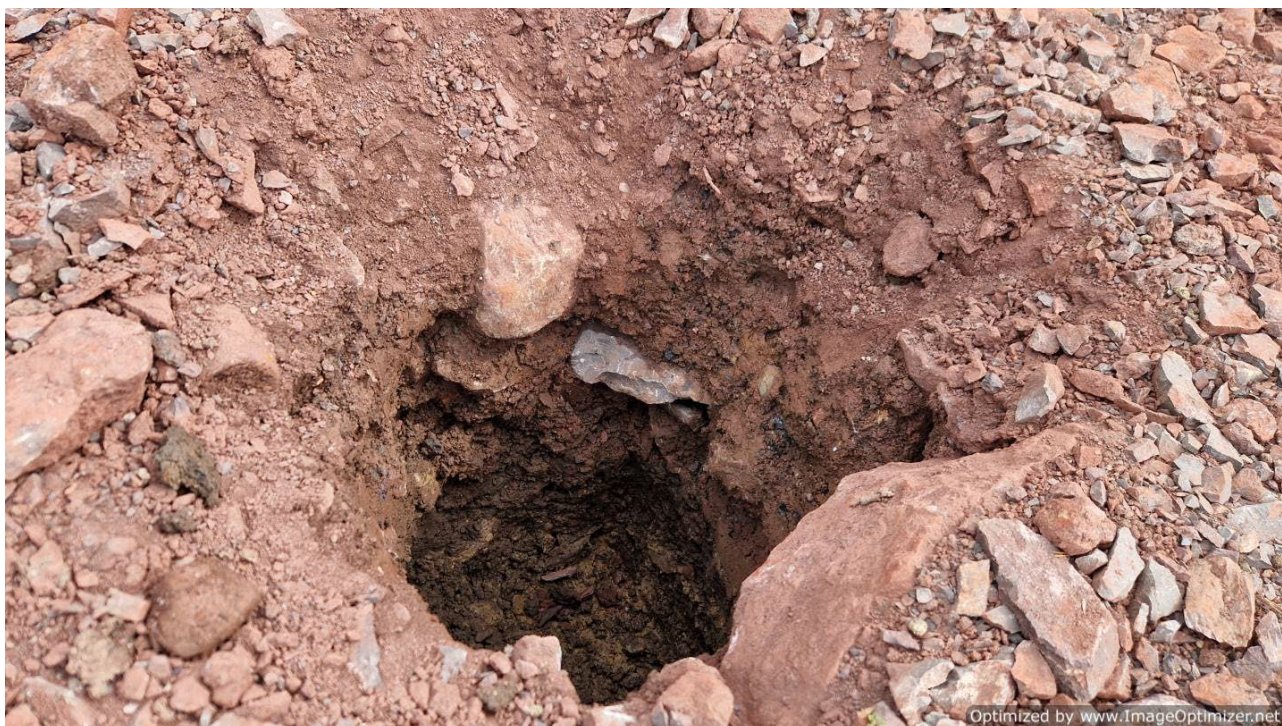
GEO2024-6348: Scurgill Terrace, Egremont – TP-C

Depth From (m)	Depth To (m)	Strata Description	Legend	Testing / Samples
0.00	0.16	MADE GROUND: Grey silty sandy angular GRAVEL of aggregate (ironstone spoil) with occasional clinker, tile, metal and clinker.

0.16	0.60	MADE GROUND: Dark grey brown silty/clayey sandy fine to coarse angular GRAVEL and COBBLES of aggregate (ironstone spoil) with occasional clinker and brick.

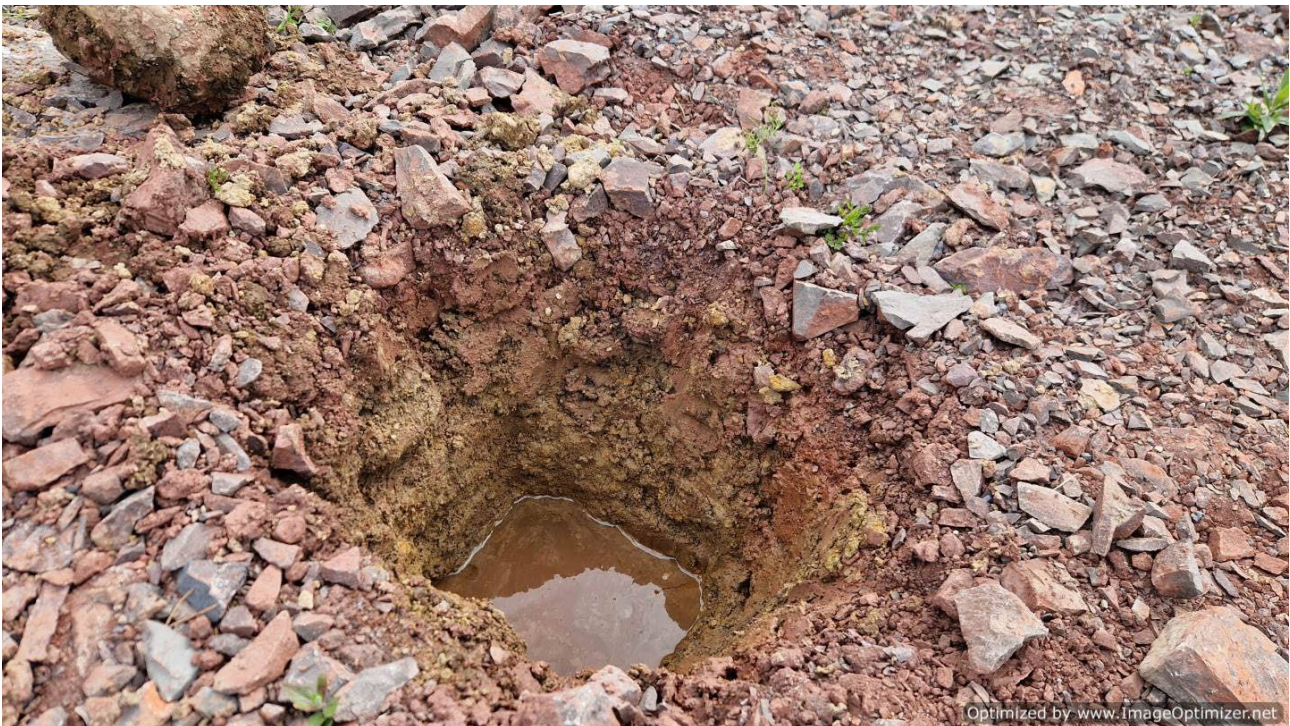
GEO2024-6348: Scurgill Terrace, Egremont – TP-D

The trial pits were dry with the exception of TP-D which had a small amount of water at the base (see photo on the trial pit log). This appears to be from a small pocket of perched water.

Depth From (m)	Depth To (m)	Strata Description	Legend	Testing / Samples
0.00	0.20	MADE GROUND: Grey silty sandy angular GRAVEL of aggregate (ironstone spoil) with occasional shale, clinker and brick.

Pocket of perched water at 0.20m bgl. Standing water at 0.40m bgl on completion. Trial hole backfilled with arisings on completion.		
Engineer: J.Brock Site Works Date: 10.05.2024 Plant: Hand digging equipment			Log Notes: HSV = Hand Shear Vane (kN/m ²) LP = Limited Penetration (HSV/CBR) B = Bulk Bag, J = Amber Glass Jar, T = Plastic Tub
