CCTV Inspection Report

**HARRAS DYKE FARM / WHITEHAVEN GOLF COURSE**

**16/10/2023**

**Approved By: S. OAKES**  
**Job Number: SK-S 161-2023**

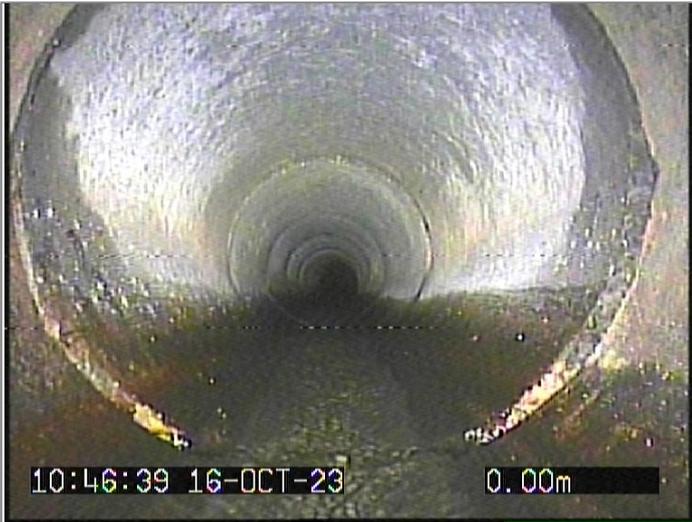
Start node type, manhole, reference MH01

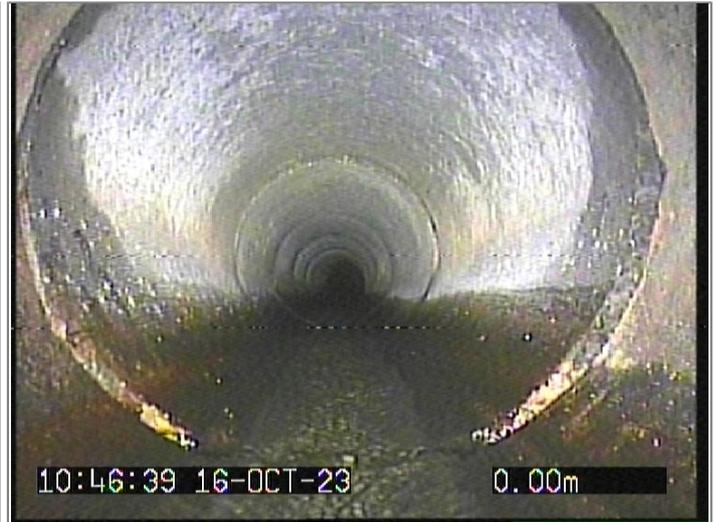
Water level 0% height/diameter

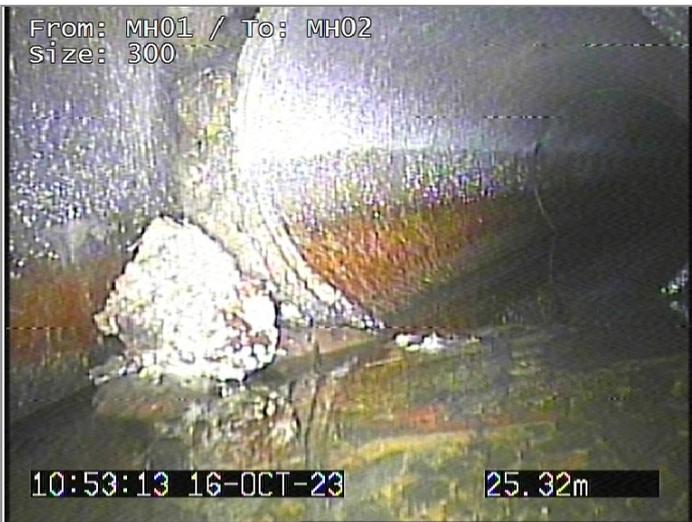
Survey abandoned - Remark: UNABLE TO PASS

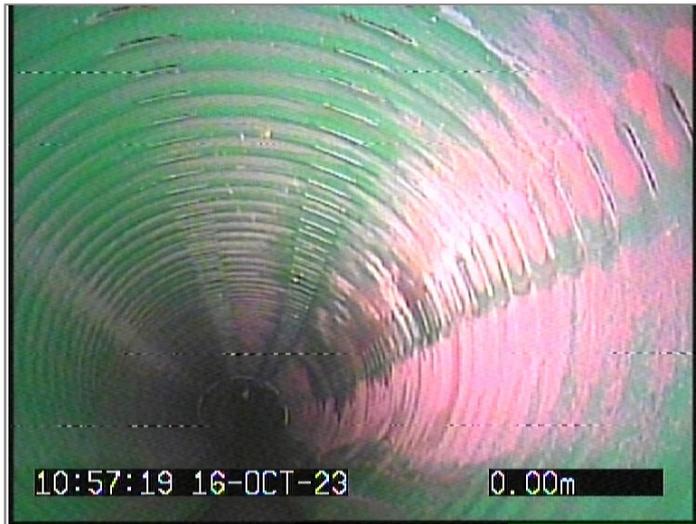
Start node type, manhole, reference MH01

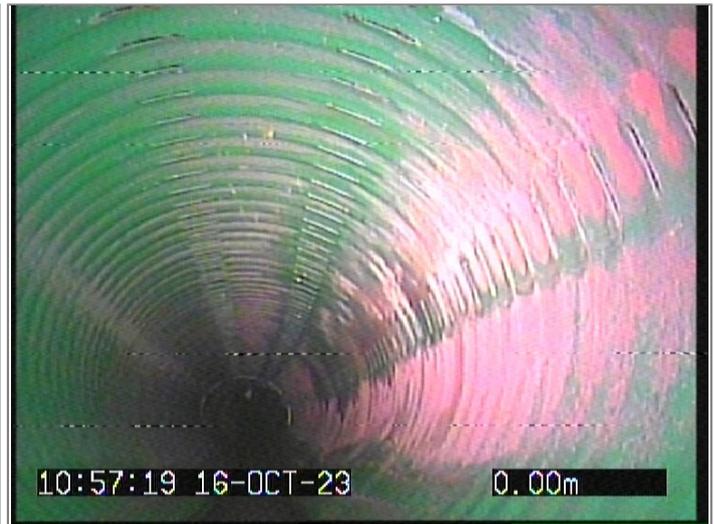
Water level 0% height/diameter

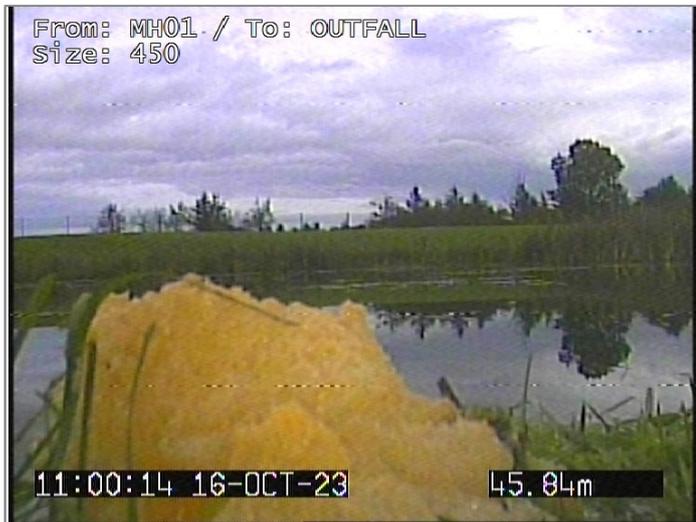
Finish node type, outfall, reference OUTFALL

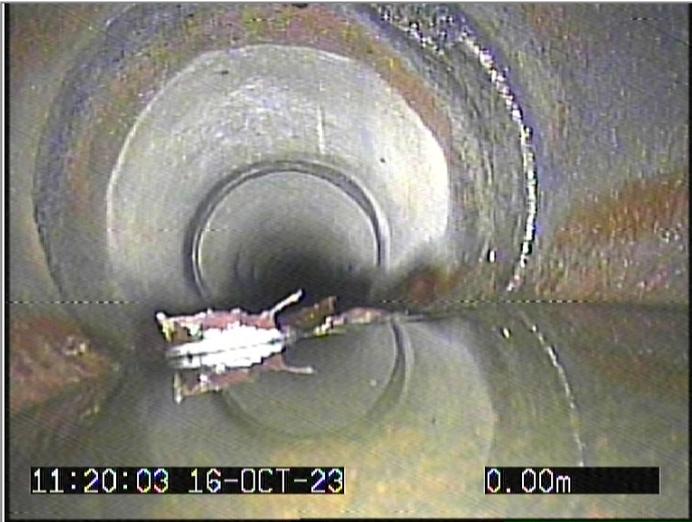
Start node type, manhole, reference MH02

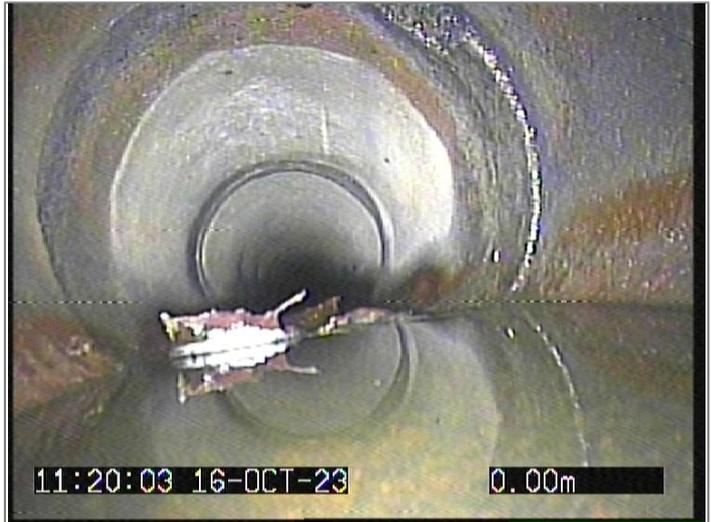
Water level 5% height/diameter

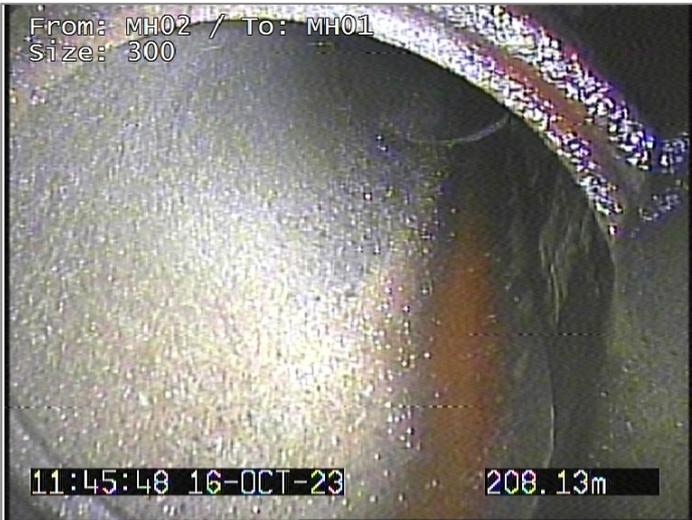
Finish node type, manhole, reference MH01A

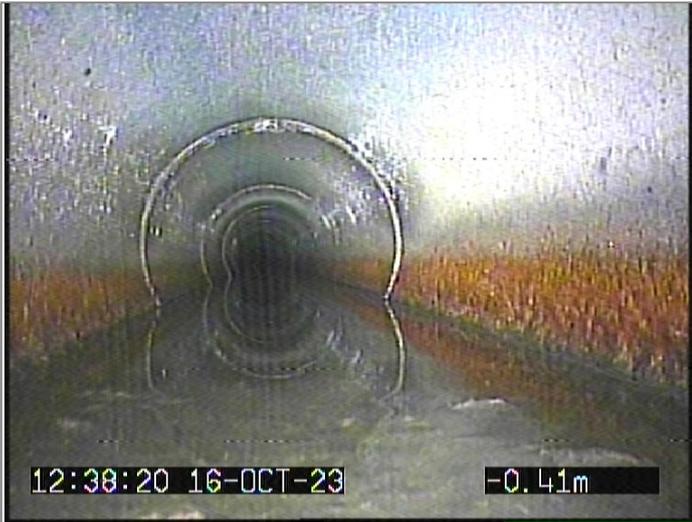
Start node type, manhole, reference MH02

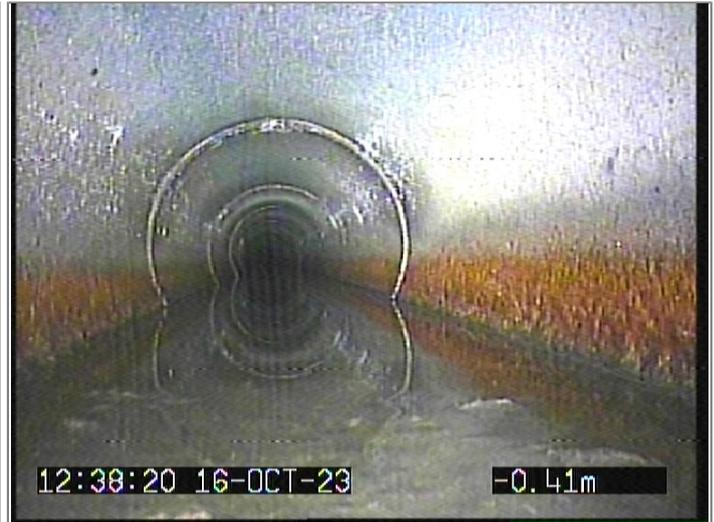
Water level 10% height/diameter

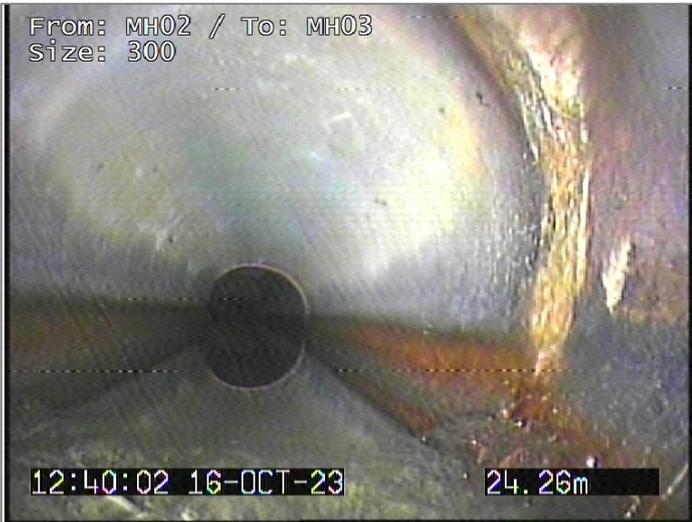
Finish node type, manhole, reference MH03

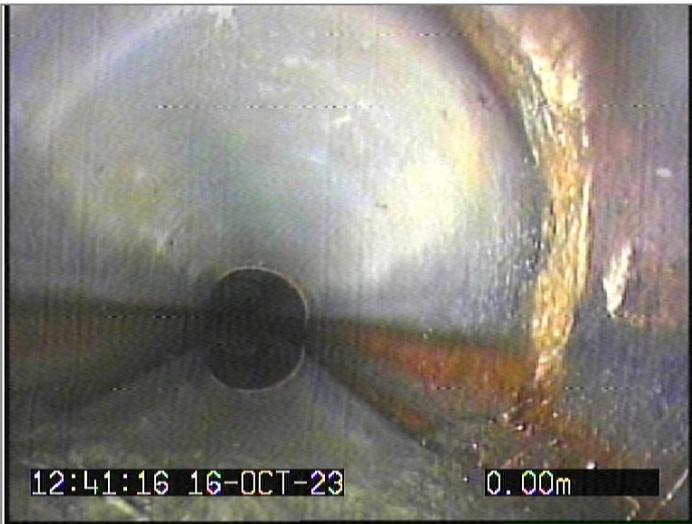
Start node type, manhole, reference MH03

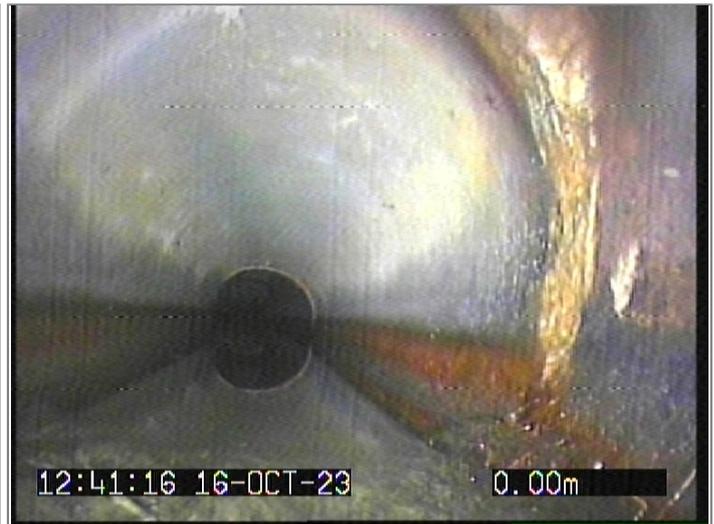
Water level 5% height/diameter

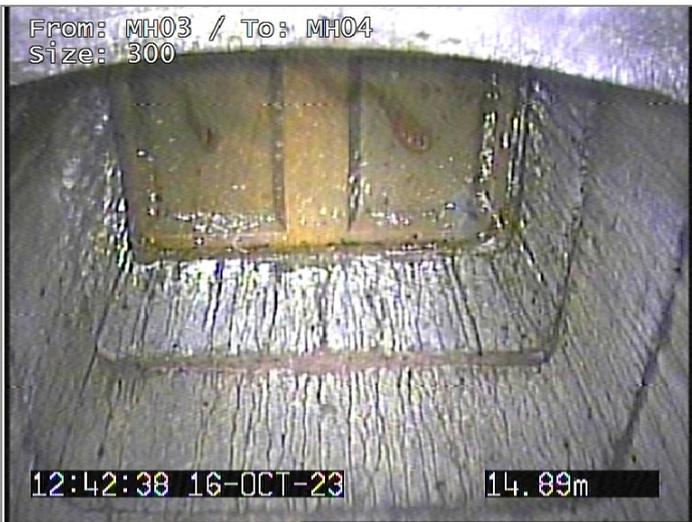
Finish node type, manhole, reference MH04

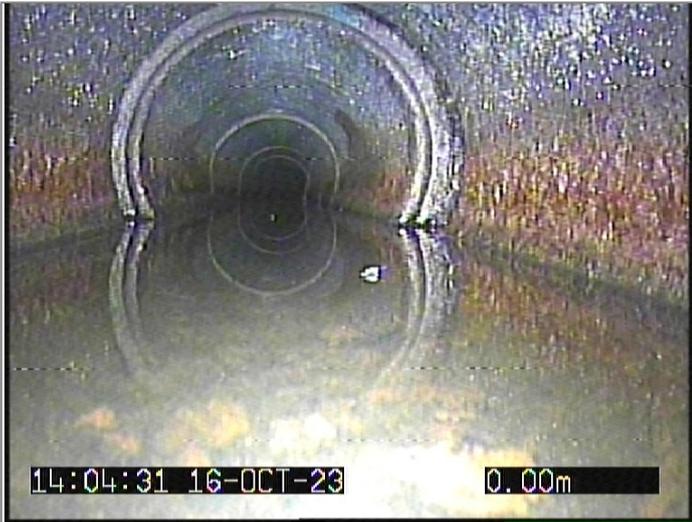
Start node type, manhole, reference MH04

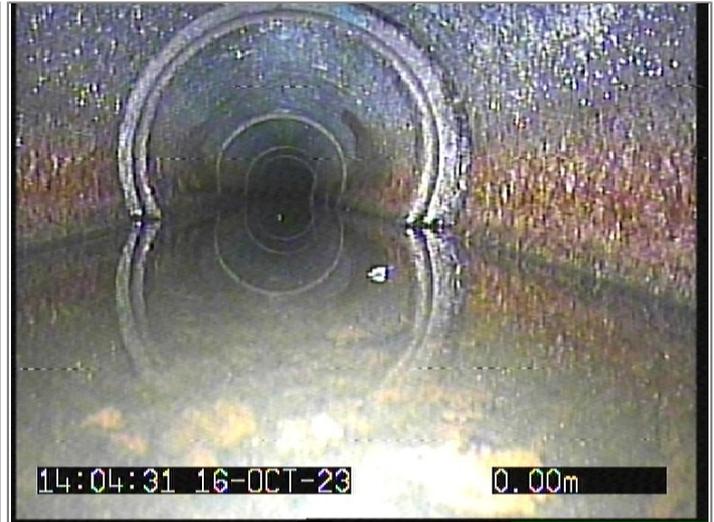
Water level 20% height/diameter

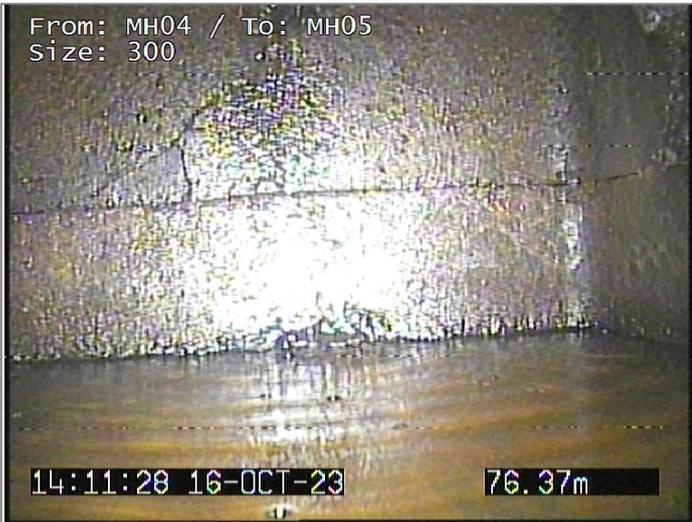
Finish node type, manhole, reference MH05

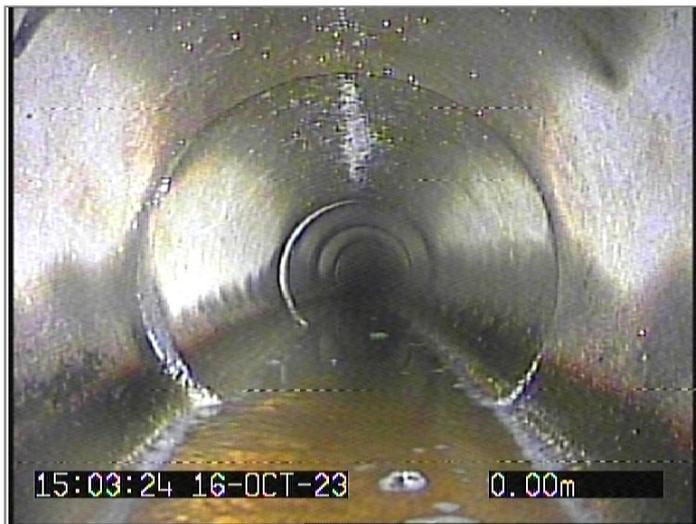
Start node type, manhole, reference MH08, Water level 5% height/diameter, Water level 40% height/diameter, Start

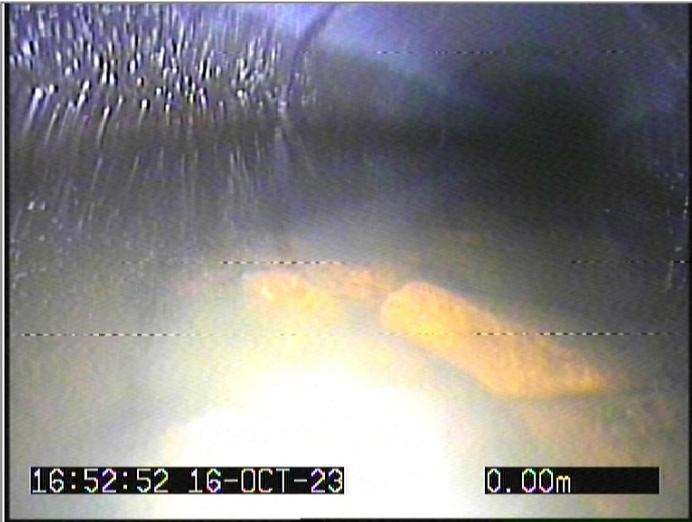
Start node type, manhole, reference MH01A

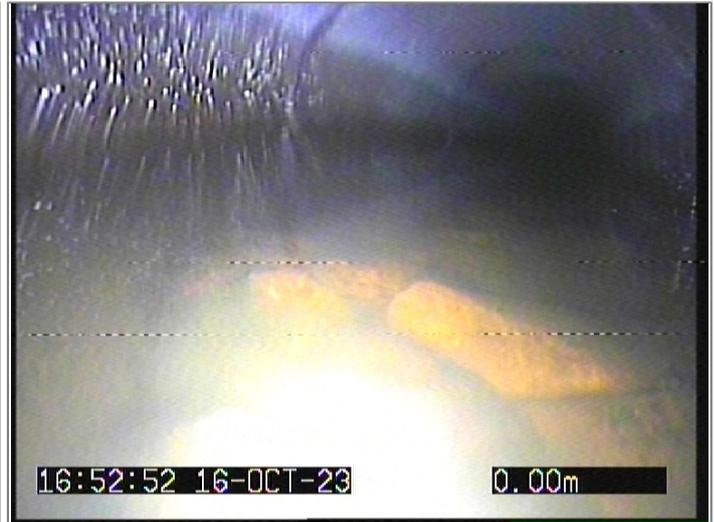
Water level 20% height/diameter

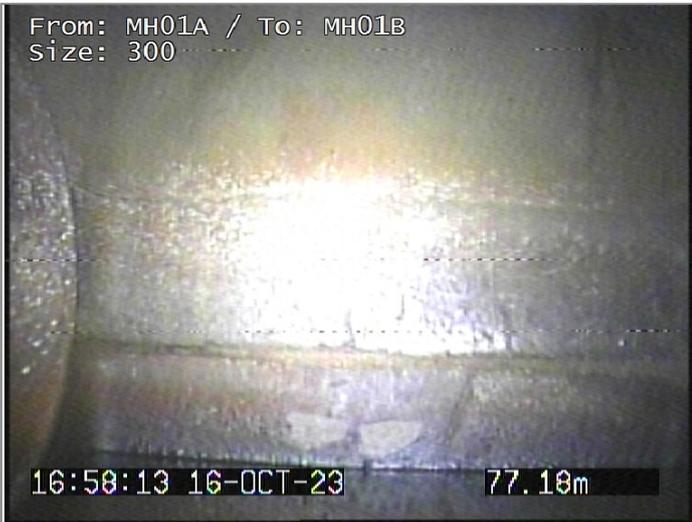
Finish node type, manhole, reference MH01B
