VISUAL STRUCTURAL INSPECTION

**FARM HOUSE & BARN BUILDINGS
HIGH LING BANK
Nr EGREMONT
CUMBRIA**

Reference - WDS/05/4233/REP01

Date - 29/03/2019

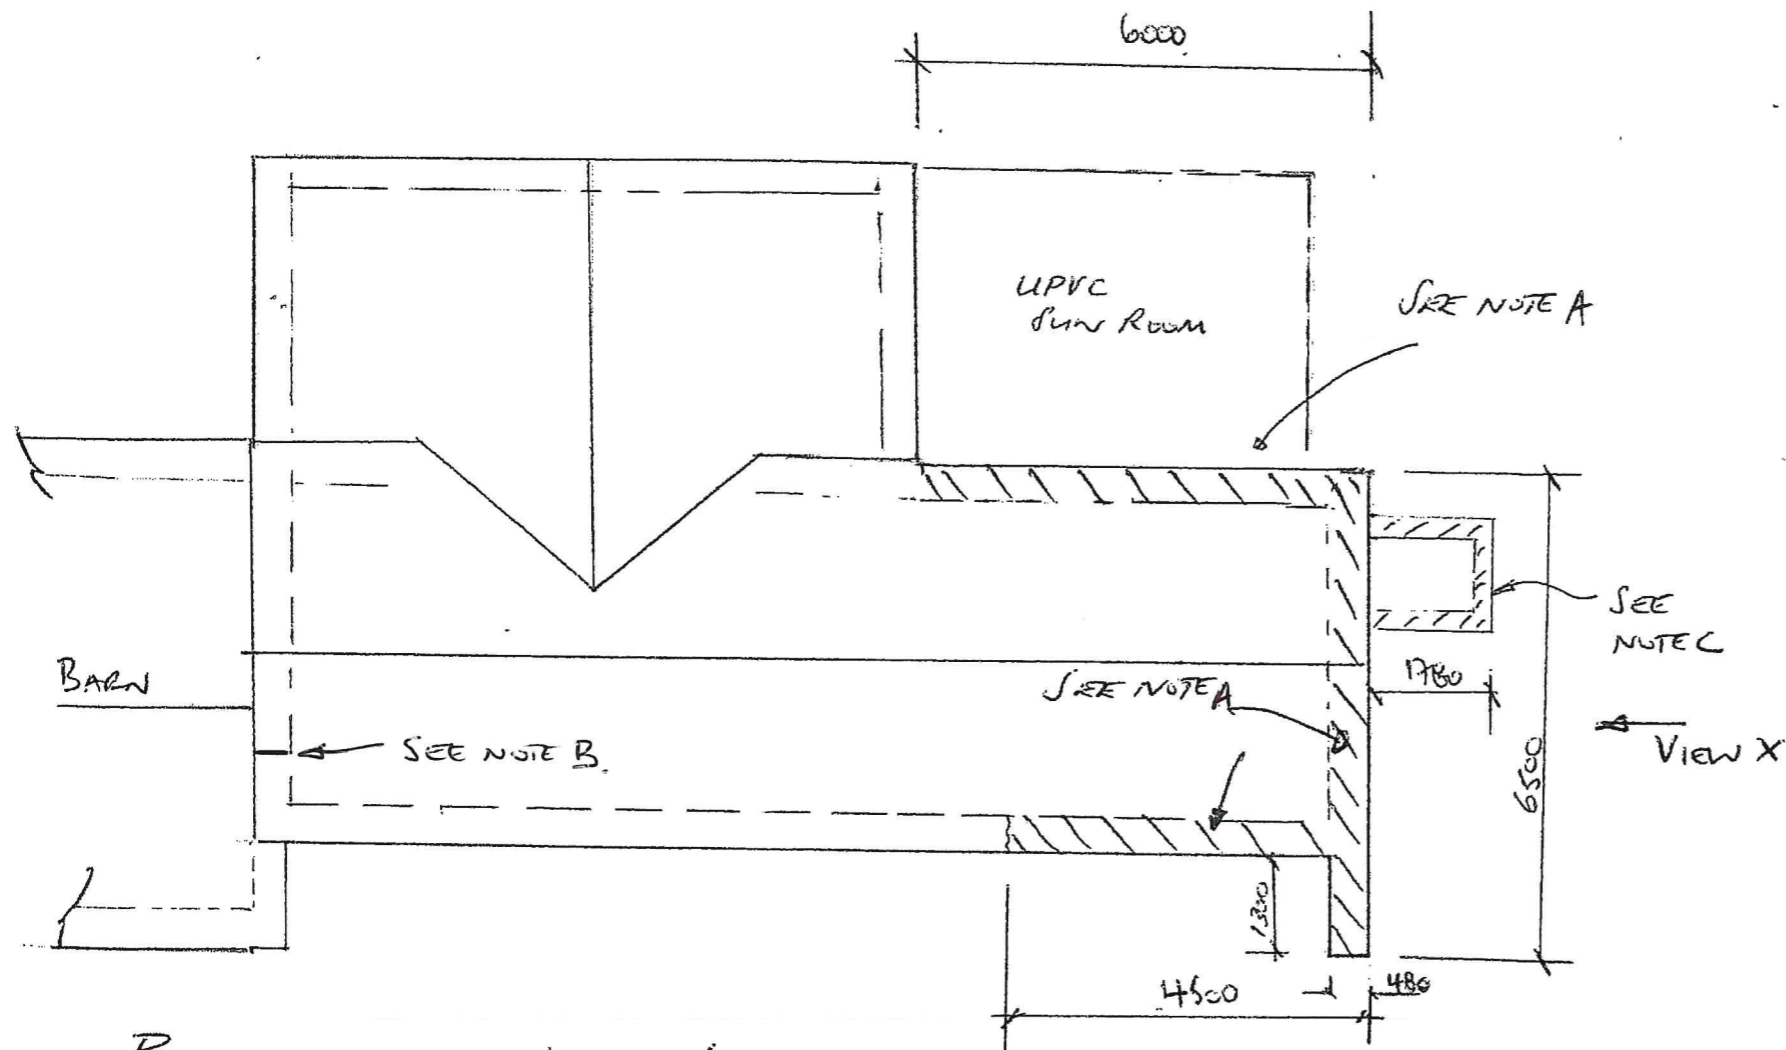
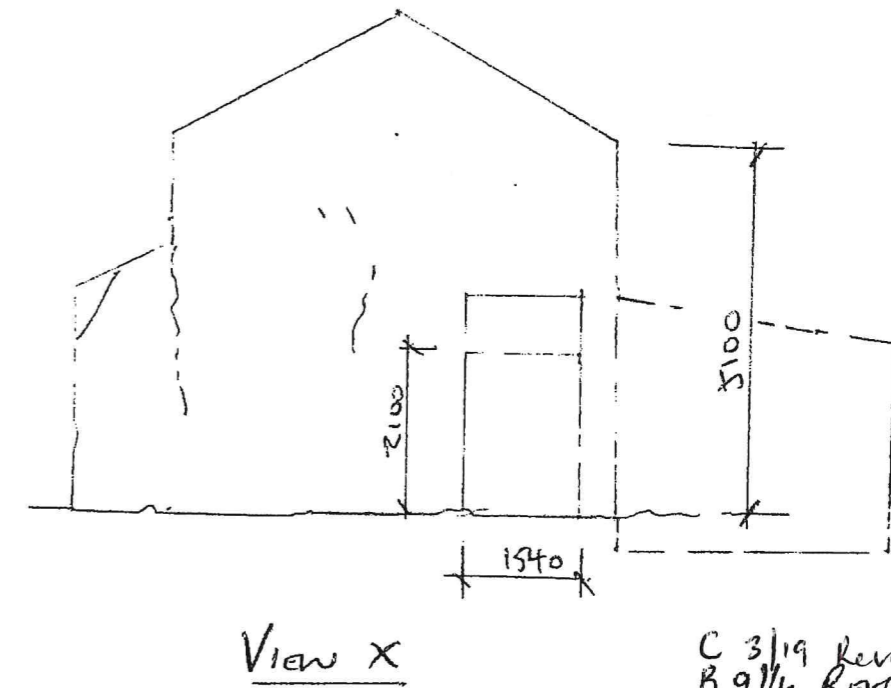
PLAN ON MAIN HOUSE (1:100 @ A3)

- 2.3** The right hand gable end wall to the farmhouse is excessively weathered and appears to bow outwards, significant cracking is also apparent in various locations, the masonry also appears to have lost its cohesion. Internally there is no evidence of structural movement. It appears that the outer face of stone has de-bonded from the inner; the rubble fill has probably slumped and caused the outward bulging apparent. The wall to the right hand end of the front elevation is in a similar condition to the gable.

- 2.4** The rear wall of the farmhouse is significantly out of plumb above the conservatory. Significant cracking is not apparent which suggests the masonry has been like this for some time.

TAKE DOWN GABLE AND WALLS AS INDICATED ON THE PLAN AND REBUILD IN 7N/mm² CONCRETE BLOCK 440mm WIDE TO SUIT EXISTING WALL WIDTH. WALL TO COMPRISE 215mm INNER LEAF 100mm INSULATED CAVITY AND 100 BLOCK OUTER LEAF. CAVITY TIES PROVIDED AT 450v AND 700h CENTRES. FULLY BUILD INTO THE REMAINING WALLS. WALL TO BE BUILT OFF A 750x225mm DEEP MASS CONCRETE STRIP FOOTING CAST 1500mm BELOW EXISTING GROUND LEVEL TO SUIT BUILDING NEAR TREES REQUIREMENTS. FRONT BUTTRESS IS NOT REQUIRED HOWEVER IF TO BE REBUILT TO BE FORMED IN 215mm THICK CONCRETE BLOCKWORK. FORMATION TO FOUNDATIONS TO BE APPROVED ON SITE.

EXPAMET TO BE FIXED TO WALL ACROSS INTERFACE BETWEEN NEW AND EXISTING MASONRY PRIOR TO RENDERING.

INTERNAL ROOF AND FIRST FLOOR TO BE FULLY PROPPED PRIOR TO REMOVING THE EXISTING WALLS.

ROOF STRUCTURE TO BE PROVIDED WITH TEMPORARY SUPPORT PRIOR TO DEMOLITION WORKS COMMENCING. UPVC SUN ROOM TO BE PROPPED AND REFITTED ONCE WALL BUILT WITH AN INTEGRAL CAVITY TRAY AND FLASHING AT THE INTERFACE BETWEEN THE NEW WALL AND CONSERVATORY ROOF.

TIE CRACK IN GABLE END BY INSTALLING 750mm LONG SPANLITE LINTELS INTO THE WALL ACROSS THE CRACK LOCATION AT 600mm VERTICAL CENTRES. THE CRACK SHOULD BE THEN BE FILLED WITH A SAND/CEMENT MORTAR. EXPAMET SHOULD BE FITTED TO THE WALL FACE ACROSS THE CRACK LOCATION PRIOR TO REAPPLYING RENDER OR PLASTER.

UNUSED OUT BUILDING TO BE DEMOLISHED AND THE REQUIREMENT TO REBUILD CONFIRMED WITH THE BUILDING OWNER. IF REBUILDING REQUIRED FORM IN CONCRETE BLOCK, 100mm THICK, FULLY TIED INTO THE NEW GABLE WALL AND BUILT OFF 450x150 DEEP CONCRETE STRIP FOOTINGS CAST HOMOGENEOUS WITH THE GABLE FOUNDATION. ROOF TO BE REPLACED LIKE FOR LIKE

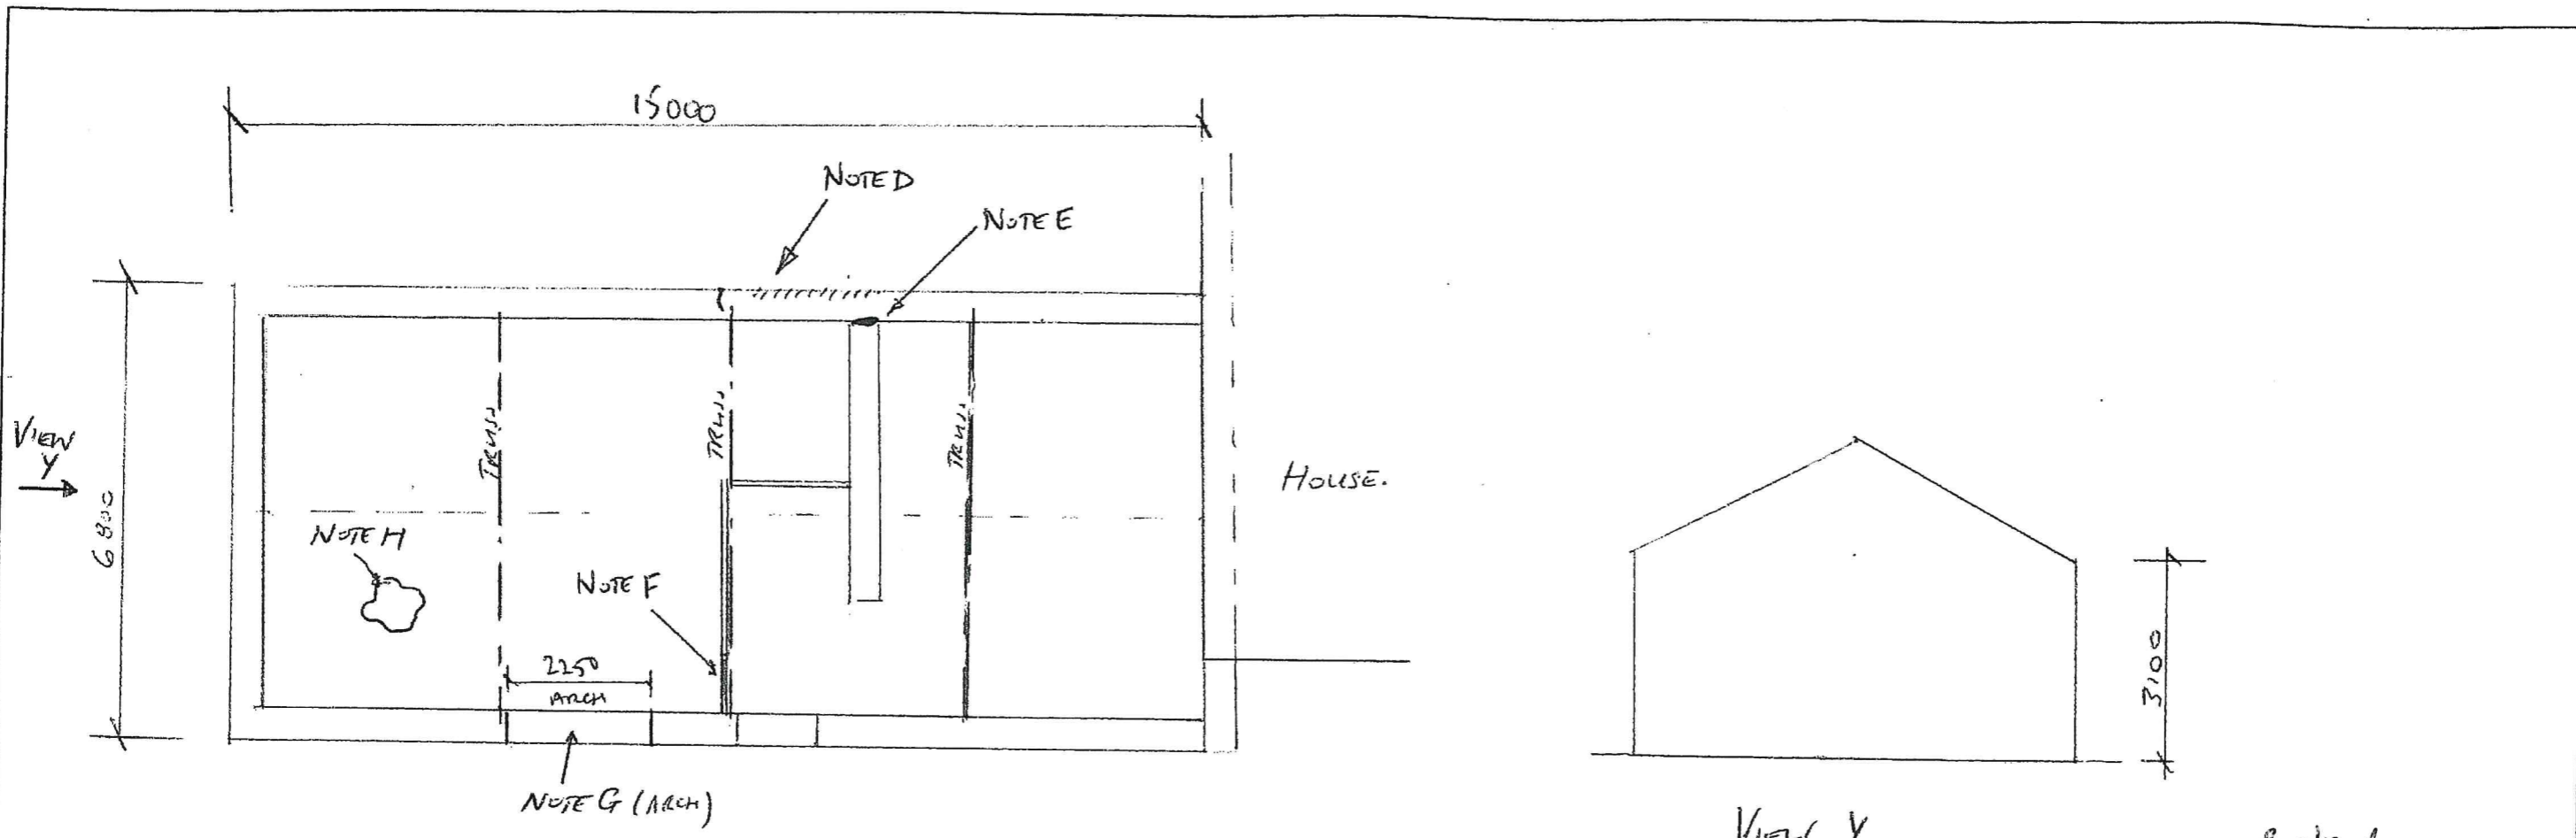
PLAN ON BARN (1:100 @ A3)

- 2.1** The roof to the barn undulates excessively. This is due to creep of the timber purlins which is common in buildings of this type and age. There is some evidence of infestation to the timber elements although not significant. A small area of roof has fell in to the front face of the barn, this appears due to impact damage rather than any structural defect. The rafters adjacent to this area have been affected by water ingress and are rotten.

- 2.2** The arch to the front elevation of the barn is distorted and the keystone has dropped slightly. There is an outward bow to the rear wall of the barn, separation cracking is apparent where the internal wall meets the rear elevation. The timber lintel over the internal doorway in the brick wall has deflected excessively and needs replaced.

- NOTE D**
 REAR ELEVATION HEAVILY WEATHERED, MASONRY APPEARS LOOSE. REINSTATE LOOSE STONEMWORK AND POINT (APPROXIMATE 10m2 AREA). TIE VERTICAL CRACK IN REAR ELEVATION USING 750mm LONG SPANLITE LINTELS BUILT INTO WALL AT 450mm VERTICAL CENTRES AND FILL CRACK WITH SAND/CEMENT. ALTERNATIVELY USE HELIFIX Lid CRACK STITCHING SYSTEM.
 GENERALLY EXTERNAL BARN ELEVATIONS NEED REPOINTED.

- NOTE E**
 RE-TIE INTERNAL WALL TO REAR WALL USING SIMILAR STITCHING TECHNIQUE AS NOTED ABOVE, REQUIRED OVER FULL HEIGHT OF WALL.
- NOTE F**
 REPLACE TIMBER LINTEL OVER INTERNAL BRICK WALL WITH A 150x100 ACP Lid PSL2 LINTEL WITH 150mm BEARING AT EACH END. LOCALLY REBUILD BRICKWORK ABOVE.

- NOTE G**
 ARCH KEYSTONES NEED RE-FITTED AND PACKED. REMOVE MASONRY UP TO EAVES (PROP ROOF) AND REINSTATE ARCH OVER TEMPORARY CENTERING AND REBUILD WALL OVER. STRIKE CENTERING 7 DAYS AFTER WALL IS REINSTATED. ALTERNATIVELY REPLACE ARCH WITH A TRADITIONAL CONCRETE LINTEL SYSTEM COMPRISING 4No 215x100 ACP Lid PSL 4 LINTEL (TO SUIT WALL WIDTH) GIVEN 150mm END BEARING.

- NOTE H**
 ROOF LATS NEED REPLACED WHERE ROTTEN. FULL ROOF TIMBERS NEED INSPECTED BY A TIMBER SPECIALIST TO CONFIRM CONDITION. WHERE NECESSARY RAFTERS SHOULD BE REPLACED IN A LIKE OF LIKE FASHION, PURLINS SHOULD BE REPLACED WITH 225x100 C16 TREATED TIMBERS AT SAME CENTRES AS THE EXISTING LAPPED AND FIXED OVER THE TRUSSES.

- FIRST FLOOR**
 NO ACCESS WAS MADE ONTO THE FIRST FLOOR AS THE TENANT ADVISED THE FLOOR WAS UNSAFE. FLOOR SHOULD BE REMOVED AS PART OF THE REFURBISHMENT SCHEME IF NOT REQUIRED.

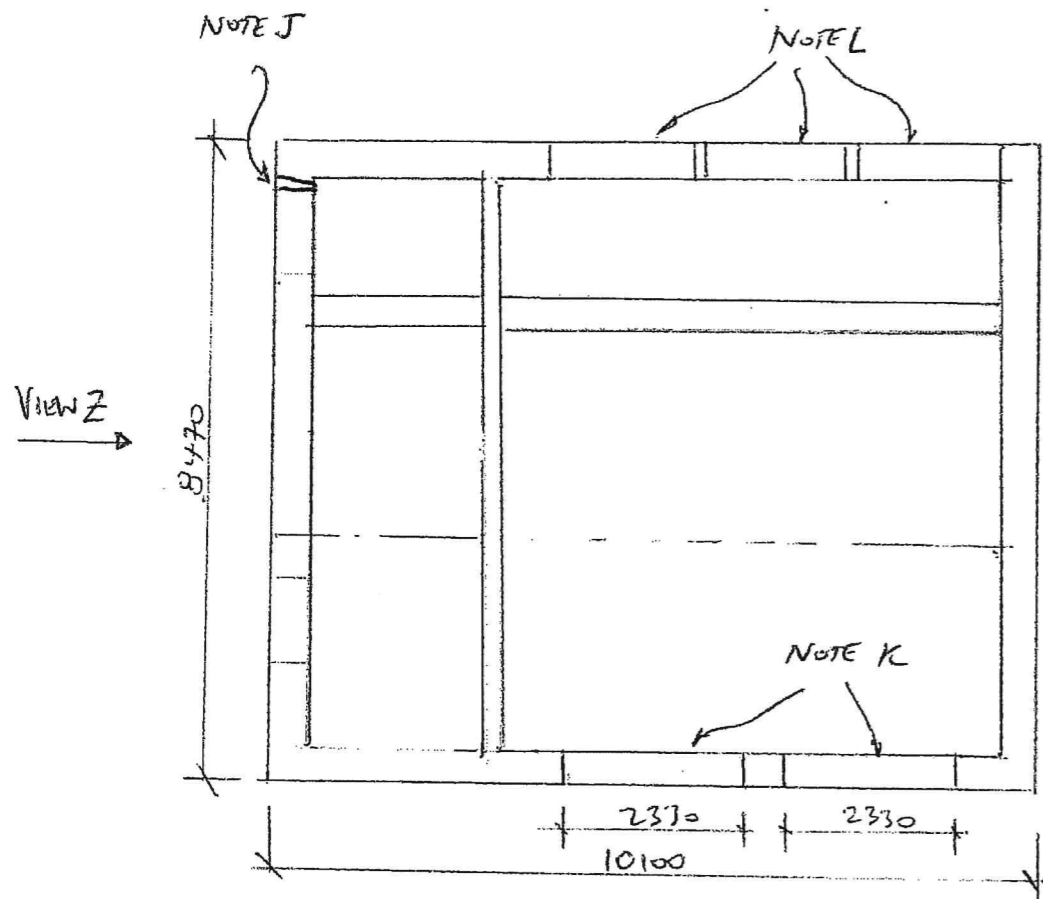
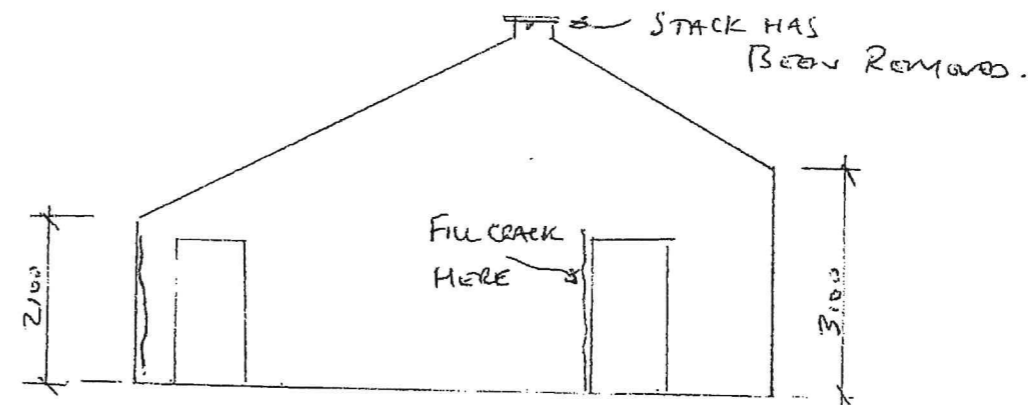
PLAN ON COACH HOUSE (1:100 @ A3)

- 2.8** Separation cracking is apparent at the rear left hand corner of the coach house. The masonry arches above the main doors have suffered movement. The keystones need reseated.

2.9 The canopy structure to the rear of the coach house is in a poor condition. The timber lintels are rotten as are the rafter ends over. In addition the pillar supports to the lintels are structurally inadequate and need replaced with a suitably designed structure.

SEPARATION CRACK TO BE TIED AS NOTED ON SKETCH 101.

ARCH KEYSTONES NEED RE-FITTED AND PACKED. REMOVE MASONRY UP TO EAVES (PROP ROOF) AND REINSTATE ARCH OVER TEMPORARY CENTERING AND REBUILD WALL OVER. STRIKE CENTERING 7 DAYS AFTER WALL IS REINSTATED. ALTERNATIVELY REPLACE ARCH WITH A TRADITIONAL CONCRETE LINTEL SYSTEM COMPRISING 4No 215x100 ACP Ltd PSL 4 LINTEL (TO SUIT WALL WIDTH) GIVEN 150mm END BEARING.

TIMBER LINTELS ROTTEN AND RAFTER ENDS OVER. AREA IS NOT USED SUGGEST REMOVING ROOF OVER BACK TO MAIN INTERNAL WALL AND REMOVE SANDSTONE MULLIONS. AT PRESENT AREA IS STRUCTURALLY UNSAFE.

NO ACCESS WAS POSSIBLE ONTO THE FIRST FLOOR, ROOF TO MAIN AREA OBSCURED. SUGGEST ROOF TIMBERS ARE INSPECTED BY A TIMBER SPECIALIST AND IF NECESSARY REPLACE IN A LIKE FOR LIKE FASHION.

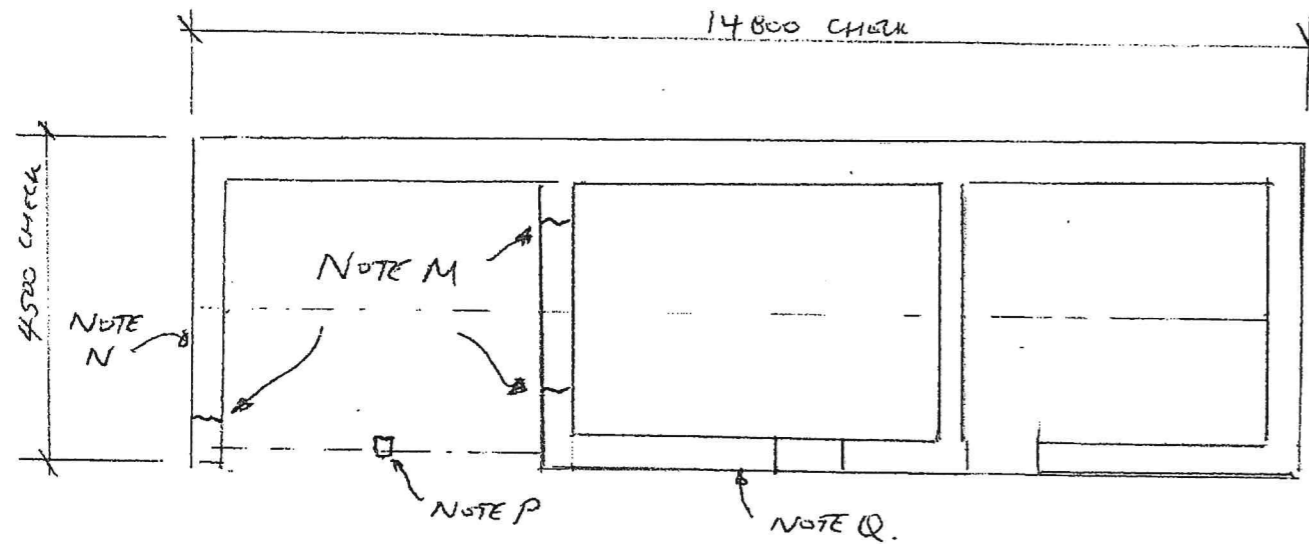
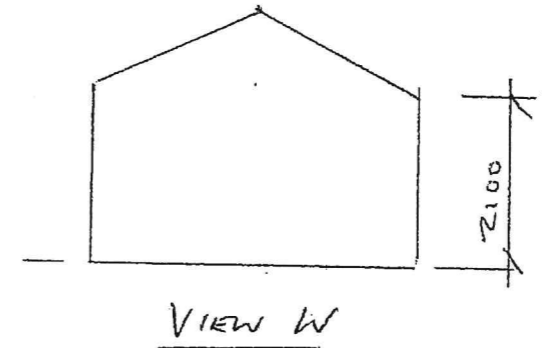
PLAN ON OUT BUILDINGS (1:100 @ A3)

2.10 Separation cracking is evident in the left hand gable and internal walls of the outbuildings which suggest the building has suffered structural movement. It is likely that the movement is historic. The masonry to the building is heavily weathered. In addition there is a sandstone post which supports the front portion of the roof to the left hand bay to the building. The post is out of plumb and appears to have been undermined, the post is structurally inadequate. The roof timber have some infestation and are affected by damp in areas.

- NOTE M**
SEPARATION CRACK TO BE TIED AS NOTED ON SKETCH 101.
GENERALLY EXTERNAL ELEVATIONS NEED REPOINTED.
- NOTE N**
ELEVATION HEAVILY WEATHERED, MASONRY APPEARS LOOSE. REINSTATE LOOSE STONEMWORK AND POINT.

- NOTE P**
SANDSTONE POST ROOF SUPPORT UNDERMINED AND LEANS, THIS IS CURRENTLY STRUCTURALLY UNSAFE, PROPPING NEEDS PROVIDED. NEEDS REPLACED WITH A 325mm MASONRY PILLAR BUILT CENTRALLY OFF A 600x600x300mm DEEP MASS CONCRETE PAD FOUNDATION. LINTELS SUPPORTED TO BE STRAPPED DOWN PILLAR USING 1200mm LONG BAT STRAPS.

- NOTE Q**
MASONRY HEAVILY WEATHERED, MASONRY APPEARS LOOSE. REINSTATE LOOSE STONEMWORK AND POINT. LOWER PORTION OF WALL APPEARS TO HAVE DROPPED ADJACENT TO DRAIN SUGGEST CHECK DRAIN FOR LEAKS AND REINSTATE IF NECESSARY. LOCALLY REBUILD WALL (1.5m² AREA)

- ROOF TIMBERS TO BE INSPECTED BY A TIMBER SPECIALIST AND REPLACED IN A LIKE FOR LIKE MANNER WHERE NECESSARY.
- CONSIDER REMOVING TREES AND BUSHES TO AT LEAST 5.0m AWAY FROM THE BUILDING
