Arboricultural Report
Hillcrest Avenue Jericho Plantation
Whitehaven
January 2025

1.2 The inspection commissioned to assess 3 No. semi mature Sycamore, *Acer pseudoplatanus*, and 1 No. semi mature Ash, *Fraxinus excelsior*, situated in an amenity woodland known as Jericho Plantation to the rear, east, of residential properties at Hillcrest Avenue, Whitehaven. CA28 6ST. The inspection being undertaken from ground level with no exploratory excavation works undertaken.

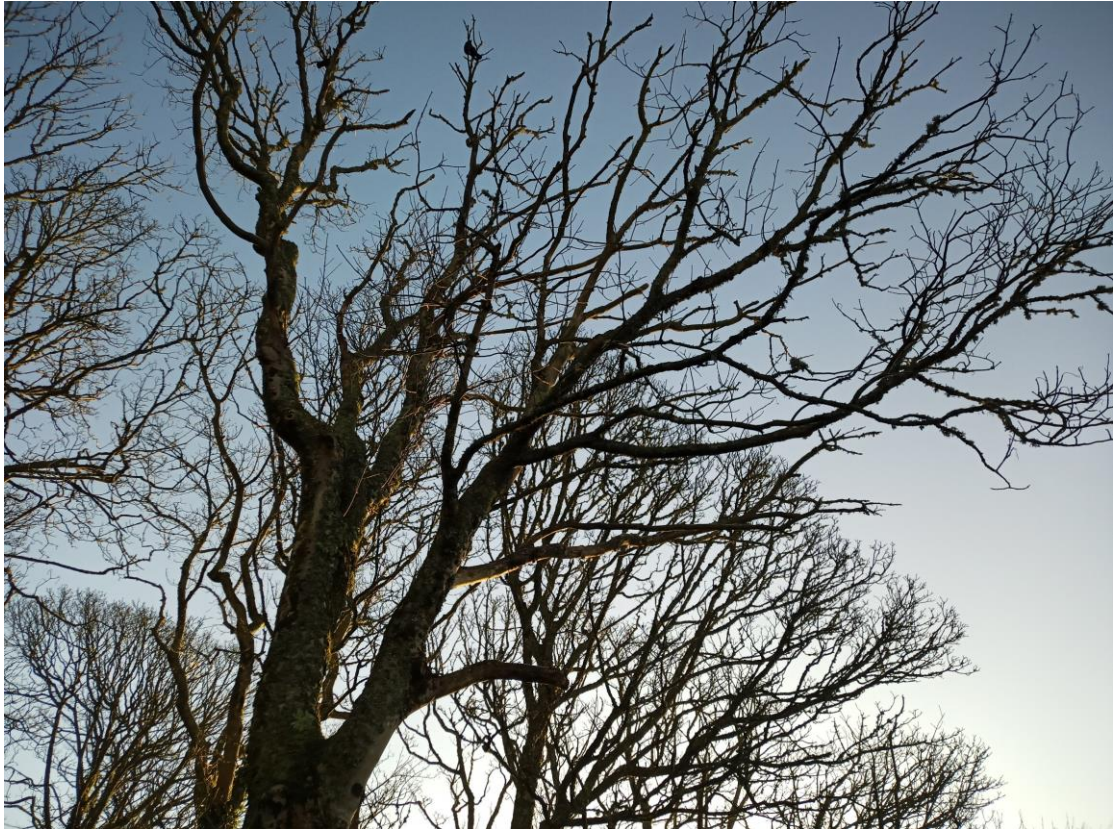
T1. Upper crown dying back with deadwood present.

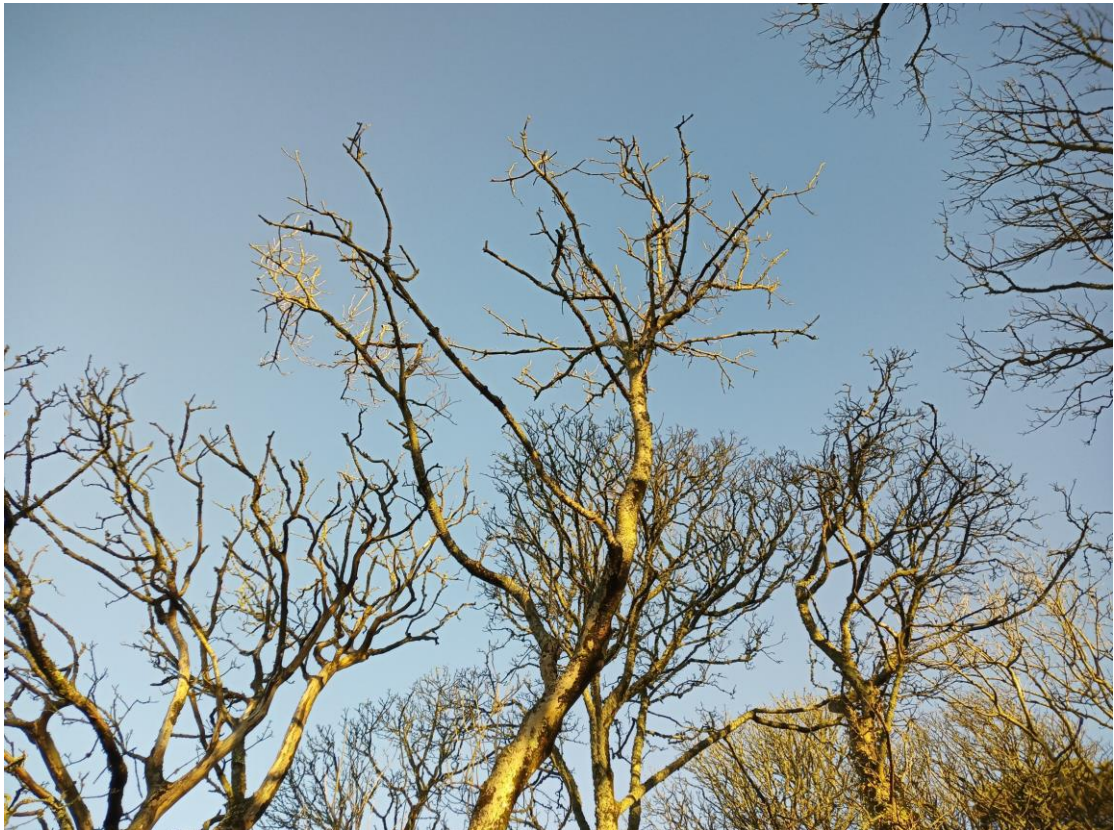
T2. Upper crown dying back with deadwood present.

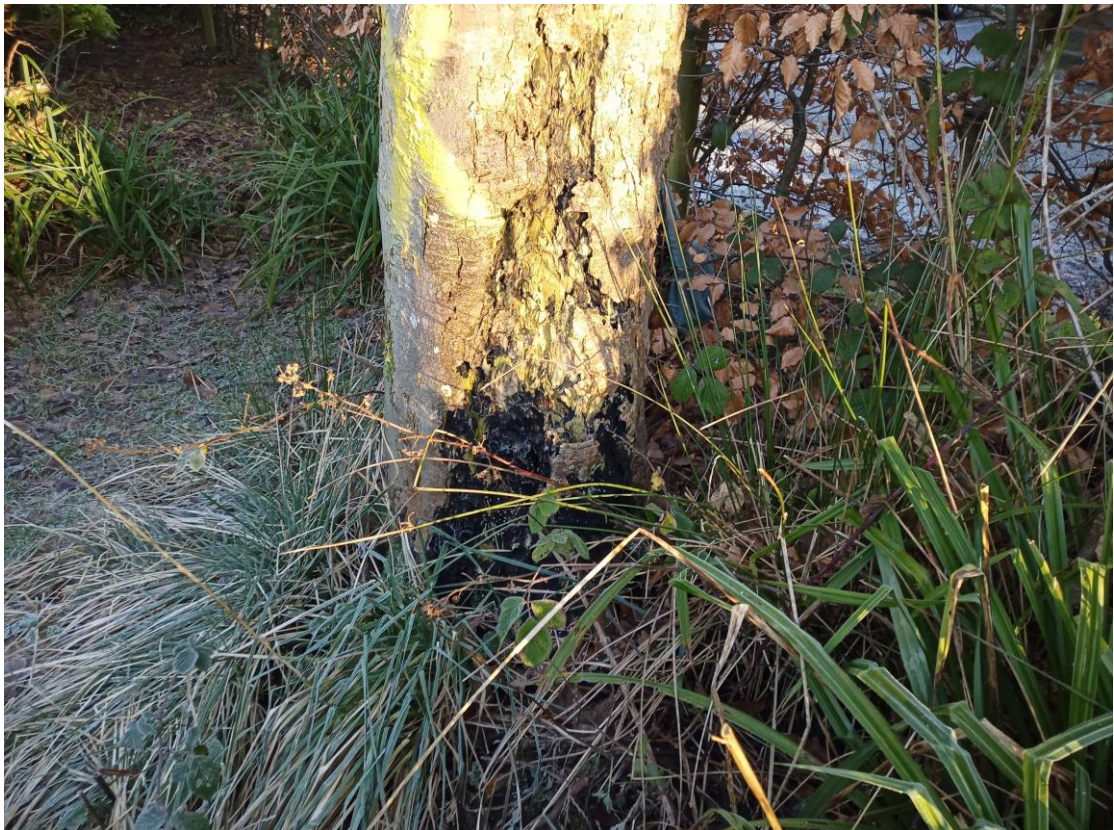
3.2 T4, Sycamore is clearly in decline with deadwood throughout the crown. At the base of the specimen on the main stem is evidence of *Kretchmaria deusta*, commonly known as Brittle Cinder.

3.3 Brittle Cinder often establishes on tree specimens following damage / wounding to the stem and or rooting system and is particularly associated with Sycamore, *Acer pseudoplatanus*.

3.4 Generally regarded as a Soft Rot. Brittle Cinder degrades both lignin and cellulose. Lignin being the main cell structure associated with tree rigidity providing structure, support, and acts as a barrier to insects and pathogens. Cellulose is also a cell structure associated with tree and plant strength and rigidity.

T4. Base of specimen with evidence of Brittle Cinder.

3.5 The presence of Brittle Cinder is an indicator that the structural integrity of the infected tree specimen has been compromised. Fell is therefore recommended.
