Inspection Report

Outline Tree Inspection Barn Cottage, Lamplugh, CA14 4TY

Arborscape - Sam Pagett

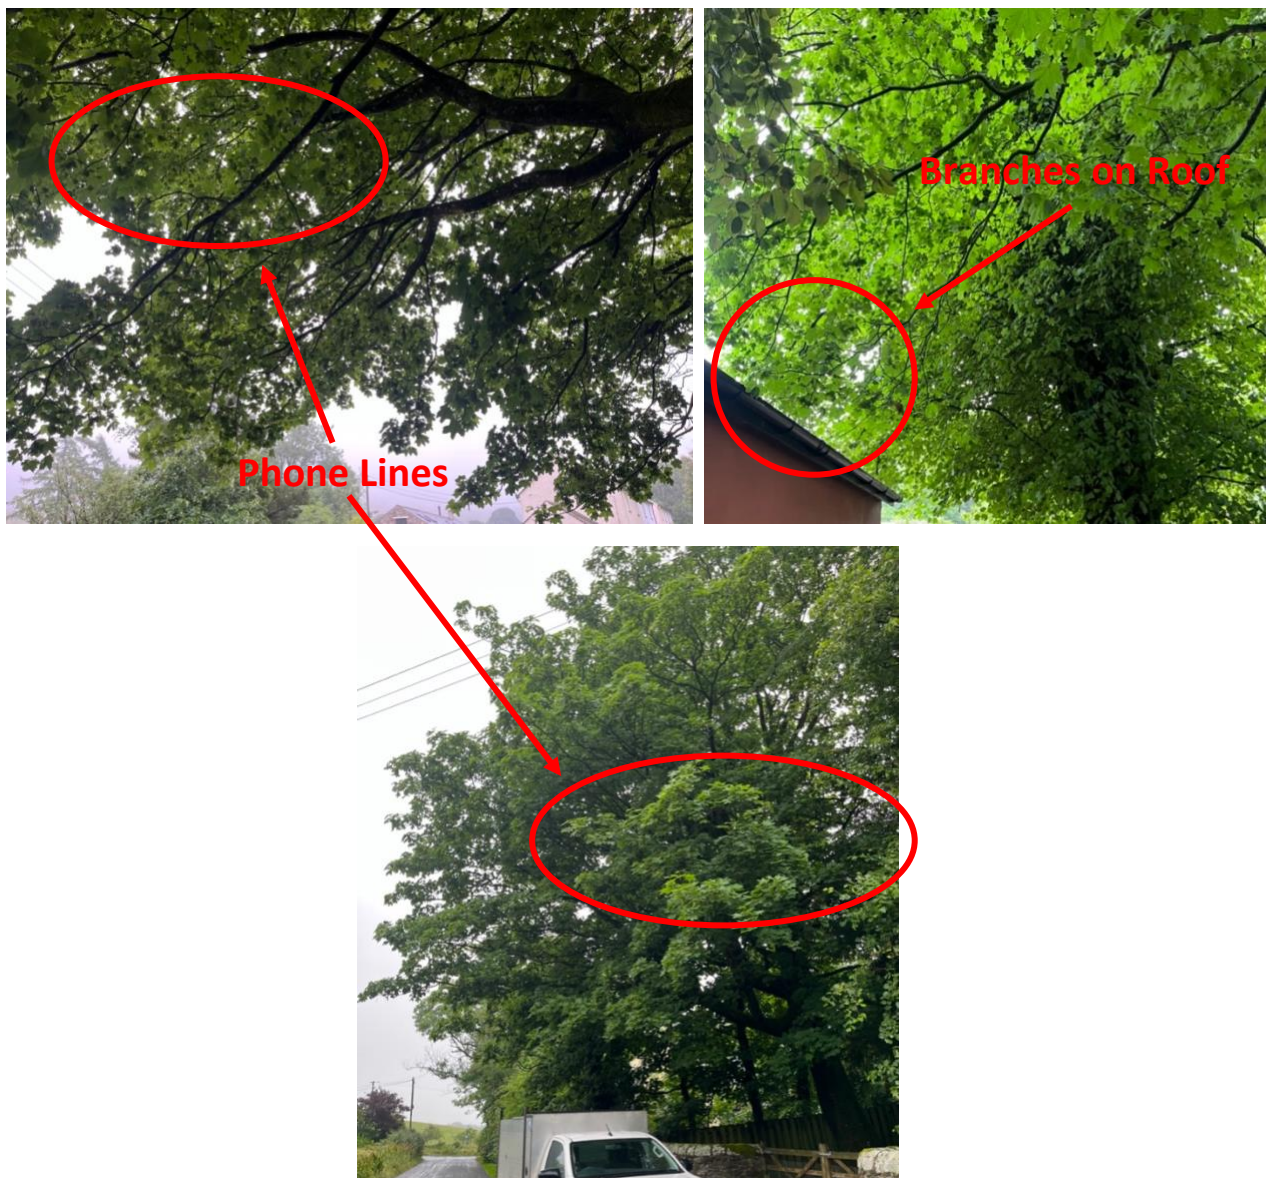
T1: Sycamore (*Acer pseudoplatanus*)

- Mature tree of good health, signs of previous pruning on garage side
- Heavily weighted towards carriageway
- Rear branch almost contacting neighbouring garage roof
- Roadside branches growing through telephone lines

Pruning to prevent damage to neighbouring property and telephone lines from unregulated growth. Most material reduction from weighted side.

Prune to crown raise, two metres clearance of garage roof to rear one metres clearance of phone line on roadway side.

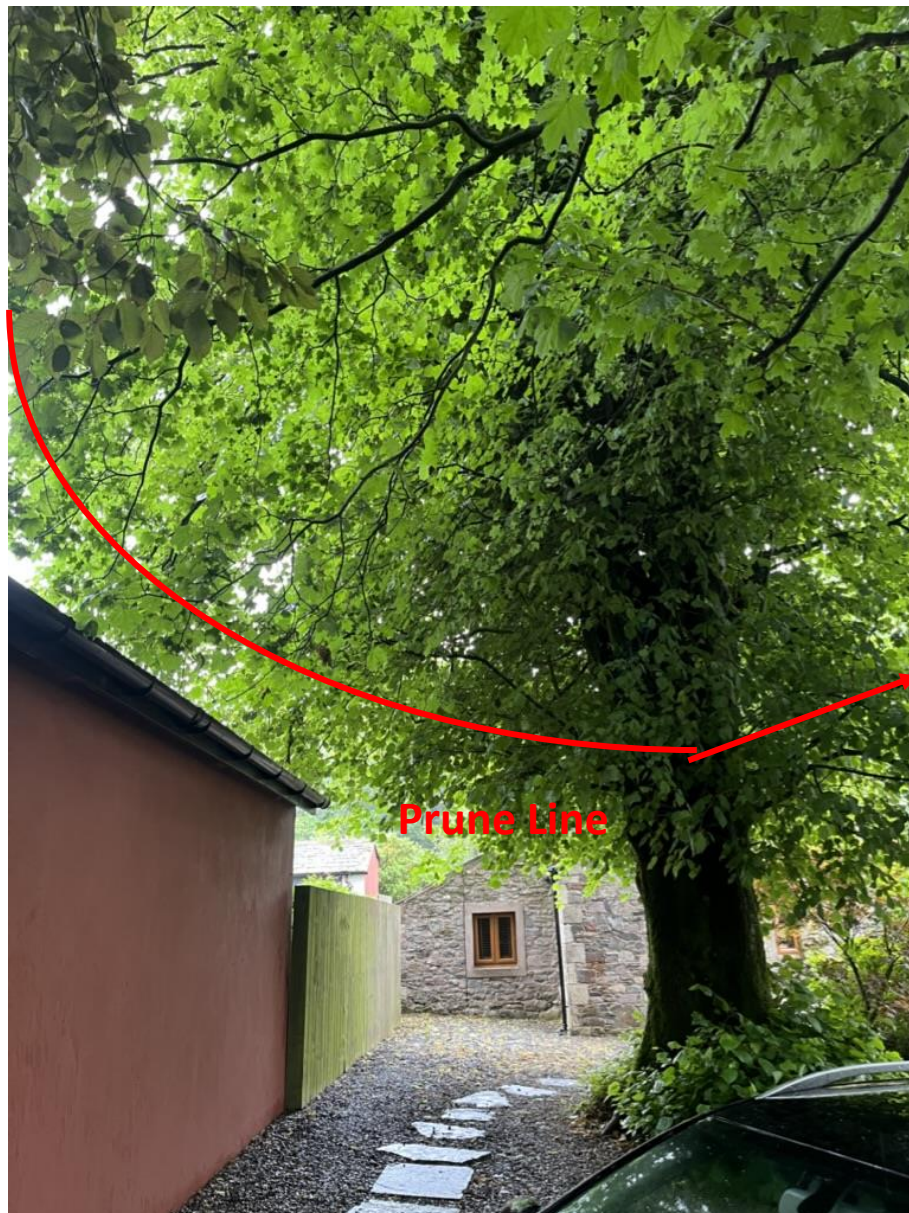
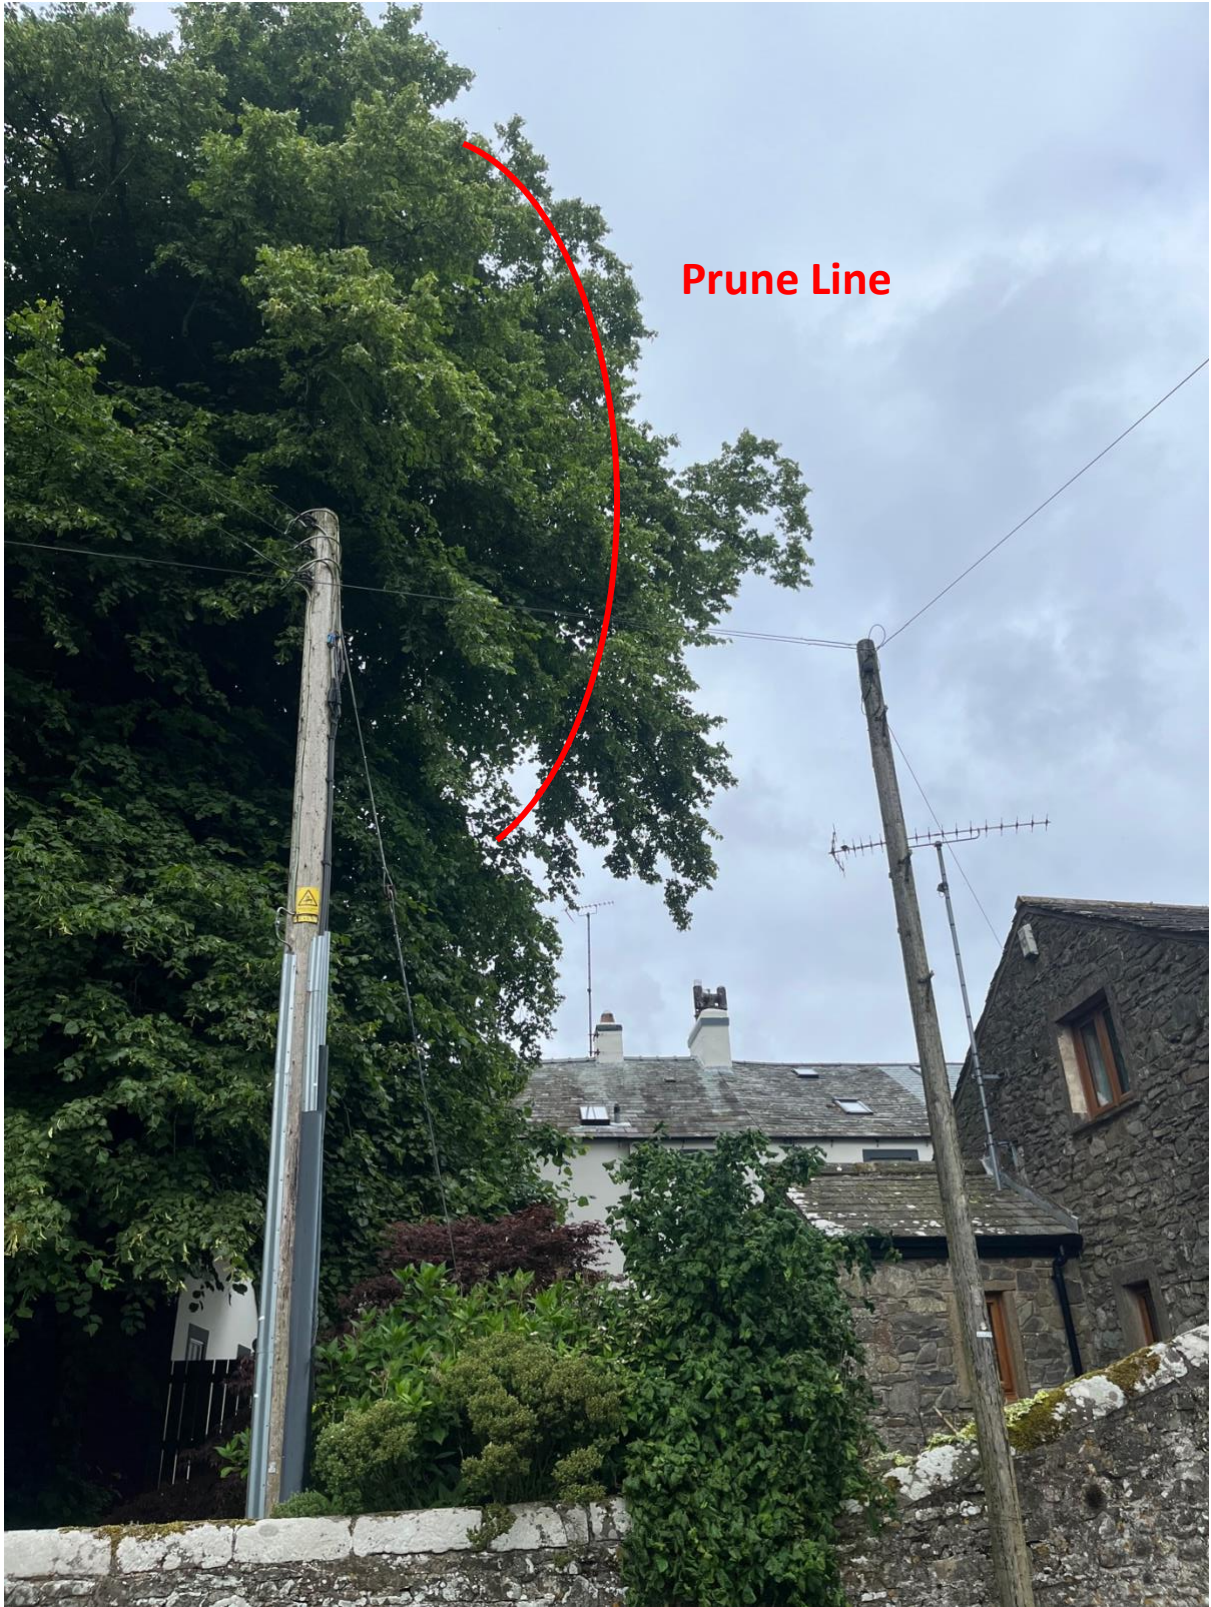
T2: Lime (*Tilia x europaea*)

- Mature tree of good health with high vigour
- Extensive bushy stem growth typical of species
- Branches hanging very low around property access
- Side branches on neighbouring garage roof
- Out growing horizontal branches over property roof

Pruning to prevent damage to neighbouring structures from unregulated growth and provide reasonable clearance for property access whilst maintaining tree uniformity.

Prune to crown raise to 3.6m, clearance of garden area, garage & property access. Side prune to reduce branch length over property roof.
