THE IRON LINE, MILLOM

MINING RISK MITIGATION STRATEGY

Curtins Ref: 080874-CUR-XX-XX-T-GE-00009

Site Address: The Iron Line, Millom, Cumbria, LA18 4LB

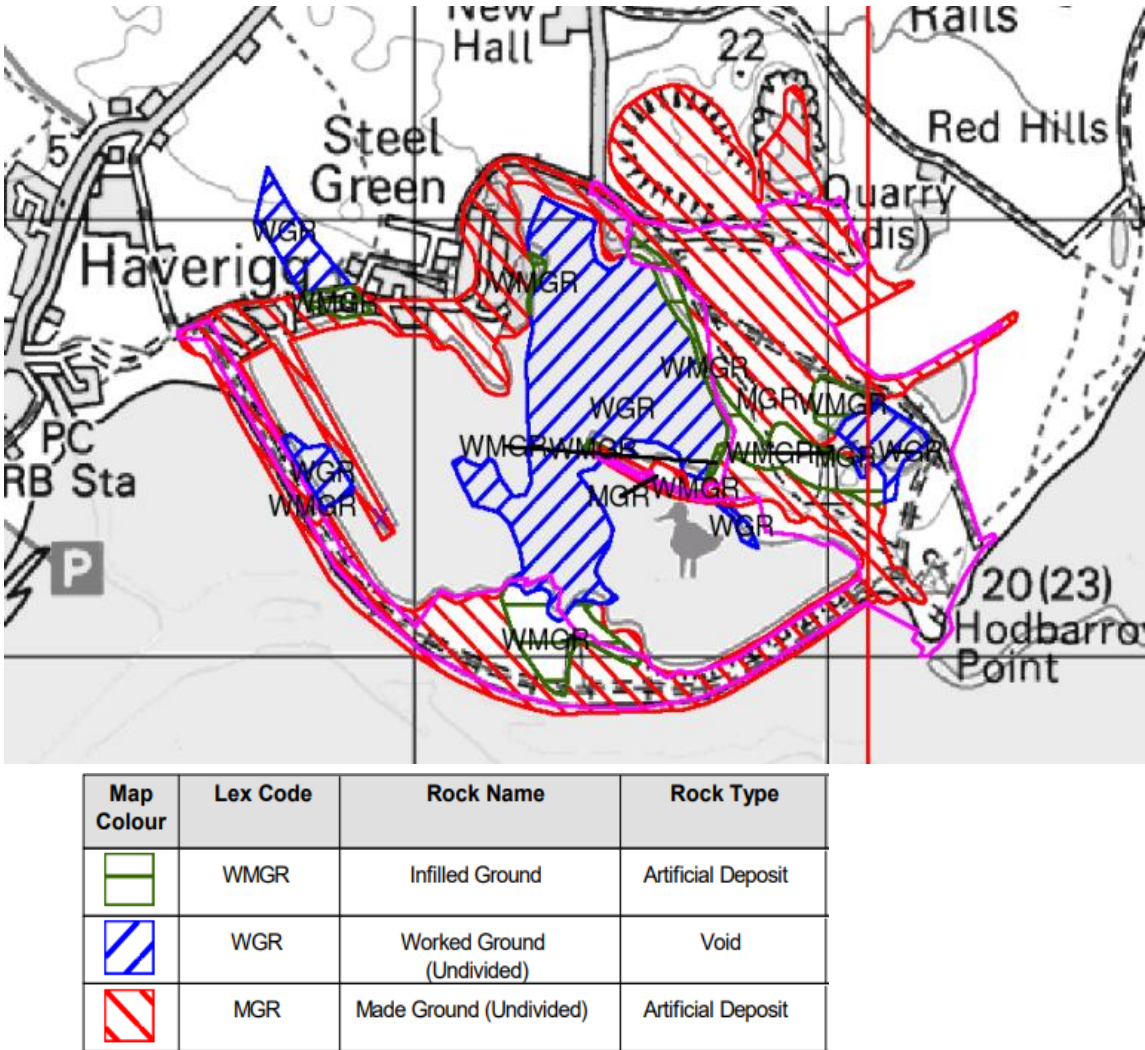
Figure 3 – Extract from BGS 1:50,000 mapping (Artificial Ground)

Desk-based study found that the site has been heavily worked with numerous areas of infilled ground, worked ground and Made Ground indicated on mapping, comprising voids and artificial deposits.

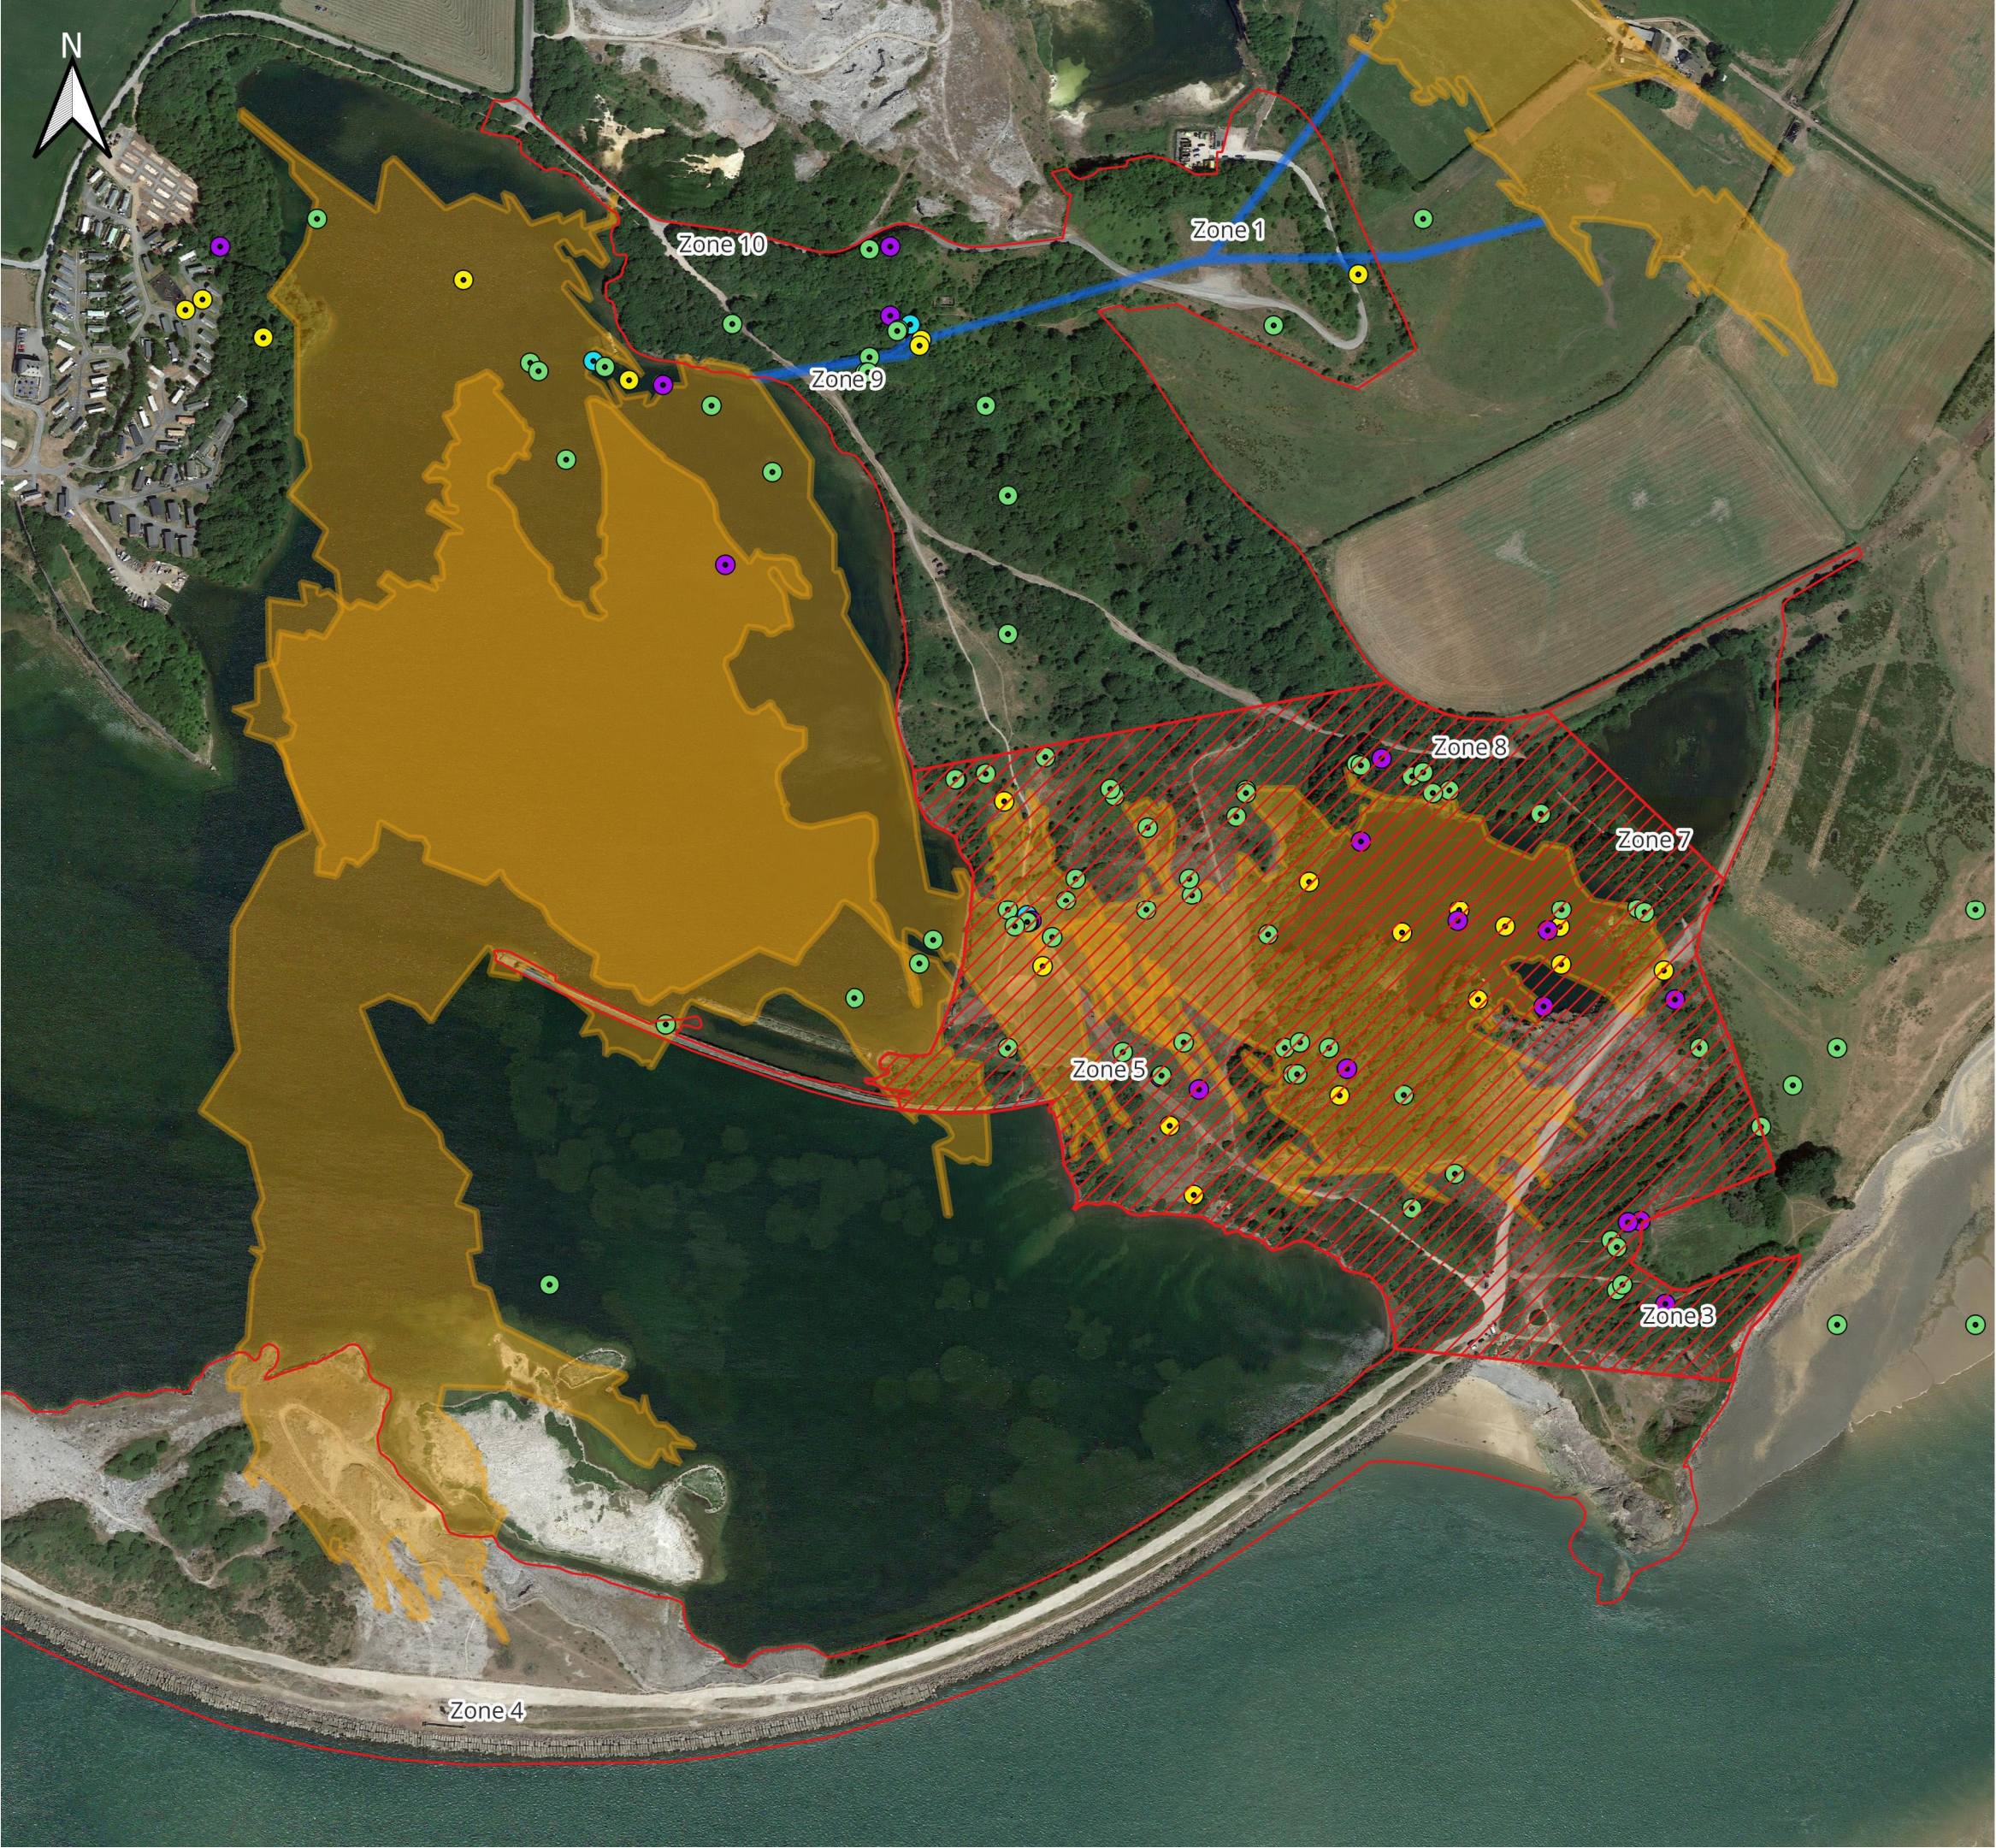
Area of Highest Risk_GeoGrid

It's unlikely to be practical to install geogrid across new roads and paths across the whole site so the highest risk areas should be targeted as identified. Notwithstanding, where Mining Remedial Action 3 (Watching brief during groundworks and construction) across the wider site identifies possible relic mining features or unexpected ground conditions, Geogrid or other treatment measures may need to be considered in these areas.
