Section Inspection - 25/02/2020 - MH1X

CCTV DRAINAGE REPORT

LOW ROAD WHITEHAVEN

Mayson Bros Ltd.
Drainage Report

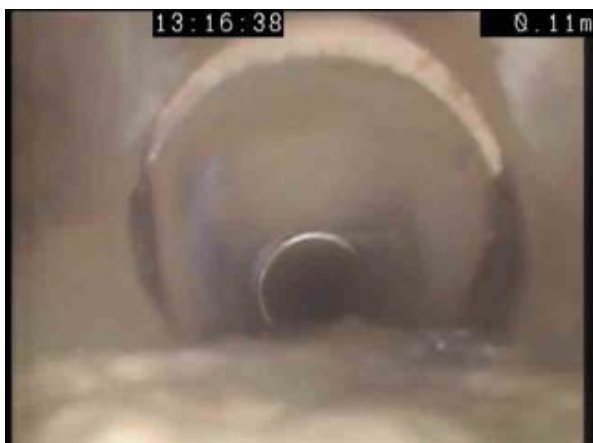
MH1X_e82f07f4-4278-4096-a40b-4d0c8a52a017_20200225_151916_131.jpg, 00:00:18, 0.12 m
Joint displaced, medium

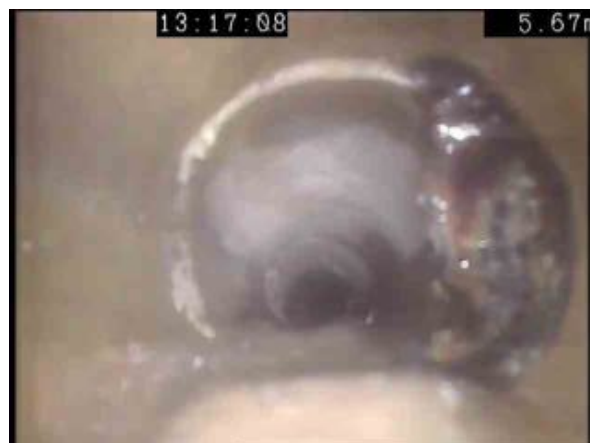
MH1X_53f2d50c-f3e5-431f-b108-4a90485e6efe_20200225_152004_133.jpg, 00:00:47, 5.67 m
Attached deposits, encrustation at joint from 01 o'clock to 06 o'clock, 20% cross-sectional area loss

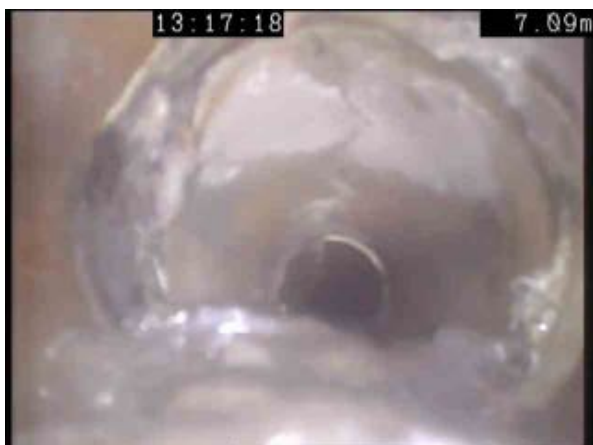
MH1X_6d548981-5f12-419a-b0c6-33c25c06ac12_20200225_152045_590.jpg, 00:00:57, 6.97 m
Attached deposits, encrustation at joint from 12 o'clock to 12 o'clock, 5% cross-sectional area loss

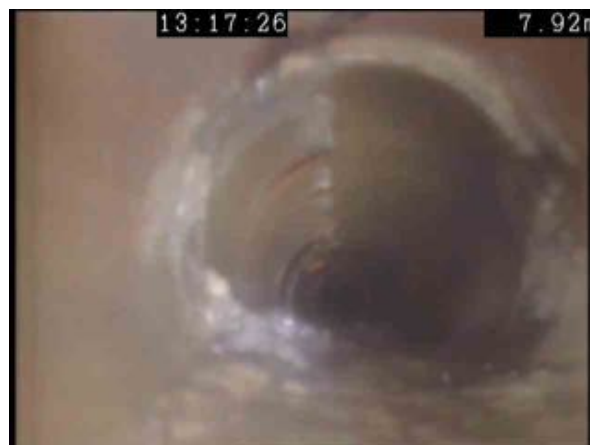
MH1X_48eec4de-904f-4be5-ba33-f21f81524477_20200225_152140_366.jpg, 00:01:05, 7.92 m
Attached deposits, encrustation at joint from 02 o'clock to 09 o'clock, 15% cross-sectional area loss

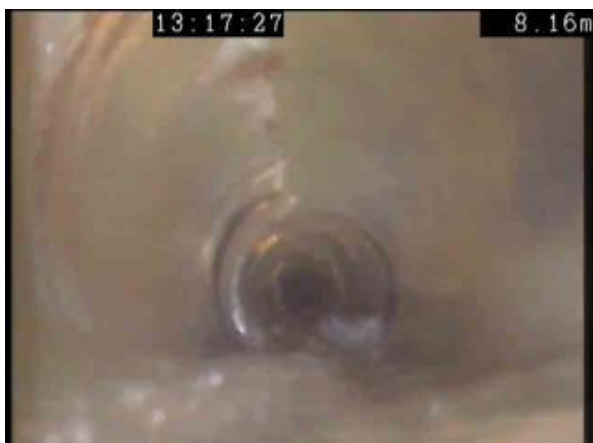
MH1X_60aa83a6-cc65-408f-b89e-f3a013ebb865_20200225_152153_002.jpg, 00:01:06, 8.16 m
Crack, longitudinal at 11 o'clock

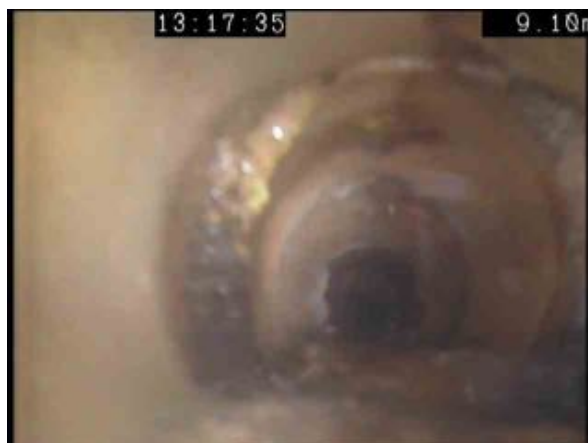
MH1X_f37de10b-7df3-403f-99df-838bb01db9db_20200225_152216_384.jpg, 00:01:14, 9.10 m
Attached deposits, encrustation at joint from 12 o'clock to 12 o'clock, 10% cross-sectional area loss

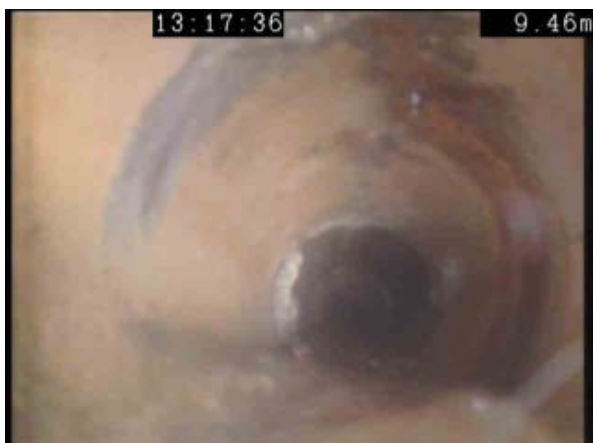
MH1X_7ed44ac0-38be-47e1-a4fb-6f627d3fb9fa_20200225_152240_818.jpg, 00:01:15, 9.46 m
Crack, longitudinal at 12 o'clock

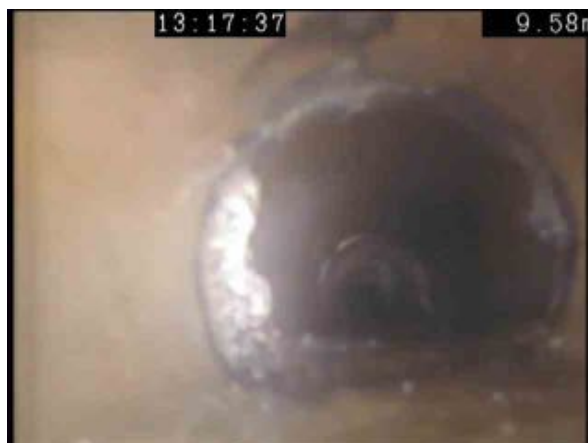
MH1X_10743e70-1bdd-4d25-af42-1f804335d3ec_20200225_152256_324.jpg, 00:01:16, 9.58 m
Attached deposits, encrustation at joint from 12 o'clock to 12 o'clock, 10% cross-sectional area loss

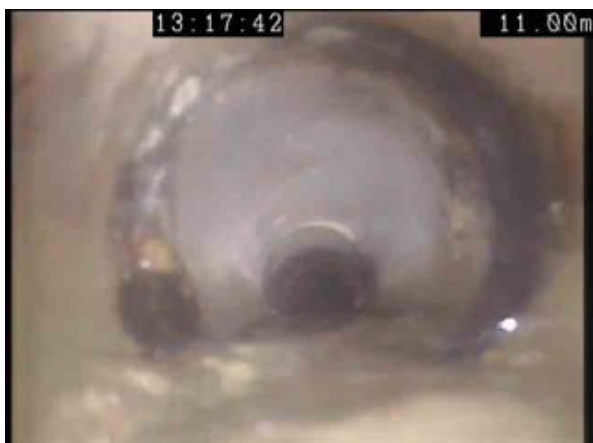
MH1X_d09dd2a7-3195-485d-a33c-282457107e09_20200225_152318_902.jpg, 00:01:22, 11.00 m
Attached deposits, encrustation at joint from 12 o'clock to 12 o'clock, 5% cross-sectional area loss

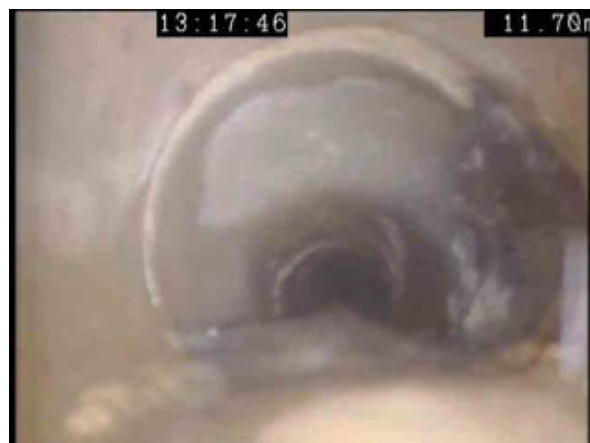
MH1X_30e8334b-3829-497f-ab2e-a0ecc3aaf3e5_20200225_152335_298.jpg, 00:01:25, 11.70 m
Attached deposits, encrustation at joint from 02 o'clock to 06 o'clock, 10% cross-sectional area loss

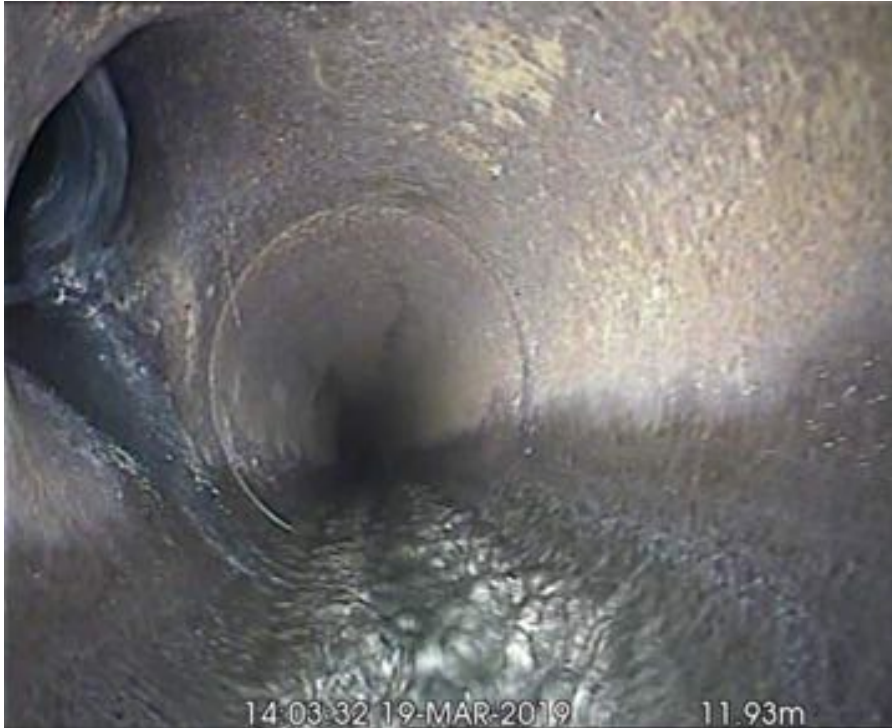
Description
				Junction at 10 o'clock at 11.93m

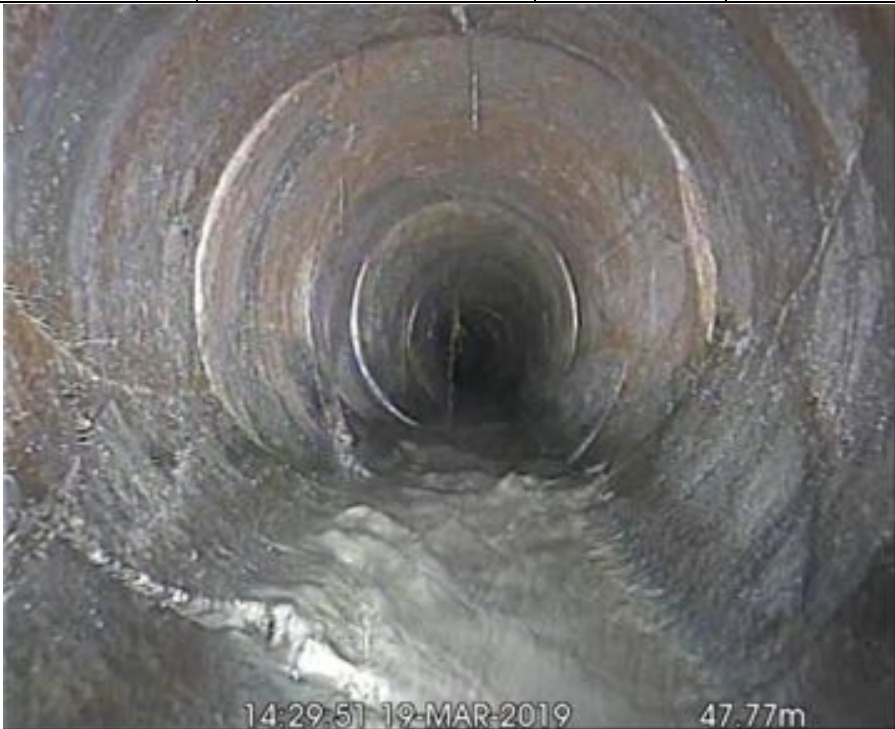
Description
				Broken pipe from 5 to 8 o'clock at 47.77m

RECOMMENDATIONS			
<p>Excavate and repair sections that are damaged and collapsed and carry out root cutting from MH08 upstream.</p> <p>It is recommended that test pits be used to prove the condition and existence of the drainage system in the old cemetery, especially along the line of the old workhouse land.</p>

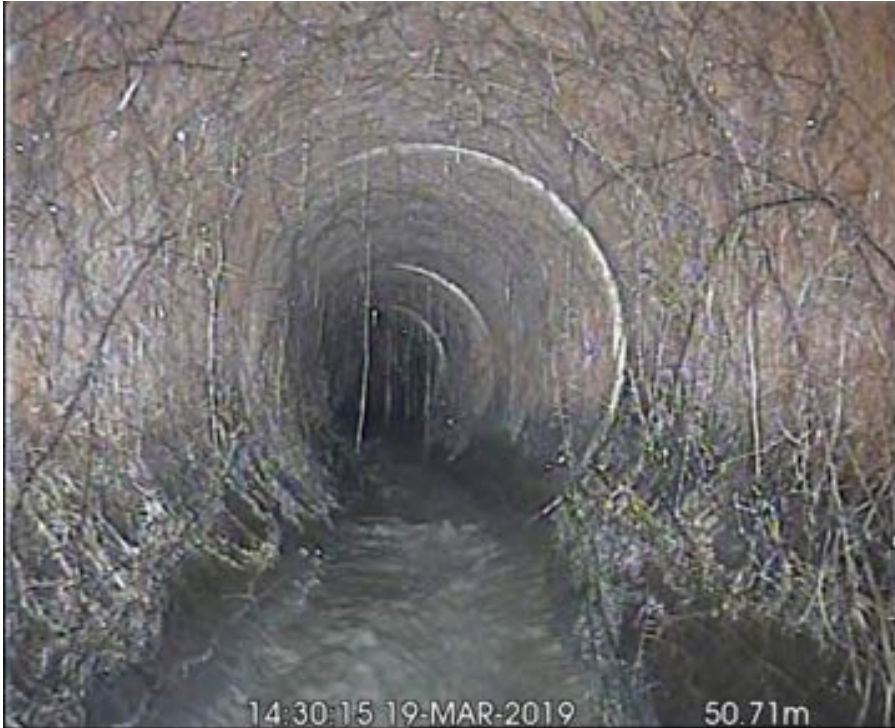
Description
				Start of roots ingress into pipe at 50.71m

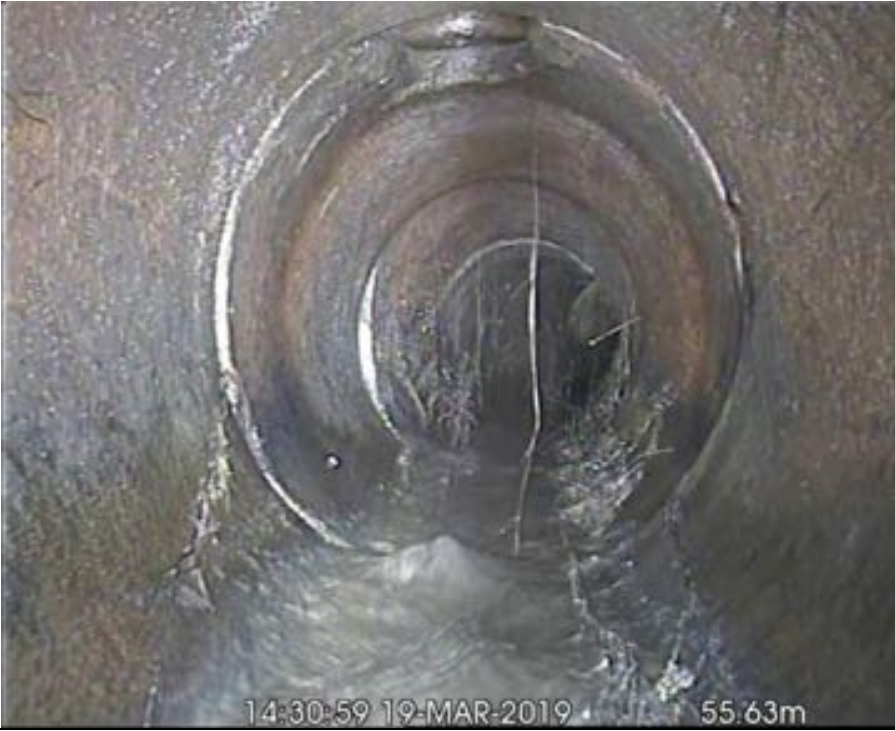
Description
				<p>Junction at 12 o'clock at 55.63m</p> <p>Spiral crack from 7 o'clock to 8 o'clock</p> <p>Slight displaced joint visible in next section of pipe from 7 o'clock to 10 o'clock</p> <p>Slight horizontal deformation <5%</p>

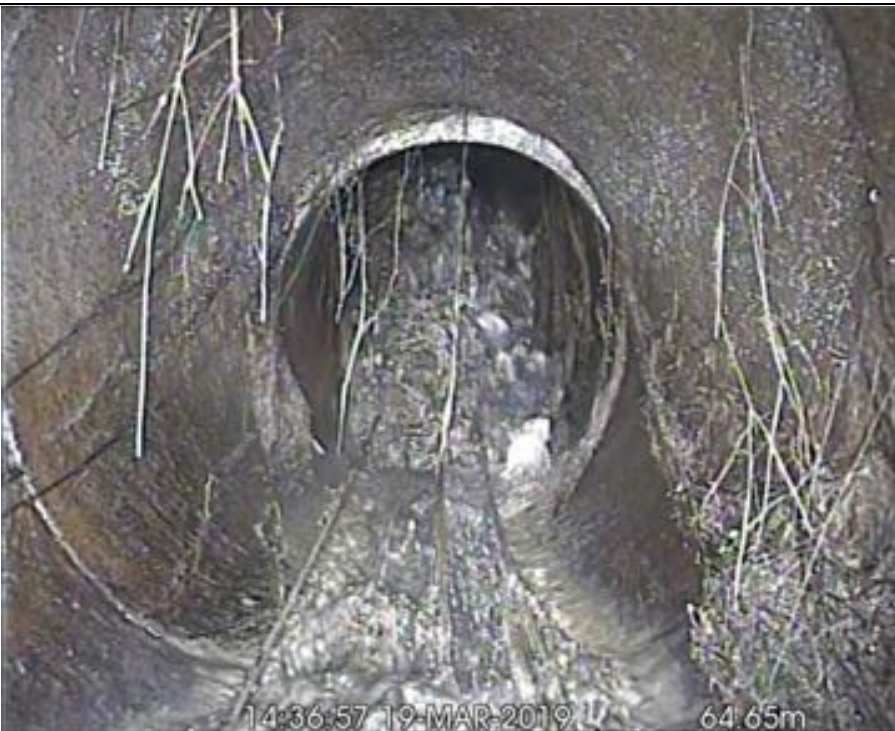
Description
				<p>End crawler unable to continue due to root ingress debris at 64.65m</p> <p>Displaced joint at 1 o'clock.</p> <p>Line of pipe deviates down.</p>

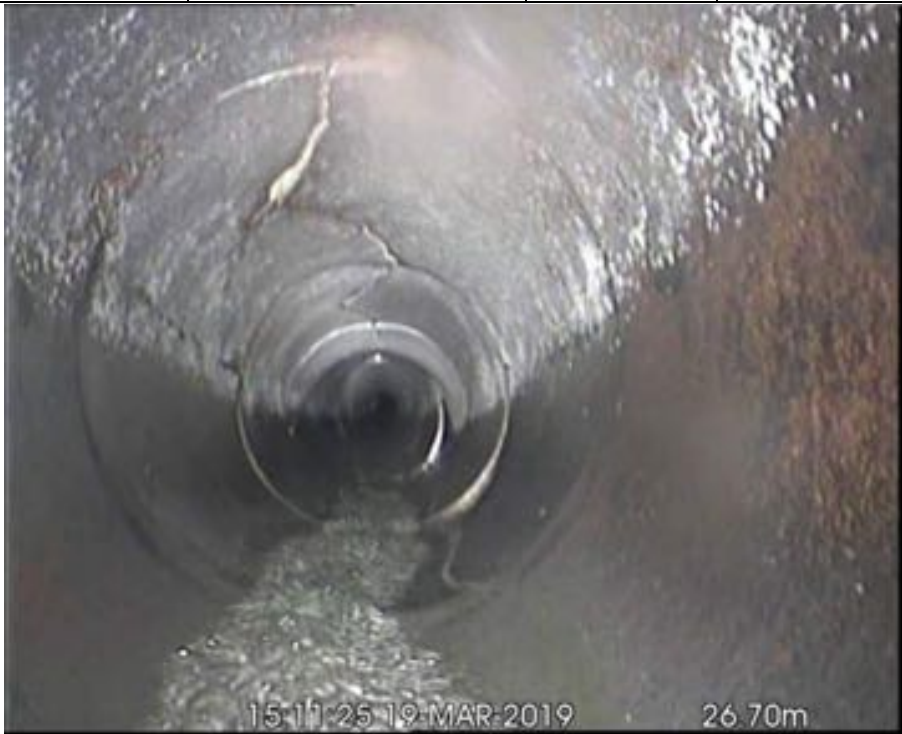
Description Crack longitudinal at 12 o'clock at 26.70m

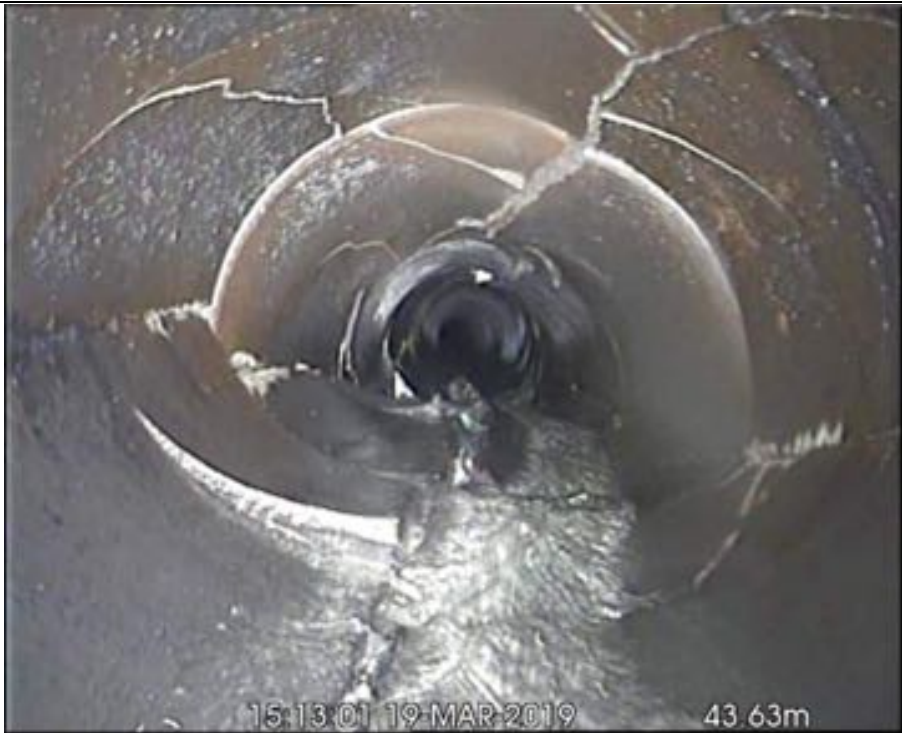
Description Collapsed pipe at 43.63m end unable to pass

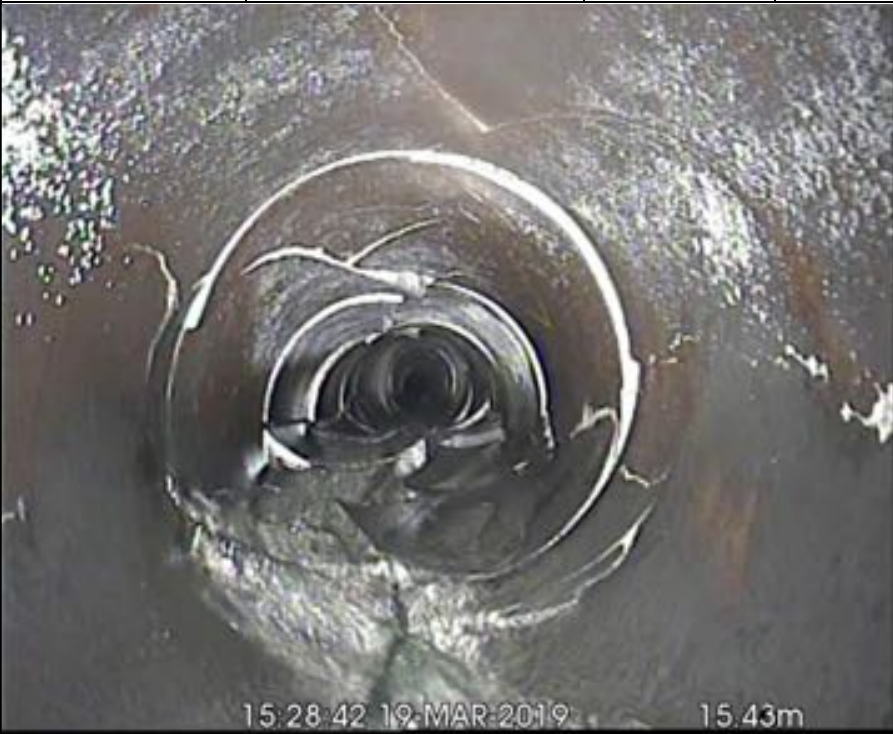
Description
				Collapsed pipe at 15.43m end unable to pass

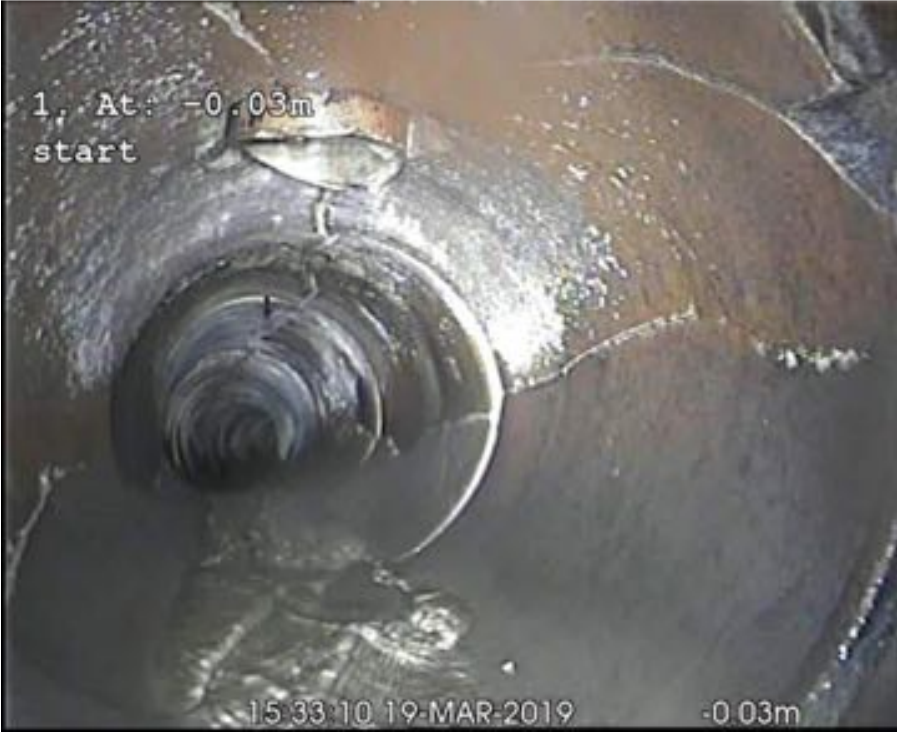
<p>Description</p> <p>Start from MH03 at 0.00m Downstream to MH04 Junction at 12 o'clock Cracks longitudinal</p>

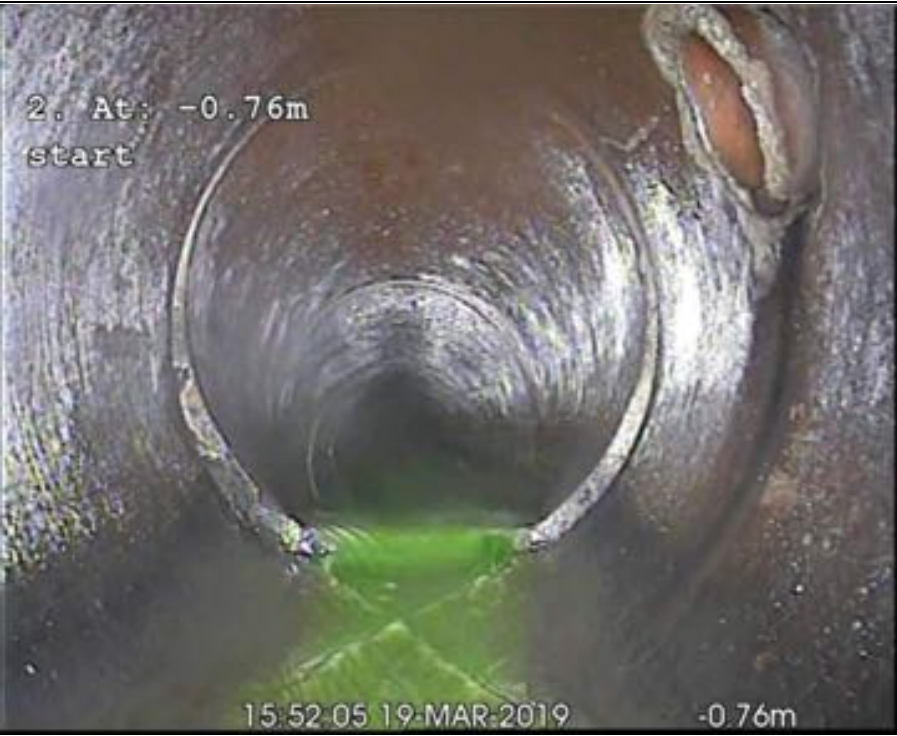
Description Start from MH04 at 0.00m Upstream to MH03 Junction at 2 o'clock Displaced joint

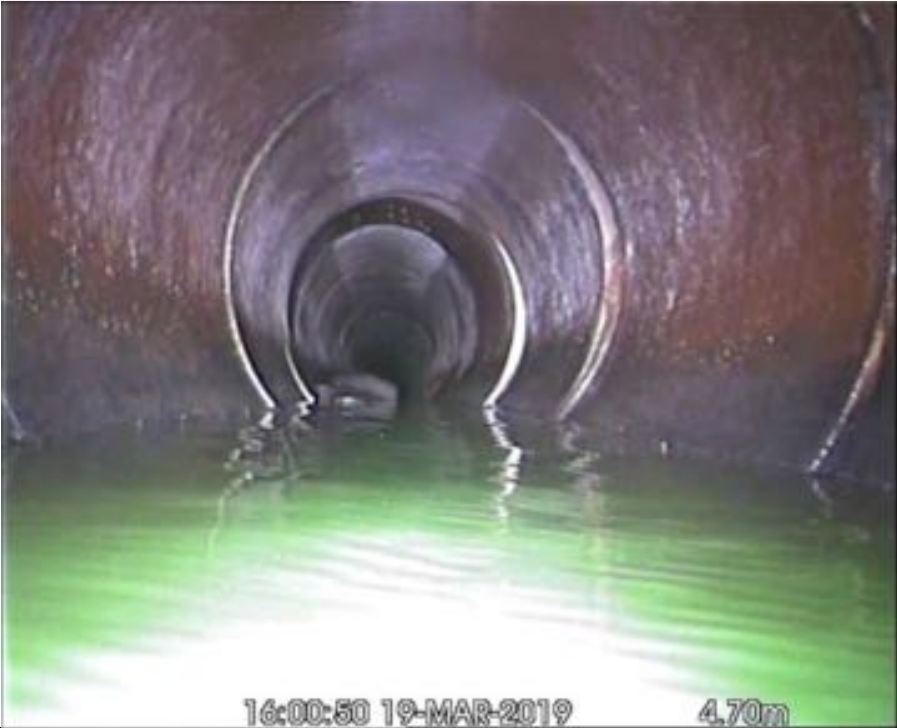
Description
				Bottom of pipe collapsed at 4.70m end Standing water 10% Obstruction visible

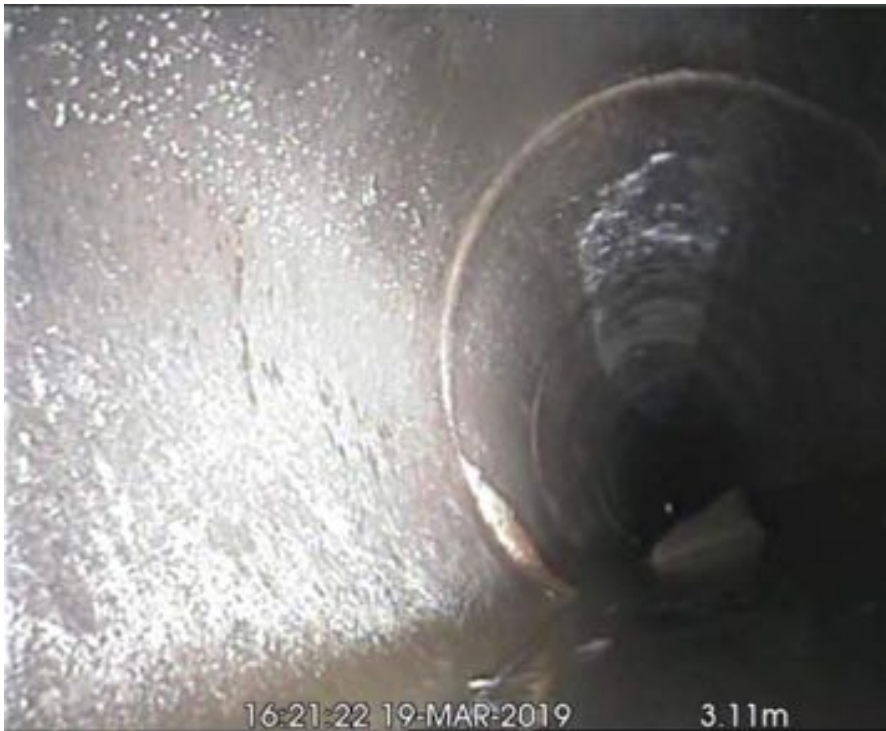
Description Unable to pass due to rocks in pipe but able to see light from outlet at the end of pipe at 3.11m
