Flood Risk Assessment & Drainage Strategy
Proposed Residential Development, Griffin Close, Frizington

Thomas Armstrong Construction and Home Group

Ref: K41128.FRA/001

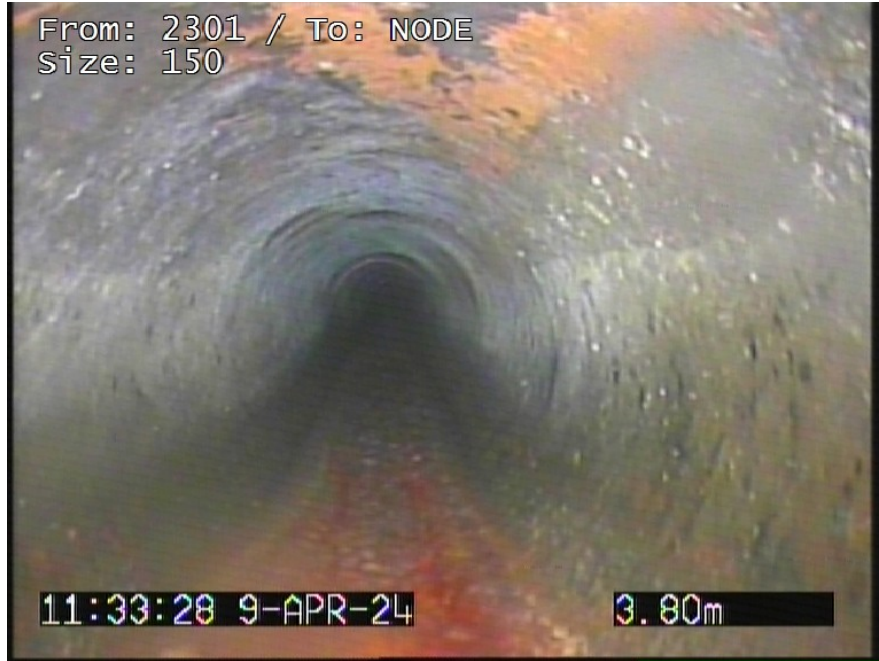
S1C5

00:00:59 - 3.80 m

Survey abandoned - Remark: CRAWLER UNABLE TO PASS JDM

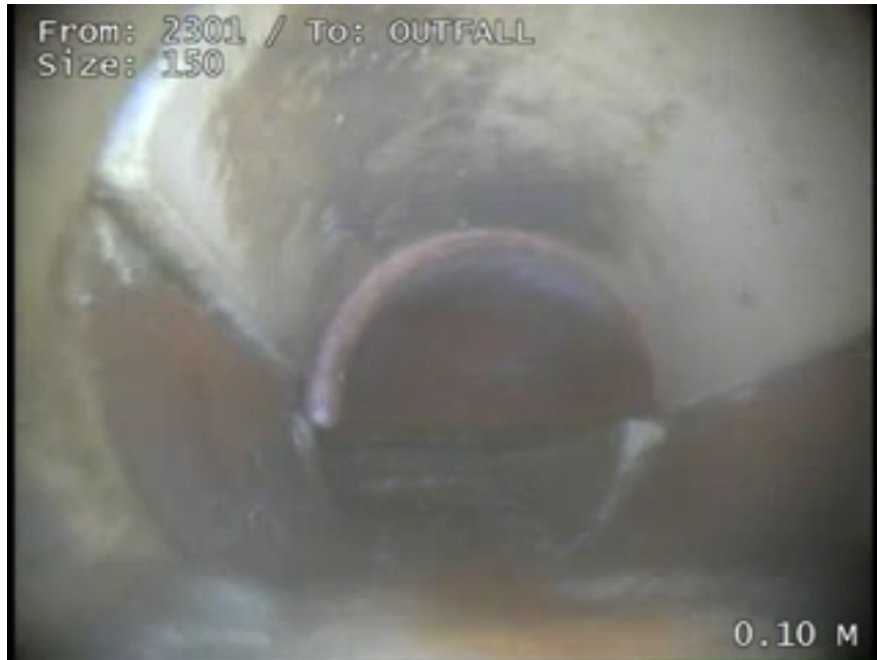
S3C3

Fracture longitudinal at 9 o'clock - Remark: Possibly been a manhole

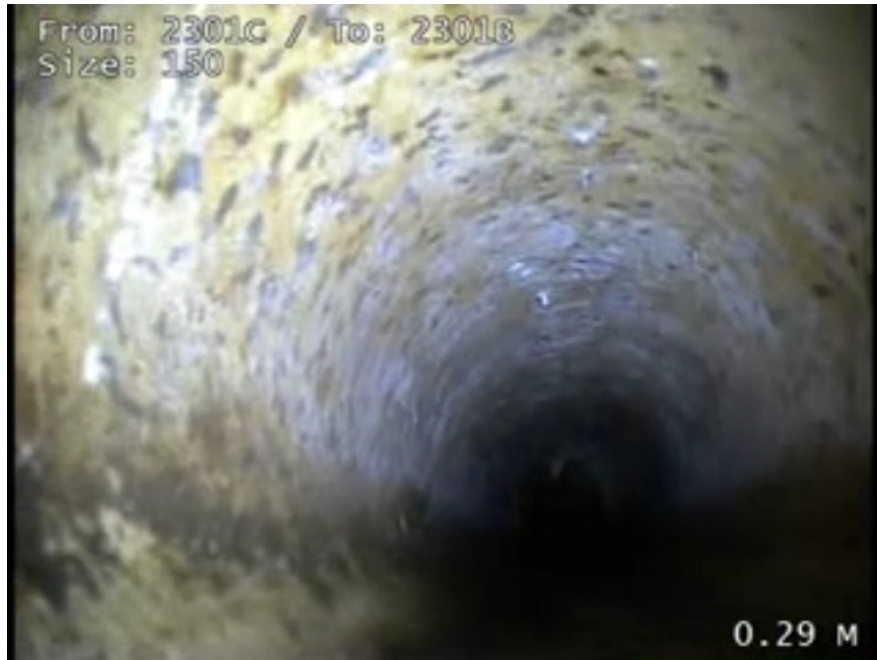
S4C3

Crack circumferential from 7 to 10 o'clock

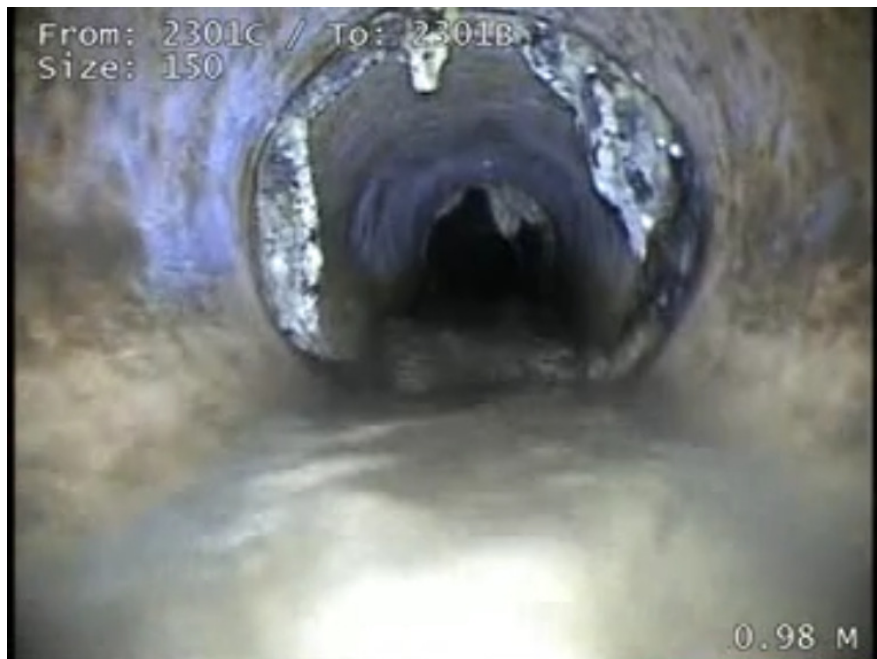
S4C4

Roots mass 10% cross-sectional area loss at joint

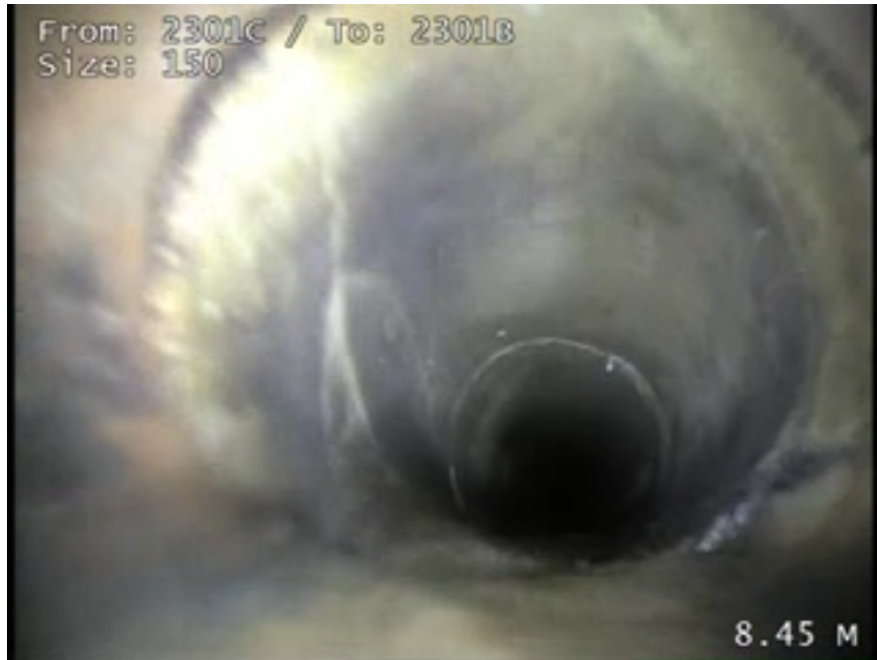
S4C7

00:00:45 - 8.45 m
Fracture multiple from 4 to 11 o'clock

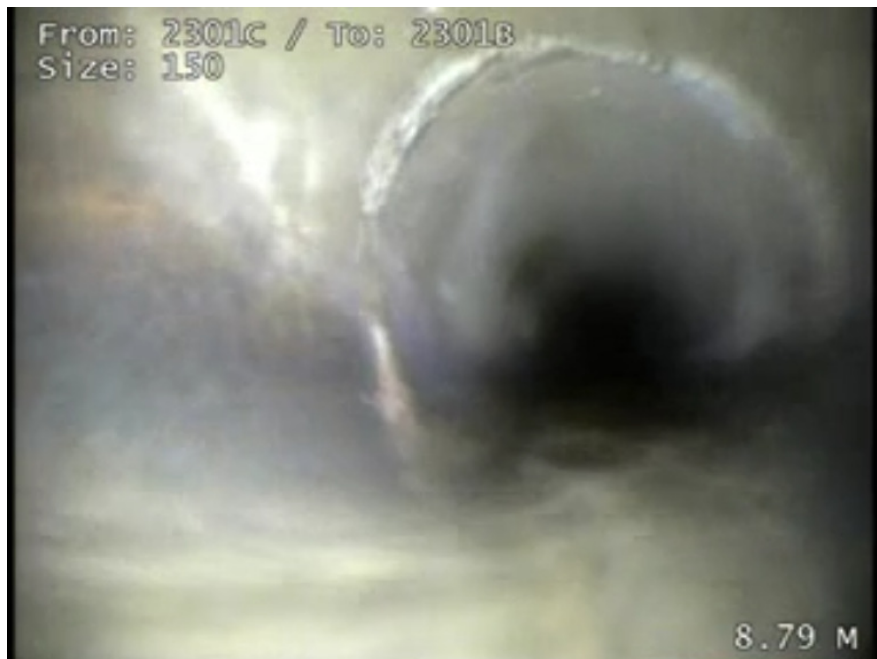
S4C8

00:00:46 - 8.79 m
Fracture longitudinal at 9 o'clock

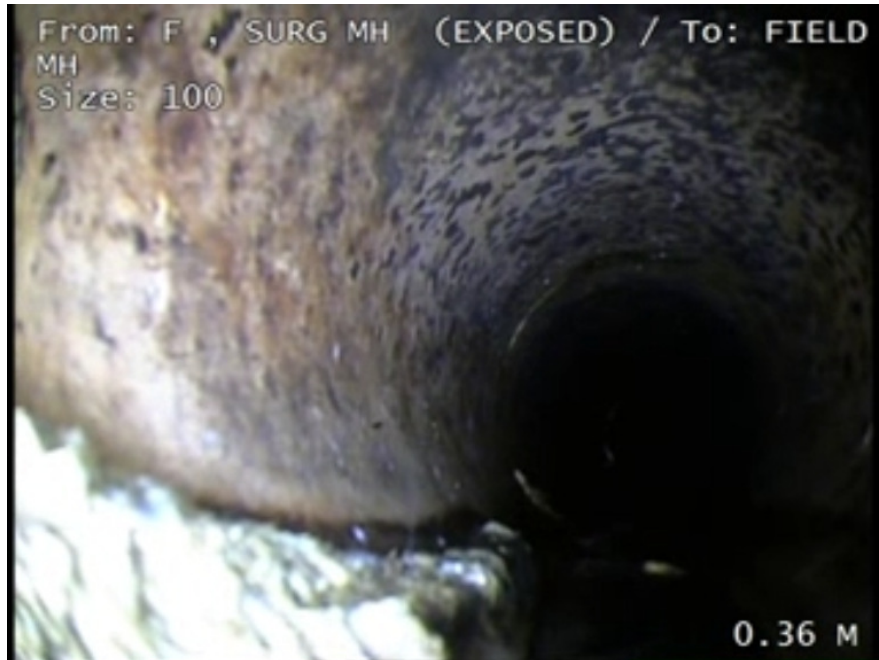
S8C3

Other attached deposits from 6 to 9 o'clock 5% cross-sectional area loss - Remark CONCRETE, Start

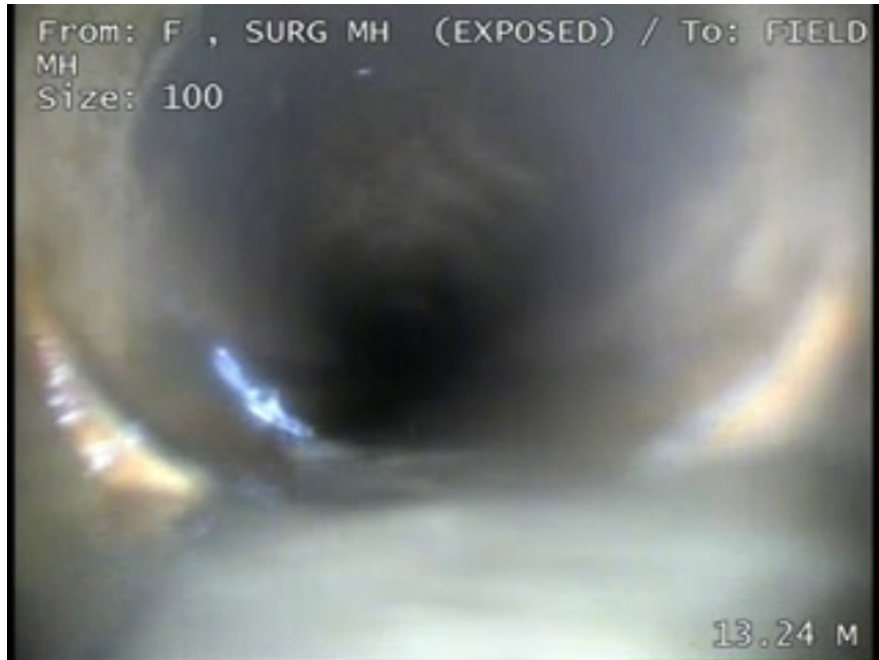
S8C7

00:02:22 - 13.24 m
Joint displaced 10mm

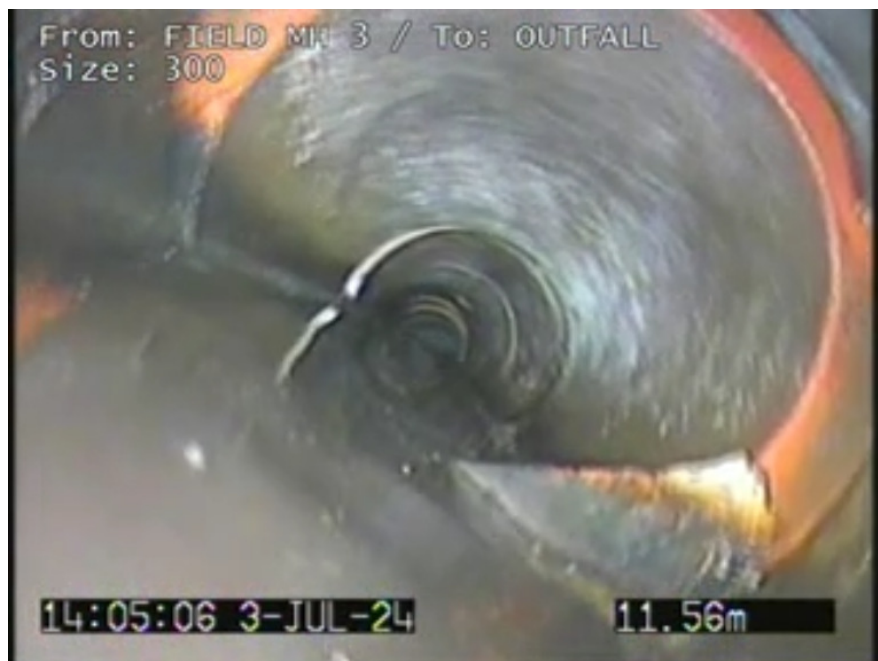
S13C4

00:00:55 - 11.56 m
Other obstacles protruding through wall at 4 o'clock 20% cross-sectional area loss at joint

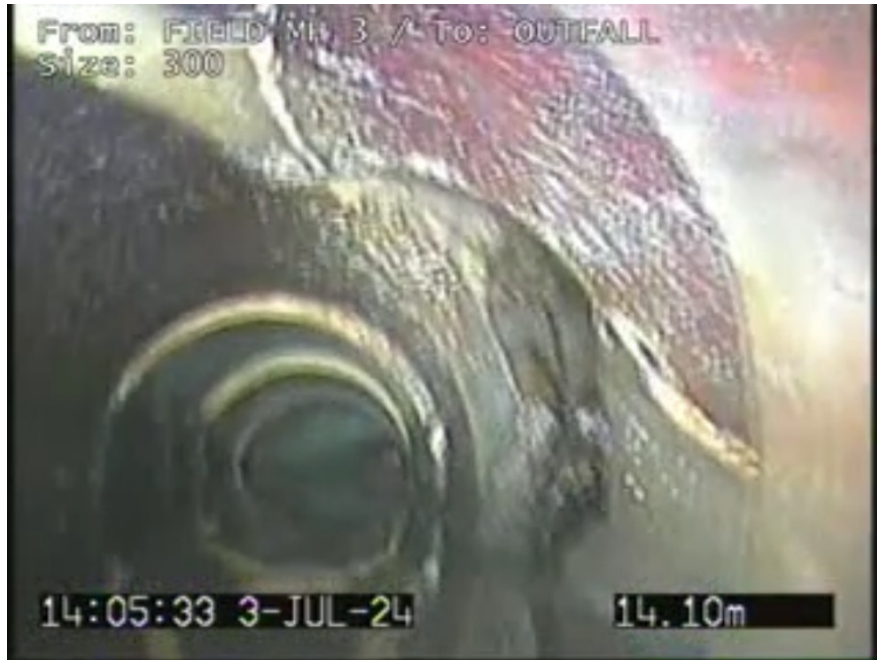
S13C5

Connection other than junction at 3 o'clock, diameter 150mm - Remark: FRACTURES AROUND THE CONNECTION

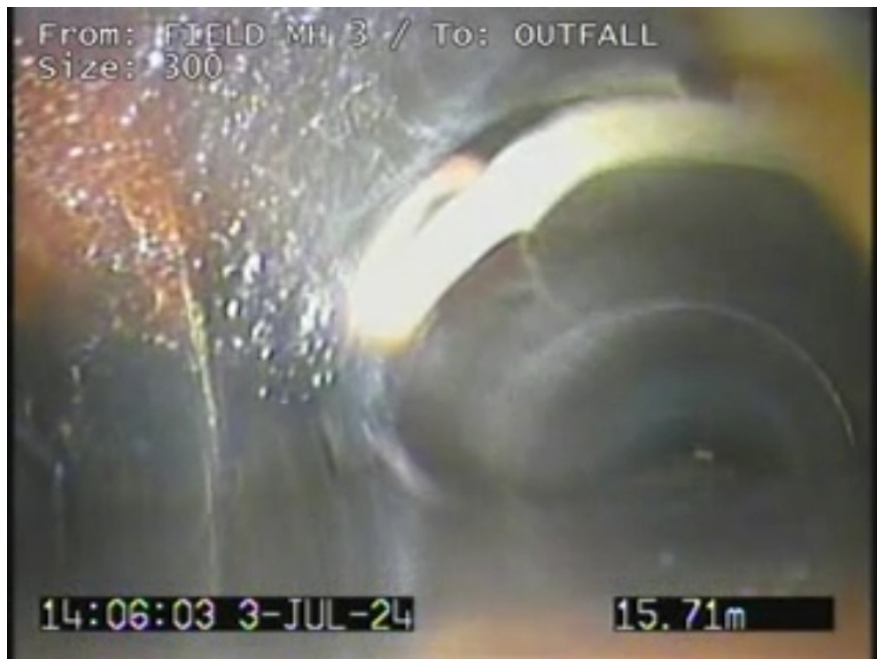
S13C6

Joint displaced 30mm

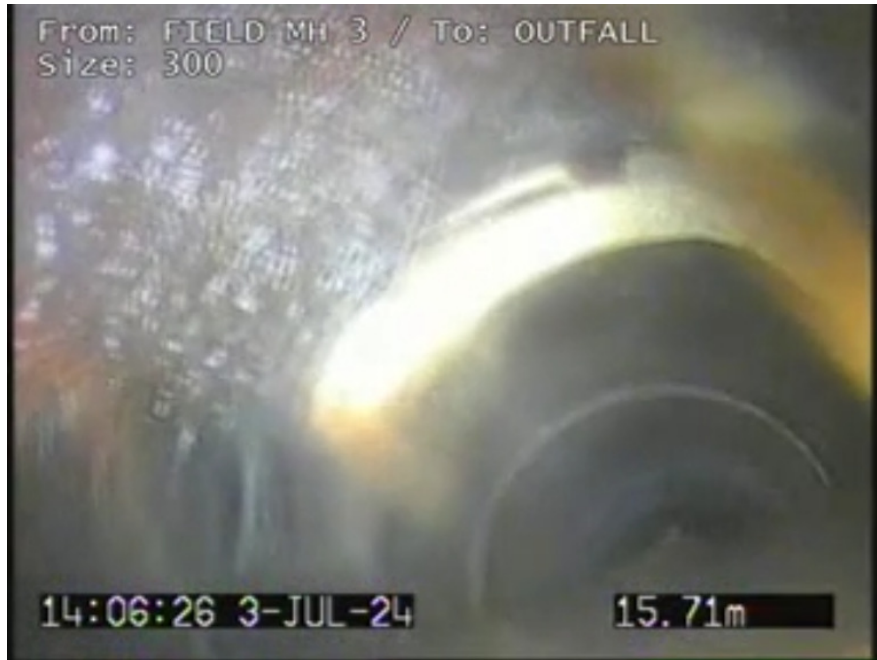
S13C7

Survey abandoned - Remark: UNABLE TO PROCEED DEBRIS AND DEFECT

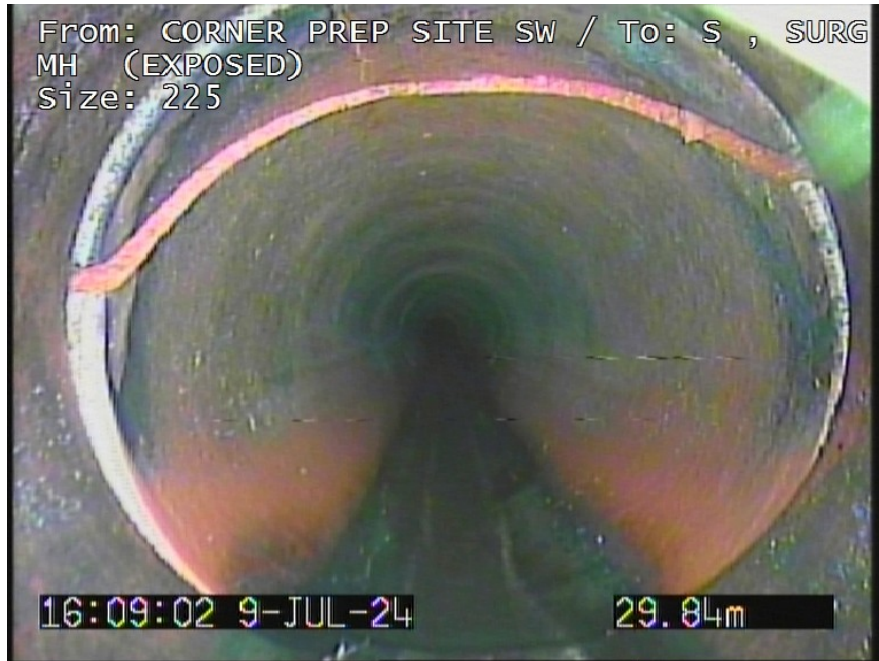
S16C3

00:02:33 - 29.84 m
Fracture multiple from 9 to 3 o'clock

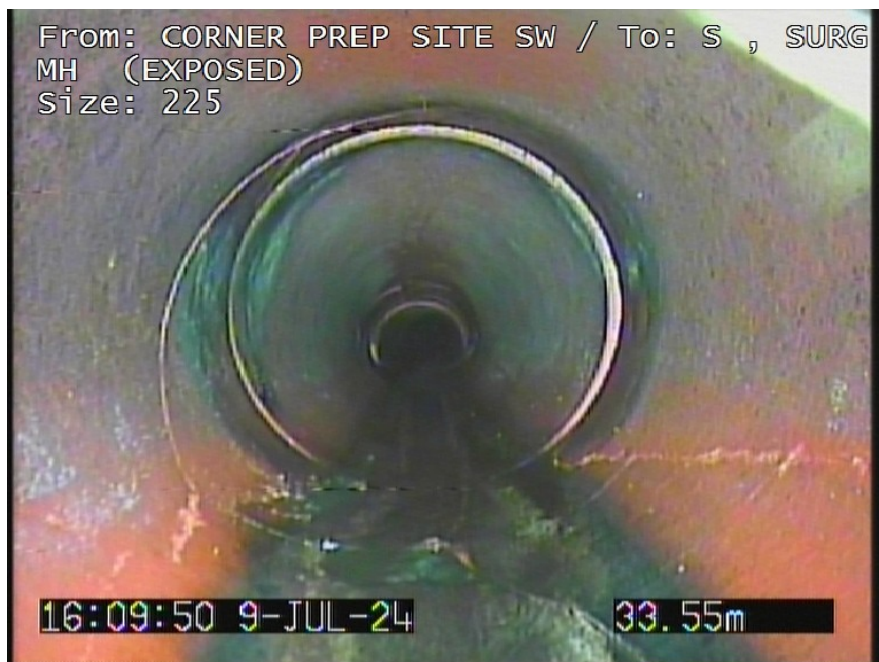
S16C4

00:02:57 - 33.54 m
Fracture multiple from 12 to 12 o'clock

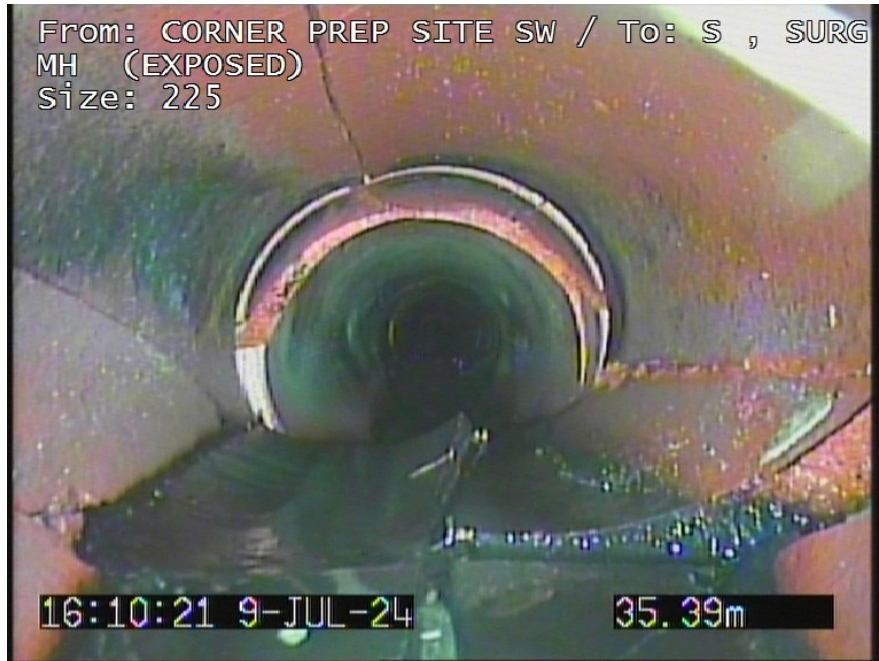
S16C5

The surface water outfall pipe was traced in the direction of the surgery where approximately 36m downstream the pipe was found to be fractured and in very poor condition preventing the passage of the crawler unit, the downstream connection point was not therefore able to be verified. In addition, access issues to potential connecting downstream manholes being located in third party land in an areas of dense vegetation prevented any further investigation.

00:03:11 - 35.39 m
Broken pipe from 12 to 12 o'clock

It is therefore considered most appropriate to replicate the original surface water drainage disposal arrangement utilising the existing surface water drainage pipework for conveyance off site. There is a small section of pipework near the surgery that will need to be repaired/replaced.

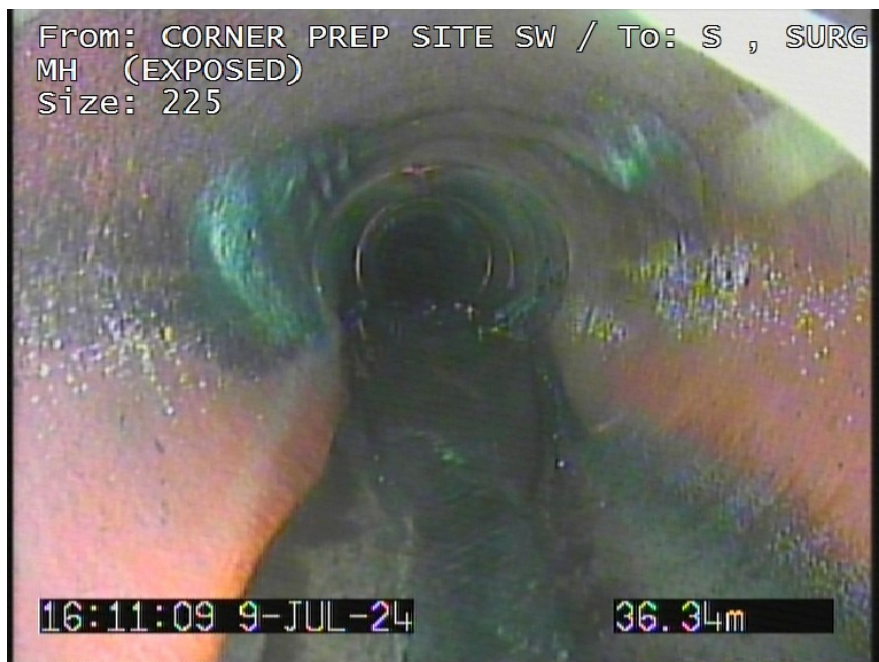
S16C6

00:03:32 - 36.34 m
Survey abandoned - Remark: APROX 5M FROM MH EXPOSED ON CORNER OF SURGERY SITE
