## Flood Risk Assessment & Drainage Strategy

Proposed Residential Development, Griffin Close, Frizington

Thomas Armstrong Construction and Home Group

Ref: K41128.FRA/001

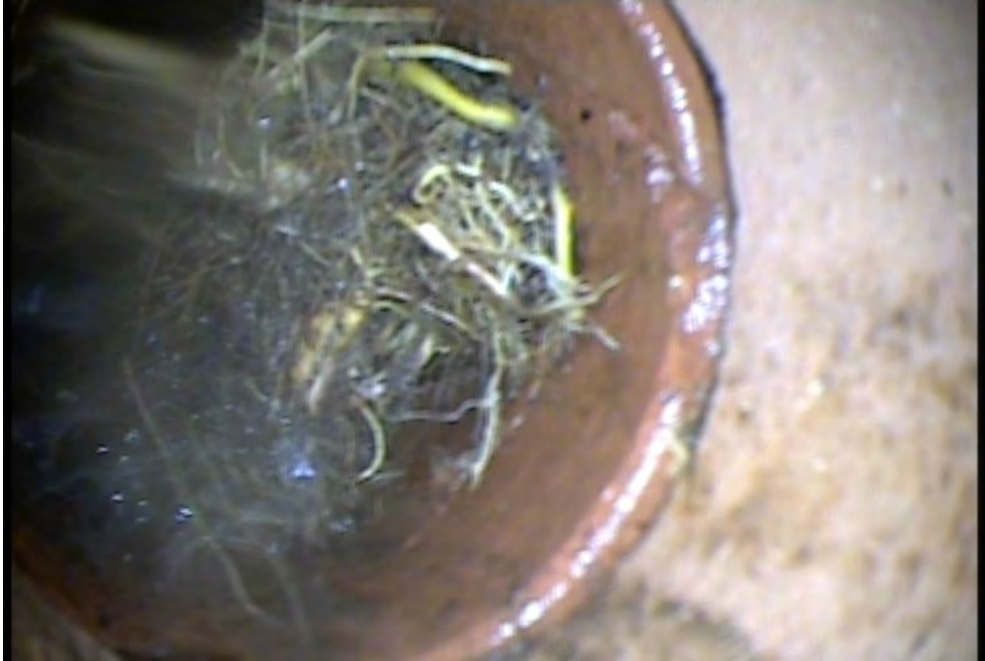
Other Site Photos

sw uncovered mh back up to surgery mh

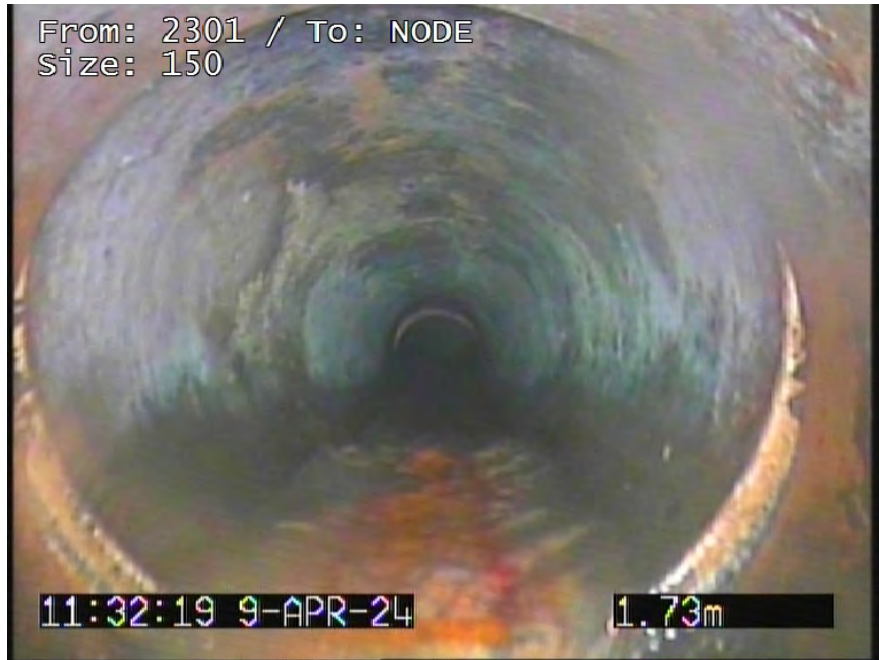
S1C3

00:00:20 - 1.72 m  
Joint displaced 15mm

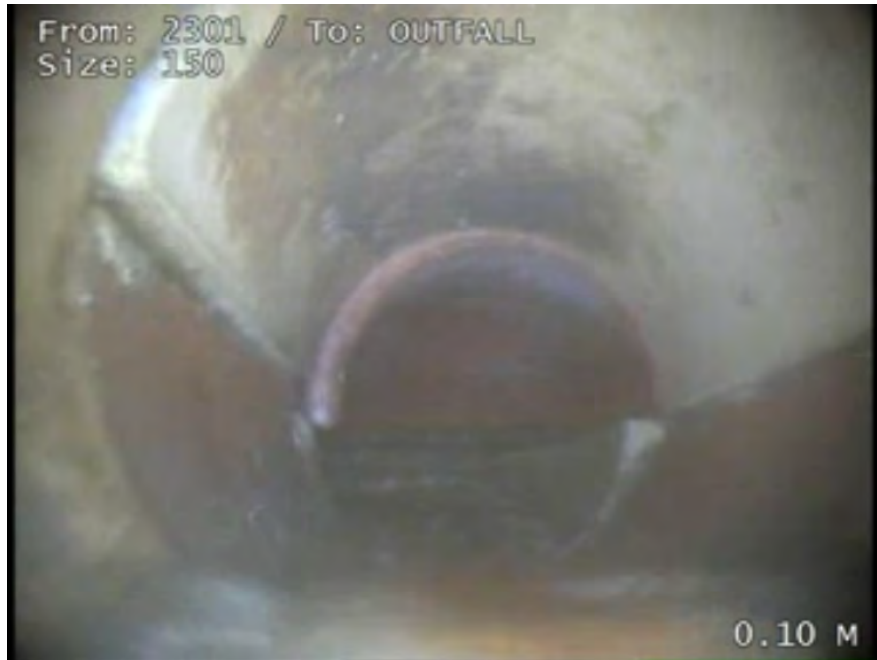
S3C3

00:00:14 - 0.10 m

Fracture longitudinal at 9 o'clock - Remark: Possibly been a manhole

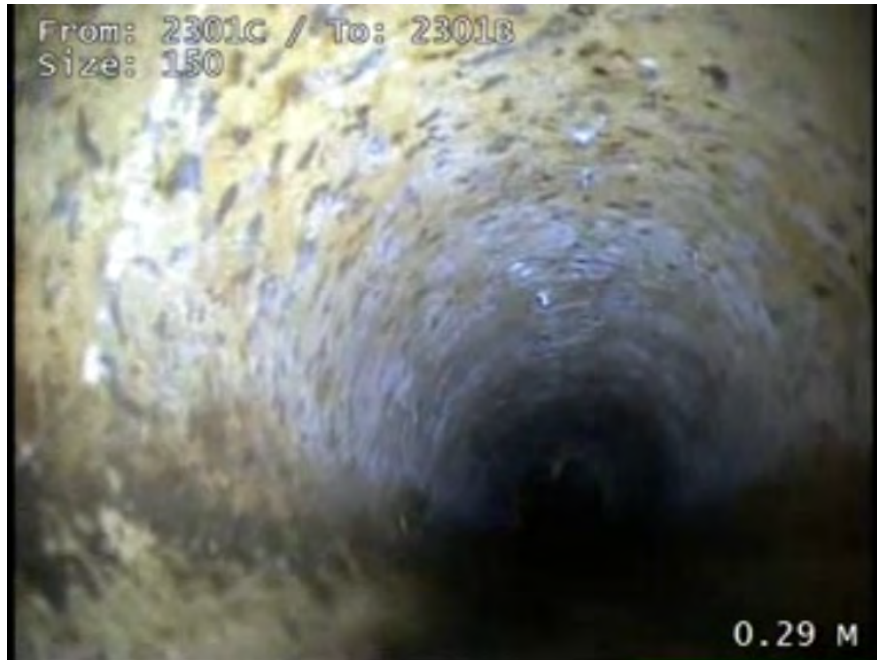
S4C3

00:00:05 - 0.29 m

Crack circumferential from 7 to 10 o'clock

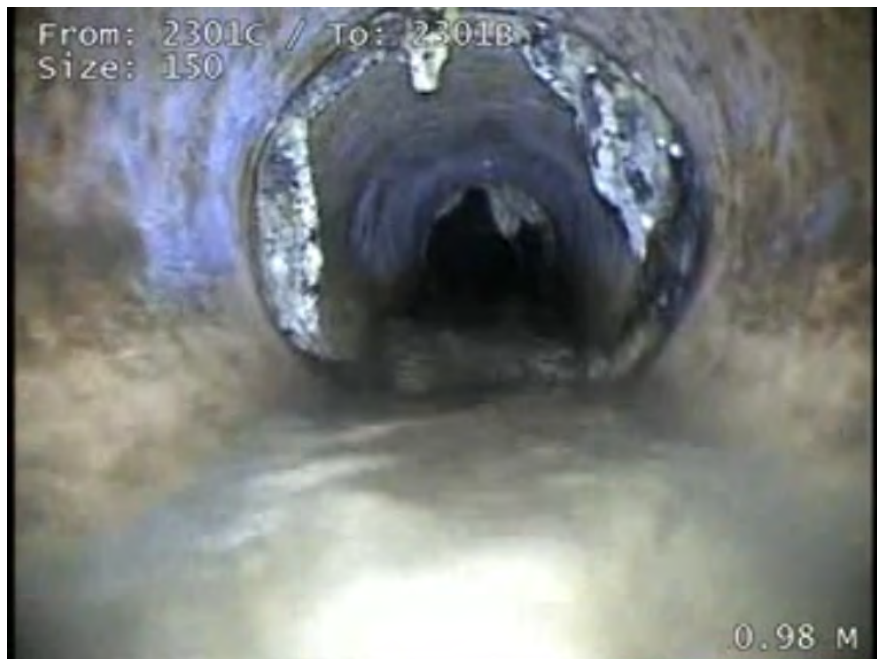
S4C4

00:00:09 - 0.98 m

Roots mass 10% cross-sectional area loss at joint

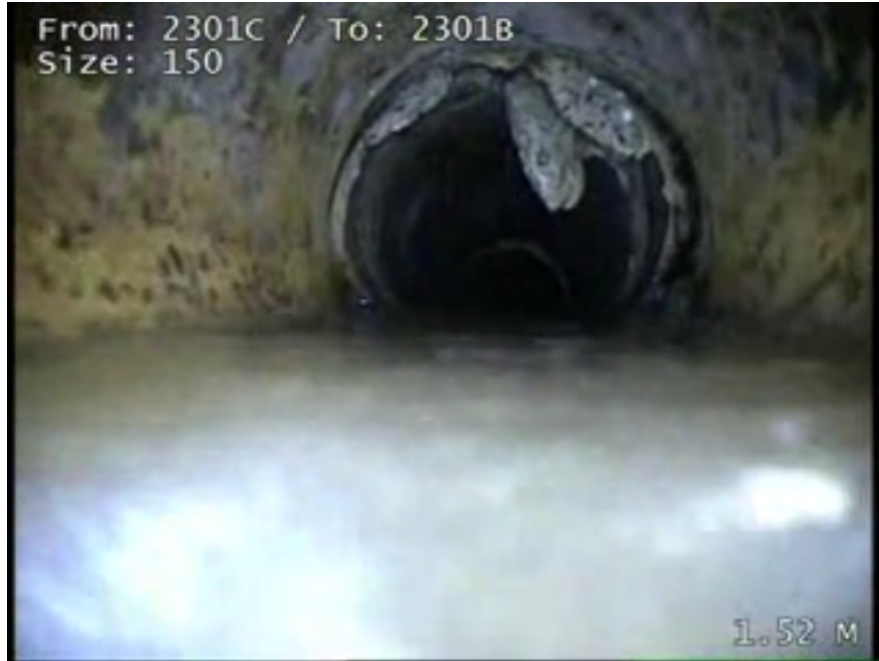
S4C5

00:00:12 - 1.52 m

Roots mass 15% cross-sectional area loss at joint

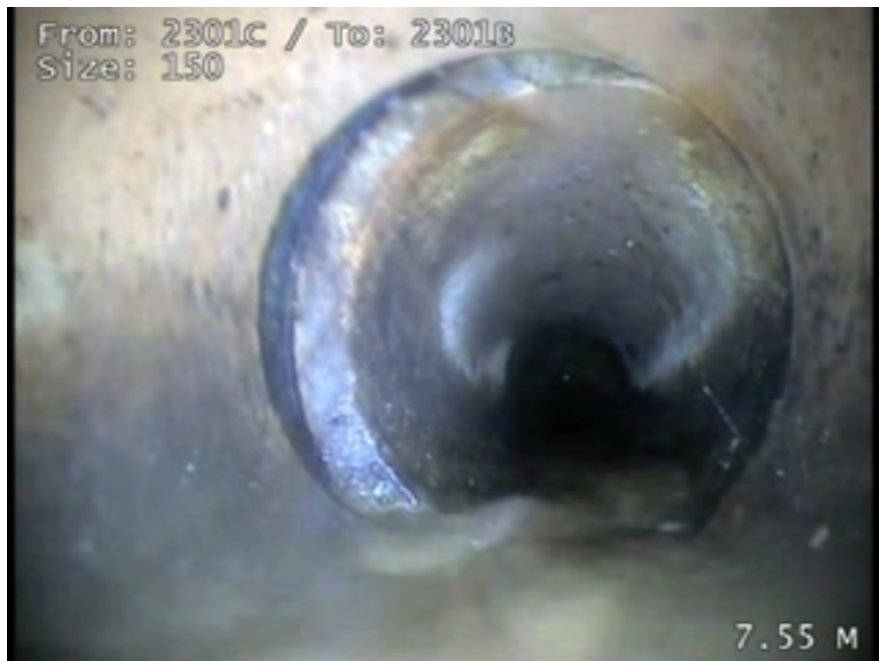
S4C6

00:00:40 - 7.55 m

Joint displaced 25mm

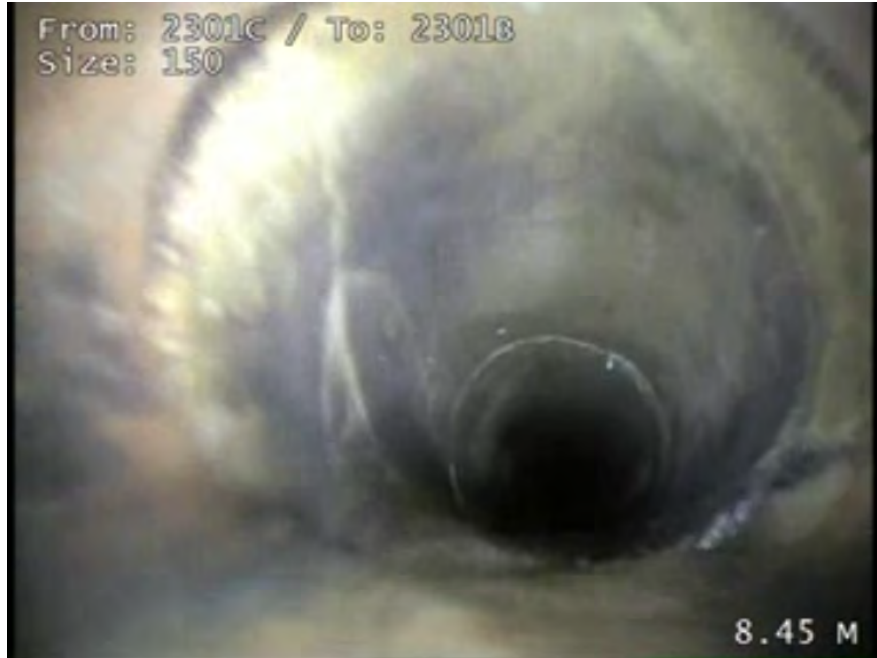
S4C7

00:00:45 - 8.45 m  
Fracture multiple from 4 to 11 o'clock

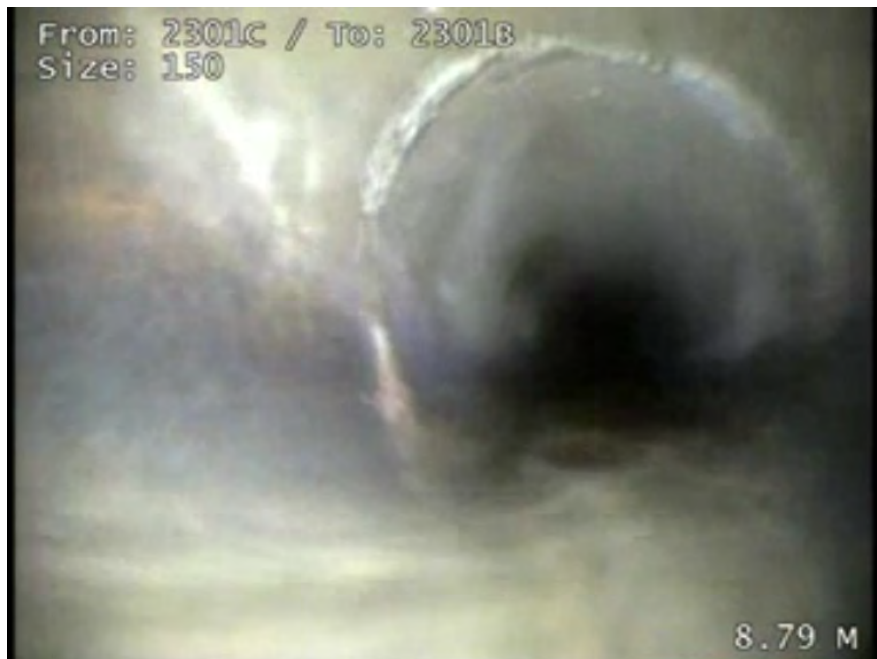
S4C8

00:00:46 - 8.79 m  
Fracture longitudinal at 9 o'clock

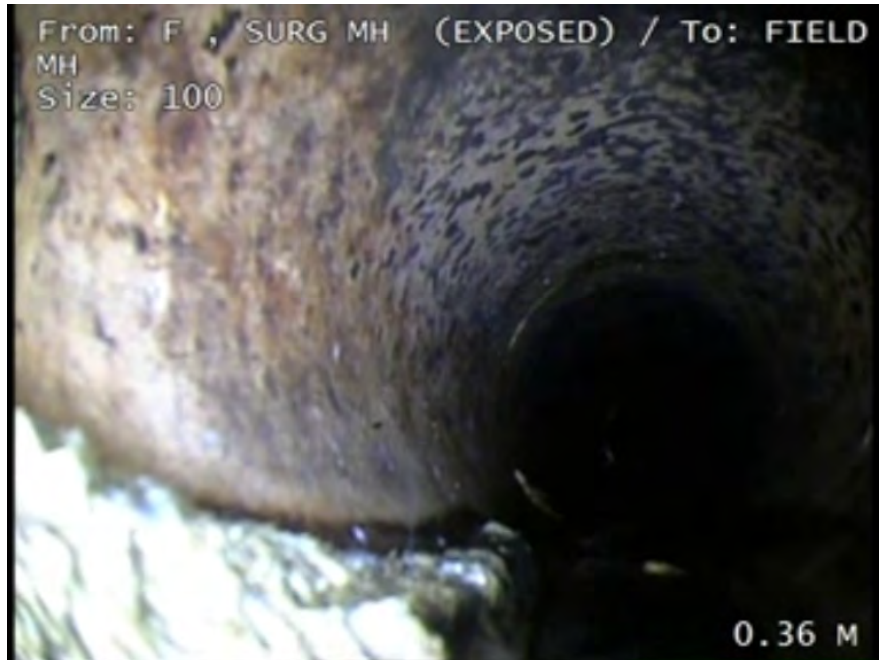
S8C3

00:00:05 - 0.36 m

Other attached deposits from 6 to 9 o'clock 5% cross-sectional area loss - Remark CONCRETE, Start

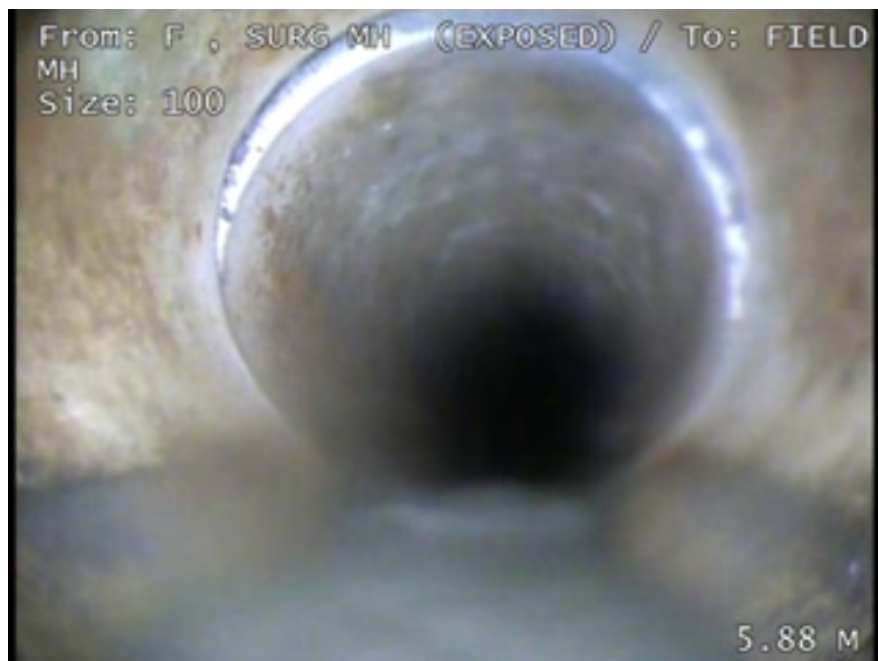
S8C6

00:01:32 - 5.88 m

Joint displaced 10mm

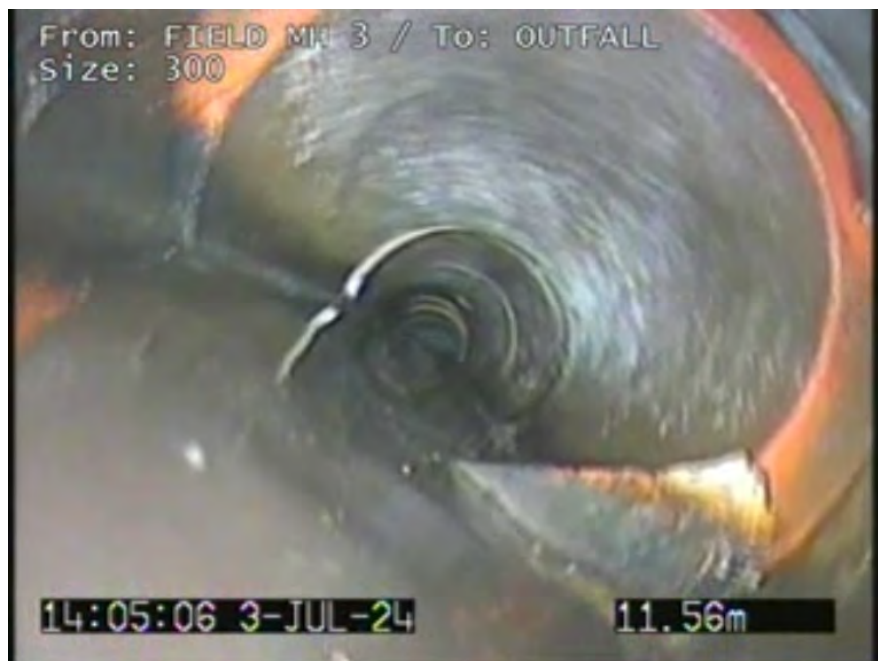
**S13C4**

00:00:55 - 11.56 m  
Other obstacles protruding through wall at 4 o'clock 20% cross-sectional area loss at joint

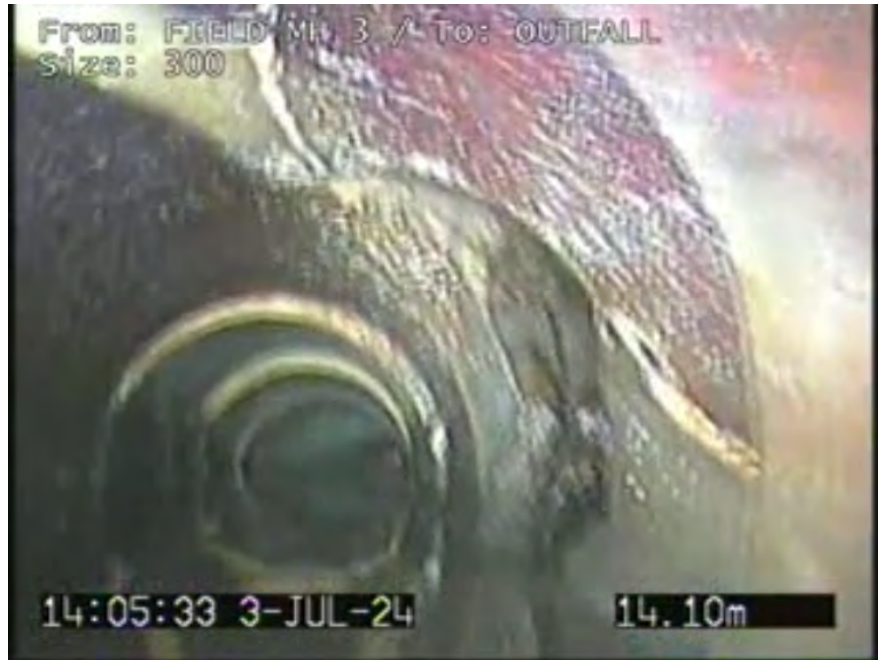
S13C5

00:01:22 - 14.10 m

Connection other than junction at 3 o'clock, diameter 150mm - Remark: FRACTURES AROUND THE CONNECTION

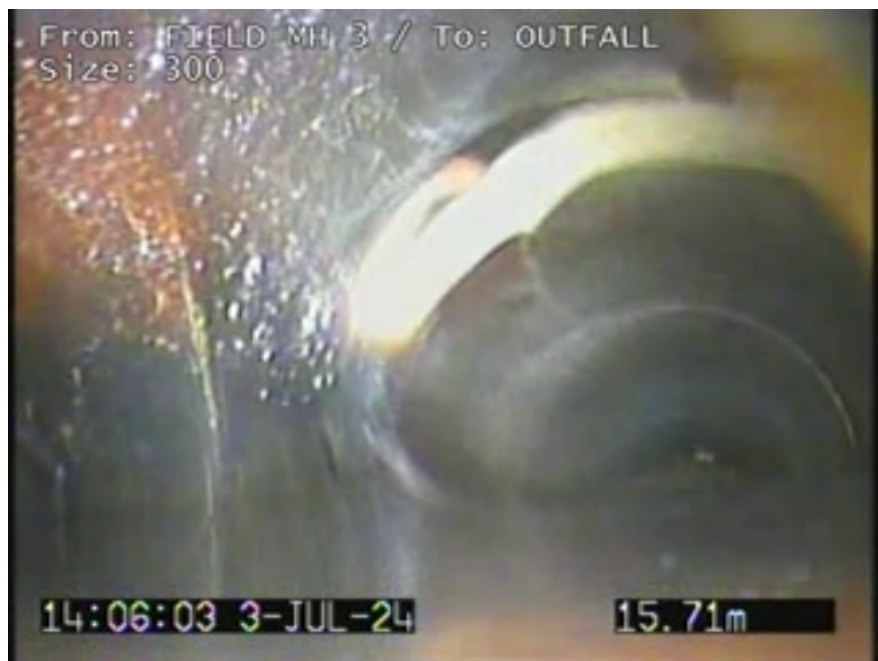
S13C6

00:01:52 - 15.71 m

Joint displaced 30mm

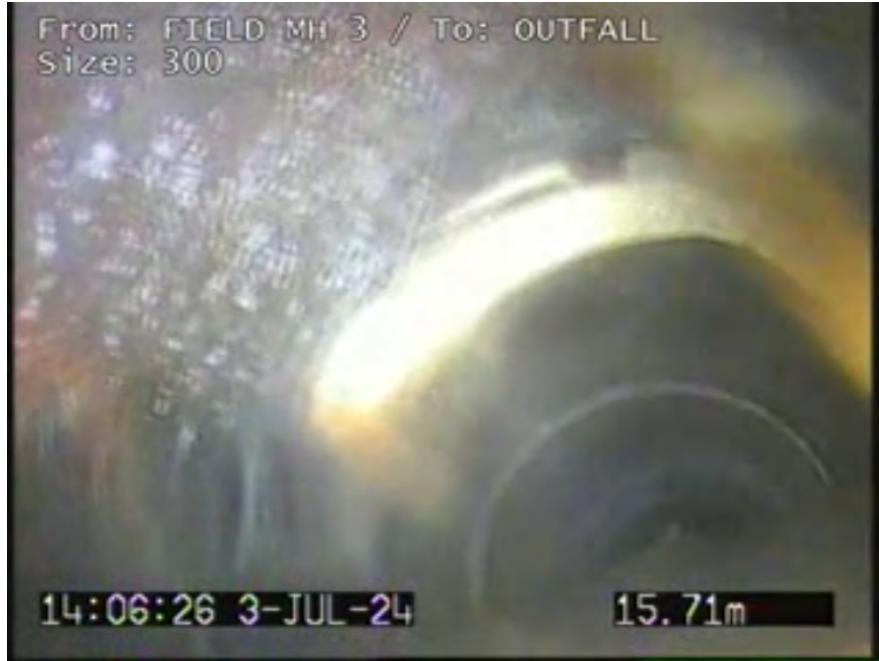
S13C7

00:02:15 - 15.71 m

Survey abandoned - Remark: UNABLE TO PROCEED DEBRIS AND DEFECT

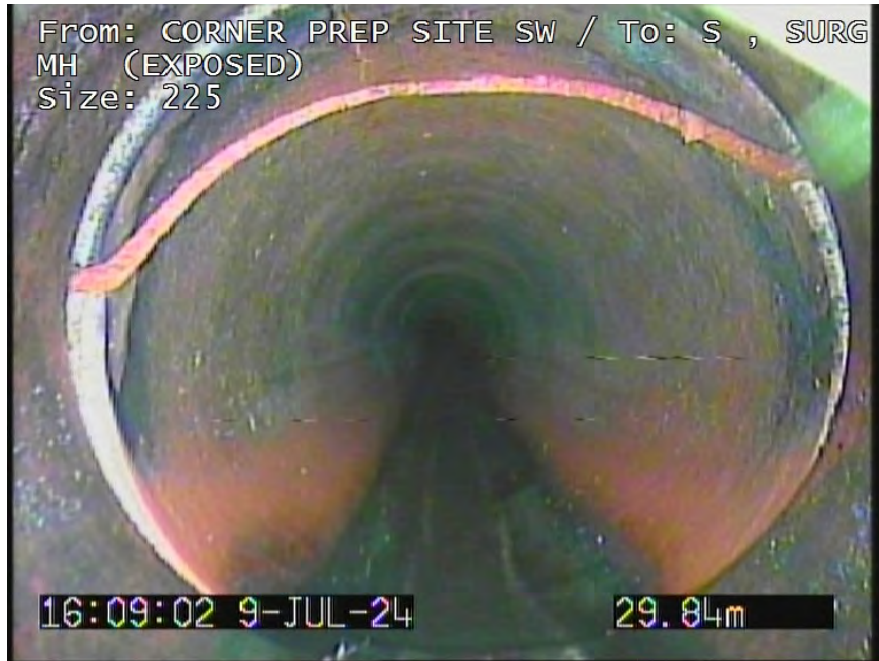
S16C3

00:02:33 - 29.84 m  
Fracture multiple from 9 to 3 o'clock

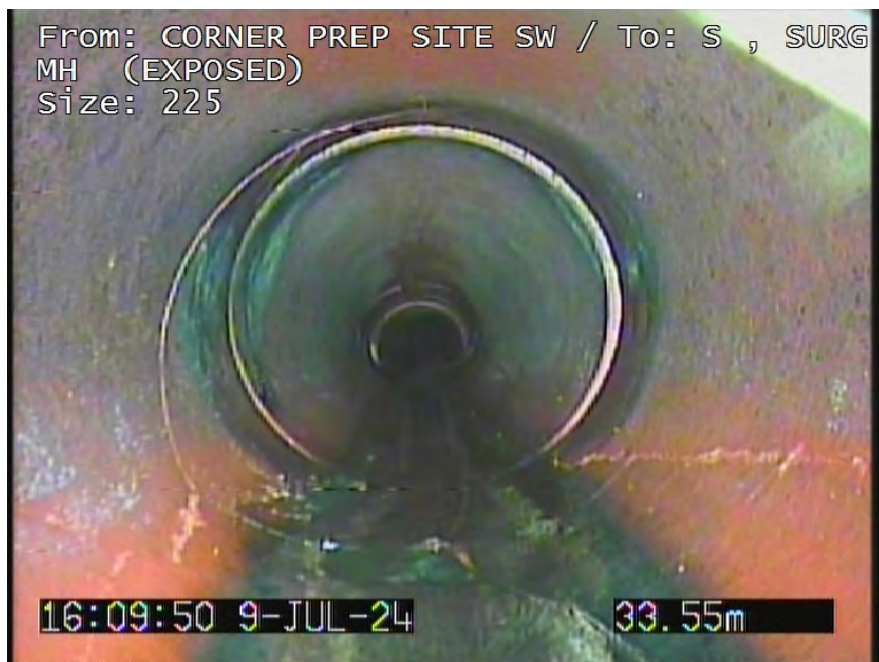
S16C4

00:02:57 - 33.54 m  
Fracture multiple from 12 to 12 o'clock

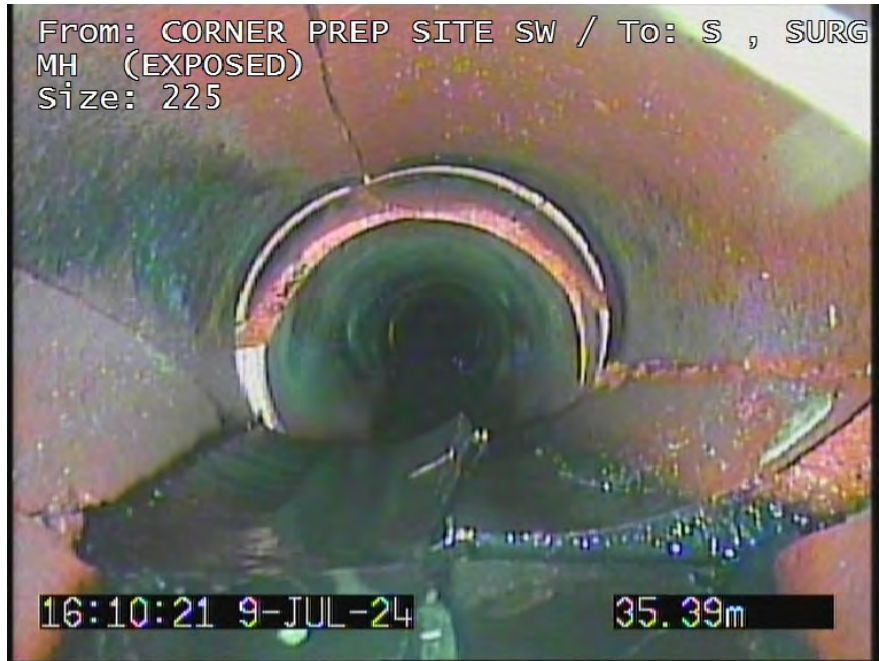
S16C5

The surface water outfall pipe was traced in the direction of the surgery where approximately 36m downstream the pipe was found to be fractured and in very poor condition preventing the passage of the crawler unit, the downstream connection point was not therefore able to be verified. In addition, access issues to potential connecting downstream manholes being located in third party land in an areas of dense vegetation prevented any further investigation.

00:03:11 - 35.39 m  
Broken pipe from 12 to 12 o'clock

It is therefore considered most appropriate to replicate the original surface water drainage disposal arrangement utilising the existing surface water drainage pipework for conveyance off site. There is a small section of pipework near the surgery that will need to be repaired/replaced.

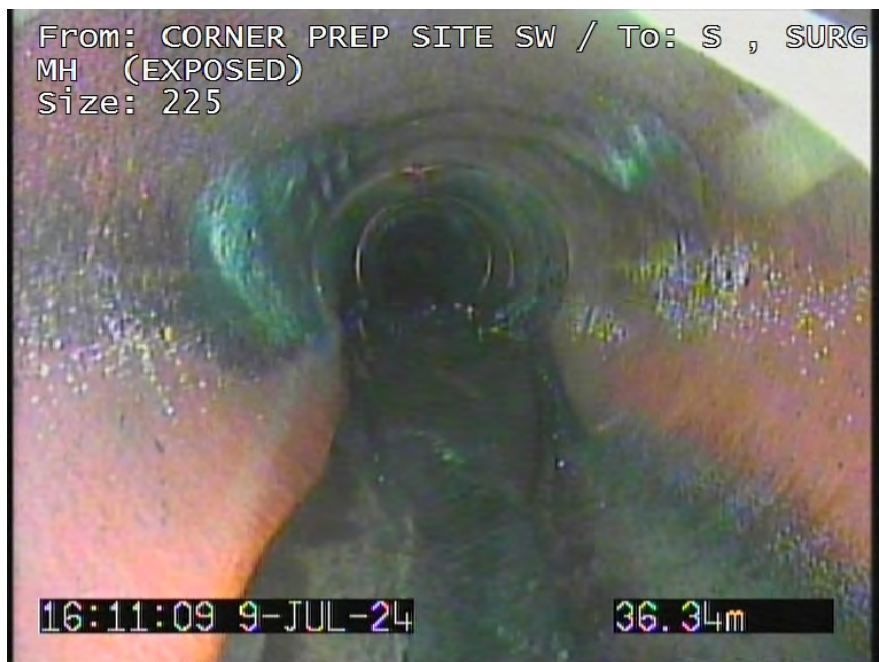
S16C6

00:03:32 - 36.34 m  
Survey abandoned - Remark: APROX 5M FROM MH EXPOSED ON CORNER OF SURGERY SITE
