**Kirkland Road, Ennerdale Bridge
Proposed Residential Development**

Combined Stage 1 and 2 Road Safety Audit

Report No. A103748/RSA1-2

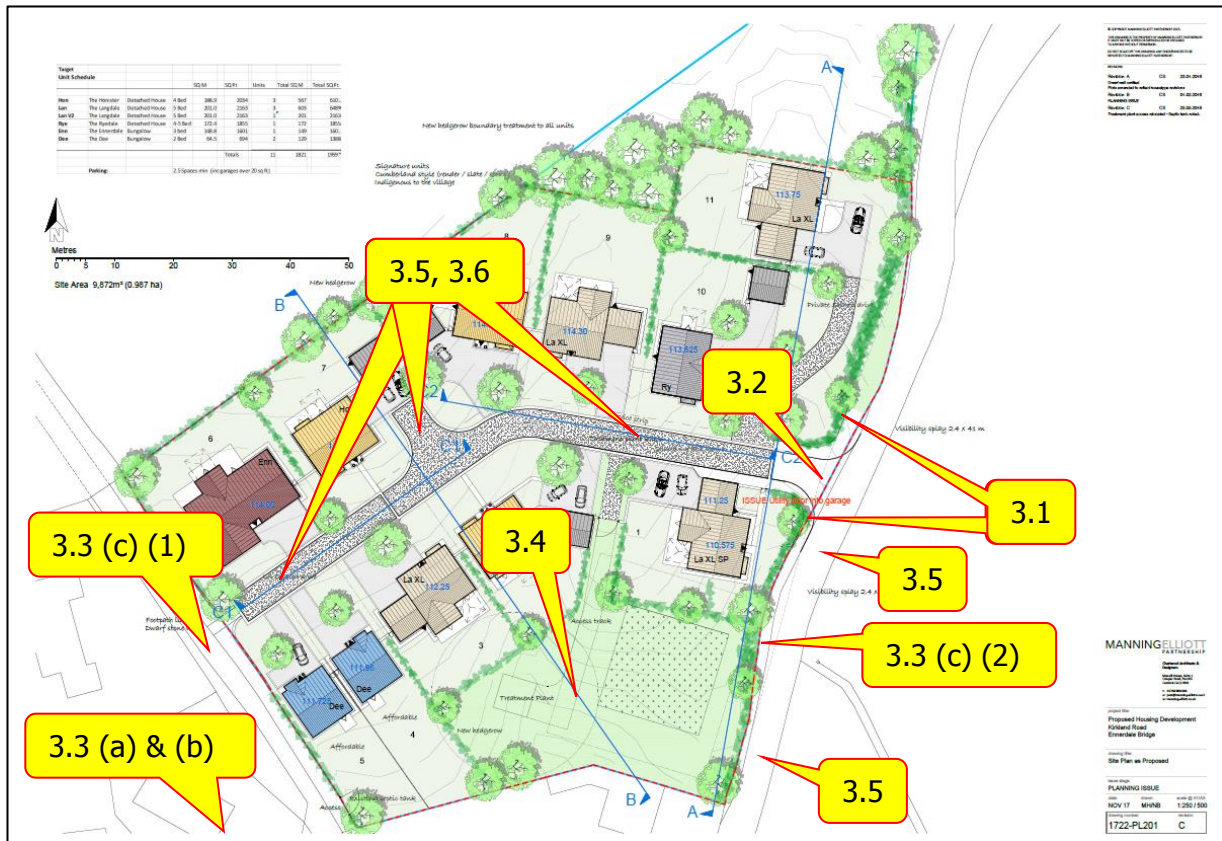
6. LOCATION PLAN OF ITEMS RAISED BY THIS AUDIT

Location: The junction of the development access road with Kirkland Road.

Summary: The existing roadside features could compromise mutual visibility at the junction.

There are high and deep hedges along the development site boundary that lie close to the lines of the visibility splays, particularly the splay to the north of the junction. The hedges are not specified for removal or relocation and if left in place could compromise mutual visibility between motorists on Kirkland Road and those on the access road, increasing the risk of turning collisions.

Summary: The absence of road markings could increase the risk of a number of collision types.

There are no centreline or give way markings shown on the approach to the junction. If these are not provided, motorists turning into the development access road might be led to believe that they are entering a one-way street, increasing the risk of collisions with opposing vehicles or with pedestrians on their offside. Motorists leaving the development might fail to give way correctly with the attendant risk of overshoot or restart type collisions.

Location: The pedestrian routes between the development and the village footways.

Summary: The absence of footways could increase the risk of collisions.

Pedestrians travelling between the development and the village will have a choice of using the link to the lane between Plots 5 and 6 or Kirkland Road itself. Both choices will result in them crossing the bridge over Croasdale Beck to reach the existing footway on the east side of Kirkland Road.

Location: The access track to the Treatment Plant.

Summary: The absence of a turning area could increase the risk of collisions.

The arrangements for maintenance vehicles to turn at the end of the access track are not clear. If turning facilities are not present, the maintenance operative could be forced to reverse onto the shared surface road with the attendant risk of collisions with street furniture, pedestrians or other vehicles.

Location: Kirkland Road and the shared surface roads within the development.

Summary: The absence of street lighting could result in pedestrians tripping or slipping and being struck by vehicles.

Street lighting has not been shown on the drawings submitted for audit. If lighting is not provided within the development, there will be an increased risk of pedestrian trips and slips. In addition, because there will be some pedestrian movements along Kirkland Road between the development and the village, the likelihood of collisions with vehicles will increase in the absence of lighting.

Location: The shared surface roads within the development.

Summary: The absence of drainage could result in pedestrians slipping and falling.

Drainage has not been shown on the drawings submitted for audit and it is not clear if it is to be provided in the form of gullies. If drainage is not provided within the development, there will be an increased risk of ponding and of pedestrian slips and falls, particularly in freezing conditions.

It is recommended that the drawings specify the hedges for removal or relocation where they lie close to the lines of the splays, taking into account the potential for growth.

It is recommended that centreline, edge of carriageway and give way markings to Diagrams 1004, 1009A and 1003A respectively are installed at the junction.

- a) a section of footway is installed on one side of the bridge with a crossing point between the east and west sides of Kirkland Road (the position of which will depend on which side of the bridge the footway is located);

- b) to address the reduced carriageway width, a vehicle priority system is installed over the bridge in line with that in place on the River Ehen bridge to the south;

- c) either, or both of the following are provided -
 - 1) the lane along the south-western boundary of the site, between Kirkland Road and the link into the site, is surfaced to a standard suitable for pedestrian use and/or

- 2) a footway is installed on the west side of Kirkland Road between the development access road junction and the bridge. If this recommendation is taken up, ensure that the remaining carriageway width is sufficient for two-way traffic (this could involve building the footway either fully or partially outside the existing carriageway).

It is recommended that a turning area is provided at the end of the access track.

- a) an appropriate system of lighting is specified for the development and
- b) the existing system of lighting on Kirkland Road is extended northwards to the junction with the development access road.

It is recommended that an appropriate system of drainage is provided for the development.
