**PRELIMINARY ENVIRONMENTAL RISK ASSESSMENT
FOR
LAND ADJACENT TO KIRKLAND ROAD
ENNERDALE BRIDGE**

Appendix 3 – Photographs

**Project No: EES17-099
16th January 2018**

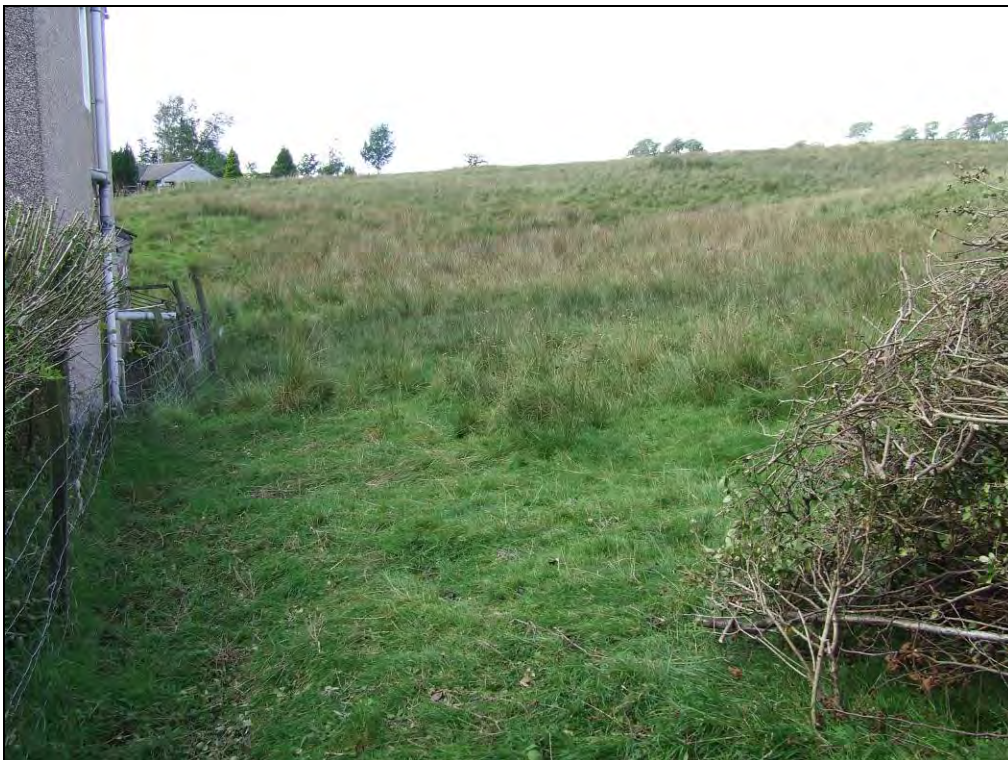
Photo 4: Perimeter – View along eastern part of the southern site boundary with adjoining residential dwelling, looking west from the south eastern corner of the site and showing garden hedge clippings (right)

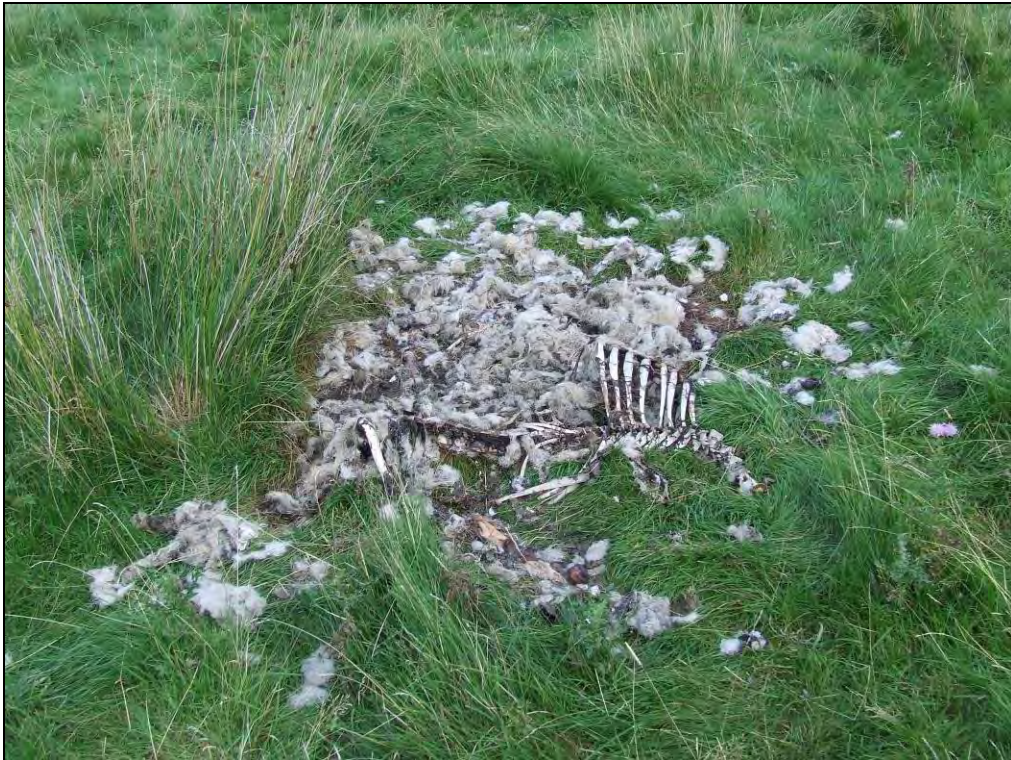
Photo 11: Site Interior – Remains of sheep carcass within the eastern part of the site

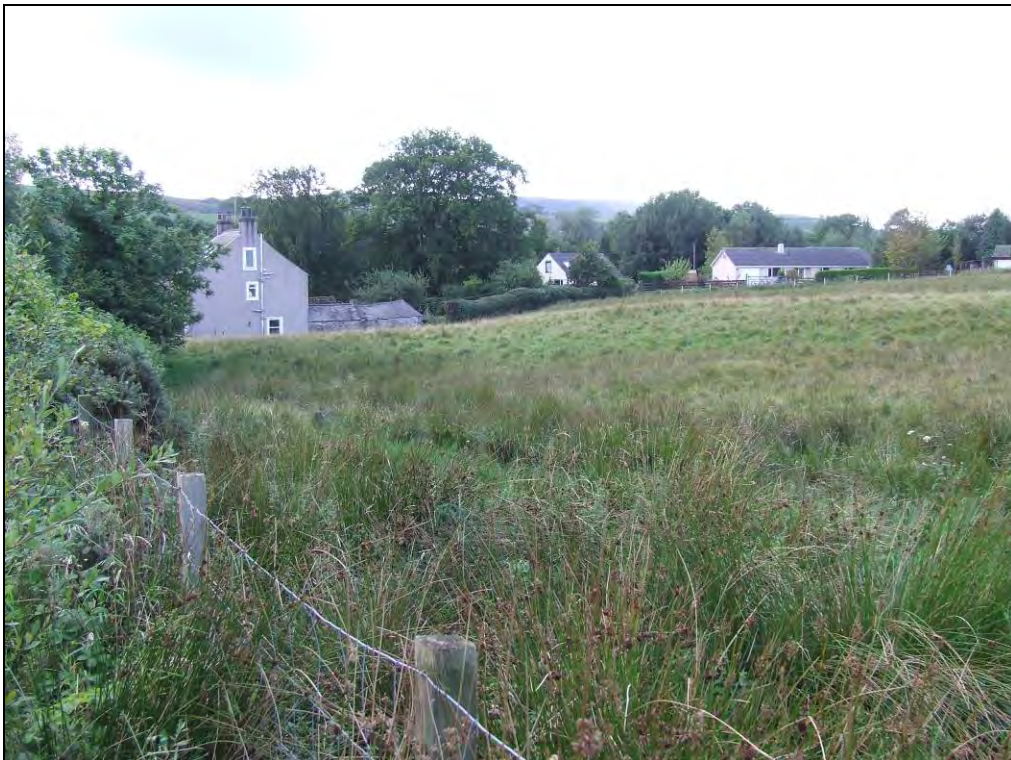
Photo 12: Site Interior – Low lying area of wet ground dominated by rushy grass on the eastern side of the site, as observed from eastern boundary fence

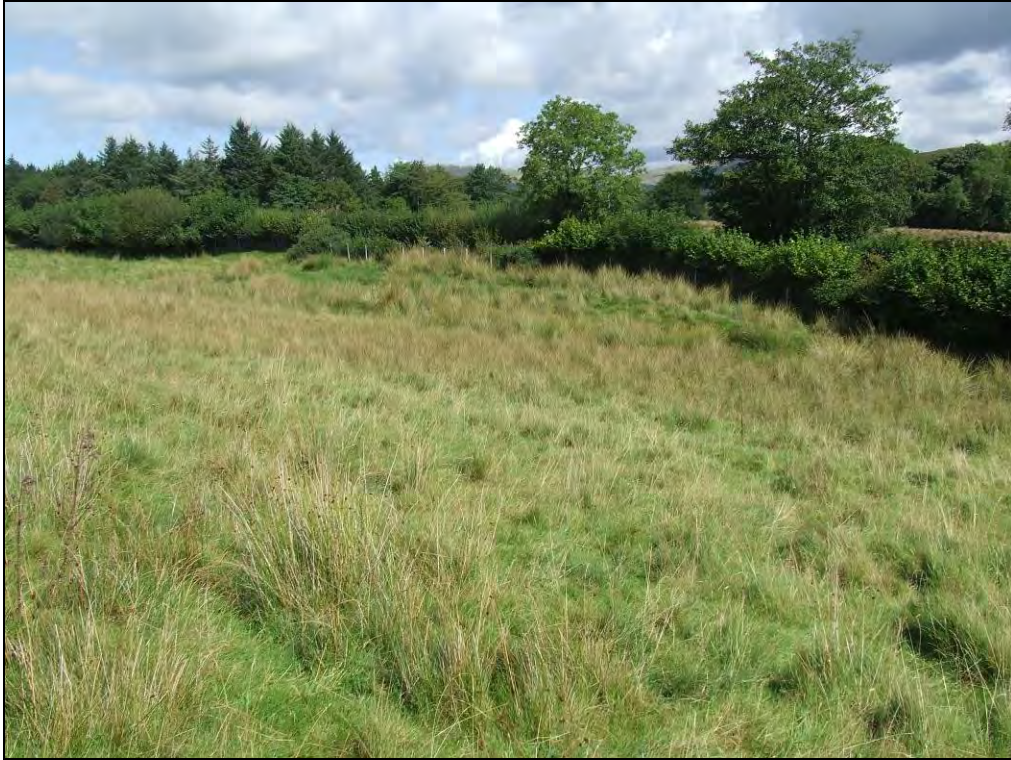
Photo 13: Site Interior – Low lying area of wet ground in the eastern part of the site, looking north east towards the eastern site boundary

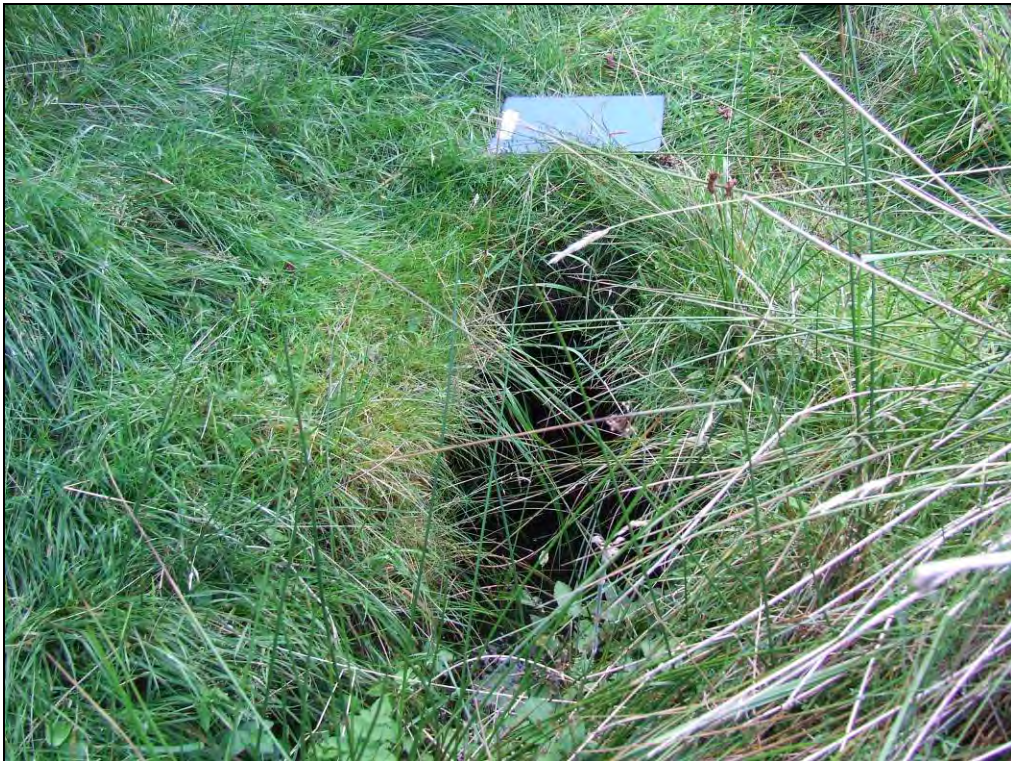
Photo 14: Site Interior – Small issue of water from the low lying area of land and near the eastern site boundary. The stream is believed to flow into the culvert extending beneath Kirkland Road

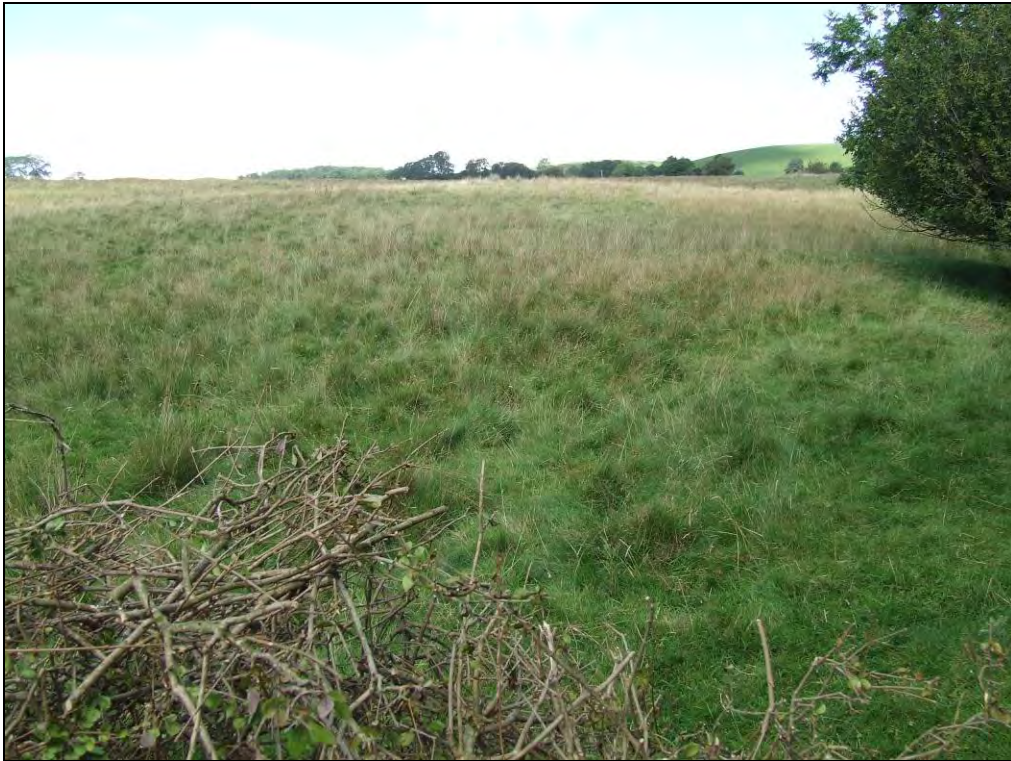
Photo 15: Site Interior – View across the site looking north from within the south eastern corner, showing hedge clippings from adjoining garden

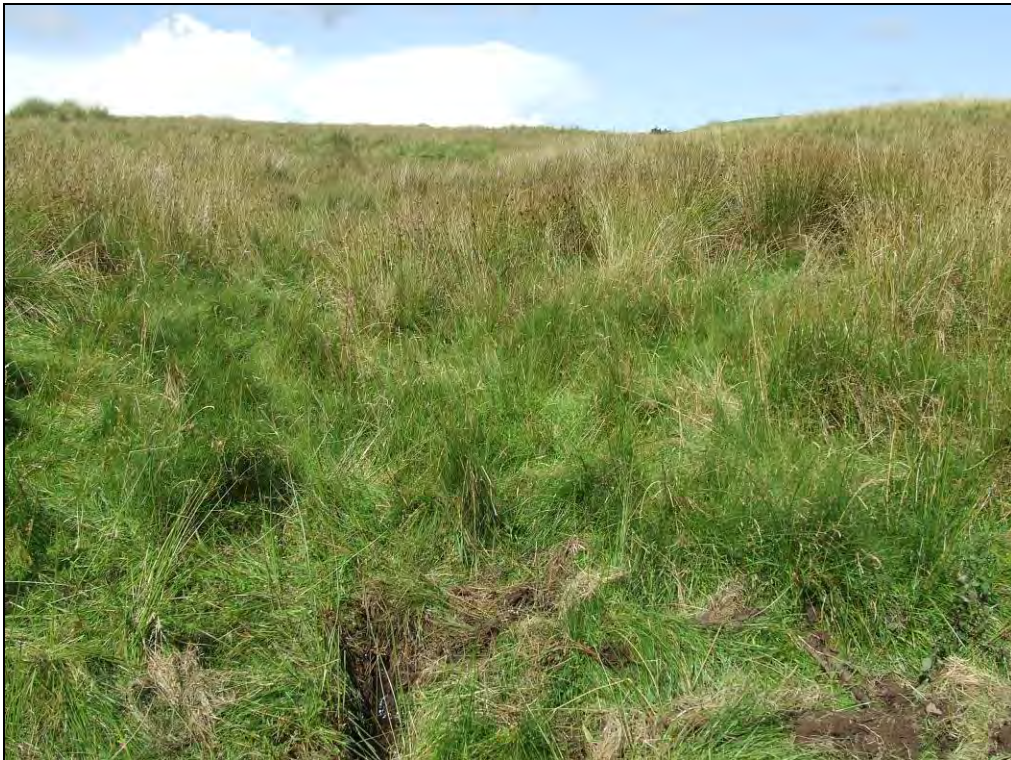
Photo 18: Site Interior – Small issue of water from the valley bottom and close to the southern site boundary, looking north

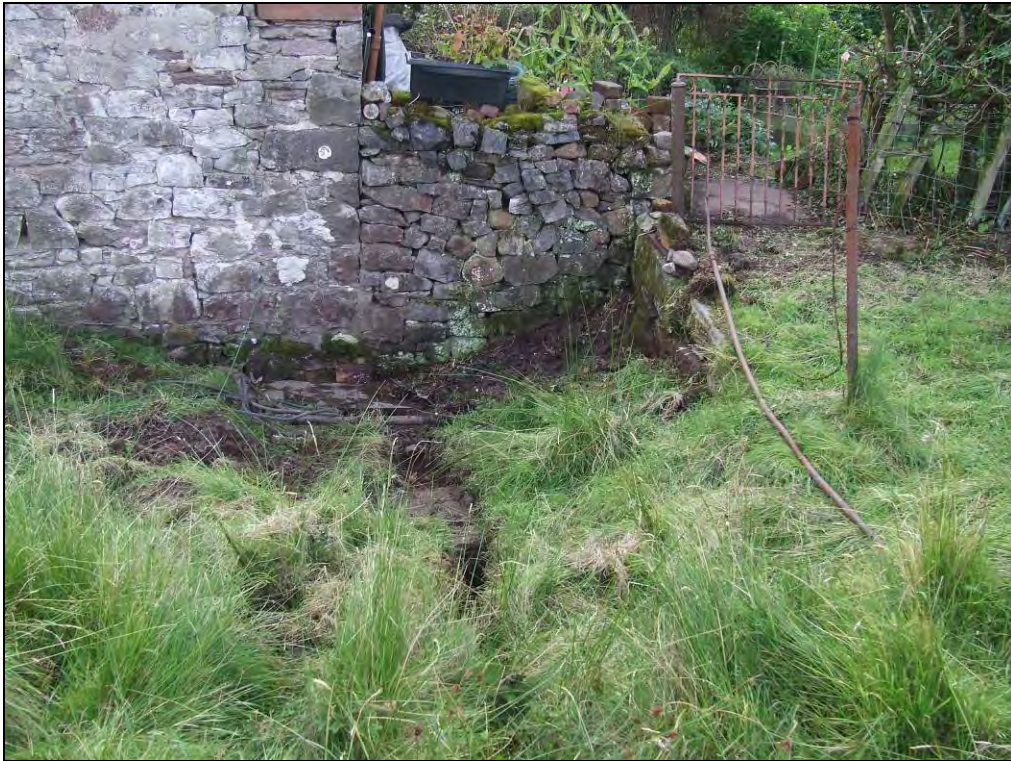
Photo 19: Site Interior – Small issue of water shown on photo 18, showing path of stream flowing south towards edge of outbuilding on southern site boundary, but disappearing beneath stone slab (centre)

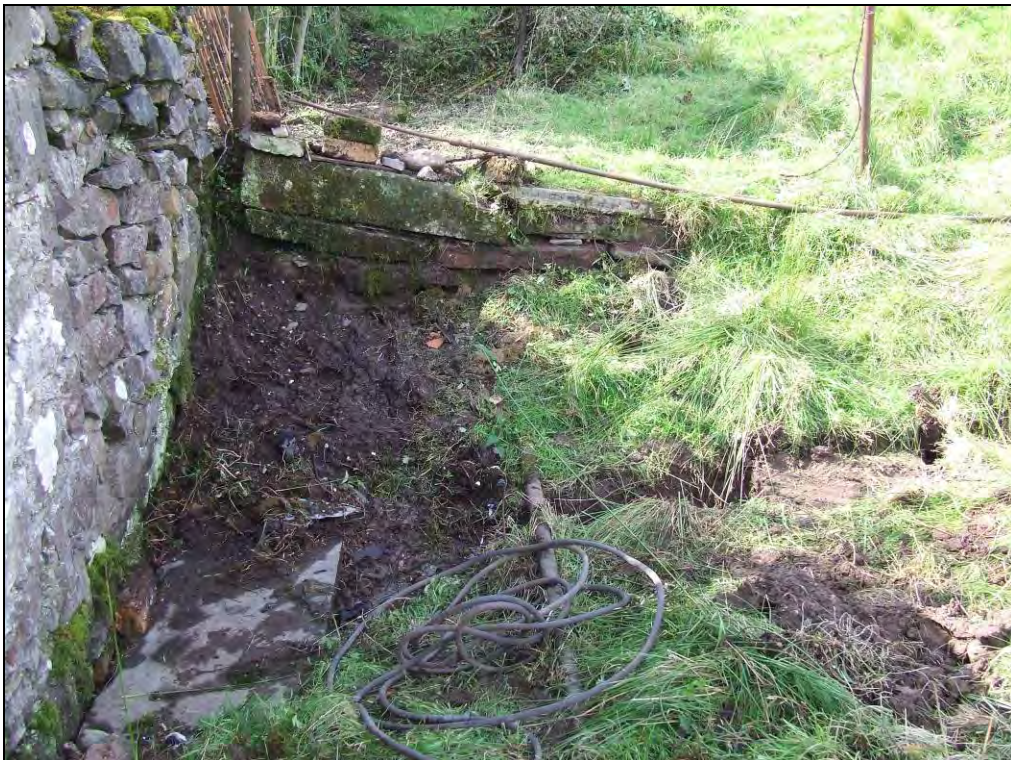
Photo 20: Site Interior – View of small stream channel shown on photo 19, looking west and showing metal pipe crossing path of channel

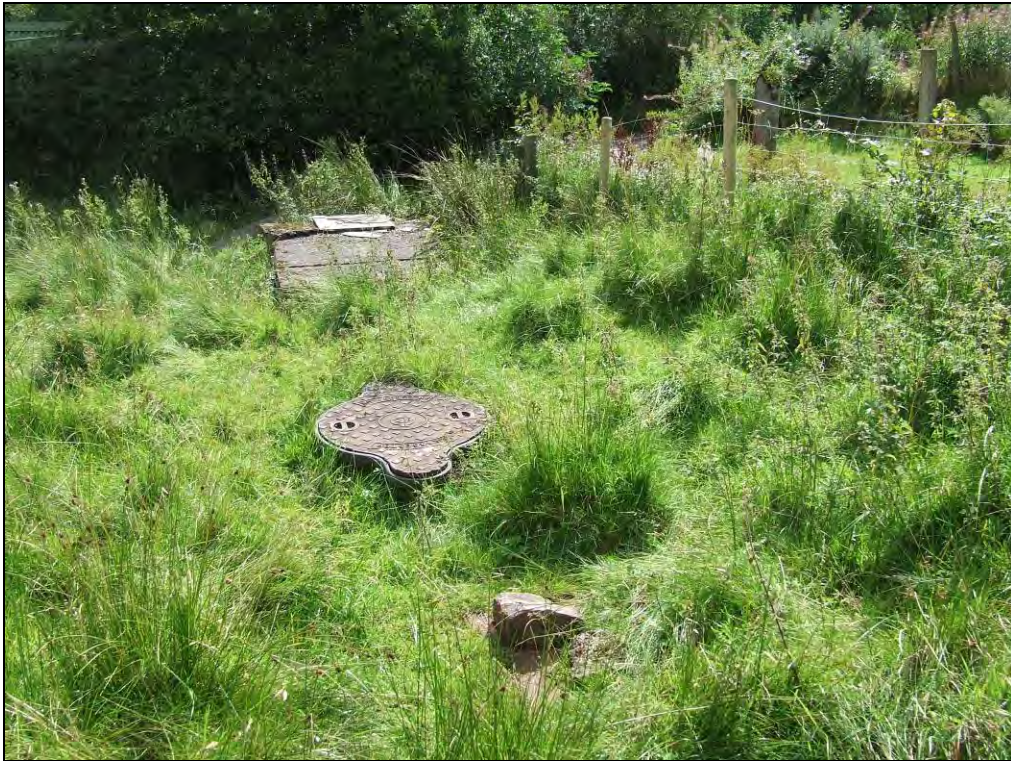
Photo 21: Site Interior – Small private sewage treatment plant located within south western corner of the site with square metal MH cover (foreground), large cast iron MH cover to Klargester (centre) and rectangular brick constructed sump or soakway (top)

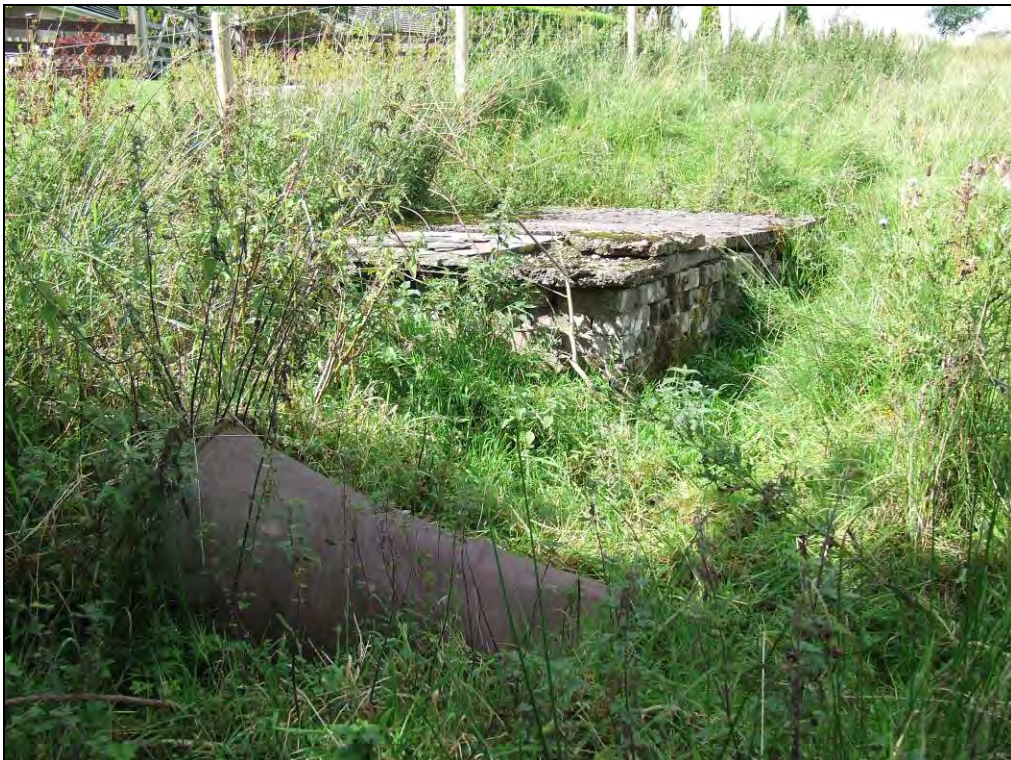
Photo 22: Site Interior – Old partially buried rusted metal drum located in the south western corner of the site near the brick tank shown on photo 21
