Plot 7 West End Rheda Park Frizington

Memorandum

Treescapes Consultancy Ltd.

Ref: EJC/131-2023

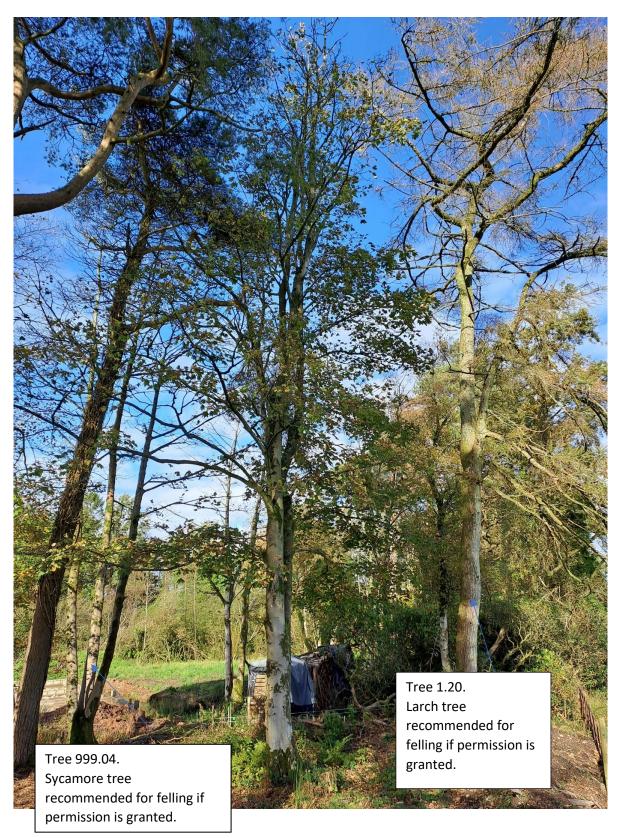
Photo 1. - 12/10/23. Trees 1.20 and 999.04.

- 13. These further recommendations are recorded in the attached Tree Data Schedule, and I discuss some of them below:
 - Tree 1.20 (Photo 1). Recommendation: Fell If permission is granted. A mature larch tree that is of only moderate quality that may become infected with *Phytophthora ramorum* disease of larch. This novel tree disease is endemic in the area and subject to statutory plant health controls. There is only a very low risk of significant harm arising from this tree, but any anticipated works might be done most easily and economically at the same time as other tree works in the plot.

- Tree 999.04 (Photo 1). Recommendation: Fell If permission is granted. A young-mature sycamore tree that is growing close to the boundary with Plot 8, in which there are other buildings under construction. This tree has three codominant stems. Though the stem unions are currently non-acute, and apparently stable, it might reasonably be anticipated that this tree may be of sufficient concern in future to the occupiers of either plot that, if not now, they soon will be seeking permission to fell this tree. Such anticipated work(s) might therefore best be done most easily and economically soon, and at the same time as any other permitted tree works in the plot.

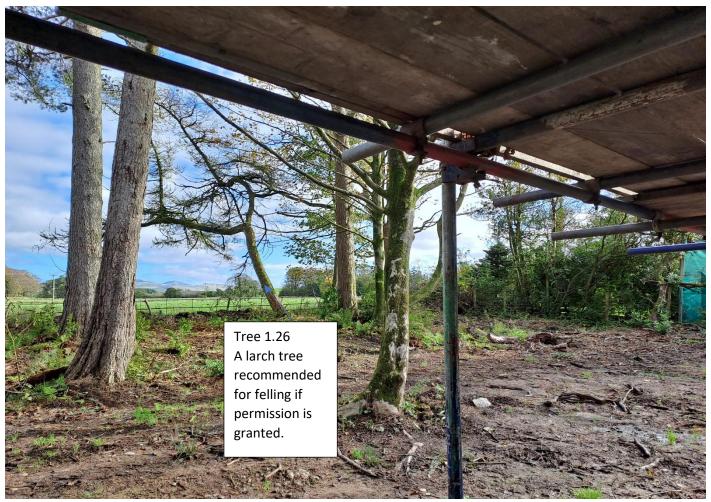
Photo 2. - 12/10/23. Tree 1.26

- Tree 1.26. (Photo 2). Recommendation: Fell If permission is granted. A larch tree that is of only moderate quality and may become infected with *Phytophthora ramorum* disease of larch. This novel tree disease is endemic in the area and subject to statutory plant health controls. There is only a very low risk of significant harm arising from this tree, but any anticipated works might be done most easily and economically at the same time as any other permitted tree works in the plot.

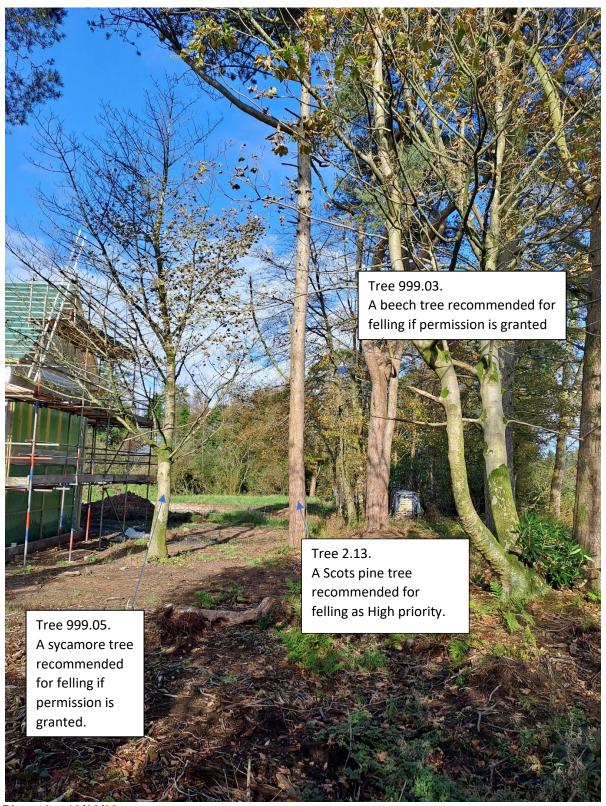
Photo 3. - 12/10/23. Trees 2.13 and 999.05, and 999.03

- Tree 999.03 (Photo 3). Recommendation: Fell If permission is granted.
 A young-mature beech tree that has grown under the canopy of the nearby mature Scots pine to develop a crown that is weight biased in the direction of, and within less than six metres of, the building now under construction.

- Tree 2.13. (Photo 3). Recommendation: Fell High Priority.

An old-mature Scots pine tree that due to crown damage long ago is now weight biased in the direction of the building under construction. There is an old wound at the base of the trunk that I consider to be a major defect (Photo 4) because it will be affecting the wood tissues under tension there to oppose the tree's weight bias towards the new building under construction.
 - Tree 999.05 (Photo 3). Recommendation: Fell If permission is granted.
 A young-mature sycamore tree whose crown, on its west side, is already overhanging the building under construction. The overhanging foliage is at a

- point where it might soon interfere with the structure of the building, and in places occupants might want not to be heavily shaded (e.g., a french, and other windows that are all facing morning light from the east).
- Tree 2.18. (Photo 5). Recommendation: Fell If permission is granted. A substantial, old-mature Scots pine tree that is weight biased to the north-east, and in the general direction of the building now under construction. Currently, there are not any obvious indications of the root plate being unstable, but I note that on this relatively wet site this tree was previously growing within the mutual shelter of other trees that have now been removed.

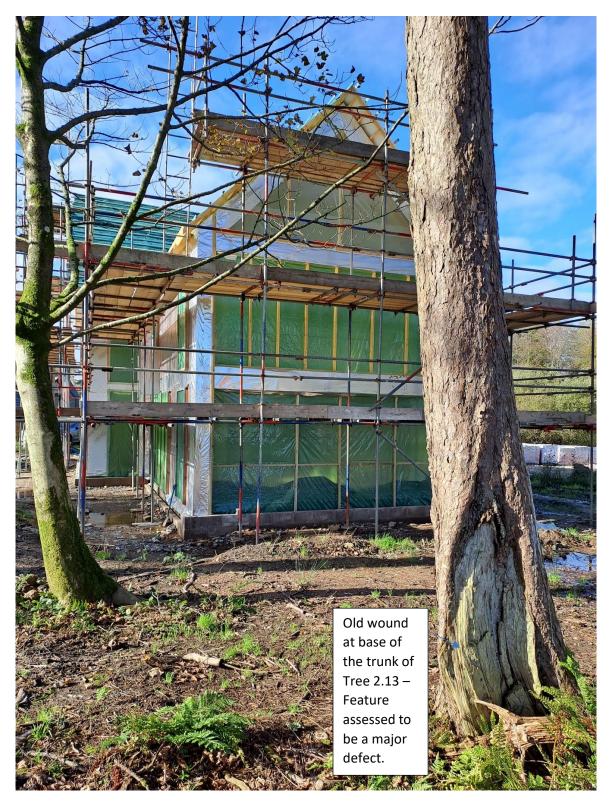
Photo 4. - 12/10/23. Old wounding at base of Tree 2.13.

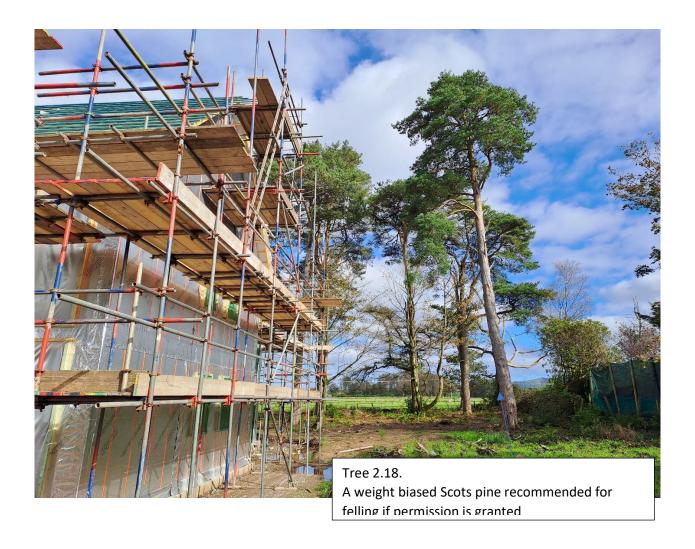
Photo 5 - 12/10/23. Tree 2.18

Further assessment of this tree using techniques such as sonic tomography and/or load testing could be undertaken but, because of time and resources required to conduct such tests they are most appropriate for the assessment of large, mature trees with either high visual amenity and/or considerable historical, cultural, or ecological value. I consider, therefore, that felling this tree soon is most likely to provide, at most reasonable cost, the reassurance the owners

I recommend that, should this tree be felled, the nearby tree and shrub planting previously recommended be slightly extended and enhanced in mitigation.

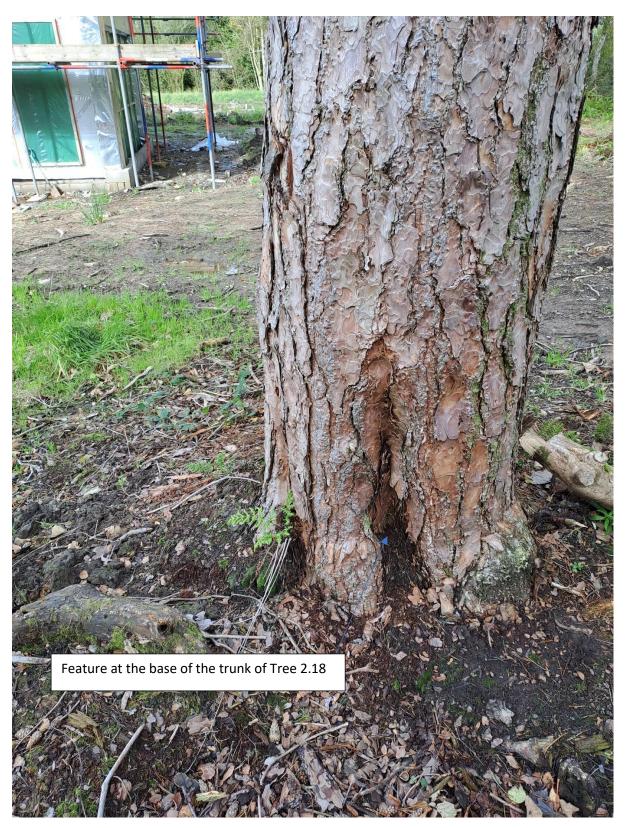
There is a feature at the base of the stem which may be either an old wound, or a natural separation space/flute between two buttresses (Photo 6). The significance of this feature I have therefore recorded as unknown.

Photo 6. - 12/10/23. Base of the trunk of Tree 2.18.
