VISUAL STRUCTURAL INSPECTION

**MID TARN FARM
FARM HOUSE & ASSOCIATED BUILDINGS
SELLAFIELD
SEASCALE
CUMBRIA**

AVISON YOUNG

Reference - WDS/05/6133/REP03

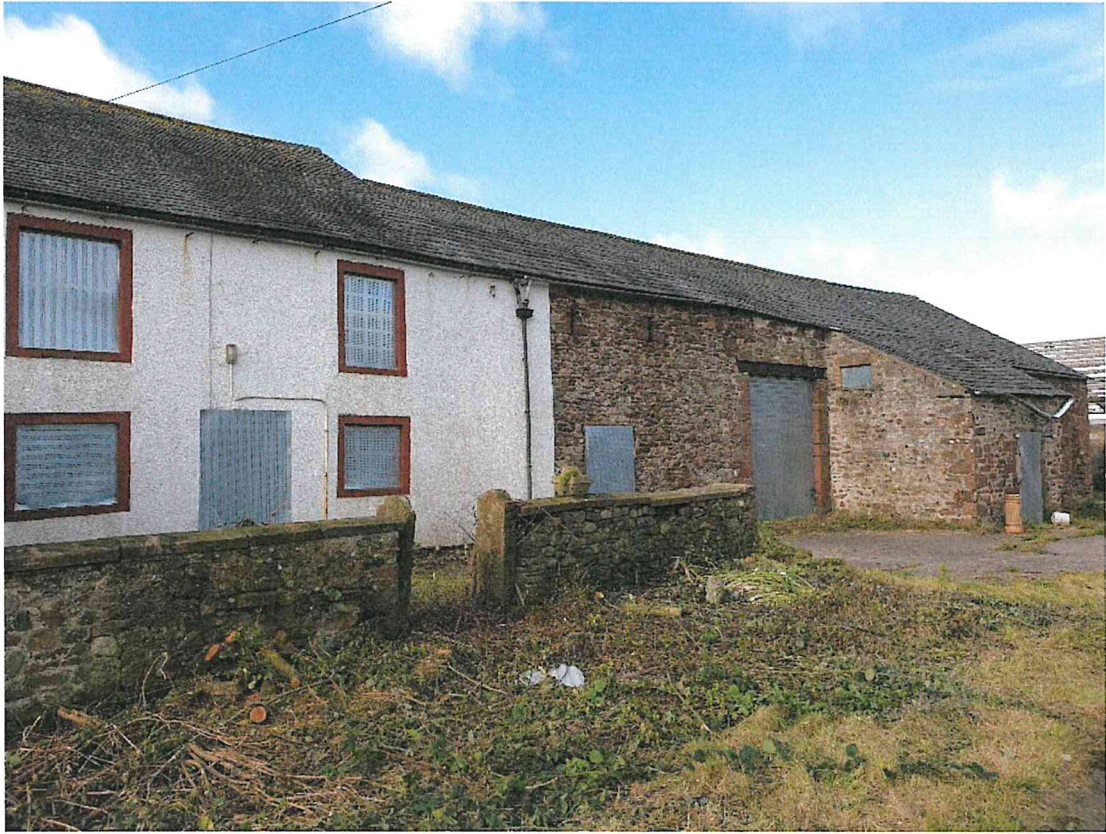
PHOTOGRAPH 1 MAIN FARM HOUSE

1.2 The Main Farmhouse and Barn both comprise two storey buildings which are formed in brick and random stone rubble filled masonry walls which support a traditional timber rafter and purlin roof and timber joisted first floor structures. The ground floor to the house comprises a combination of ground bearing concrete slabs and joisted floating floors; the barn ground floor comprises concrete ground bearing slabs and stone flagged areas. There is a single storey lean-to to the front elevation of the farm house which is of more modern construction. The property has been empty for some time. See photograph 1 in the Appendix.

- 2.1 The farm house is in need of total refurbishment and modernisation with all the internal finishes in need of replacement. Similarly, the external render needs totally replaced.
- 2.2 There is an outward bulge to the front wall to the left hand portion of the front elevation. It appears that the roof truss over has failed and spread pushing the wall
- 2.3 There is a full height crack to the left hand gable wall which may indicate some structural movement.
- 2.4 The attached barn walls are heavily weathered and need refurbished. Internally the timber structural elements to the roof, floor and lintels show signs of infestation. The walls have a number of cracks and bulges but these are not excessive.

7.1 The farm house is in need of total refurbishment. The ground floor slabs will need lifted to allow a DPC and insulation to be inserted and any slag fill beneath to be removed. The spreading roof truss needs strengthened/replaced and the adjacent bulging wall rebuilt. The cracks apparent will need tied throughout. In essence the farm house will merely be the shell and with the requirement to replace timber lintels it is likely that much of the masonry above will need replaced as part of this work. The disused attached barn is

also in a poor condition and its condition will only worsen if not refurbished in the near future. With this we would suggest that a more cost effective approach would be to demolish the farm house and the barn.

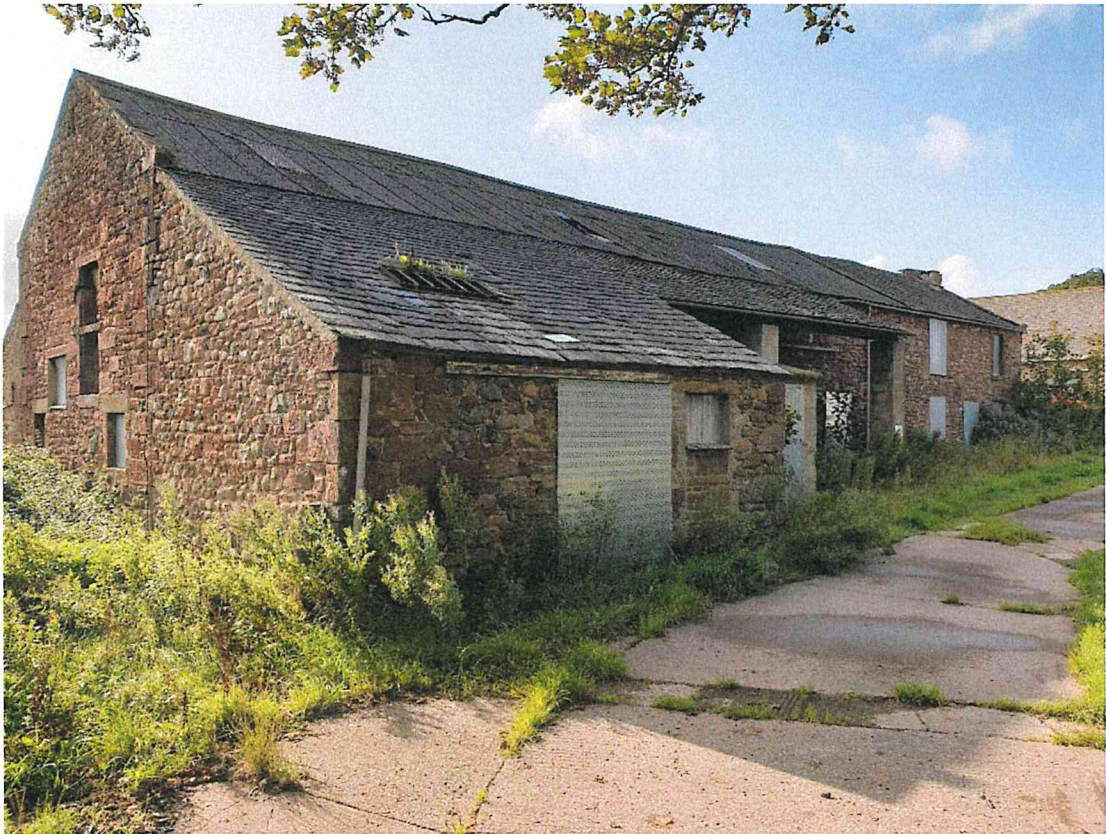
PHOTOGRAPH 2 OLD STONE BARN AND COTTAGE

1.3 The Old Stone Barn and attached Cottage are of similar construction to the main farm house. There is more amodern concrete block extension built off the rear elevation. See photograph 2.

- 3.1 The buildings are in a very poor condition and are effectively derelict. The walls are heavily weathered and excessively out of plumb in various locations, especially the left hand gable. The front canopy support beam is heavily rusted and the timber wall plate rotten, the canopy roof is at risk of collapse.

3.2 The main roof has failed and fallen in in localised areas. The timber elements adjacent are rotten and further collapse can not be discounted.

3.3 The timber elements throughout the building have been affected by rot and infestation to varying degrees.

- 7.2 The Stone Barn and attached Cottage structures are in a very poor condition and are basically derelict. We would recommend that these building are demolished as soon as possible as they are a safety hazard to personnel.
- 7.3 The disused Cubicle Shed is generally structurally adequate except the rear portion where the steel framed extension has been added. As the building is no longer of use we suggest it is taken down before further weathering and deterioration renders the structure unsafe.
- 7.4 The Silage Barn and Portal Store are also structurally adequate and similar to the Cubicle Shed we recommend that these are taken down before further deterioration renders them unsafe.

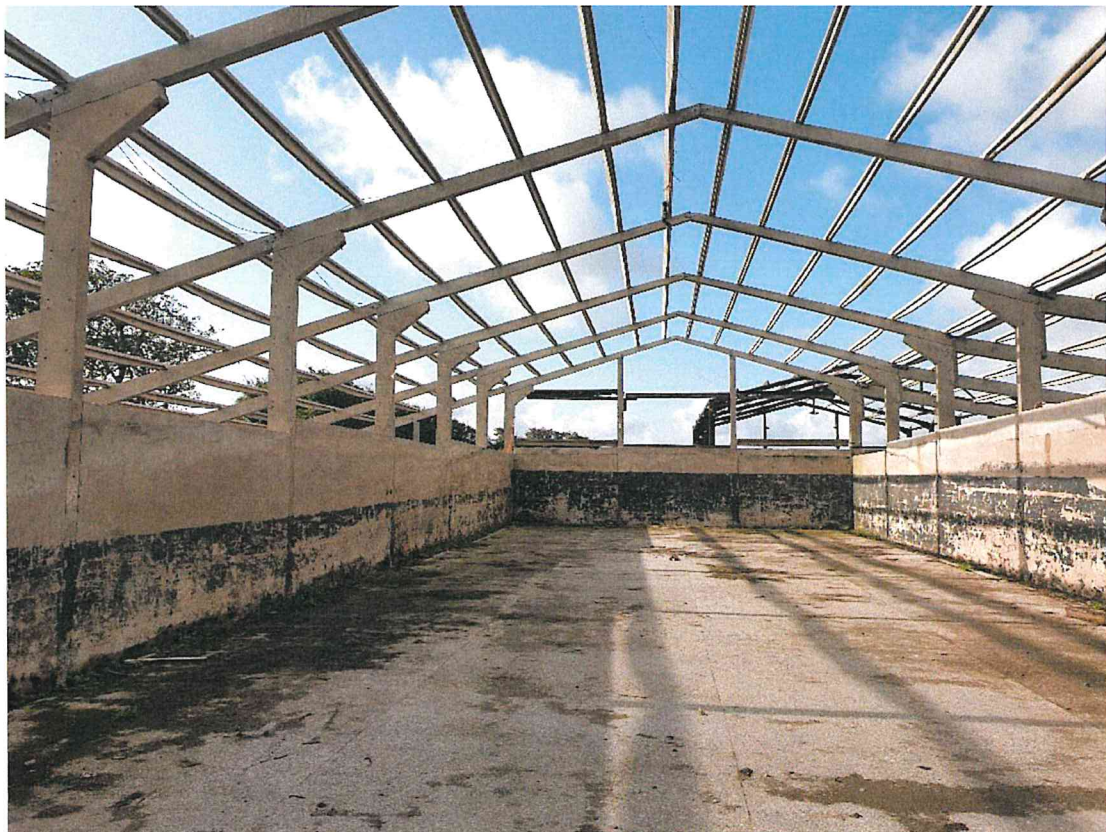
PHOTOGRAPH 3 CUBICLE SHED

1.4 The Cubicle Shed comprises a precast concrete framed structure. The rear extent of the frame has been extended with a partial steel frame. The cladding to the structure has been totally removed. The ground floor comprises a concrete slab. See photograph 3.

4.1 The shed is disused with all the cladding having been removed. A number of concrete elements are cracked due to the embedded reinforcement having rusted. Generally however the concrete frame appears in an adequate condition.

4.2 The frames have been extended at the rear of the building by installing a steel rafter and column extension. This is structurally inadequate and needs taken down and the supported concrete rafter to the rear bay removed also.

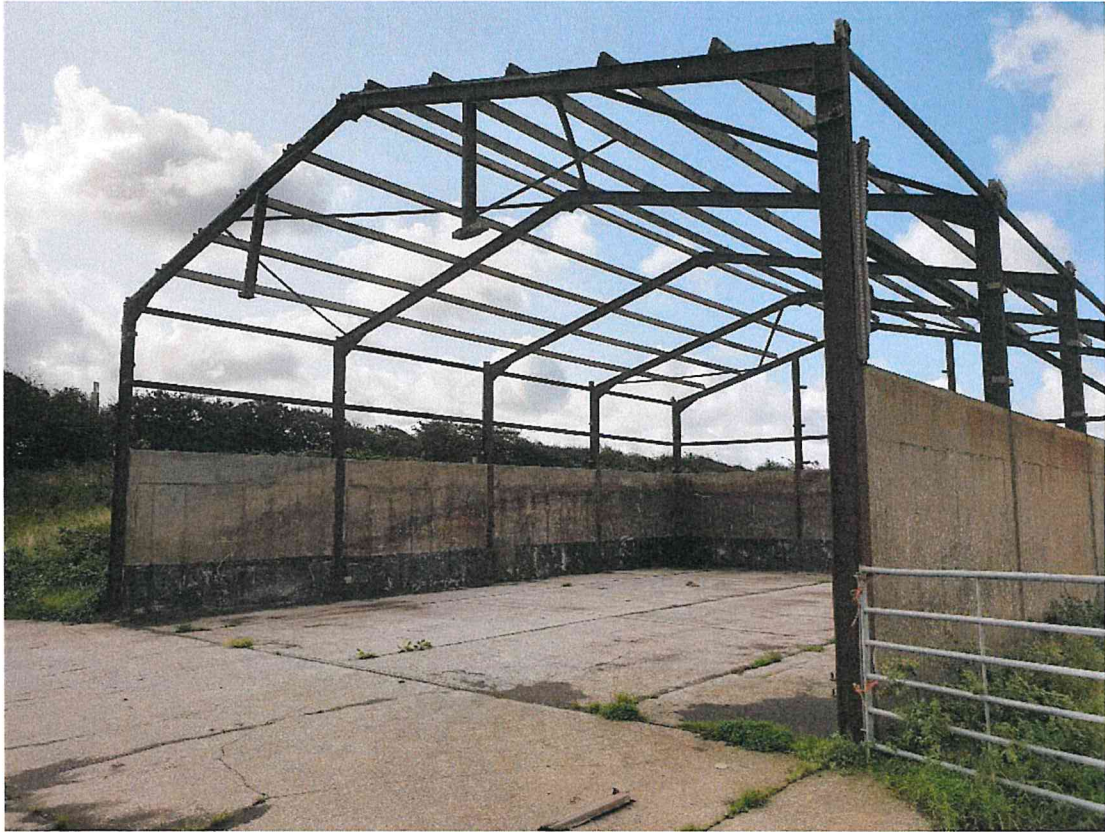
PHOTOGRAPH 4 THE SILAGE BARN

1.5 The Silage Barn comprises a steel portal framed structure with precast concrete plank lower side walls. The cladding to the building has been removed. The floor slab comprises ground bearing concrete. See photograph 4.

5.1 The steel frame and concrete wall planks are in an adequate condition. The steel portal elements do appear heavily rusted in localised areas however as the frame is unclad the steel attracts limited load and is therefore structurally adequate.

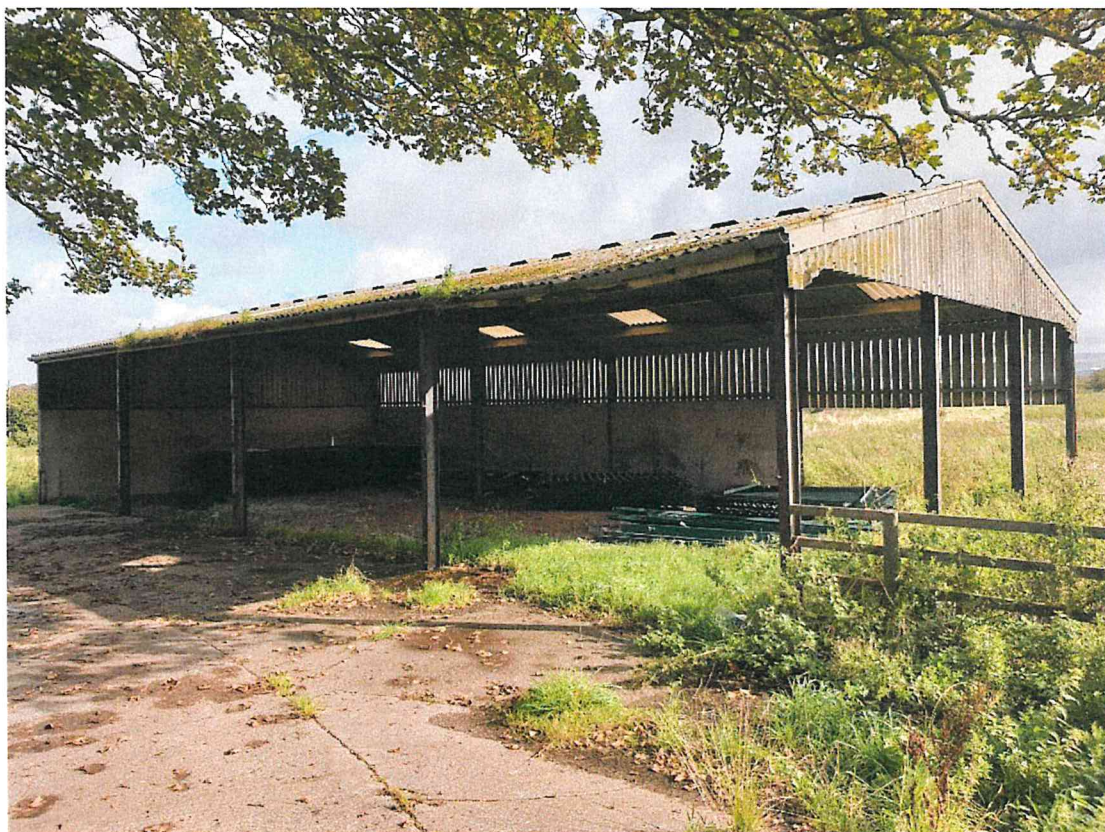
PHOTOGRAPH 5 THE PORTAL STORE

1.6 The Portal Store comprises a propped steel portal framed structure. The building is open sided with the roof cladding still in place. See photograph 5

6.1 The steel frame is rusting with excessive rust in localised areas. One of the main internal column props has been impacted and is bent. The frame in its current condition is structurally adequate.
