Bat Scoping Survey

Former Natwest Bank, St George's Road, Millom

13th March 2023

Report No. 0323/2

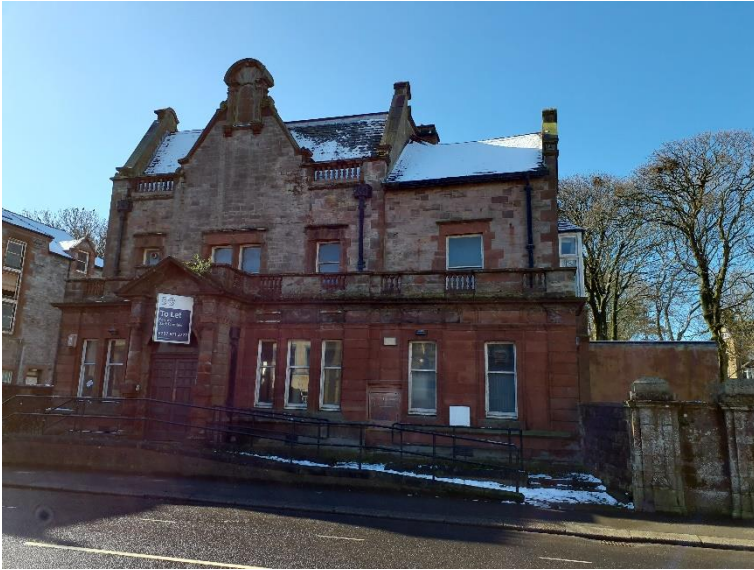
Image 1. Front (East) elevation of property.

Note the steep pitch of the upper roof on this elevation.

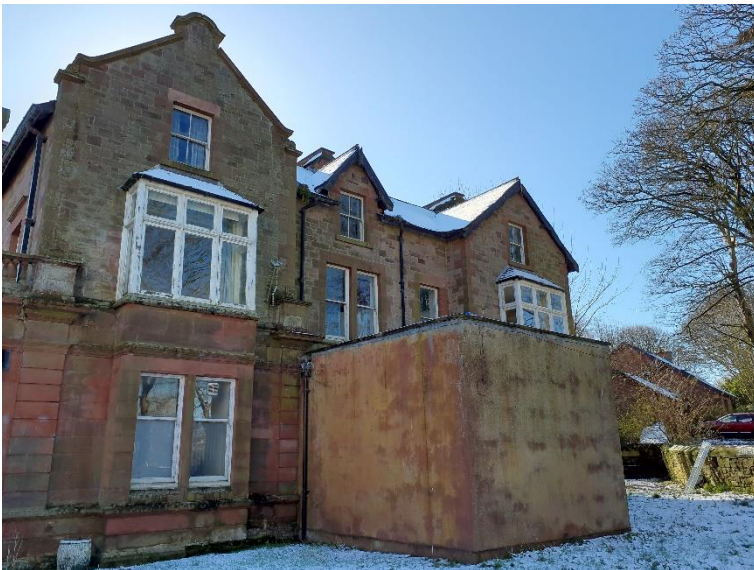
Image 2. Side (north) elevation of the property, showing extension on ground floor to house the safe.

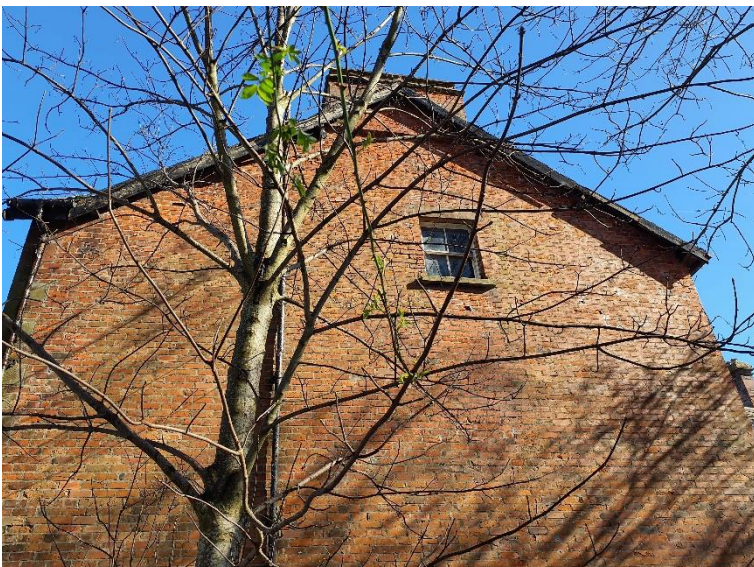
Image 3. Rear (west) elevation. No render over the brickwork.

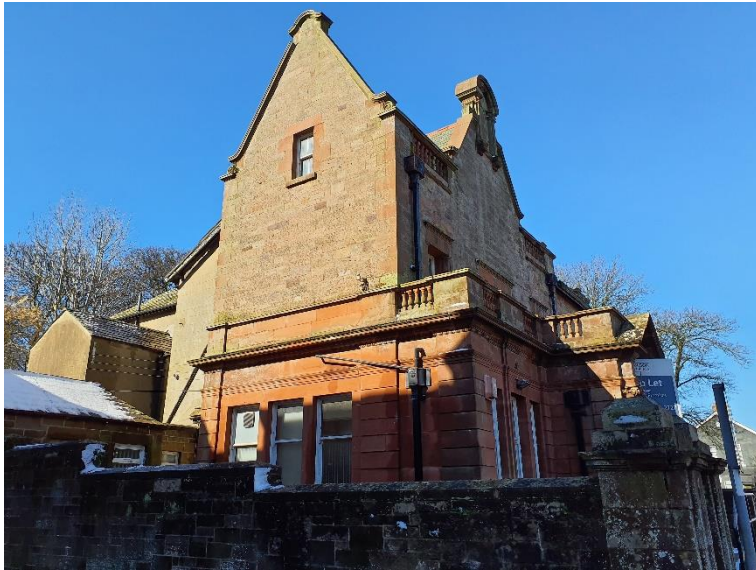
Image 4.
Side (south) elevation, showing the decorative gables, and the rendered walls towards the rear of the building.

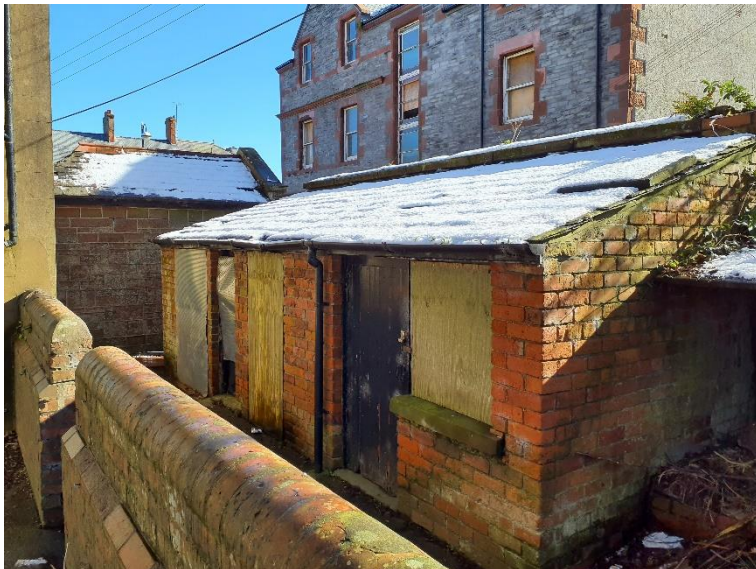
The two outbuildings had some scope to host bats. The brick lean-to at the south-west corner of the landholding had gaps around roof slates and coping stones on the high boundary wall (forming the ridge of the building). The sandstone outbuilding (male toilets) also has some slipped slates around the roof.

Image 5.
Two outbuildings on the south elevation. Detached lean-to against the boundary wall in foreground, and stone building to rear of image (male toilets).

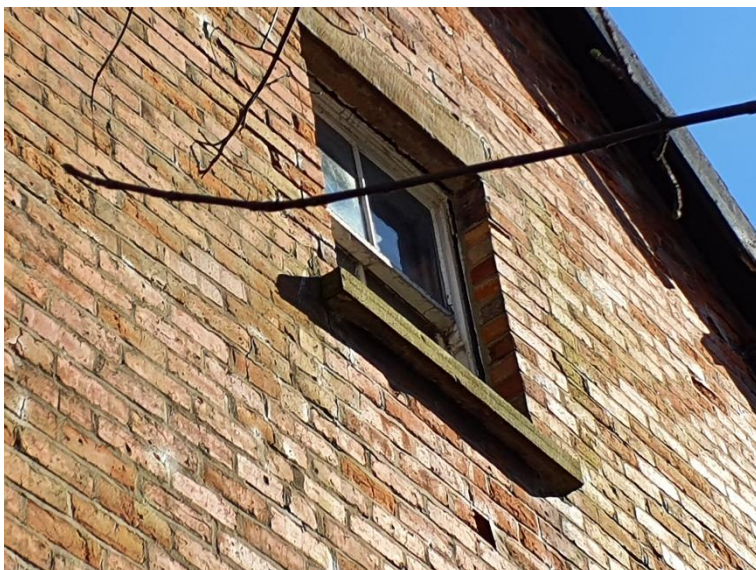
The external walls offer very limited roosting opportunities for bats, as the walls are well sealed at the eaves and there are few significant cracks or holes in the stonework or around the timber window frames. A notable exception to this is a significant gap surrounding the first floor window on the rear (west) elevation. The wooden fascia and soffits are in poor repair, but there are no gaps at the wall tops.

Image 6.
Window on rear elevation where brickwork has bowed out creating gaps around the wooden frame suitable for roosting bats.

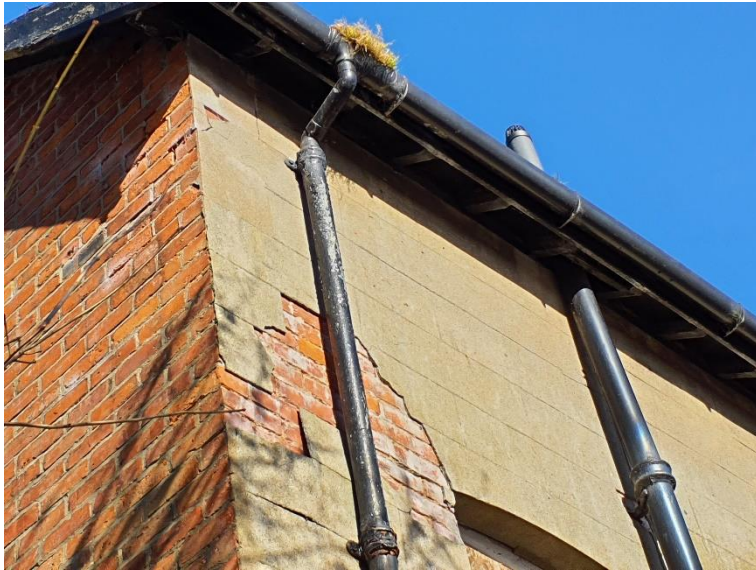
Image 7.
South-west corner of the building where the render has crumbled to reveal brickwork. No gaps at wall tops seen.

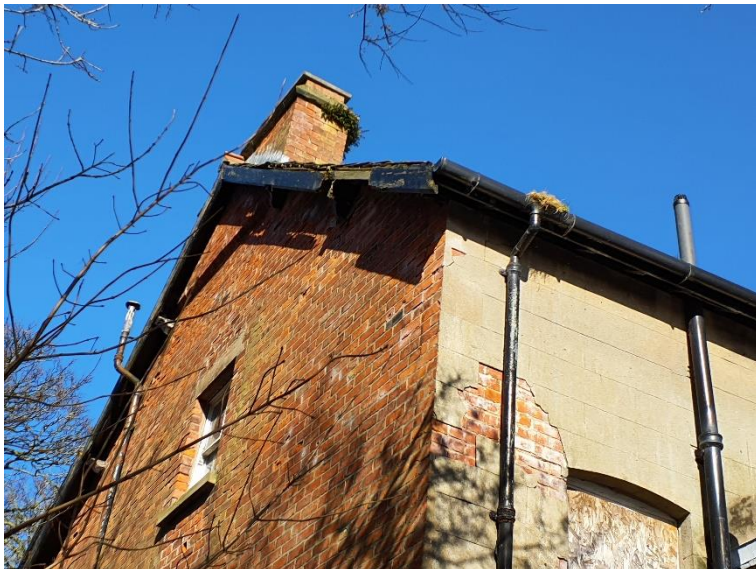
The roof slates are generally all in place and tightly fitted together (especially on the steeper pitches of the front elevations). Some missing slates were noted on the side (north) elevation in the structural report – but these could not be seen due to the covering of snow on the inspection date. There were gaps noted along the rakes on the rear and south elevations where the barge boards had rotted away.

Image 8.
West elevation showing gaps along the rakes where the boards have rotted – potential for use by bats.

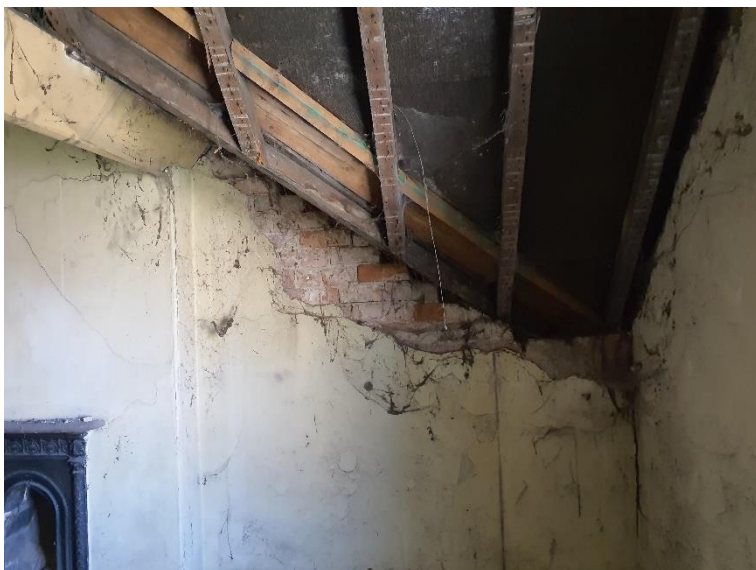
Image 9.
Second floor of property, showing poor condition of rooms on this floor, and clearly visible roof timbers.

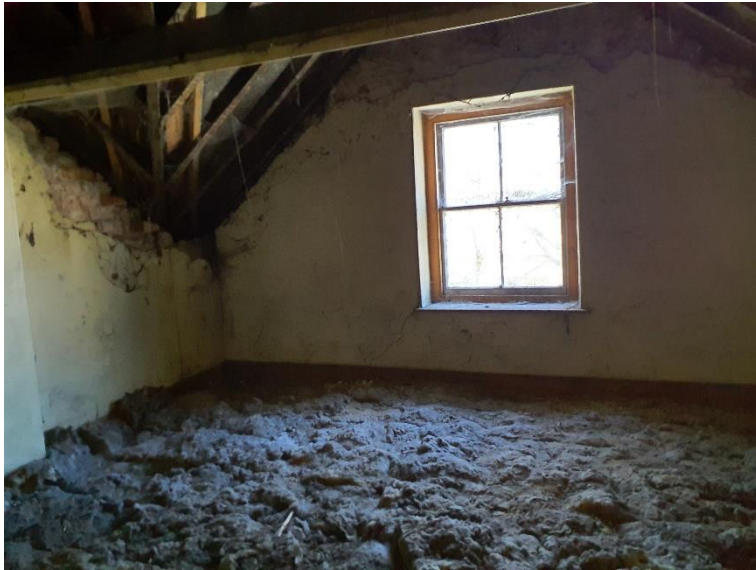
Image 10.
Second floor room, showing crumbled mortar around eaves, and the roof insulation covering all the floorboards.

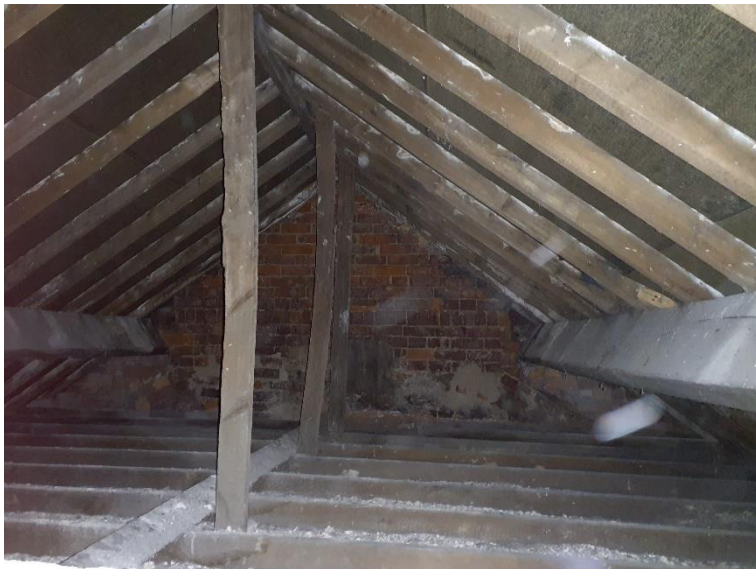
Image 11.
Interior of roof void at the rear of the building (looking west).
Empty void – no insulation or stored materials.

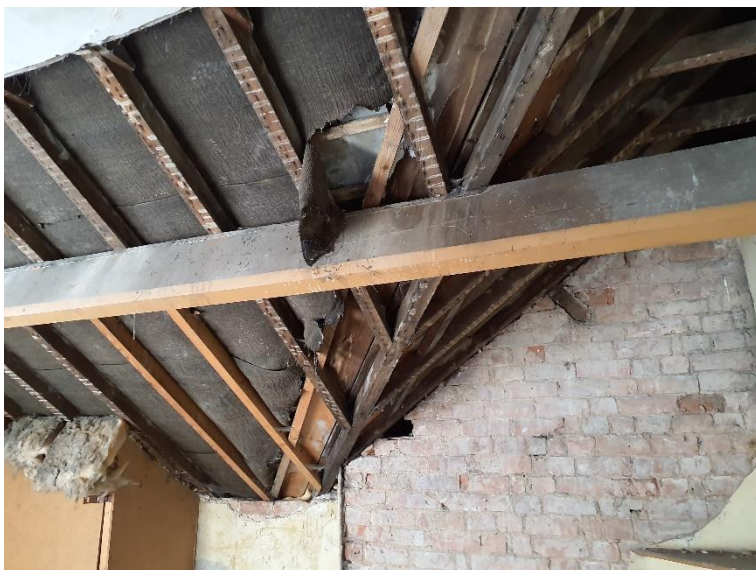
Image 12.
Second floor room at the front of the property with tear in roofing felt. Felt in quite good condition throughout the rest of the roof area.

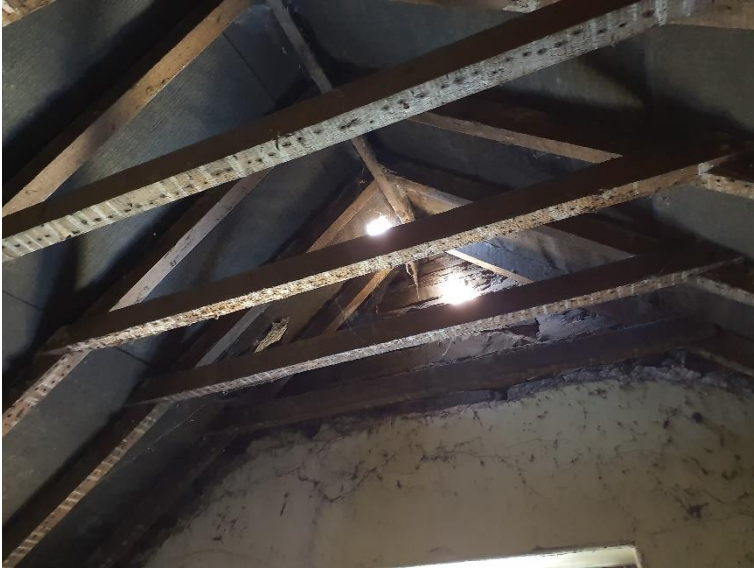
Image 13.
Roof void seen through fallen ceiling, showing missing slate (clear daylight).

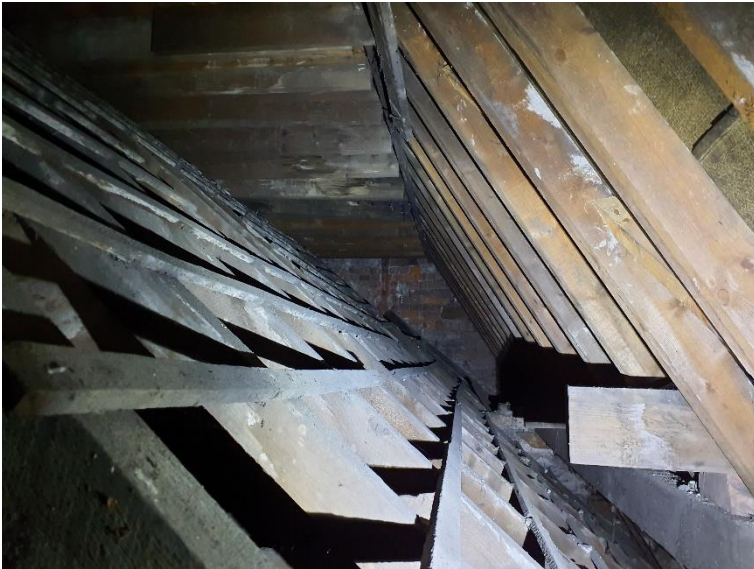
Image 14.
Inside void at the front of the property showing steep roof pitch over the top of other roof trusses.
