### Site Inspection (Bats) - Moorleys, St Bees, Cumbria, CA22 2TZ

Natalie Barratt  
Moorleys,  
St Bees,  
Cumbria,  
CA22 2TZ

Our Ref. No.: NB20BAT041  
Date: 23 March 2021  
Your Ref. No.: N/A

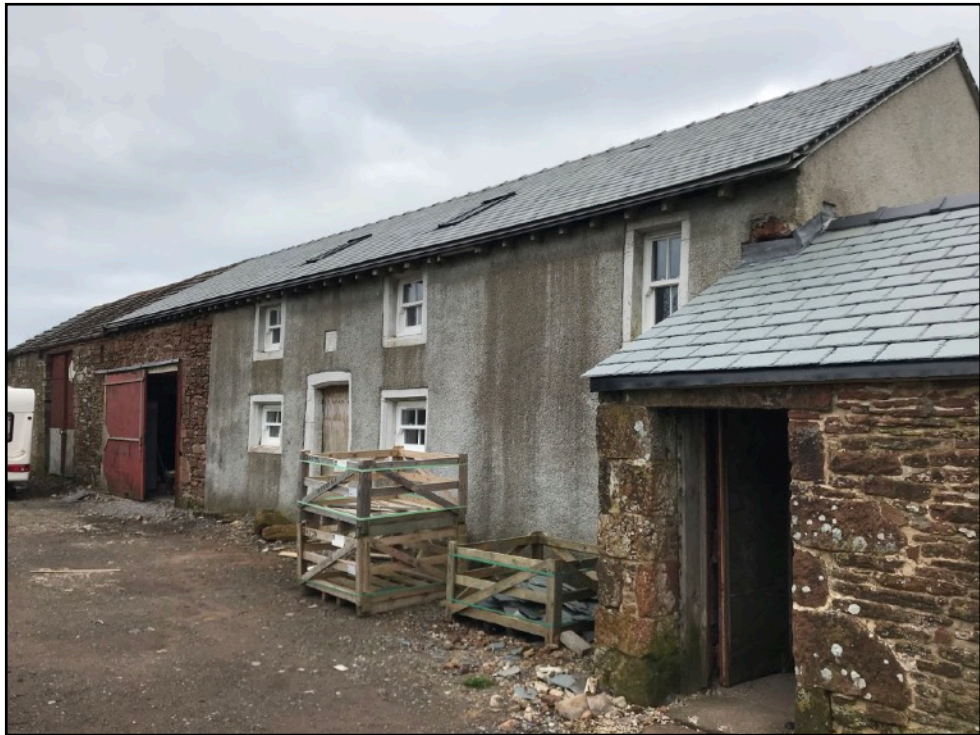
**Figure 3:** *Showing the southern elevation of Moorleys, with outbuilding and cottage in the foreground, and house and barn beyond.*

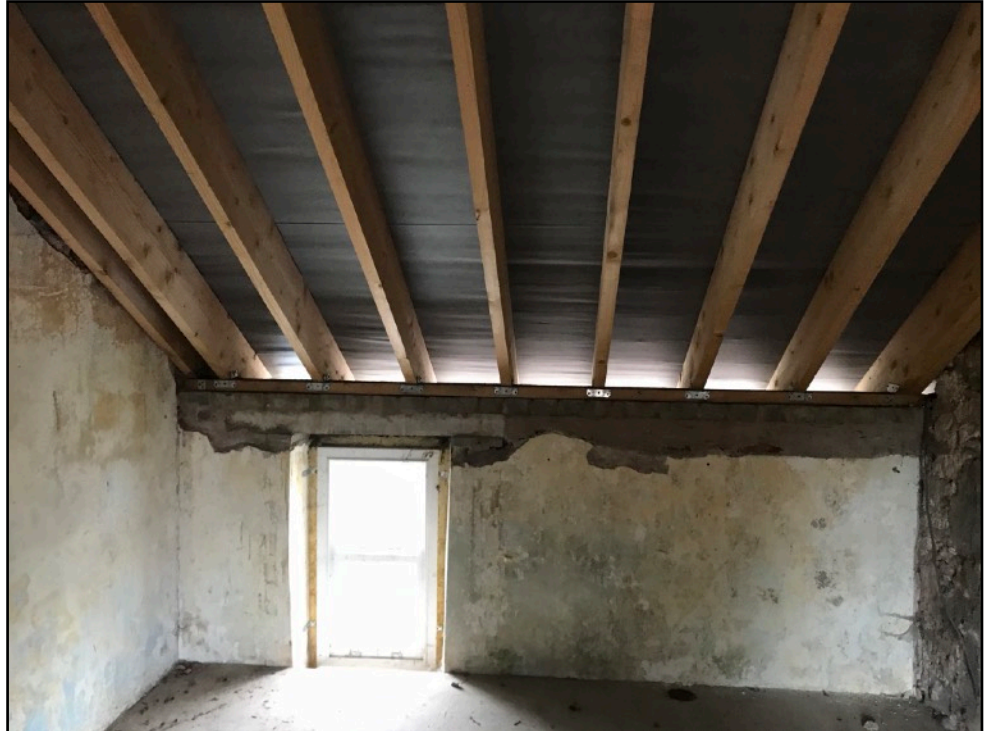
No enclosed roof voids exist within any of the buildings and the eaves are unenclosed on the house and cottage making the interior draughty and light during the day. The roof cladding (slates and tiles) are tight and do not offer any gaps or crevices between. The external walls of the barn do contain deep gaps, but in the absence of functioning gutters these are all wet and very open, and do not offer highly suitable potential roost locations. The curtilage of the property has recently been cleared and landscaped and consequently the property is somewhat isolated with only very limited connectivity to high quality foraging habitat in the surrounding area. The site is surrounded by open fields of improved grassland pasture and arable land.

**Figure 4:** Showing the interior of the farmhouse (First floor) with new roof and unenclosed eaves.

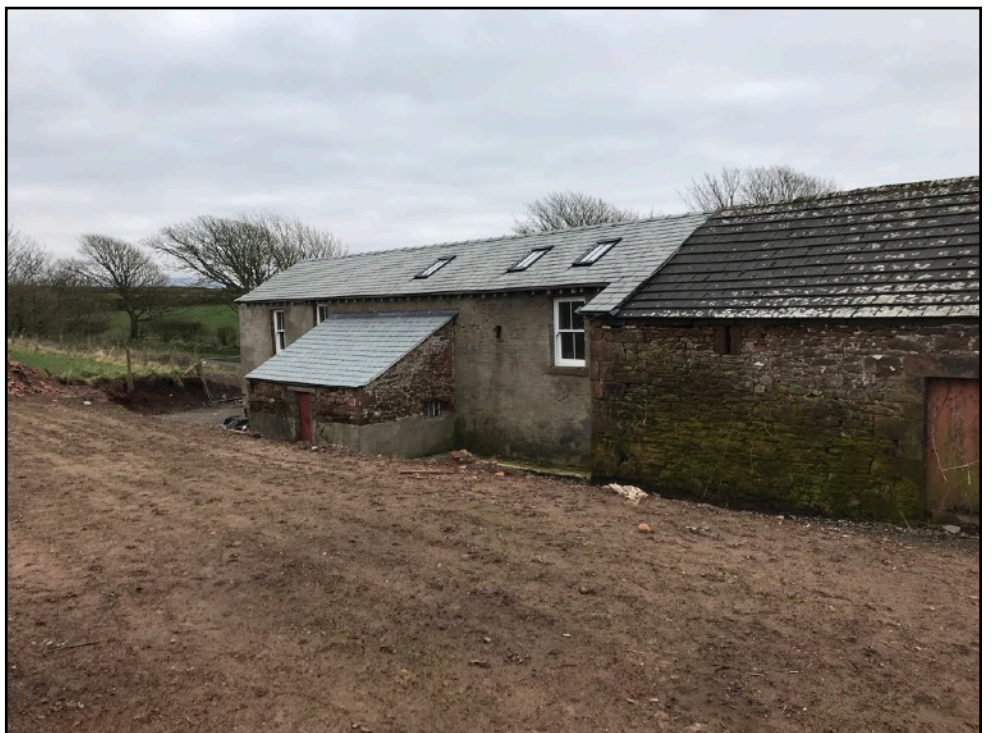
**Figure 5:** Showing the rear (north) of the property.

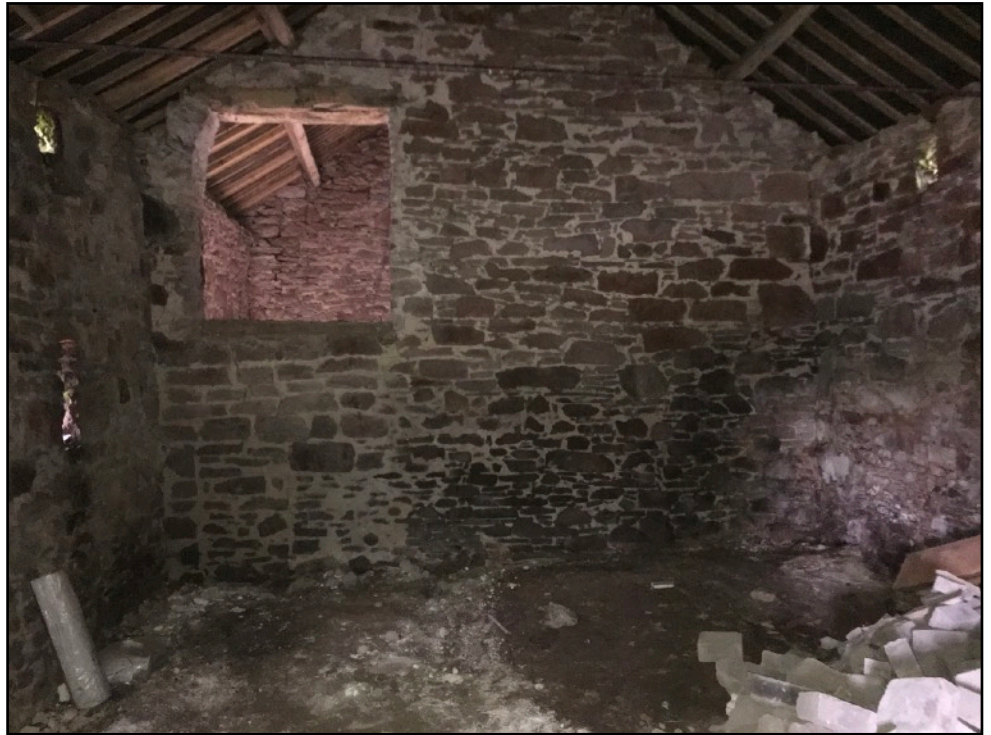
Gaps identified in the external walls of the barn were inspected with a high powered torch. All internal areas were inspected in detail. No evidence of bats - or barn owls - having used the buildings was identified. No droppings or other evidence was discovered anywhere within or around the property.

The property is considered to offer 'negligible' potential for roosting bats. The presence of suboptimal potential roost features within gaps in the external wall of the barn means that it is not possible to conclude 'nil' potential, but a thorough inspection of the crevices is adequate to conclude that bats are not currently using these 'negligible' potential roost features.

**Figure 6:** Showing the interior of the barn.

There is a small risk that individual bats could opportunistically occupy gaps whilst works are underway. As a precautionary measure, in order to minimise the risk of individual bats being harmed during works, the following measures should be observed;

- This report should be made available to any contractor working on site.
- If bats are discovered at any time prior to or during works, all work must stop and the acting consultant contacted immediately. If this unlikely event does occur a European Protected Species licence will be sought.
- The work will be completed as quickly as possible once started. Any gaps created during the course of the works will be left open for the minimum possible period. Where possible gaps will not be left open over night to avoid the possibility of bats opportunistically roosting in gaps which will later be blocked.
