Natalie Barratt  
Moorleys,  
St Bees,  
Cumbria,  
CA22 2TZ

## Site Inspection (Bats) - Moorleys, St Bees, Cumbria, CA22 2TZ

Our Ref. No.: NB20BAT041  
Date: 23 March 2021  
Your Ref. No.: N/A

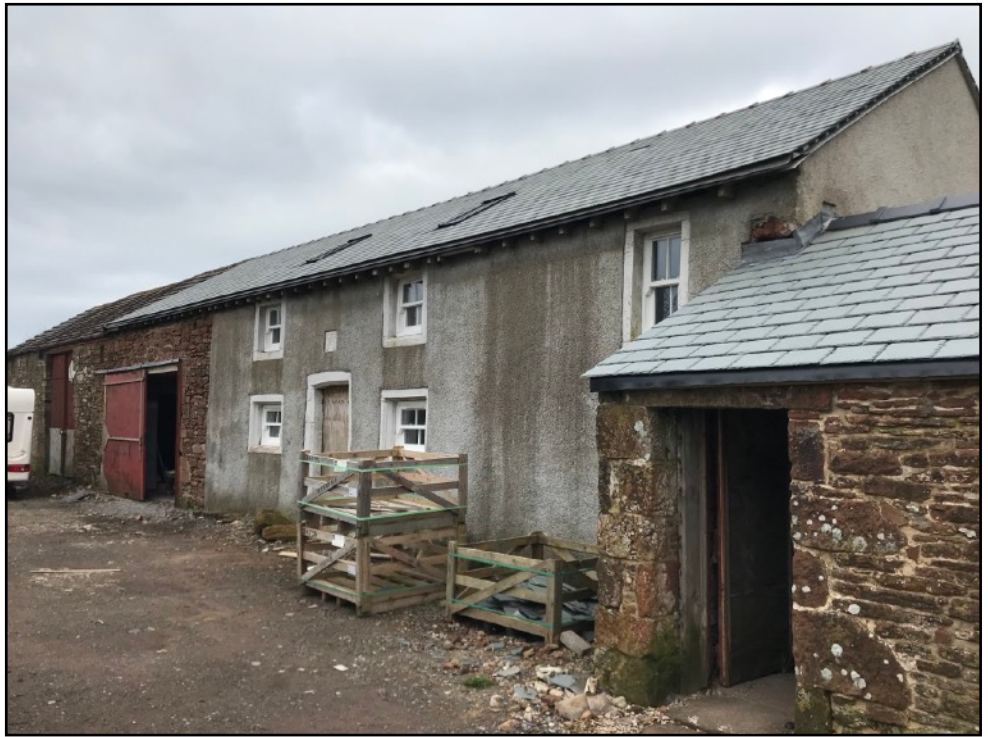
**Figure 3:** *Showing the southern elevation of Moorleys, with outbuilding and cottage in the foreground, and house and barn beyond.*

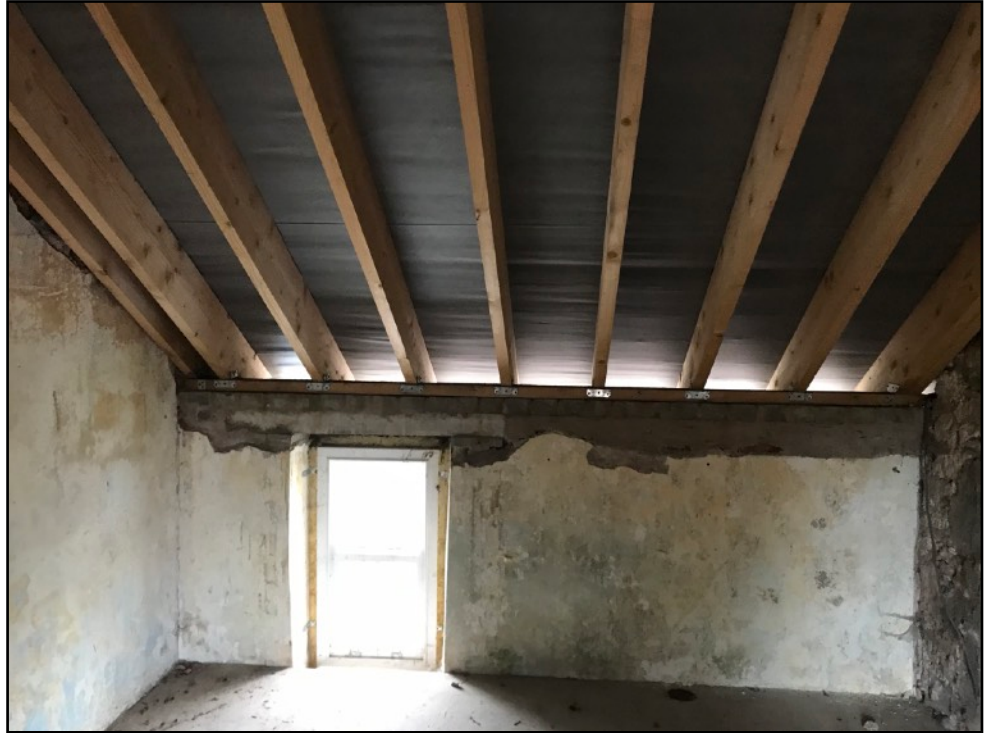
No enclosed roof voids exist within any of the buildings and the eaves are unenclosed on the house and cottage making the interior draughty and light during the day. The roof cladding (slates and tiles) are tight and do not offer any gaps or crevices between. The external walls of the barn do contain deep gaps, but in the absence of functioning gutters these are all wet and very open, and do not offer highly suitable potential roost locations. The curtilage of the property has recently been cleared and landscaped and consequently the property is somewhat isolated with only very limited connectivity to high quality foraging habitat in the surrounding area. The site is surrounded by open fields of improved grassland pasture and arable land.

**Figure 4:** Showing the interior of the farmhouse (First floor) with new roof and unenclosed eaves.

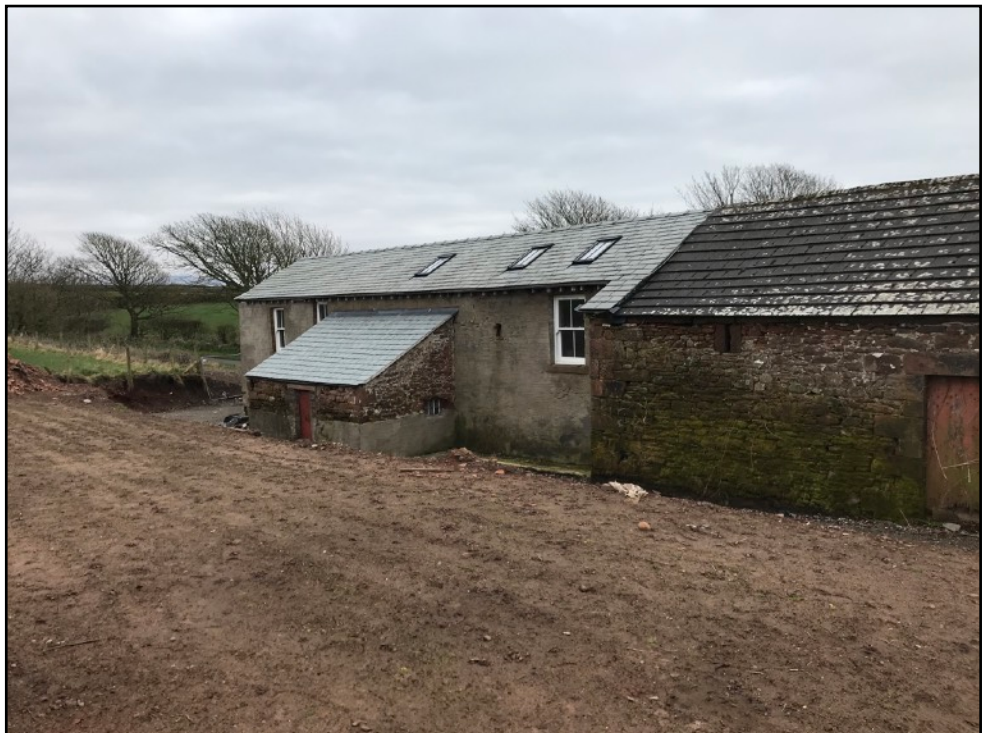
**Figure 5:** Showing the rear (north) of the property.

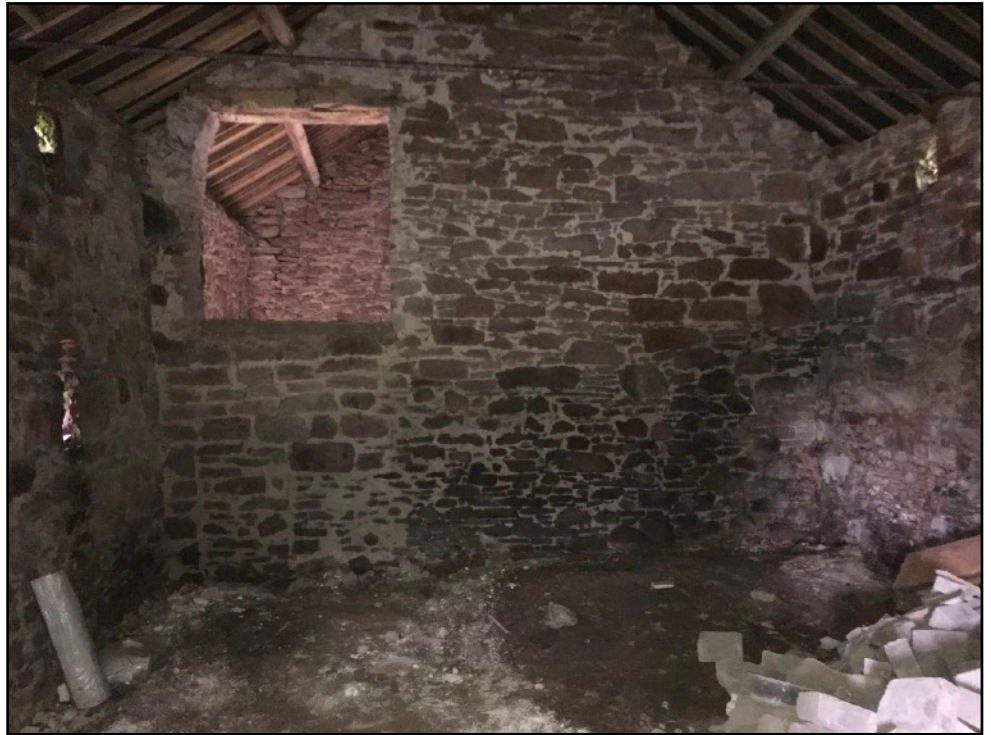
Gaps identified in the external walls of the barn were inspected with a high powered torch. All internal areas were inspected in detail. No evidence of bats - or barn owls - having used the buildings was identified. No droppings or other evidence was discovered anywhere within or around the property.

The property is considered to offer 'negligible' potential for roosting bats. The presence of suboptimal potential roost features within gaps in the external wall of the barn means that it is not possible to conclude 'nil' potential, but a thorough inspection of the crevices is adequate to conclude that bats are not currently using these 'negligible' potential roost features.

**Figure 6:** Showing the interior of the barn.

- This report should be made available to any contractor working on site.
- If bats are discovered at any time prior to or during works, all work must stop and the acting consultant contacted immediately. If this unlikely event does occur a European Protected Species licence will be sought.
- The work will be completed as quickly as possible once started. Any gaps created during the course of the works will be left open for the minimum possible period. Where possible gaps will not be left open over night to avoid the possibility of bats opportunistically roosting in gaps which will later be blocked.
