**VISUAL STRUCTURAL INSPECTION  
OF  
HAY BARN & BYRE ADJACENT TO  
NEWHOUSE FARM  
DRIGG  
SEASCALE**

**FOR  
AVISON YOUNG**

**Reference - WDS/05/6942/REP 02**

**Date - 31/03/2021**

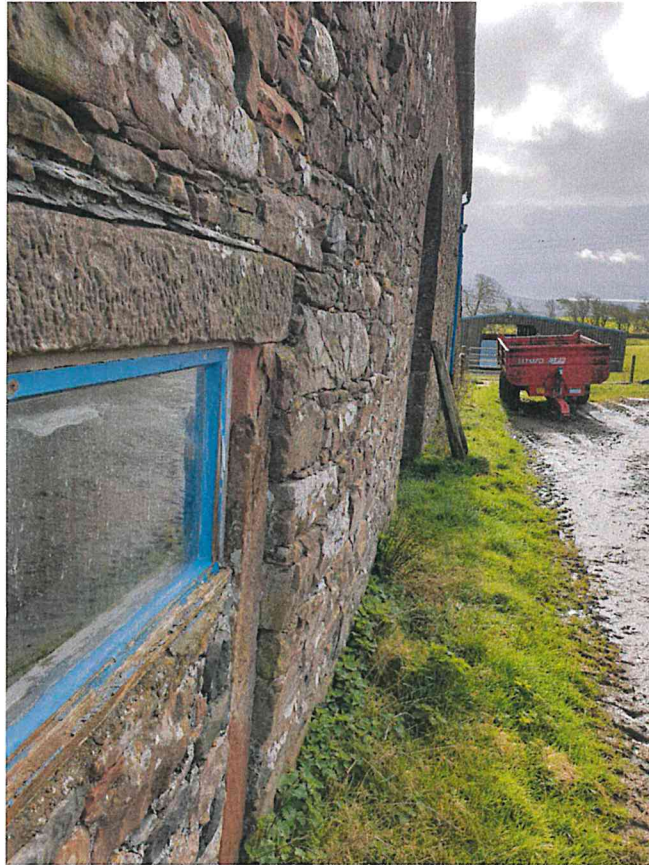
- 2.1** There is a significant outward bow in the rear wall of the barn at the right hand half of the elevation. The movement has caused separation cracking between the rear wall and internal cross wall. In addition the roof king post trusses have shunted which has pulled the front wall out of plumb. The front and rear walls of the barn are over 200mm out of plumb. Furthermore there is a separation crack to the right hand gable at approximately eaves level towards its rear extent. It is likely that the rear wall of the barn has rotated possibly due to inadequate foundations with the movement causing the cracking noted above. Vertical props have been fitted to the King Post Roof Trusses at the wall supports to both the front and rear sides of the building. It appears that the timber props have been bolted to the adjacent masonry walls possibly to enhance lateral stability. The bolts fixing the timber props to the walls appear to be merely fixed into the inner extent of the masonry which raises concerns over their effectiveness in terms of providing lateral restraint to the barn walls. Photographs 01, 02 and 03 in the Appendix show views on the walls and the propping.

PHOTOGRAPH 01 VIEW ON REAR ELEVATION

- 3.1** It is our opinion that the walls to the barn are at risk of collapse. The insertion of the timber props to the roof trusses bolted to the barn walls do offer some limited lateral restraint however with the extent to which the walls are out of plumb we are concerned that the works are insufficient and rely in part on the bolted fixing into the inner face of the barn wall. If the barn is to be retained then we recommend that the front and rear barn walls taken down and are rebuilt plumb and fully tied into the internal and gable walls. The roof structure can be retained and reused. It would be prudent to prevent access into the barn the adjacent external areas until the remedial measures noted above are completed. It will probably prove more cost effective to demolish the barn and byre and rebuild a new modern structure more suited to modern farming.

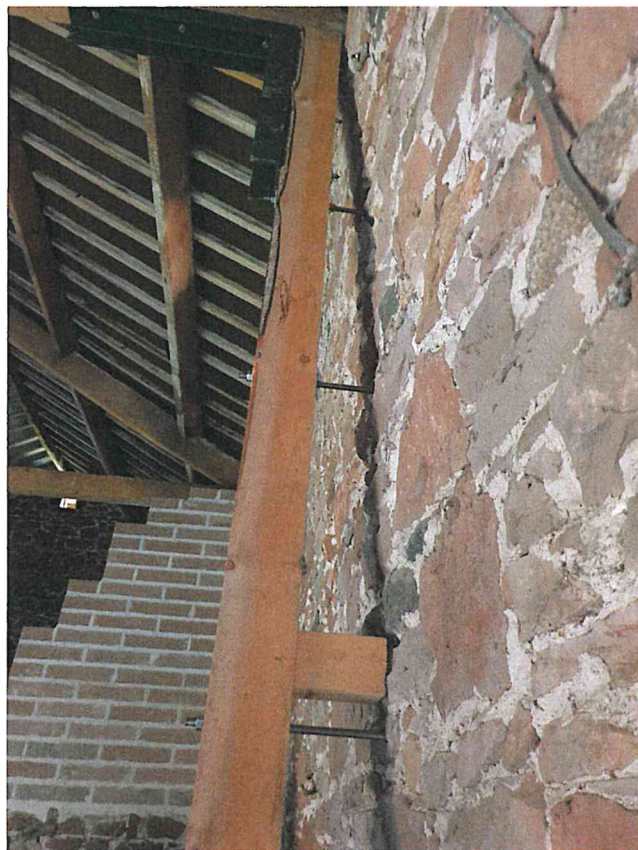
PHOTOGRAPH 02 VIEW ON INNER FACE OF FRONT WALL

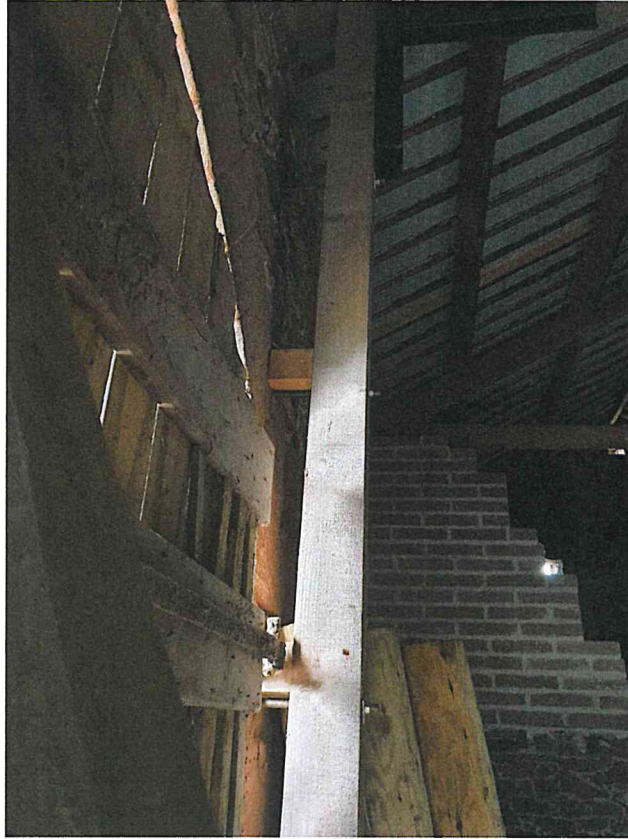
PHOTOGRAPH 03 VIEW ON INTERNAL FACE OF REAR WALL

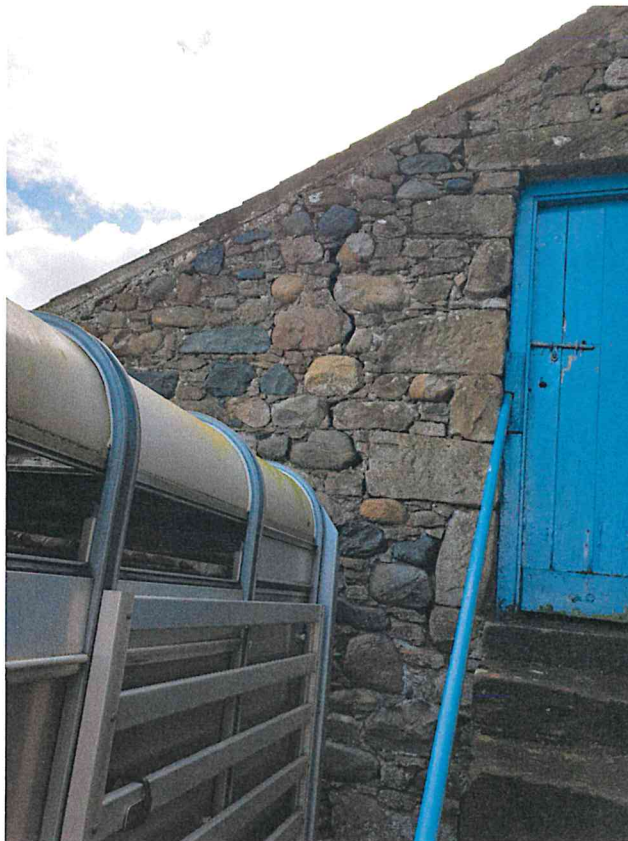
- 2.4** The lean-to off the left hand portion of the front elevation has suffered structural movement, cracking is apparent adjacent to the access door at the top of the stone access steps. The stone access steps are unsafe and very slippery, the handrail is not to any standard and appears loose. We suggest the steps were not used as they are a safety hazard. Photograph 04 in the Appendix shows a typical view on the steps and cracking noted.

PHOTOGRAPH 04 VIEW ON FRONT LEAN TO CRACKING AND STEPS
