**VISUAL STRUCTURAL INSPECTION  
OF  
HAY BARN & BYRE ADJACENT TO  
NEWHOUSE FARM  
DRIGG  
SEASCALE**

**FOR  
AVISON YOUNG**

**Reference - WDS/05/6942/REP 02**

**Date - 31/03/2021**

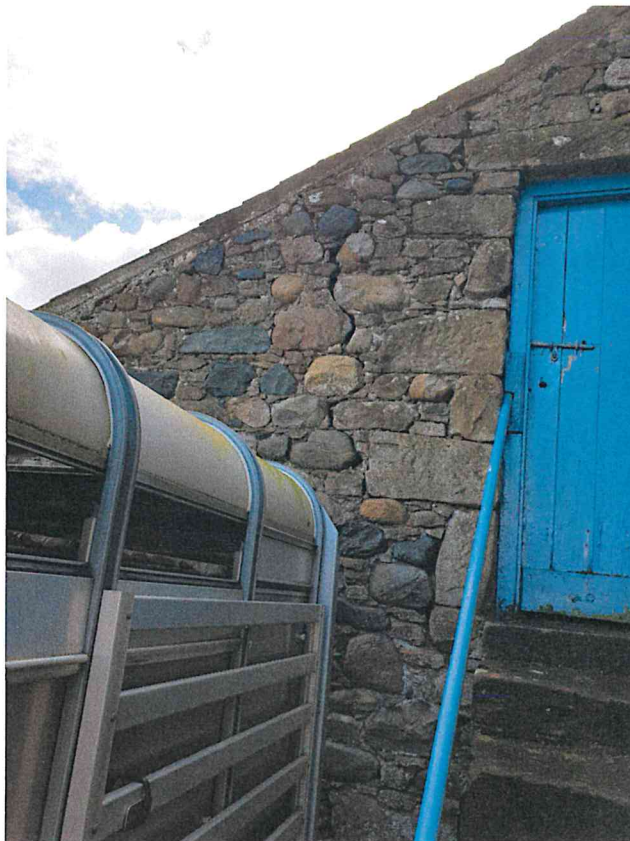
- 2.4** The lean-to off the left hand portion of the front elevation has suffered structural movement, cracking is apparent adjacent to the access door at the top of the stone access steps. The stone access steps are unsafe and very slippery, the handrail is not to any standard and appears loose. We suggest the steps were not used as they are a safety hazard. Photograph 04 in the Appendix shows a typical view on the steps and cracking noted.

PHOTOGRAPH 04 VIEW ON FRONT LEAN TO CRACKING AND STEPS
