Our Ref: WDS/05/6942/LETT002

5th April 2021

RE: Structural Inspection, Cattle Shed, New House Farm Drigg

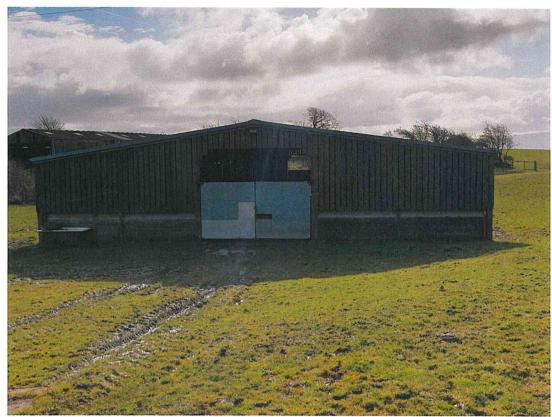
- 1. The inspection was carried out on the 26th March 2021 and was limited to a non-disruptive visual inspection of the property.
- 2. The cattle shed comprises a timber framed structure with metal profiled roof sheets and timber boarded side cladding. Photograph 01 attached shows a view on the front of the property. The building is almost 40 years old.

PHOTO 01 VIEW ON CATTLE SHED

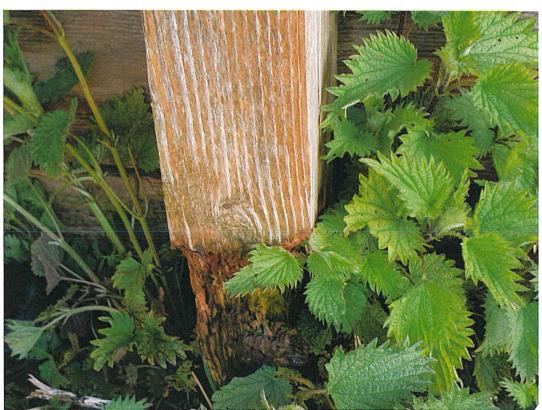
- 4. The base of the timber posts have been set into the ground into the foundation. This has allowed damp to affect the timber column bases which are starting to rot. Photograph 02 shows a typical vies on a timber base.

Considering the above it is our opinion that the timber columns are nearing the end of their life. The rot will worsen with time and the sections will be compromised which will leaf to failure of the timber elements. The columns could be fitted with steel shoes up to unaffected timber and the show bolted to the foundations however this will need carried out to each timber column.

PHOTO 02 TYPICAL VIEW ON AFFECTED COLUMN

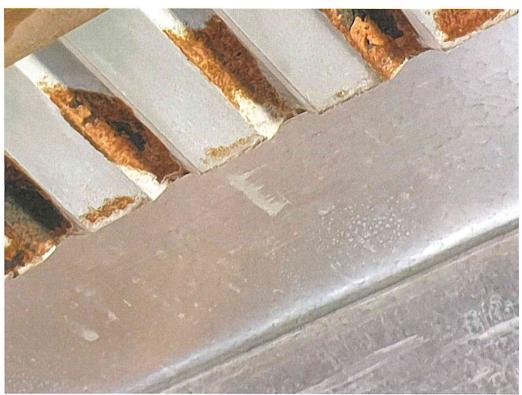
- 5. The roof cladding is rusting, the plastisol coating has been compromised in a number of areas; the steel is rusting and delaminating especially adjacent to the apex. The cladding is nearing the end of its life expectancy. Photograph 03 shows a typical view on the roof cladding.

The roof cladding need replaced in the near future. The rust will compromise the cladding fixings as the affected sheet will weaken and will pull over the fixings in high wind conditions.

This will result in the roof sheets detaching from the building. In addition the weathertightness of the roof will be compromised.

PHOTO 03 VIEW ON ROOF CLADDING
