Our Ref: WDS/05/6942/LETT001

5<sup>th</sup> April 2021

**RE: Structural Inspection, Dutch Barn, New House Farm Drigg**

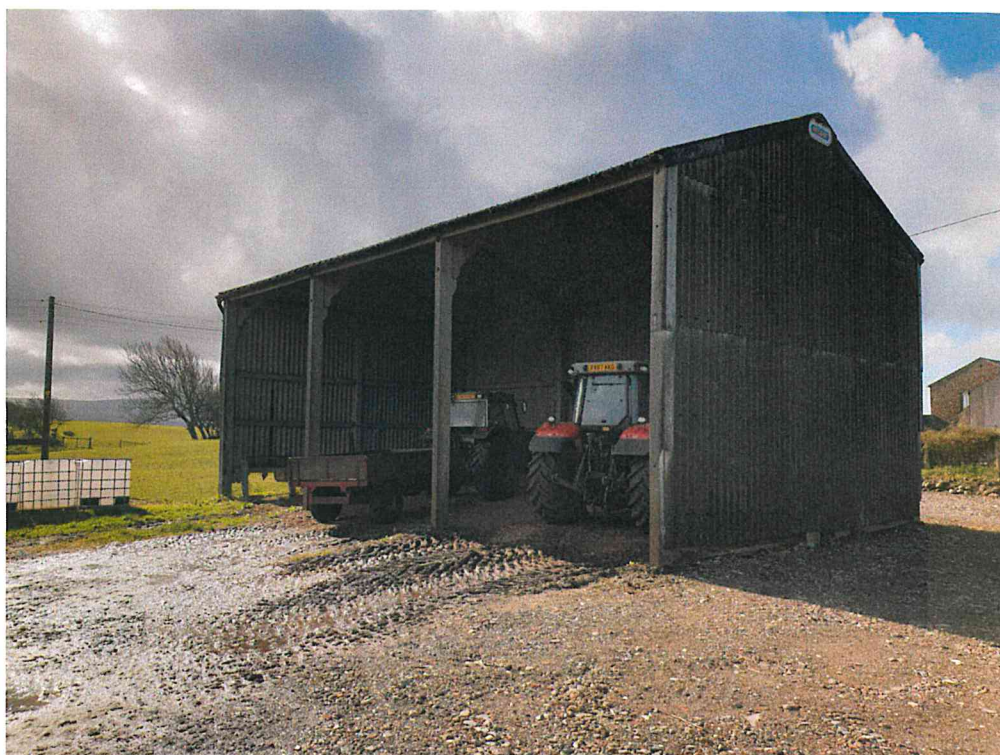
1. The inspection was carried out on the 26<sup>th</sup> March 2021 and was limited to a non-disruptive visual inspection of the property.
2. The barn comprises precast concrete framed structure with precast concrete purlins and side rails which support a cement fibre cladding system. The barn is open on one side and cladded on both gables and rear elevation. Photograph 01 attached shows a view on the front of the property. The building is over 40 years old.

PHOTO 01 VIEW ON DUTCH BARN

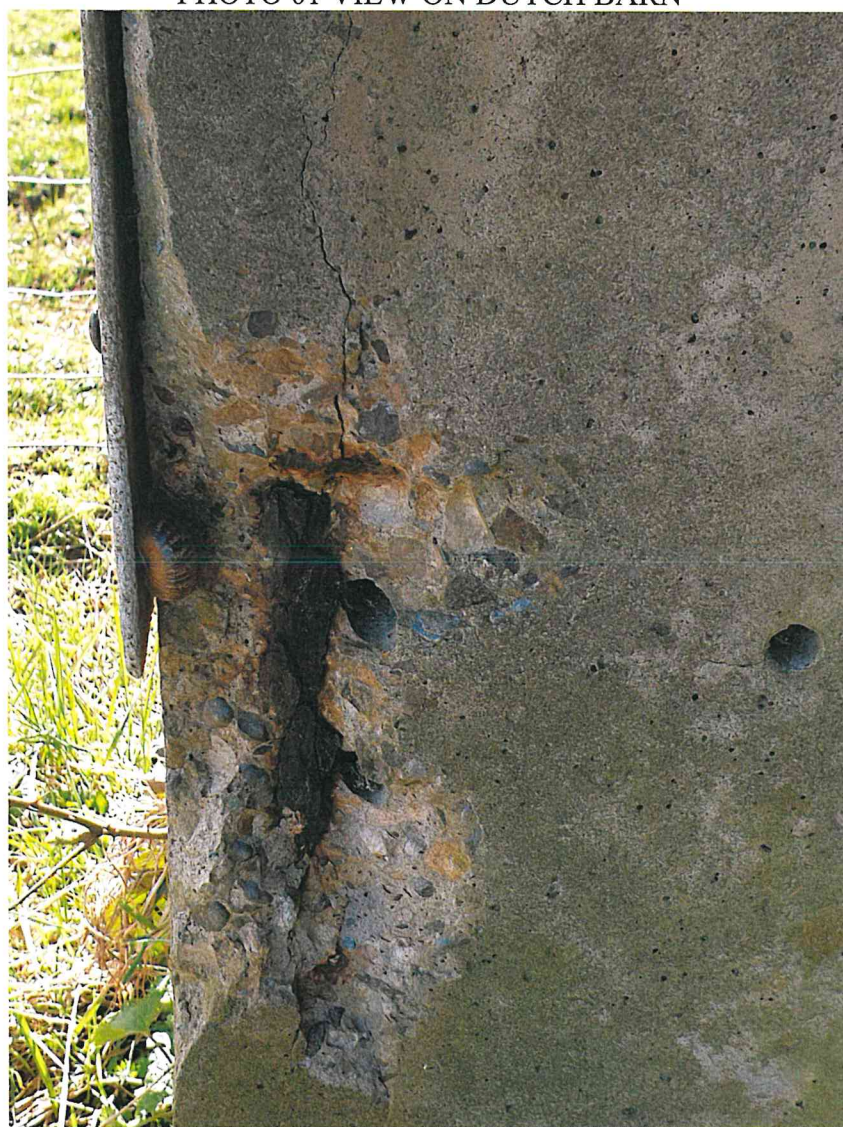
4. The concrete columns, rafters, purlins and side rails to the building have suffered carbonation and spalling of the concrete. The reinforcing bar is exposed in numerous locations and is excessively weathered. Cracking is apparent in a number of location which suggests that the concrete is close to spalling. Photograph 02 attached show a typical view on an affected area.

Considering the above it our opinion that the concrete structure is nearing the end of its life. The sections will further deteriorate as the reinforcement rusts and deteriorates. The building at present is structurally adequate however it will probably need replaced in the next 5 years.

PHOTO 02 TYPICAL VIEW ON AFFECTED CONCRETE

The concrete could be repaired however this will involve cleaning down all affected concrete areas and removing loose and cracked concrete to at least 10mm behind the embedded rebar and removing all rust and applying a rust inhibiting paint to the rebar prior to reinstating the

section with a non-shrink cementitious grout. Where the rebar is excessively corroded the bar will need replaced and a new similar rebar section spliced into place prior to reinstating the section as noted above. This will be a costly exercise and may only extend the life expectancy by a further 10 years. It probably more cost effective to replace the building than refurbish.
