VISUAL STRUCTURAL INSPECTION

**NEWHOUSE FARM HOUSE
DRIGG
SEASCALE**

Reference - WDS/05/6942/REP 01

Date - 31/03/2021

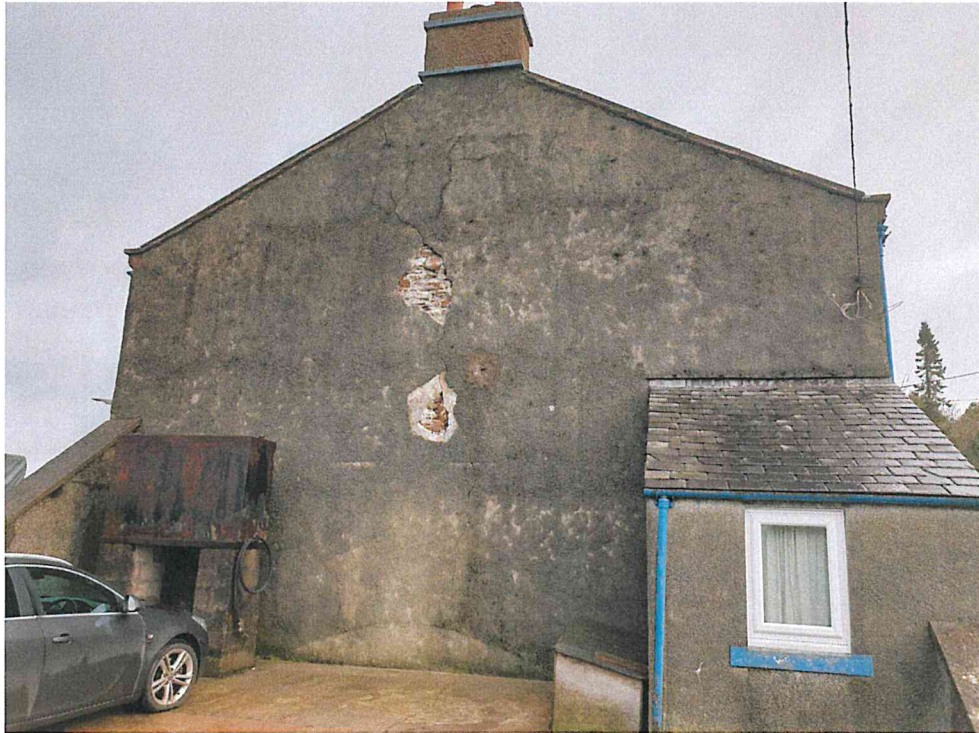
- 2.1 There is a significant outward bulge in the right hand gable wall with a full height crack apparent. Localised areas of render have been removed to reveal the cracks is evident in the masonry also, in addition the masonry appears loose where exposed. Neither the bulge or cracking are evident on the internal face which suggests the outer extent of the masonry has separated from the inner. In its current condition the wall is at risk of localised collapse. See photograph 01 in the appendix.

PHOTOGRAPH 01 VIEW ON RIGHT HAND GABLE

- 3.2 The right hand gable wall in its current condition is at risk of localised collapse. With this, we recommend that the farm yard is cordoned off beneath the gable for a distance of at least 15m to protect personnel from potential falling masonry. Should the wall collapse then there is a potential for the floor and roof elements supported on the wall to collapse also. It would therefore be prudent to vacate the property until the gable has been repaired. In terms of repair we recommend that the gable is rebuilt. Judging by the poor condition of the masonry exposed then this may result in the majority of the gable needing rebuilt. It may be that only the outer extent of the masonry will need rebuilt however this can not be confirmed until demolition works expose the condition of the inner extent of the masonry wall. Obviously the roof and floor

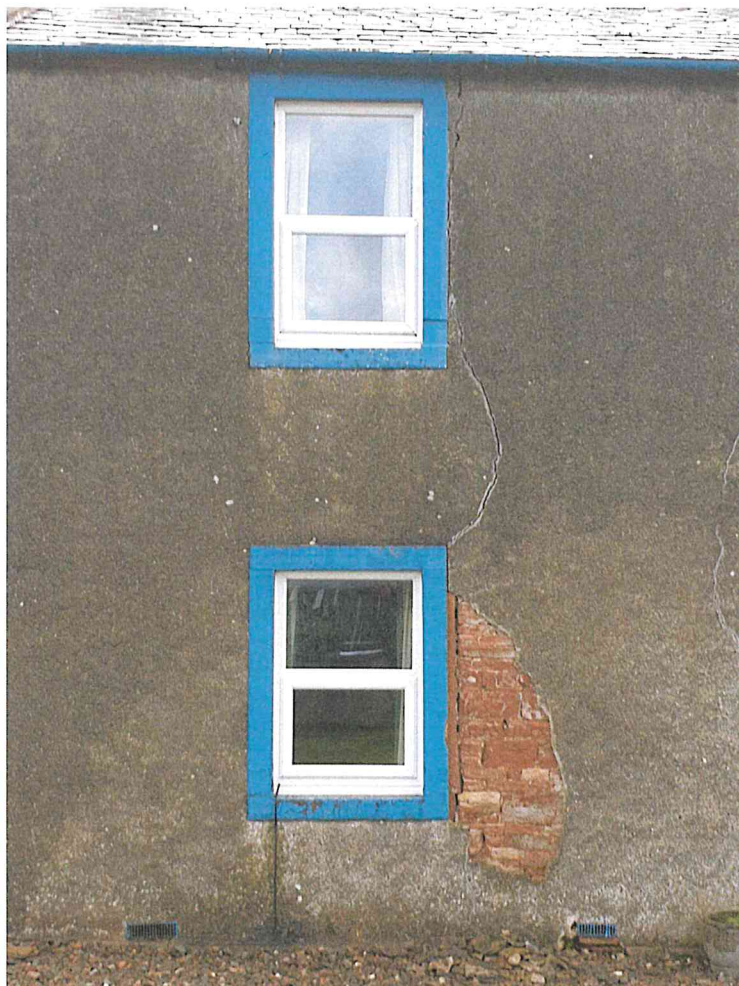
- 2.2 There are significant full height cracks to the front elevation and left hand gable, see photographs 02 & 03 in the Appendix. There are separation cracks in the internal walls where they abut the front elevation. The extent and nature of the cracks are consistent with structural movement/subsidence. We understand that the front and left hand gable walls have been recently underpinned. Avanguard Tell Tales have been fitted across the cracks within the property. We understand that these have not been read since the property

PHOTOGRAPH 02 VIEW ON CRACK TO FRONT ELEVATION

- 3.1 It is likely that the property has been subject to significant structural movement. It is unclear whether this movement is still ongoing however the lack of significant new cracking to the internal elevations suggests that movement may have ceased. However before a suitable repair specification can be recommended further movement must be discounted. We therefore recommend that the Avanguard 'Tell Tale' crack monitoring gauges currently fixed to the front wall within the bedroom are monitored over a 12 months period to check for further movement. Two further gauges should be fitted to the cracking to the left hand gable wall and monitored also. Readings should be recorded at three-week intervals over the period noted. If movement has ceased then the cracked masonry will need re-tied by installing 750mm long concrete Spanlite lintels into the wall (each face) across the crack location at 650mm vertical centres. The crack should then be filled with a non-shrink grout and Expamet fixed to the wall across the crack location prior to re-rendering.
