**VISUAL STRUCTURAL INSPECTION**

**NEWHOUSE FARM HOUSE  
DRIGG  
SEASCALE**

**AVISON YOUNG**

**Reference - WDS/05/6942/REP 01**

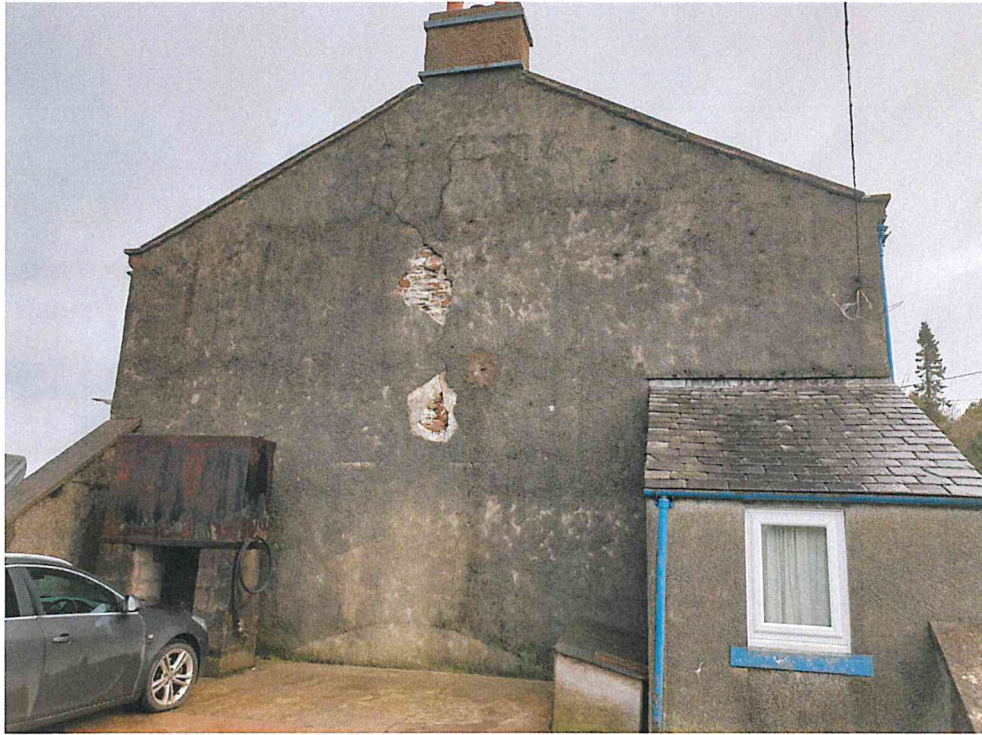
- 2.1 There is a significant outward bulge in the right hand gable wall with a full height crack apparent. Localised areas of render have been removed to reveal the cracks is evident in the masonry also, in addition the masonry appears loose where exposed. Neither the bulge or cracking are evident on the internal face which suggests the outer extent of the masonry has separated from the inner. In its current condition the wall is at risk of localised collapse. See photograph 01 in the appendix.

PHOTOGRAPH 01 VIEW ON RIGHT HAND GABLE

- 3.2 The right hand gable wall in its current condition is at risk of localised collapse. With this, we recommend that the farm yard is cordoned off beneath the gable for a distance of at least 15m to protect personnel from potential falling masonry. Should the wall collapse then there is a potential for the floor and roof elements supported on the wall to collapse also. It would therefore be prudent to vacate the property until the gable has been repaired. In terms of repair we recommend that the gable is rebuilt. Judging by the poor condition of the masonry exposed then this may result in the majority of the gable needing rebuilt. It may be that only the outer extent of the masonry will need rebuilt however this can not be confirmed until demolition works expose the condition of the inner extent of the masonry wall. Obviously the roof and floor

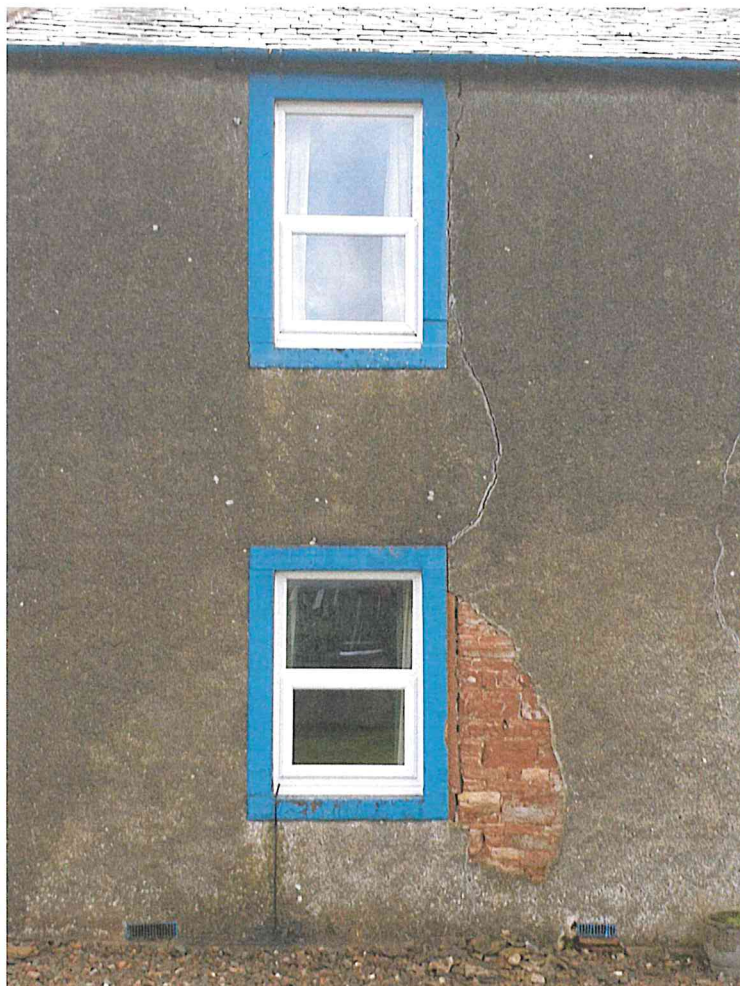
- 2.2 There are significant full height cracks to the front elevation and left hand gable, see photographs 02 & 03 in the Appendix. There are separation cracks in the internal walls where they abut the front elevation. The extent and nature of the cracks are consistent with structural movement/subsidence. We understand that the front and left hand gable walls have been recently underpinned. Avanguard Tell Tales have been fitted across the cracks within the property. We understand that these have not been read since the property

PHOTOGRAPH 02 VIEW ON CRACK TO FRONT ELEVATION

- 3.1 It is likely that the property has been subject to significant structural movement. It is unclear whether this movement is still ongoing however the lack of significant new cracking to the internal elevations suggests that movement may have ceased. However before a suitable repair specification can be recommended further movement must be discounted. We therefore recommend that the Avanguard 'Tell Tale' crack monitoring gauges currently fixed to the front wall within the bedroom are monitored over a 12 months period to check for further movement. Two further gauges should be fitted to the cracking to the left hand gable wall and monitored also. Readings should be recorded at three-week intervals over the period noted. If movement has ceased then the cracked masonry will need re-tied by installing 750mm long concrete Spanlite lintels into the wall (each face) across the crack location at 650mm vertical centres. The crack should then be filled with a non-shrink grout and Expamet fixed to the wall across the crack location prior to re-rendering.

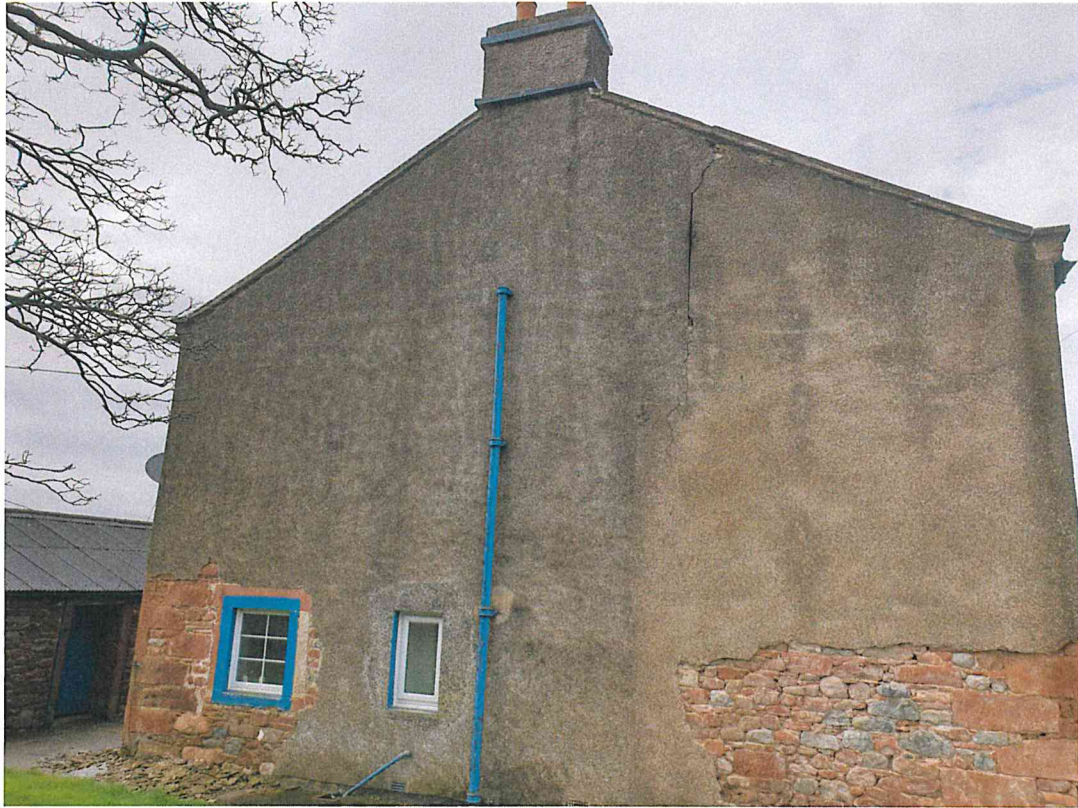
PHOTOGRAPH 03 VIEW ON LEFT HAND GABLE CRACKS

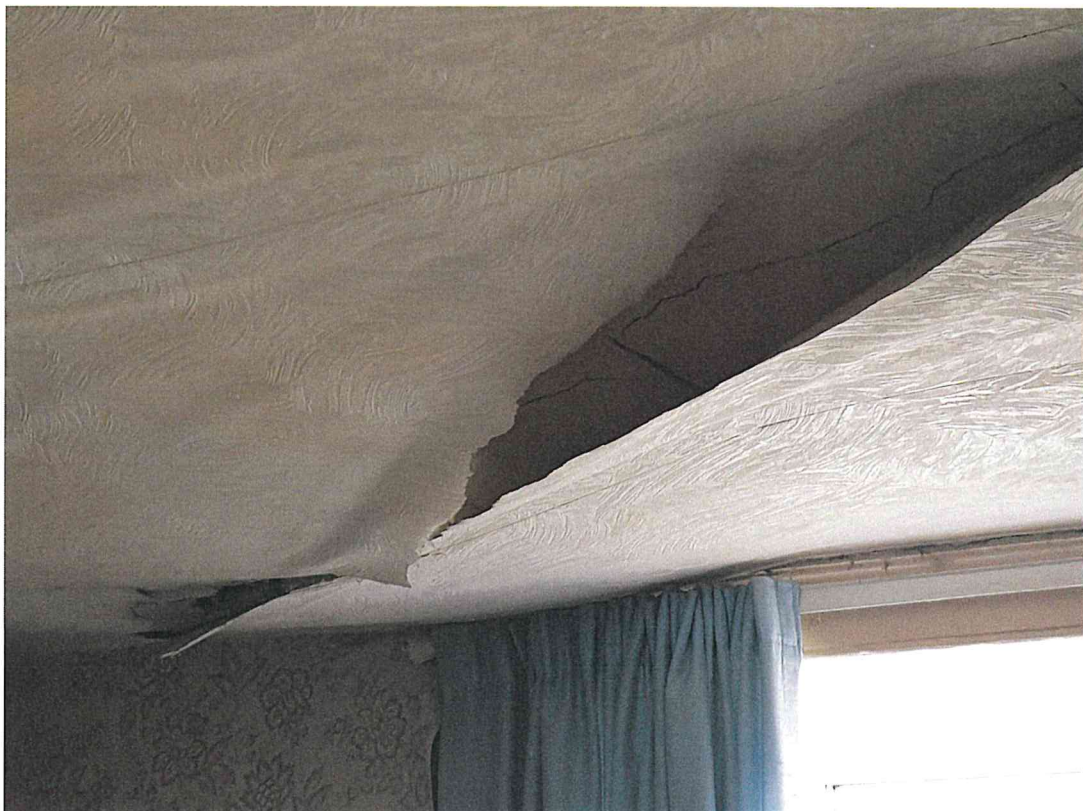
- 2.3 The property is in need of total refurbishment and modernisation. The internal finishes have been significantly affected by both penetrative damp and high humidity levels. The ceiling plaster is debonding in various areas and mildew growth is apparent throughout. See photographs 04 & 05 in the appendix.
- 2.4 The roof structure appears structurally adequate. The timber first floor structure deflects excessively when walked upon which is common in properties of this age and type. Considering the age of the property and condition rot and infestation of the timber elements cannot be discounted, further inspection by a timber specialist would be prudent.

PHOTOGRAPH 04 VIEW ON CEILING FINISH TYPICAL

- 3.3** The house is in need of total refurbishment this should include replacement of all internal plaster finishes with a suitable insulated system, the inclusion of a DPC at ground floor level to all walls, the replacement of the ground floor stone slabs with insulated concrete slabs with integral DPM, the replacement of the windows and doors and the replacement of the external render. The new render should be a lime based system to allow the house to breathe and help combat high humidity issues. As part of any refurbishment we recommend that a timber specialist is appointed to check the property for rot and infestation to allow any affected timber elements to be repaired. It may be prudent to strengthen the first floor joists as part of any refurbishment scheme

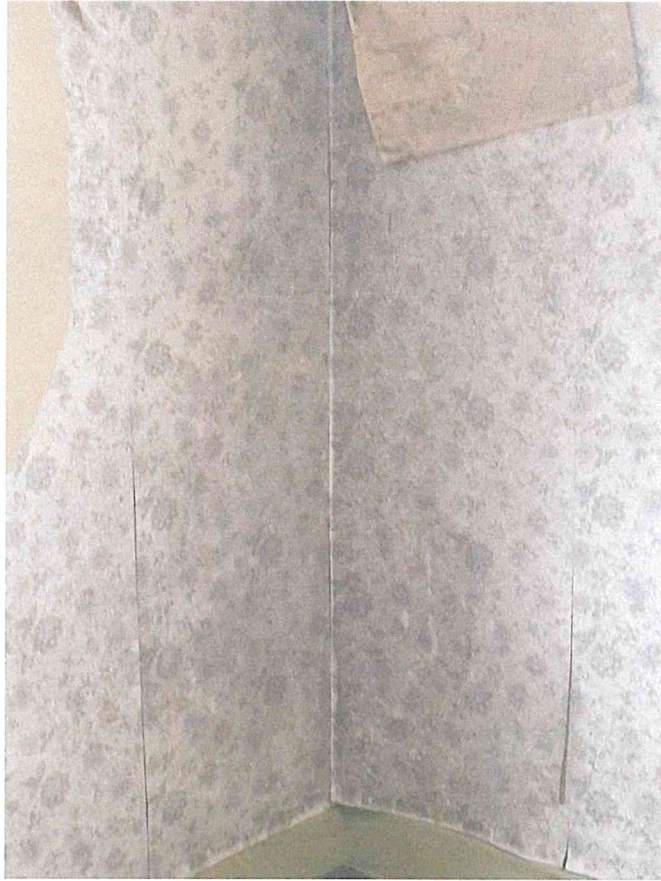
PHOTOGRAPH 05 VIEW ON MILDEW AND DAMP TYPICAL.
