VISUAL STRUCTURAL INSPECTION

**NEWHOUSE FARM HOUSE OUTBUILDING
DRIGG
SEASCALE**

Reference - WDS/05/6942/REP 03

Date - 31/03/2021

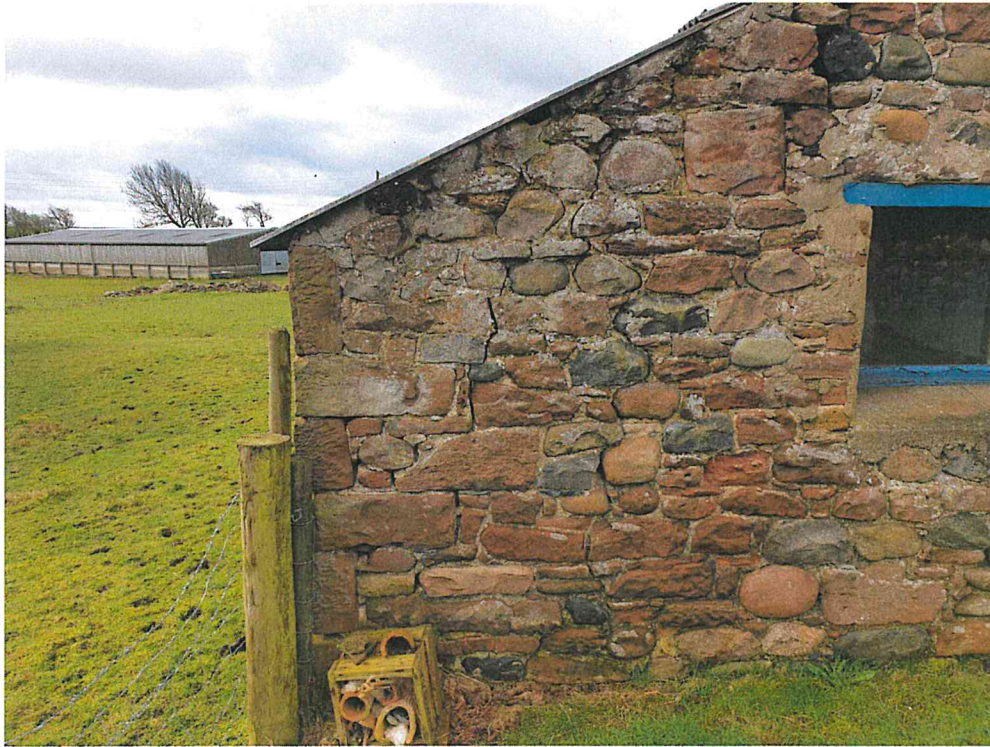
- 2.1 The rear wall to the property has suffered some movement in the past which has caused separation cracking with the gable and internal walls. Photographs 01 and 02 show views on the cracking apparent.
- 2.2 The masonry generally is weathered and needs repointed. A number of the timber lintels have been affected by rot and need replaced. The gable window lintel has deflected excessively causing cracking to the masonry over. Photograph 03 shows a view on the lintel.
- 2.3 The roof structure appears generally adequate although the purlins have suffered creep. The replacement of the original slate finish with a cement board system has reduced the weight on the roof structure.

PHOTOGRAPH 01 VIEW ON LEFT AND GABLE CRACKING

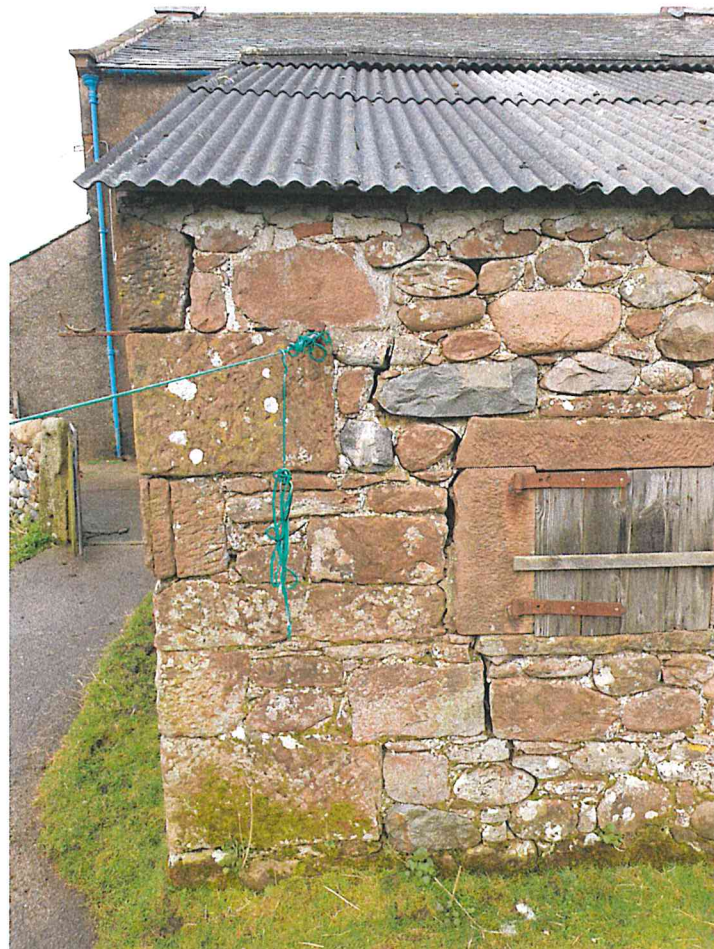
PHOTOGRAPH 02 VIEW ON CRACK TO REAR CORNER

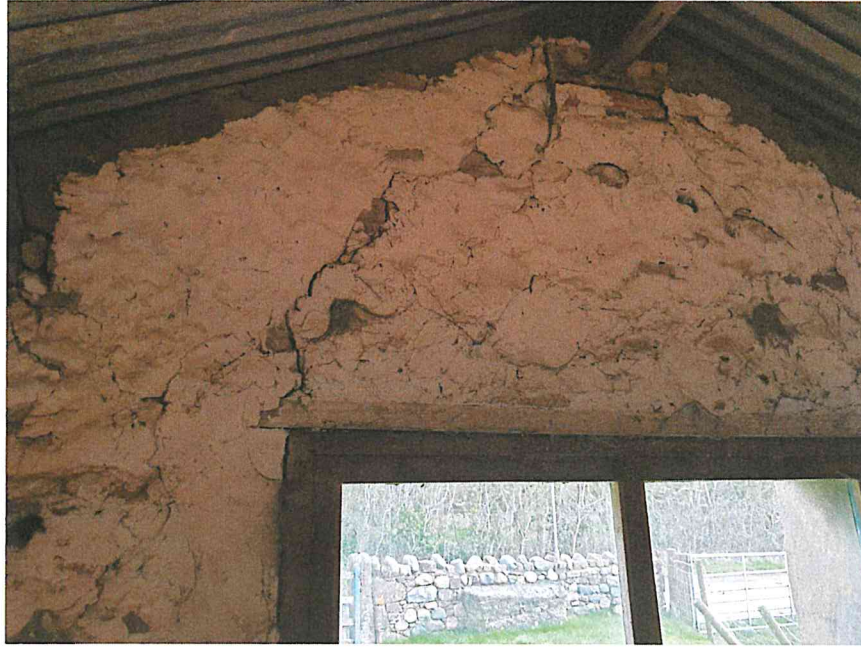
PHOTOGRAPH 03 VIEW ON GABLE LINTEL & CRACKING

- 3.1** The property although weathered and affected by historic movement is structurally adequate at present. Other than the replacement of the timber lintels with precast concrete sections, no remedial measures are deemed essential at this time.
