**VISUAL STRUCTURAL INSPECTION**

**NEWHOUSE FARM HOUSE OUTBUILDING  
DRIGG  
SEASCALE**

**Reference - WDS/05/6942/REP 03**

**Date - 31/03/2021**

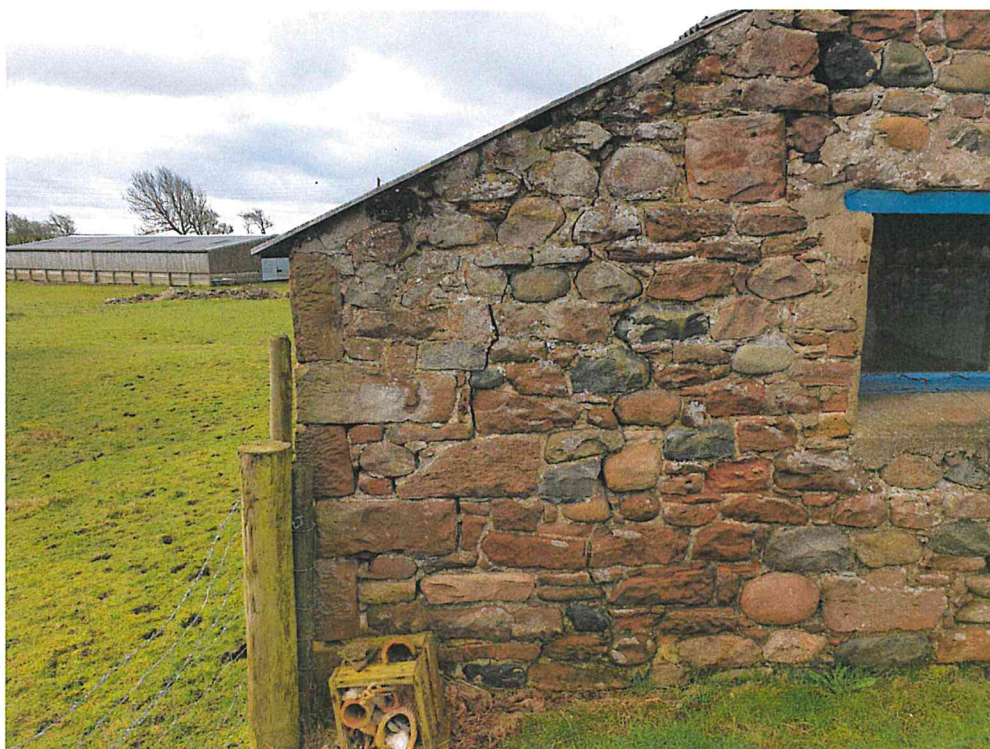
- 2.1** The rear wall to the property has suffered some movement in the past which has caused separation cracking with the gable and internal walls. Photographs 01 and 02 show views on the cracking apparent.
- 2.2** The masonry generally is weathered and needs repointed. A number of the timber lintels have been affected by rot and need replaced. The gable window lintel has deflected excessively causing cracking to the masonry over. Photograph 03 shows a view on the lintel.
- 2.3** The roof structure appears generally adequate although the purlins have suffered creep. The replacement of the original slate finish with a cement board system has reduced the weight on the roof structure.

PHOTOGRAPH 01 VIEW ON LEFT AND GABLE CRACKING

- 3.1** The property although weathered and affected by historic movement is structurally adequate at present. Other than the replacement of the timber lintels with precast concrete sections, no remedial measures are deemed essential at this time.

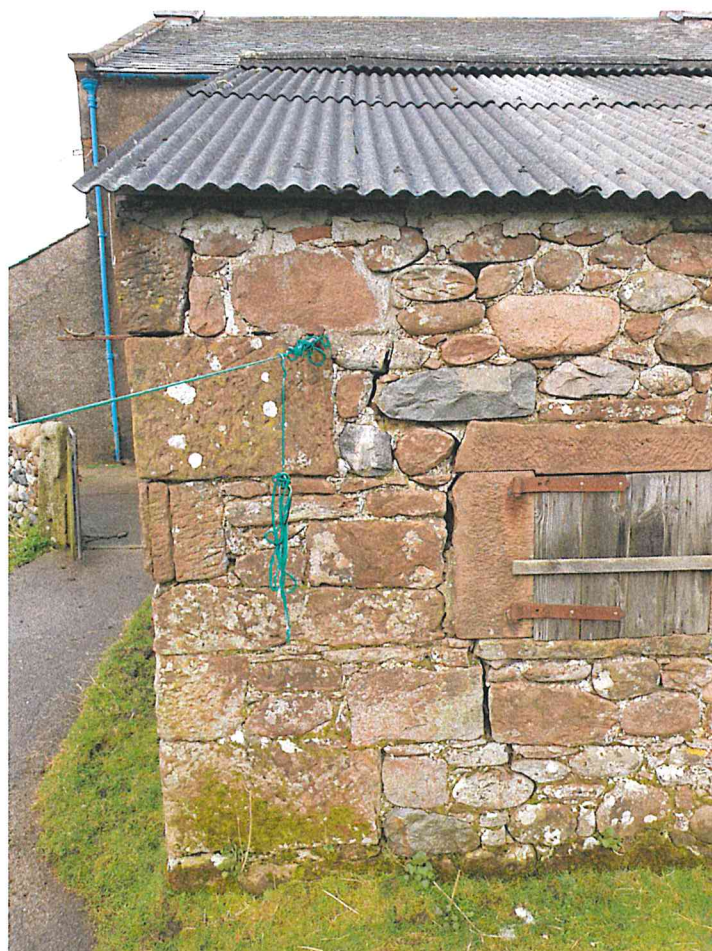
PHOTOGRAPH 02 VIEW ON CRACK TO REAR CORNER
