## **VISUAL STRUCTURAL INSPECTION**

**NEWHOUSE FARM HOUSE PIGGERY  
DRIGG  
SEASCALE**

**AVISON YOUNG**

**Reference - WDS/05/6942/REP 04**

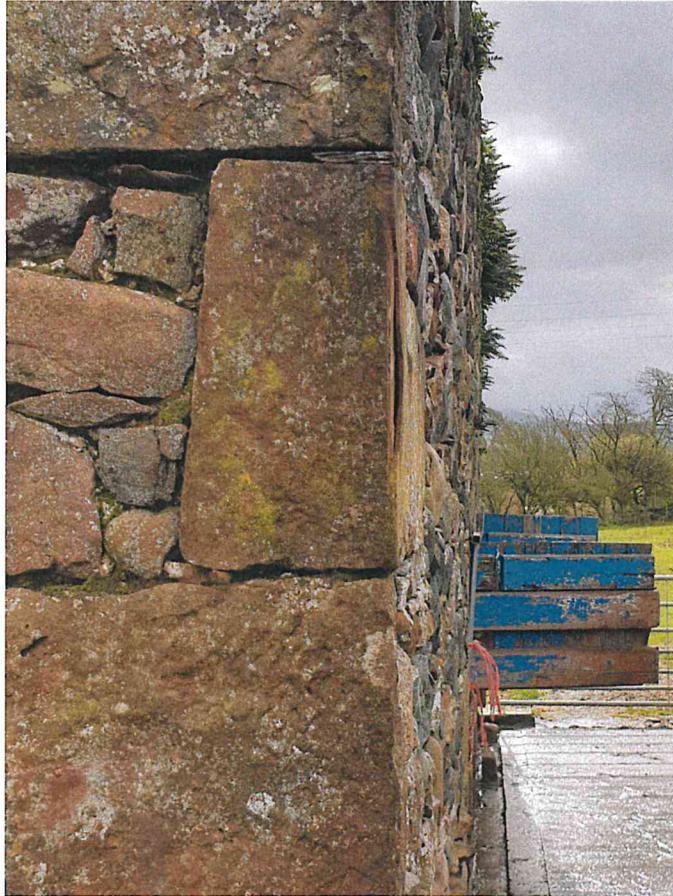
- 2.1 The property is in a very poor structural condition. The masonry is heavily weathered and the front wall is significantly out of plumb and has pulled away from the gables and internal walls. Photographs 01 & 02 in the Appendix show views on the front wall and cracking.
- 2.2 The lintel to the gable has perished and the masonry over loose and has fallen away. See photograph 03 in the Appendix
- 2.3 The roof purlins have suffered from creep and have some infestation. One purlin has failed, see photograph 04 in the Appendix. The roof needs replaced.

PHOTOGRAPH 01 VIEW ON BULGE TO FRONT ELEVATION

- 3.1** The property is in a poor condition. The roof needs replaced and the front elevation rebuilt and re-tied to the gable and internal walls. In addition the lintels need replaced. Considering the above it would be more cost effective to demolish the building and replace it with a new framed structure.

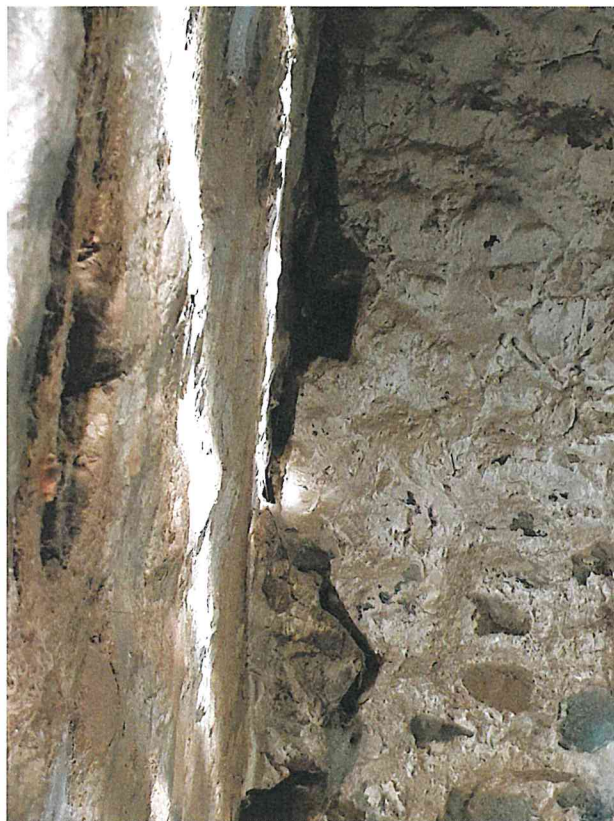
PHOTOGRAPH 02 VIEW ON SEPARATION CRACKING

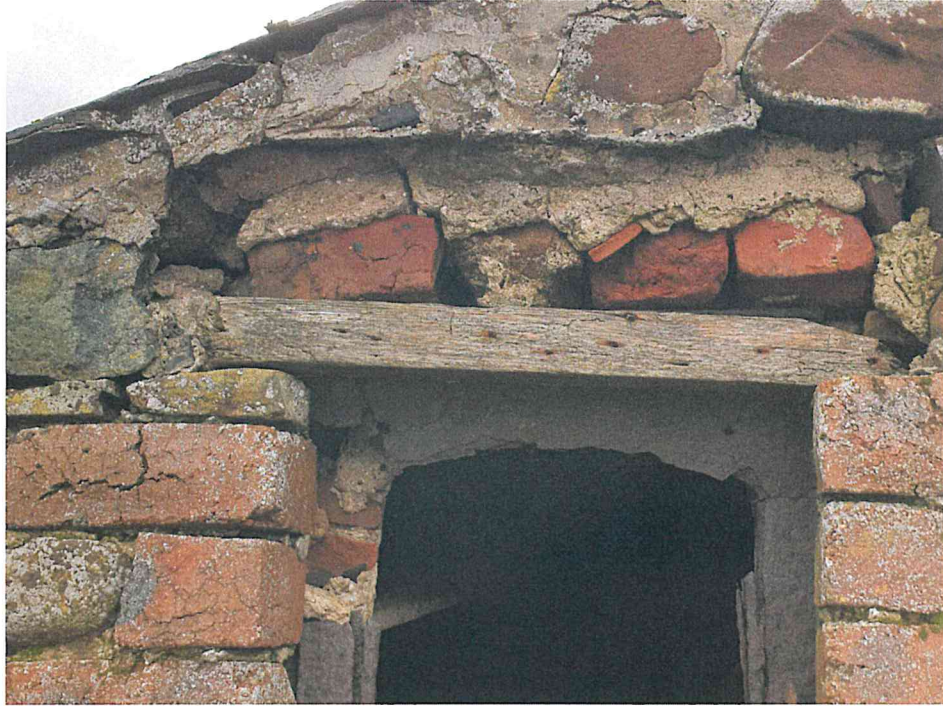
PHOTOGRAPH 03 GABLE WINDOW LINTEL

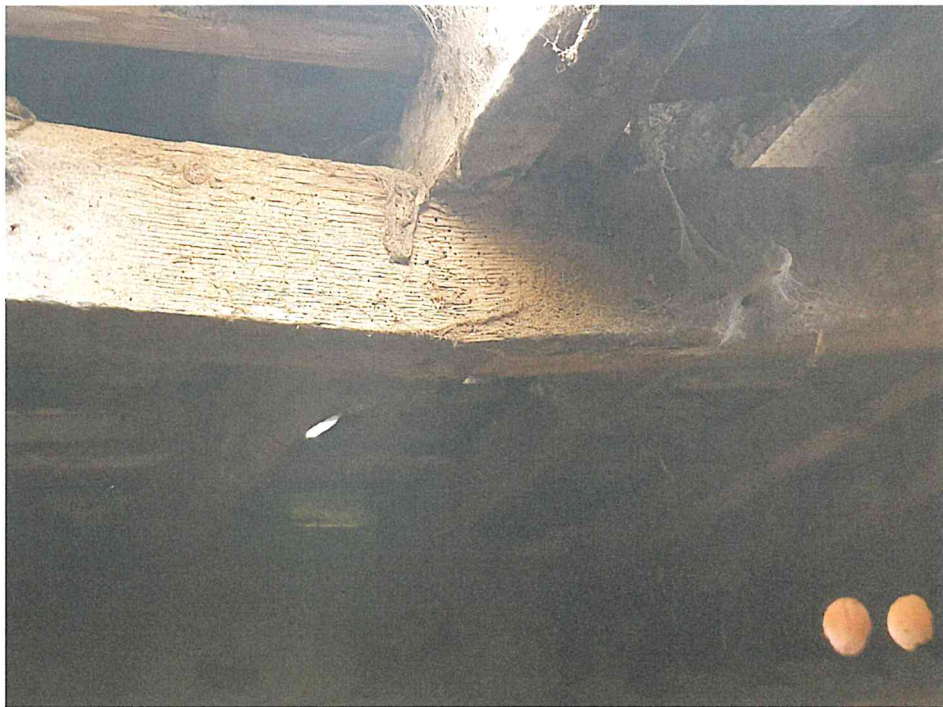
PHOTOGRAPH 04 FAILED ROOF PURLIN
