**Cumberland Council**  
**Ash Dieback Assessment**  
**New Road**  
**Whitehaven**  
**October 2025**

1.1 This New Road Ash Dieback Assessment has been commissioned by Cumberland Council, Parks and Open Spaces, Allerdale House, Workington.

1.2 The assessment commissioned to assess Ash, *Fraxinus excelsior*, tree specimens situated within Cumberland Council amenity woodlands to the east and west of New Road Whitehaven. The Ash dieback inspection assessment being undertaken from ground level with no exploratory excavation works undertaken.

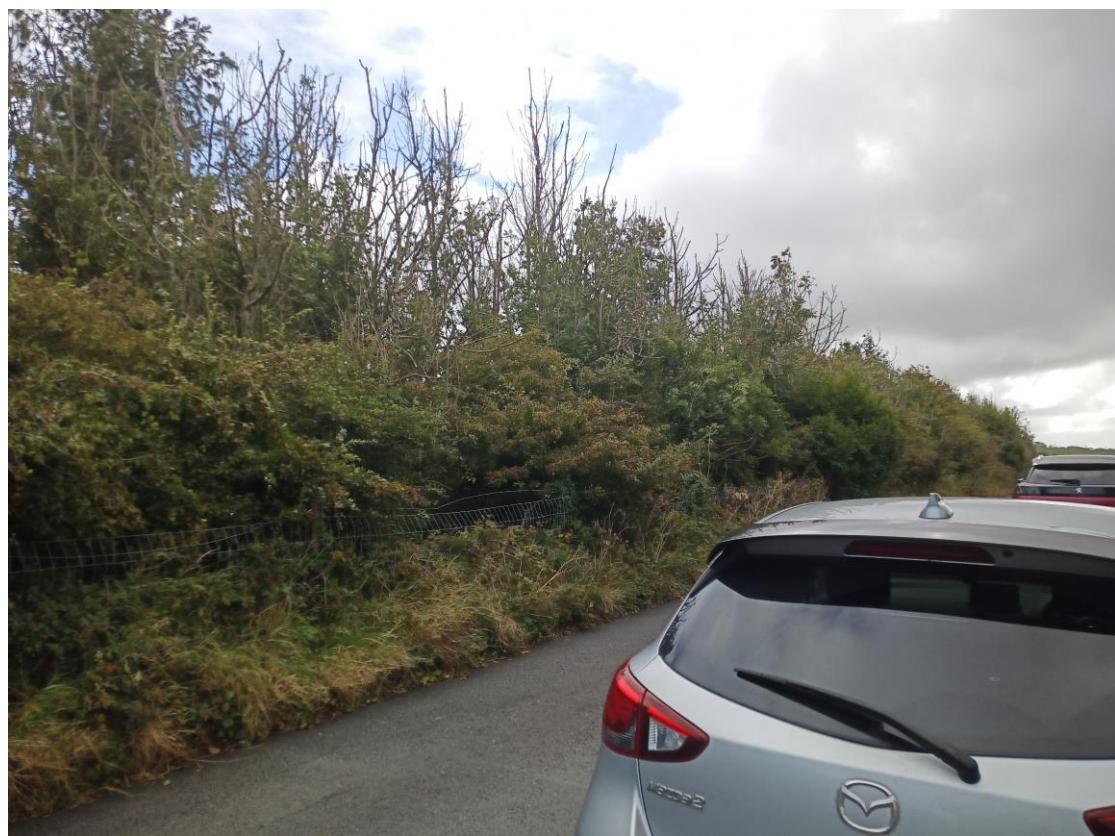
Tree Number	Species	Life Stage	Arboricultural Observations and Comments	Condition	Ash Dieback Stage	Arboricultural Recommendations
T001	Common ash ( <i>Fraxinus excelsior</i> )	Semi Mature	Linear group of Ash specimens parallel with highway. Extensive deadwood present with evidence of stage 4 Ash dieback at time of inspection. The group consists of a number of dead secondary stems / branches potentially within falling distance of highway. The area is an exposed location with the potential for windblow branches to fall onto highway and parked cars.	Poor	4	Prune to crown clean and remove deadwood.
T002	Mixed species 'Ash' ( <i>Mixed species</i> )	Semi Mature	Linear group of Ash specimens parallel with highway. Extensive deadwood present with evidence of stage 4 Ash dieback at time of inspection. The group consists of a number of dead secondary stems / branches potential within falling distance of highway. The area is an exposed location with the potential for windblow branches to fall onto highway and parked cars.	Poor	4	Prune to crown clean and remove deadwood.

T001. Linear group of Ash specimens parallel with The Crescent. Extensive deadwood present with evidence of stage 4 Ash dieback at time of inspection. The group consists of a number of dead secondary stems / branches potentially within falling distance of highway. Prune to crown clean and remove deadwood.

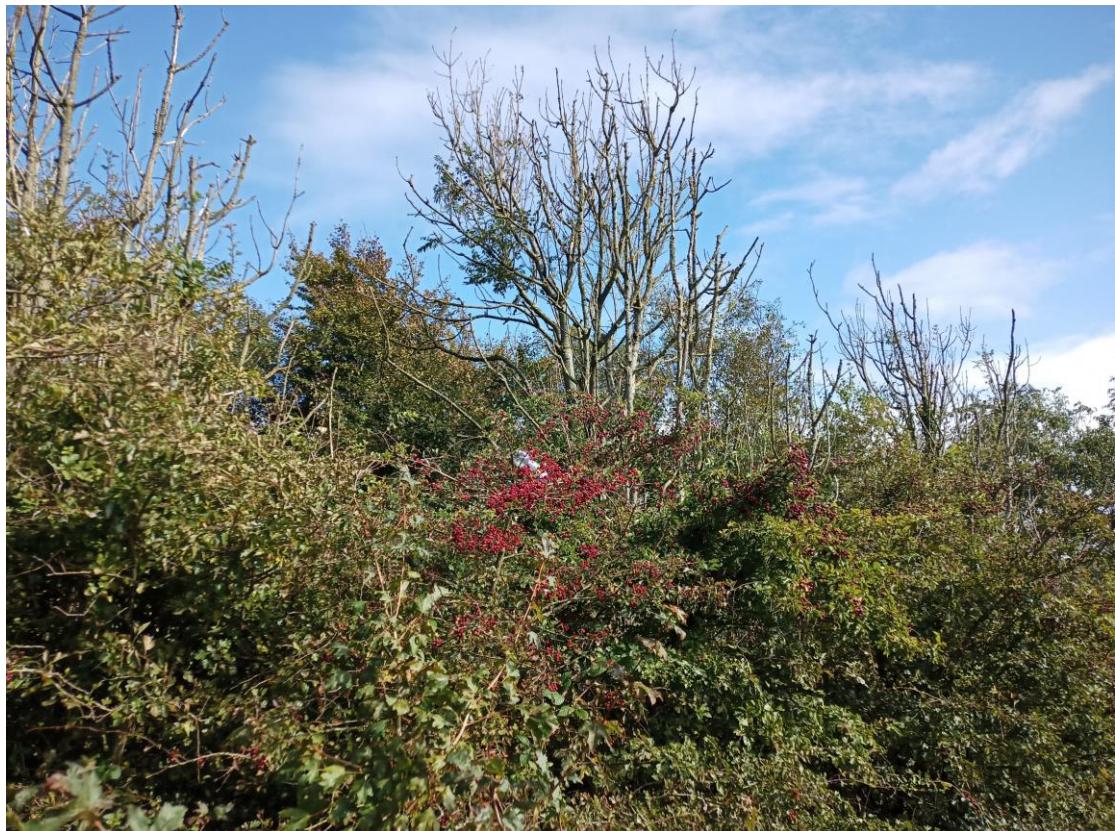
T007	Common ash x6 ( <i>Fraxinus excelsior</i> )	Semi Mature	Group of multi stemmed specimens set back from and within falling distance of footpath. Extensive scrub growth to base. Extensive deadwood present with evidence of stage 4 Ash dieback at time of inspection. Stems potential within falling distance of footpath.	Poor	4	Monitor.
T008	Common ash ( <i>Fraxinus excelsior</i> )	Semi Mature	Single stemmed specimen set back from and within falling distance of footpath. Extensive scrub growth to base. Extensive deadwood present with evidence of stage 4 Ash dieback at time of inspection.	Poor	4	Fell.
T009	Common ash x6 ( <i>Fraxinus excelsior</i> )	Semi Mature	Group of 6 specimens set back from and within falling distance of footpath. Extensive scrub growth to base. Specimens with good crown leaf cover. Evidence of stage 1 Ash dieback at time of inspection.	Fair	1	Monitor due to the presence of Ash dieback

T007. Group of multi stemmed specimens set back from and within falling distance of footpath. Monitor recommended.

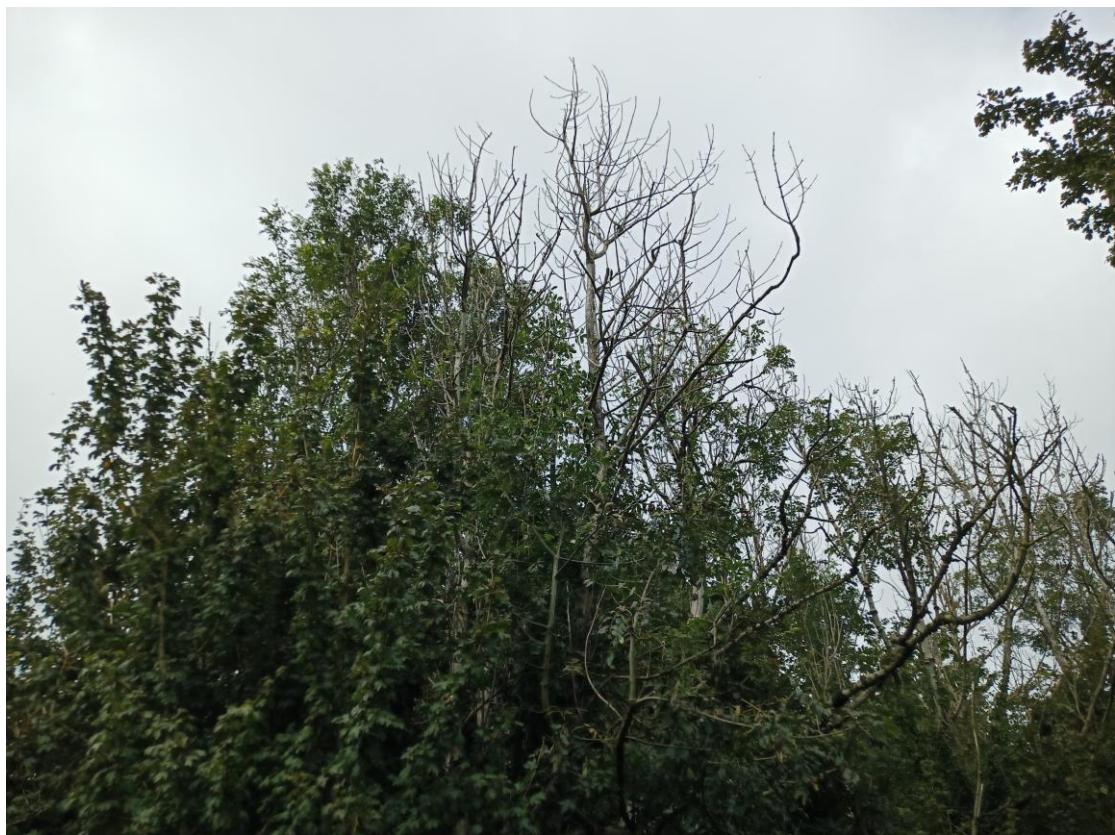
Tree Number	Species	Life Stage	Arboricultural Observations and Comments	Condition	Ash Dieback Stage	Arboricultural Recommendations
T010	Common ash ( <i>Fraxinus excelsior</i> )	Semi Mature	Twin stemmed specimen set back from and within falling distance of footpath. Extensive scrub growth to base. Extensive deadwood present with evidence of stage 4 Ash dieback at time of inspection.	Poor	4	Fell.
T011	Common ash x20 ( <i>Fraxinus excelsior</i> )	Semi Mature	Group on embankment and it within falling distance of pavement or A585. Evidence of stage 3 / 4 Ash dieback at time of inspection.	Poor	4	Monitor due to the presence of Ash dieback.
T012	Common ash x4 ( <i>Fraxinus excelsior</i> )	Semi Mature	Group of specimen offset to north of lighting column D182. Group just within falling distance of pavement. Evidence of stage 4 Ash dieback at time of inspection.	Poor	4	Fell.
T013	Common ash ( <i>Fraxinus excelsior</i> )	Semi Mature	Twin stemmed specimen set back from and within falling distance of pavement and A595. Extensive scrub growth to base. Extensive deadwood present with evidence of stage 4 Ash dieback at time of inspection.	Poor	4	Fell.

T010. Twin stemmed specimen set back from and within falling distance of footpath.

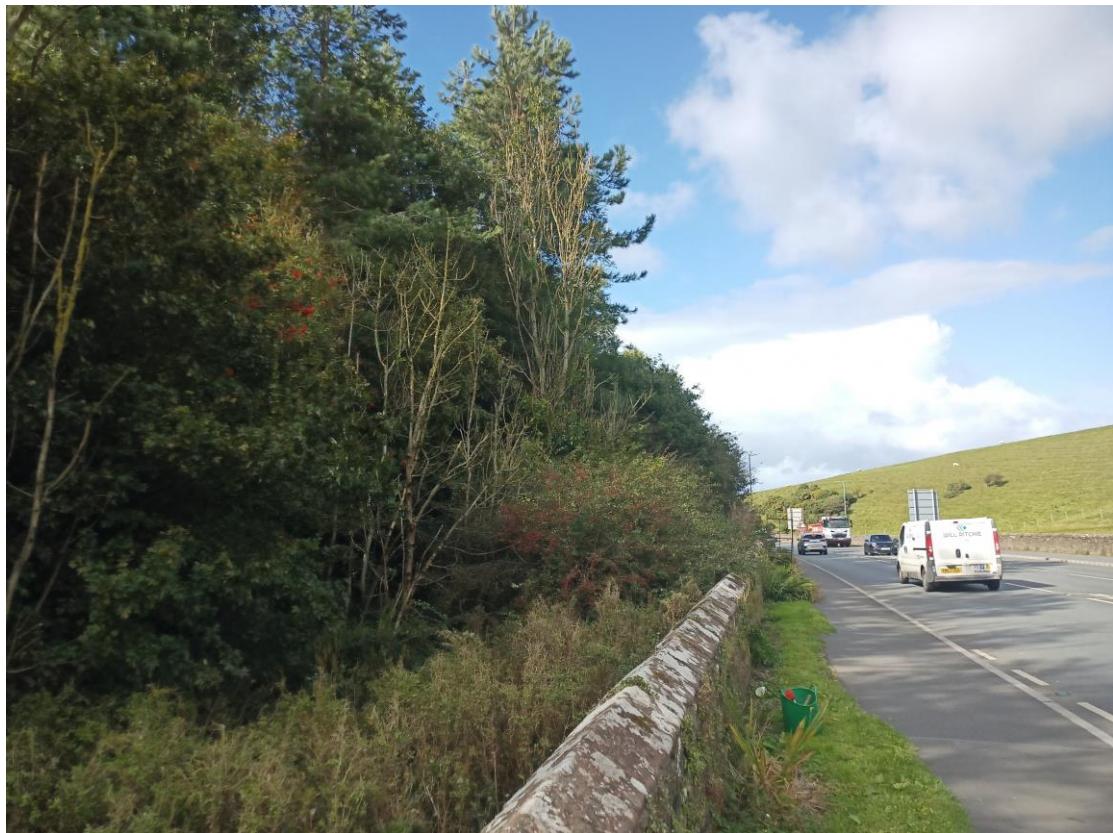
T013. Twin stemmed specimen set back from and within falling distance of pavement and A595. Fell recommended.

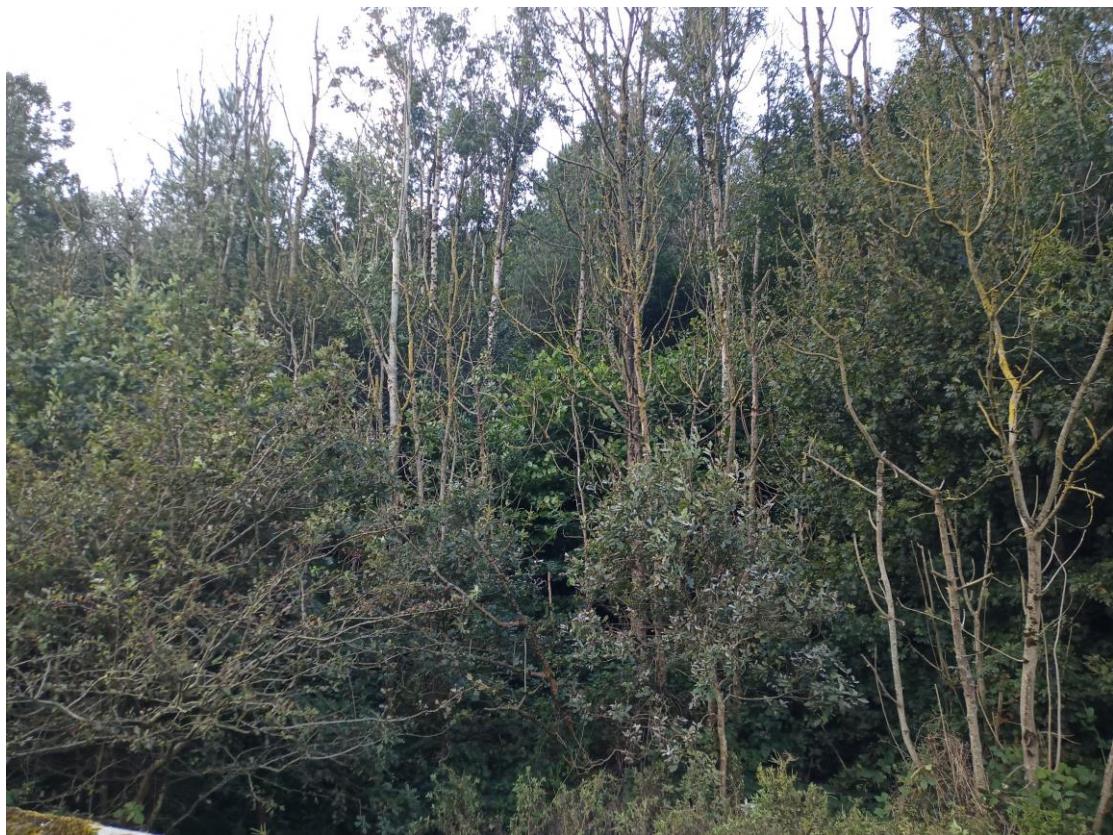
T014	Common ash x30 ( <i>Fraxinus excelsior</i> )	Semi Mature	Group of say 30, specimens, to rear of lighting column D183 and set back in wooded area. Specimens not within falling distance of pavement or highway. Extensive scrub growth to base. Extensive deadwood present with evidence of stage 4 Ash dieback	Poor	4	Monitor due to the presence of Ash dieback.
T015	Common ash ( <i>Fraxinus excelsior</i> )	Mature	Specimen of good shape and form. Single stemmed specimen set back from and not within falling distance of footpath. Extensive scrub growth to base. No discernible evidence of Ash dieback at time of inspection.	Good	0	Monitor for the presence of Ash dieback.
T016	Common ash x14 ( <i>Fraxinus excelsior</i> )	Semi Mature	Group if specimens set back from boundary in wooded area. Specimen not within falling distance of pavement or New Road. Extensive scrub growth to base. Extensive deadwood present with evidence of stage 4 Ash dieback at time of inspection.	Poor	4	Monitor due to the presence of Ash dieback.

T014. Group of 30 specimens, to rear of lighting column D183. Monitor.

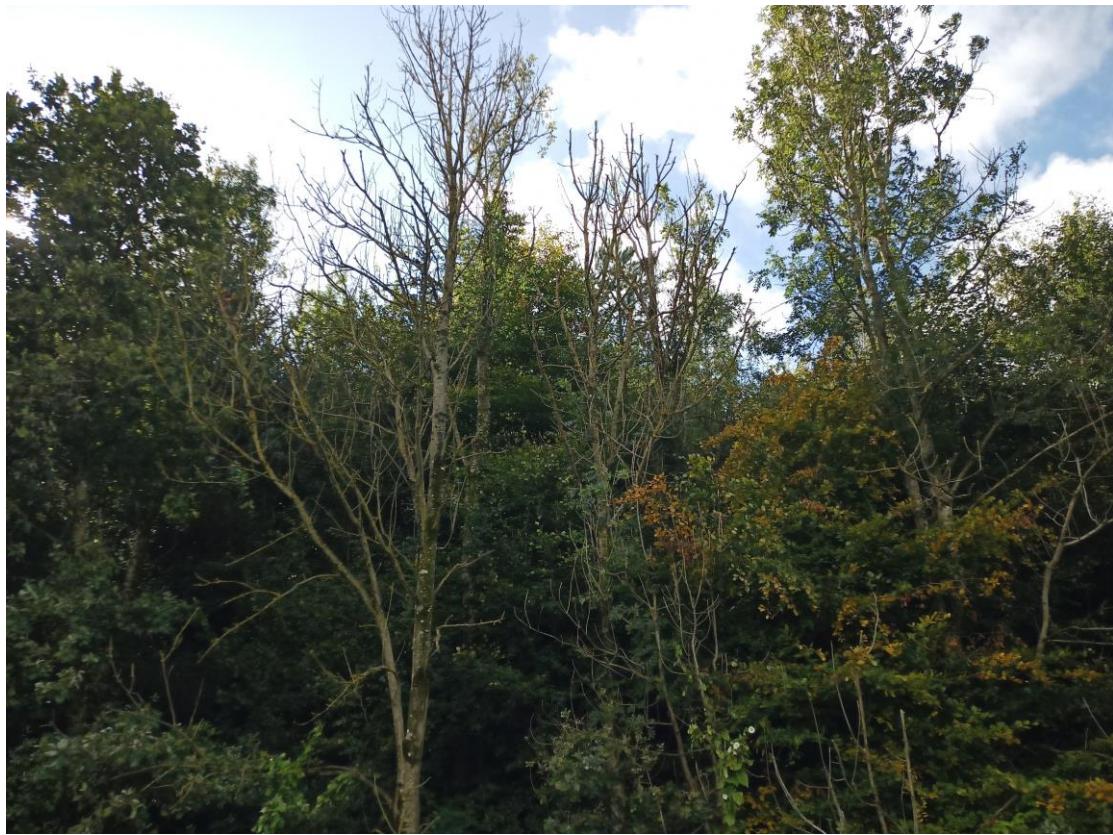
T017	Common ash x5 ( <i>Fraxinus excelsior</i> )	Mature	Group of 5 Single stemmed specimen set back from and within falling distance of pavement. Extensive scrub growth to base. Extensive deadwood present with evidence of stage 4 Ash dieback at time of inspection.	Poor	4	Fell all specimen.
T018	Common ash x2 ( <i>Fraxinus excelsior</i> )	Mature	Pair of multi stemmed specimen set back from and just within falling distance of boundary. Extensive established ivy on main stems. Extensive scrub growth to base. Extensive deadwood present with evidence of stage 4 Ash dieback at time of inspection.	Poor	4	Fell.
T019	Common ash ( <i>Fraxinus excelsior</i> )	Mature	Twin stemmed specimen set back from and within falling distance of pavement and highway. Extensive scrub growth to base. No discernible evidence of Ash dieback at time of inspection.	Fair	0	Monitor for the presence of Ash dieback.

T017. Group of 5 Single stemmed specimen set back from and within falling distance of pavement. Fell recommended.

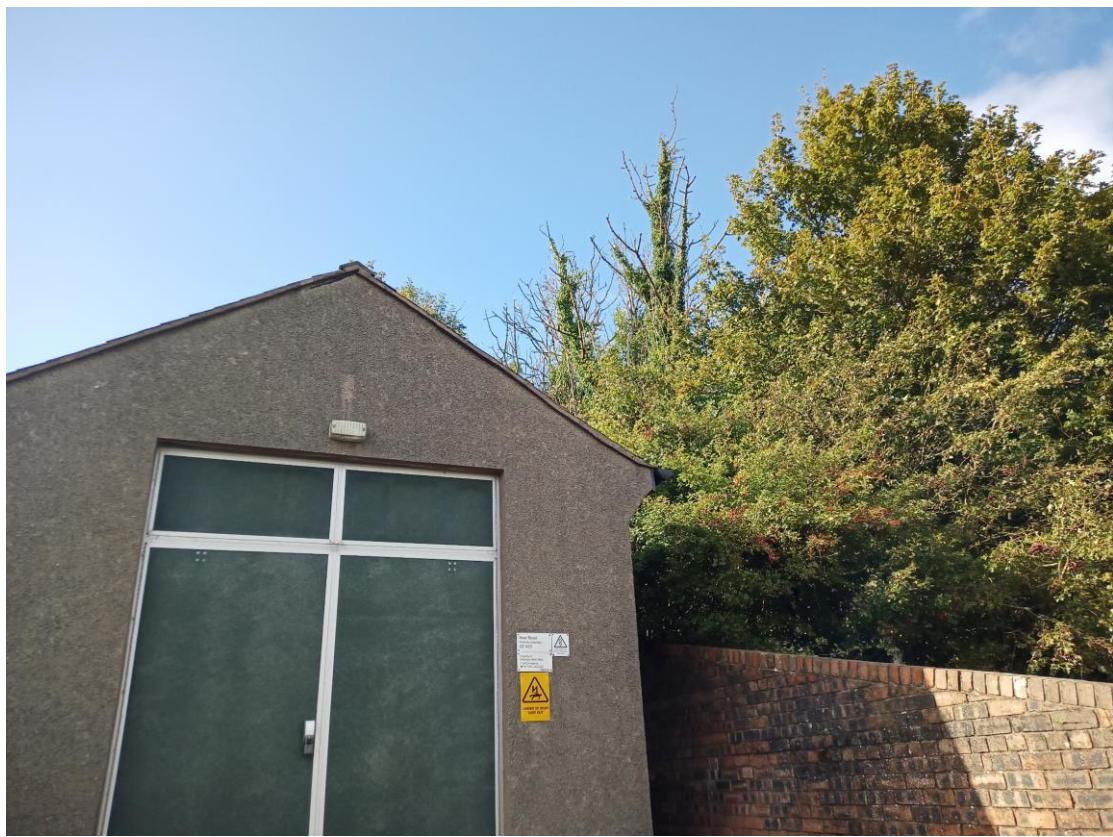
T021. Dead standing stem within falling distance of New Road electricity substation.

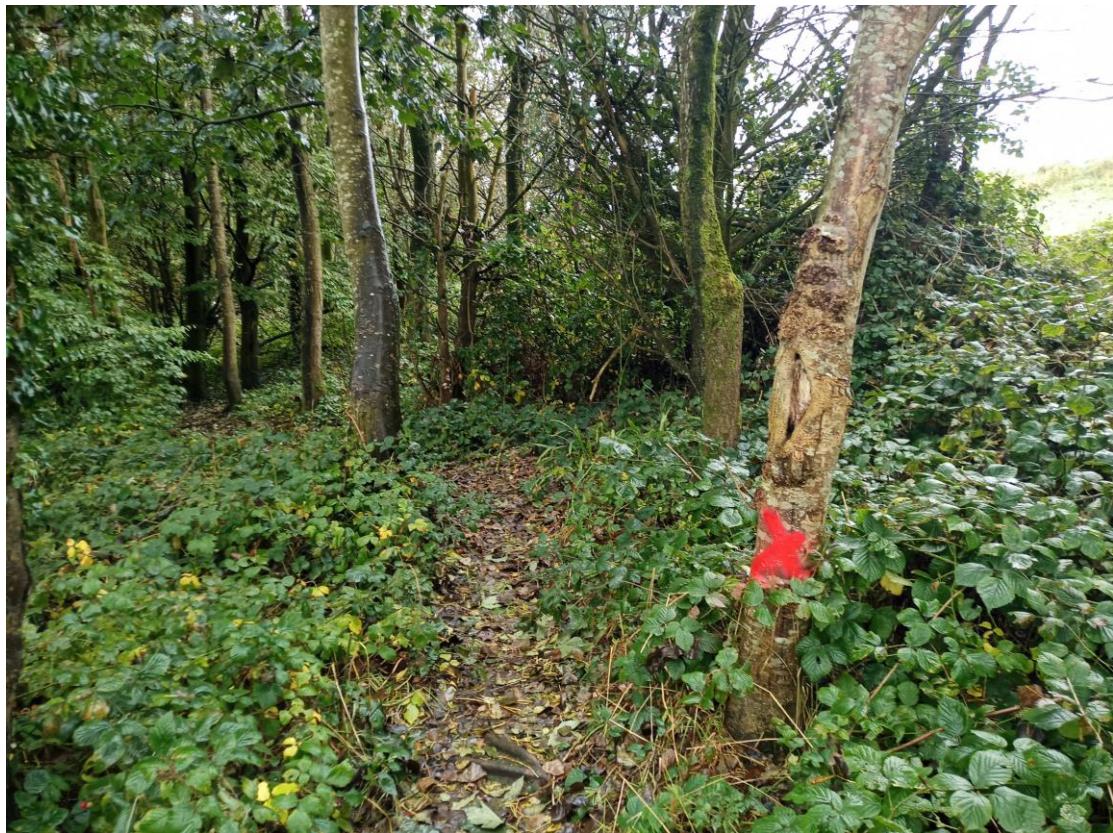
T036. Single stemmed specimen to right hand side of woodland footpath. Specimen in advanced stages of decline. Fell recommended.

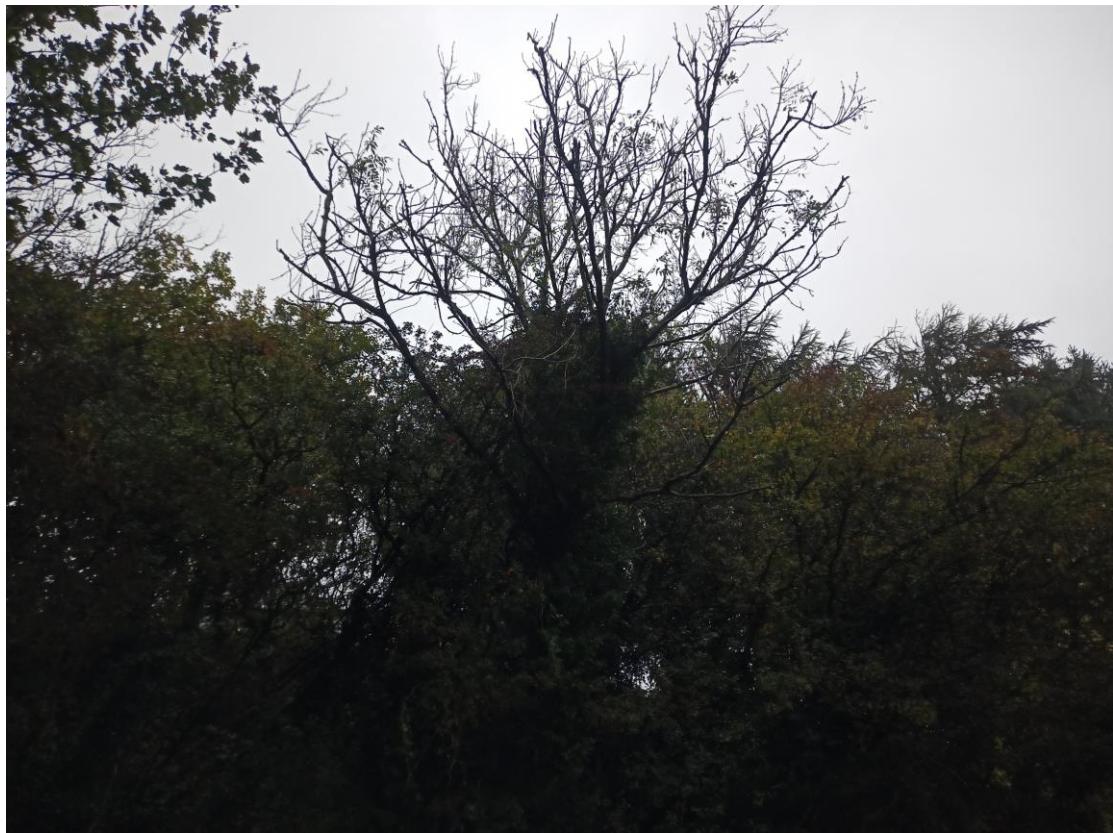
T051. Extensive deadwood in crown over pavement and highway. Fell.

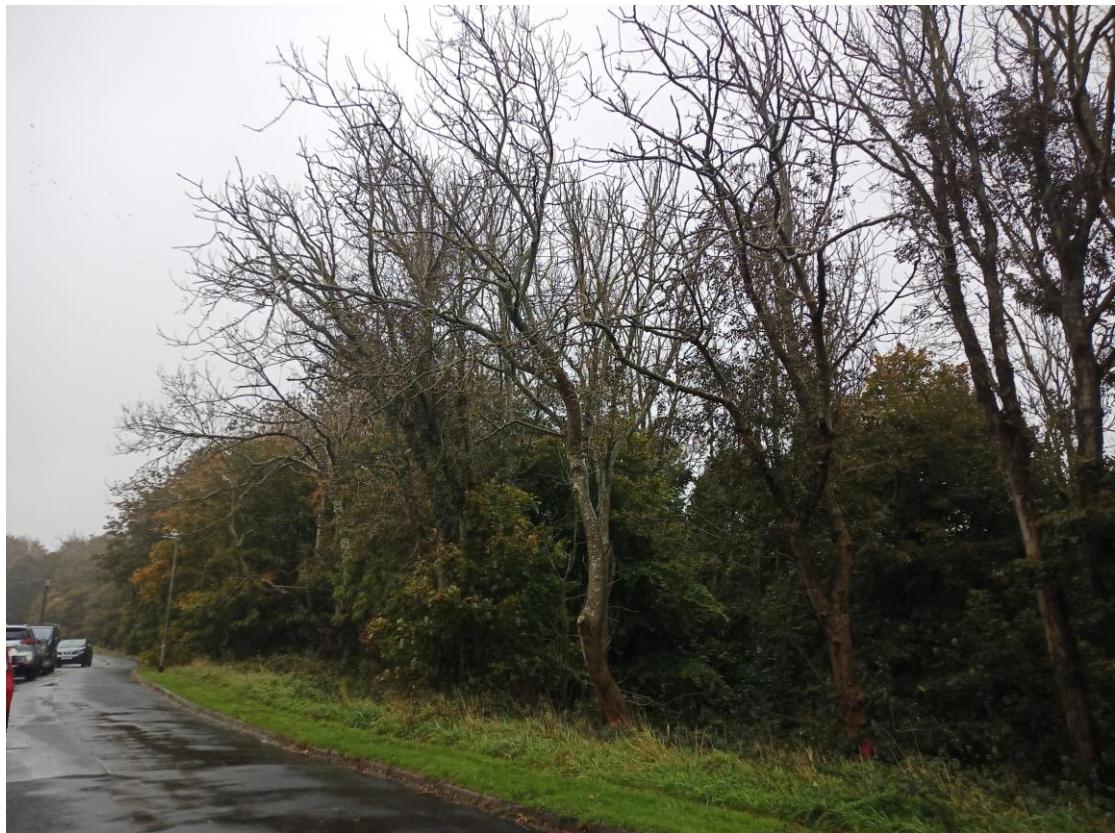
T057. Group of ten mature Ash opposite 42-45 Earls Road. Group in advanced stages of decline. Fell recommended.

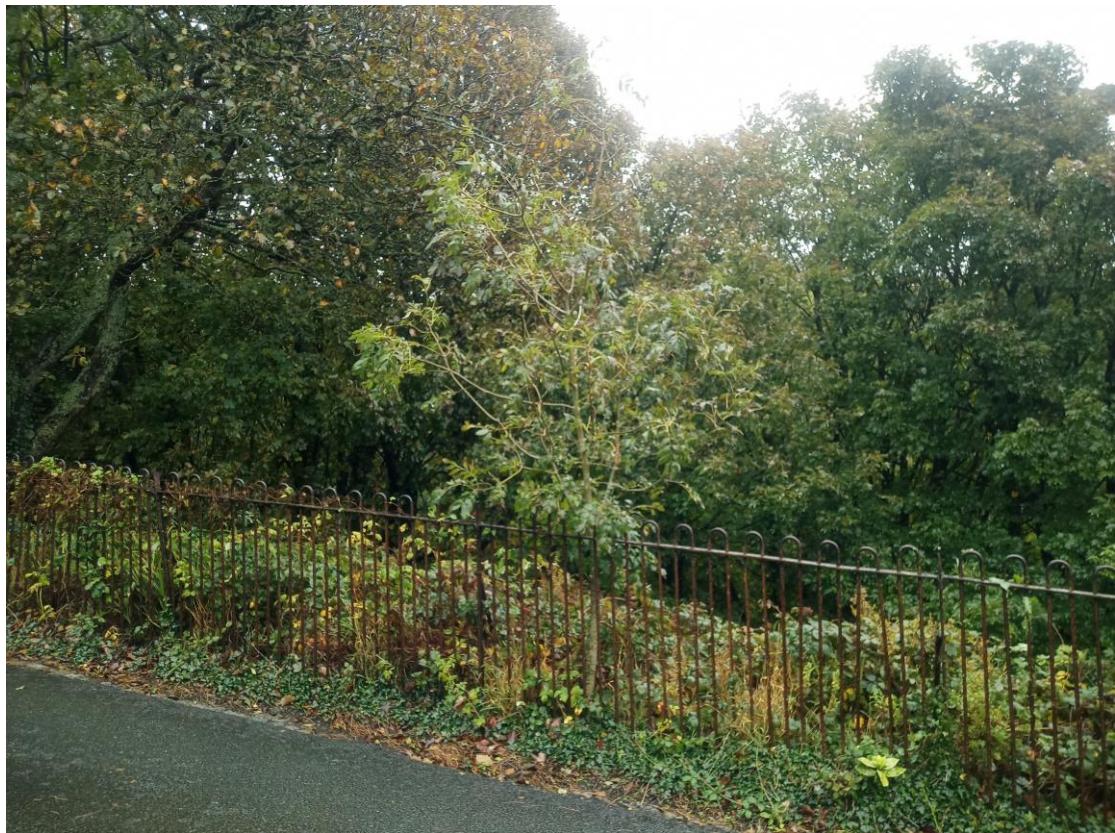
T065. Specimen with no discernible evidence of Ash dieback at time of inspection.

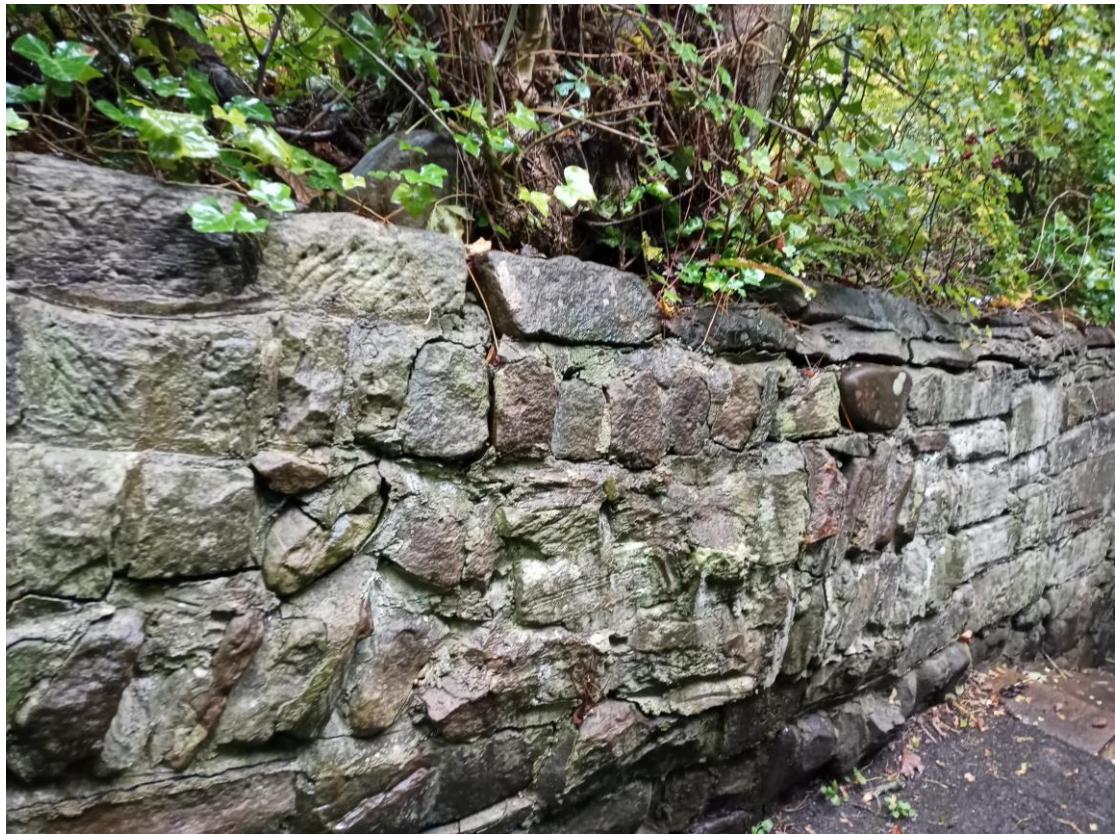
T066	Common ash ( <i>Fraxinus excelsior</i> )	Mature	Six stemmed specimen from base growing on top of retaining wall. Wall starting to fail with significant deflection evident. Damage consistent with root development. Specimen in advanced stages of decline. Deadwood throughout crown over stepped path. Evidence of stage 4 Ash dieback at time of inspection.	Poor	4	Fell.
T067	Common ash ( <i>Fraxinus excelsior</i> )	Mature	Substantial mature three stemmed specimen. One stem with acute 45° deflection over highway. Sufficient clearance at circa 6 metres. Extensive ivy on main stems. No discernible evidence of Ash dieback at time of inspection.	Fair	0	Prune / fell stem with acute deflection over highway. Monitor for the presence of Ash dieback.
T068	Common ash ( <i>Fraxinus excelsior</i> )	Mature	Group of three specimens set back in elevated position to highway. Specimens in advanced stages of decline with deadwood throughout crown being within falling distance of highway. Evidence of stage 4 Ash dieback at time of inspection.	Poor	4	Fell.

T066. Retaining wall starting to fail due to root development and establishment.

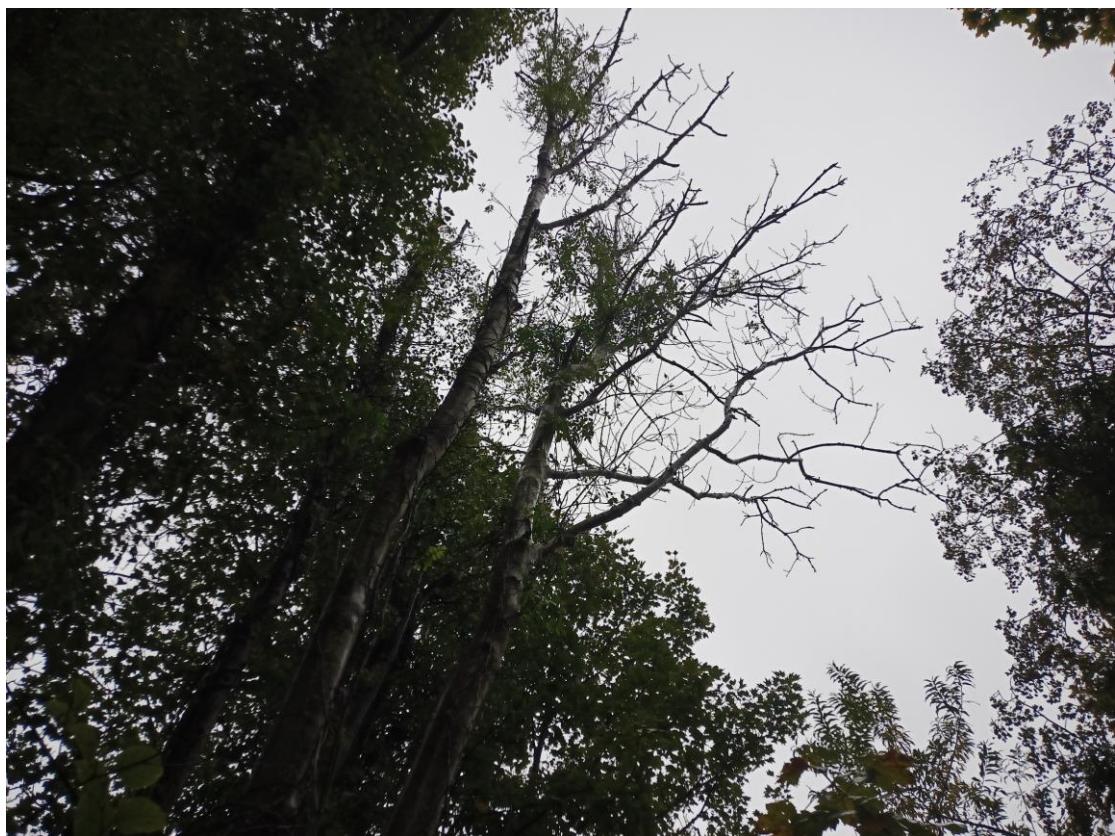
T066. Specimen in decline. Deadwood throughout crown over stepped path. Fell.

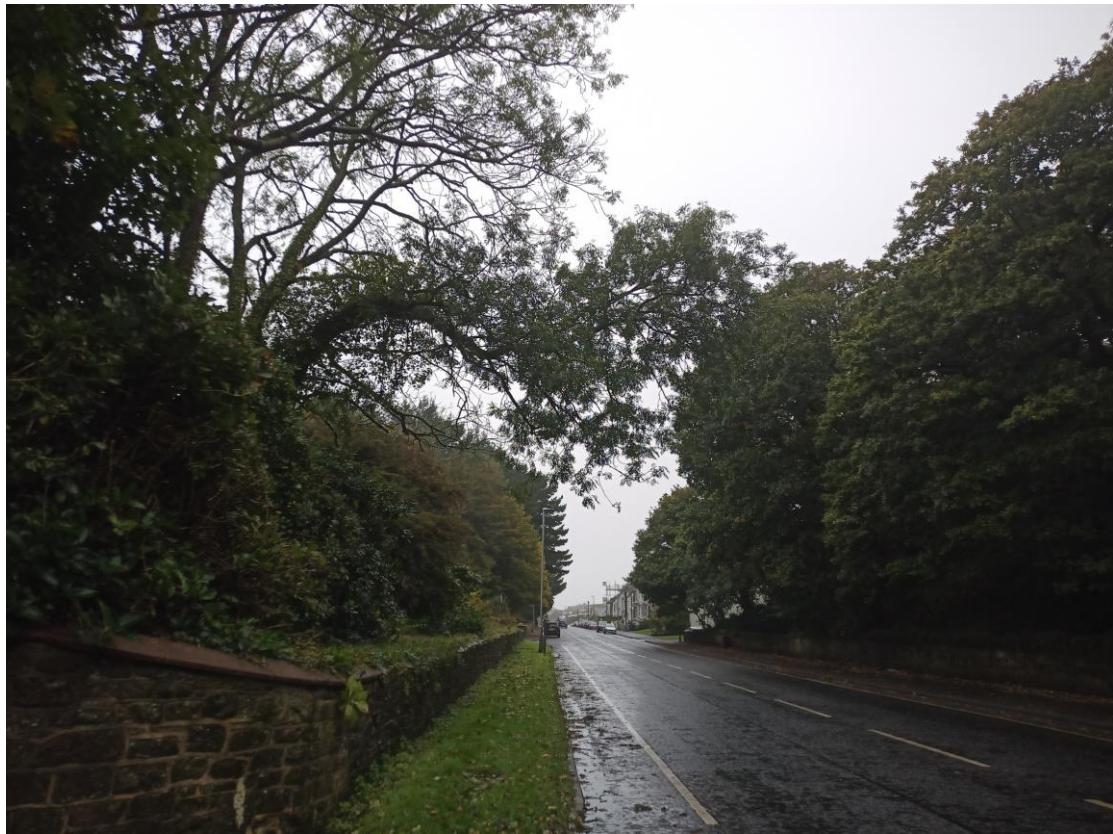
T067. One stem with acute 45° deflection over highway. Prune to remove / fell.

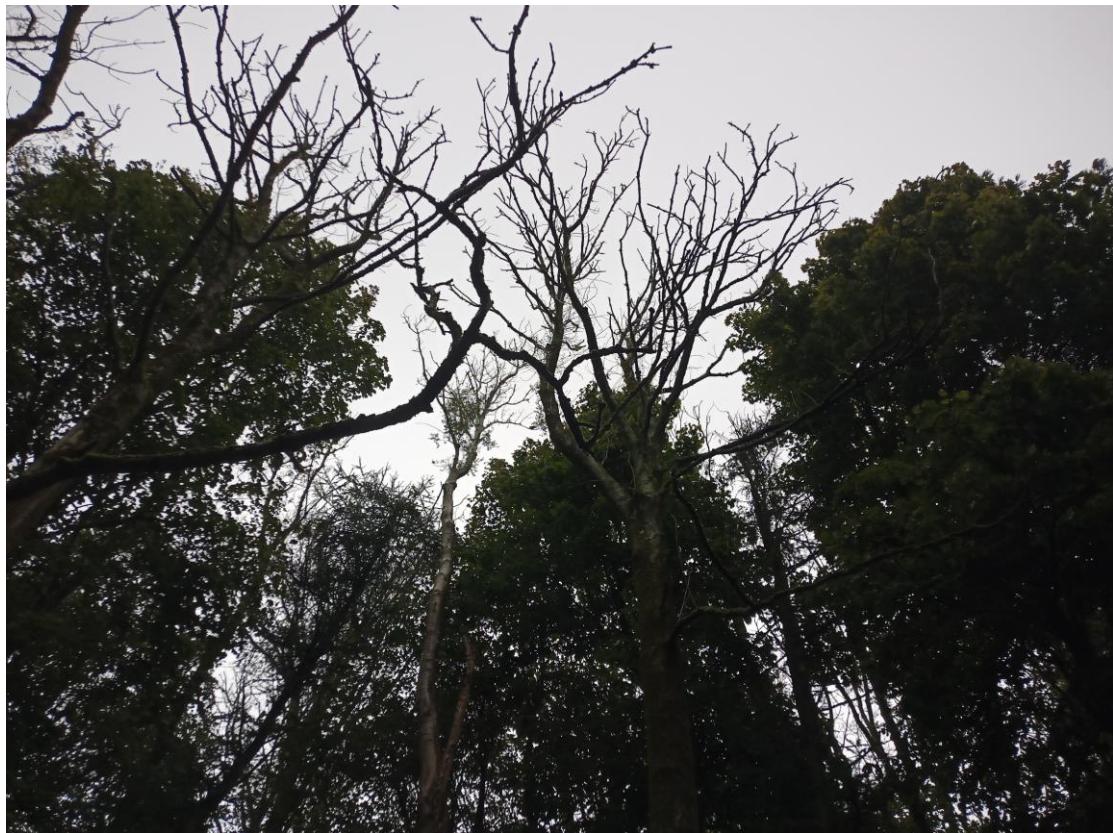
T084. Specimen in advanced stages of decline with deadwood throughout crown being within falling distance of highway. Fell recommended.

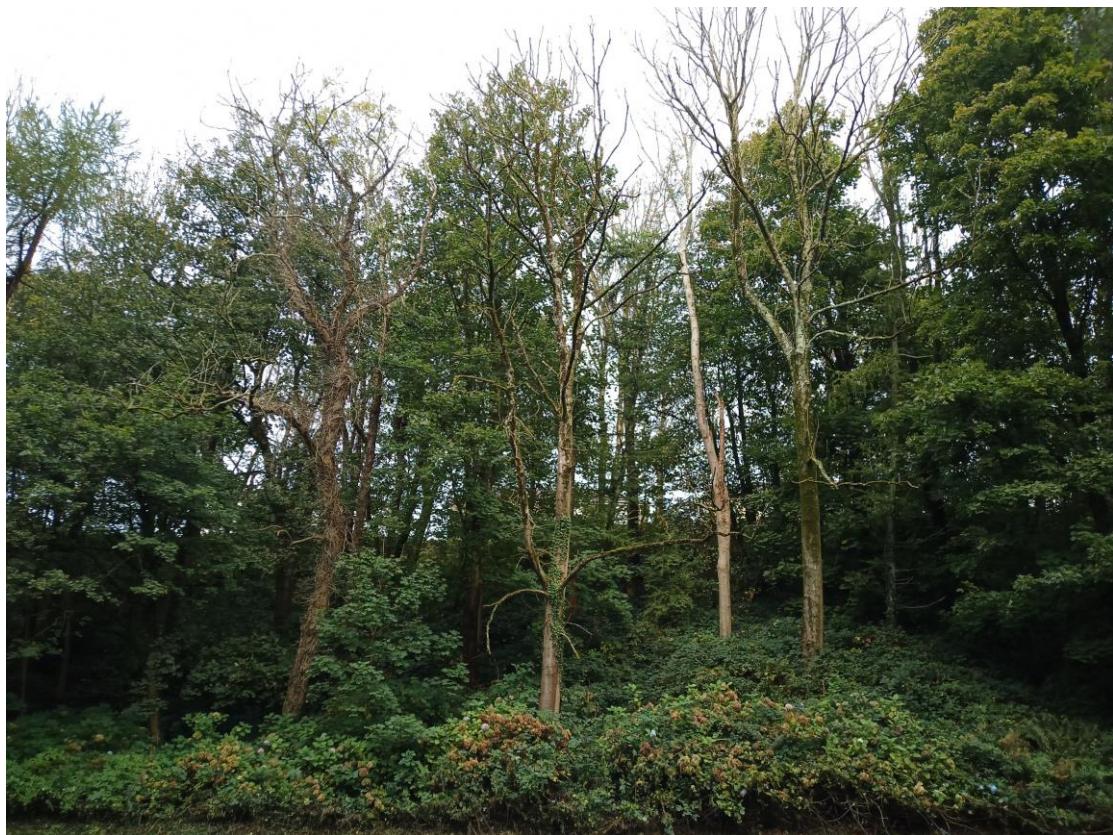
T089 etc. Group in advanced stages of decline. Fell recommended.

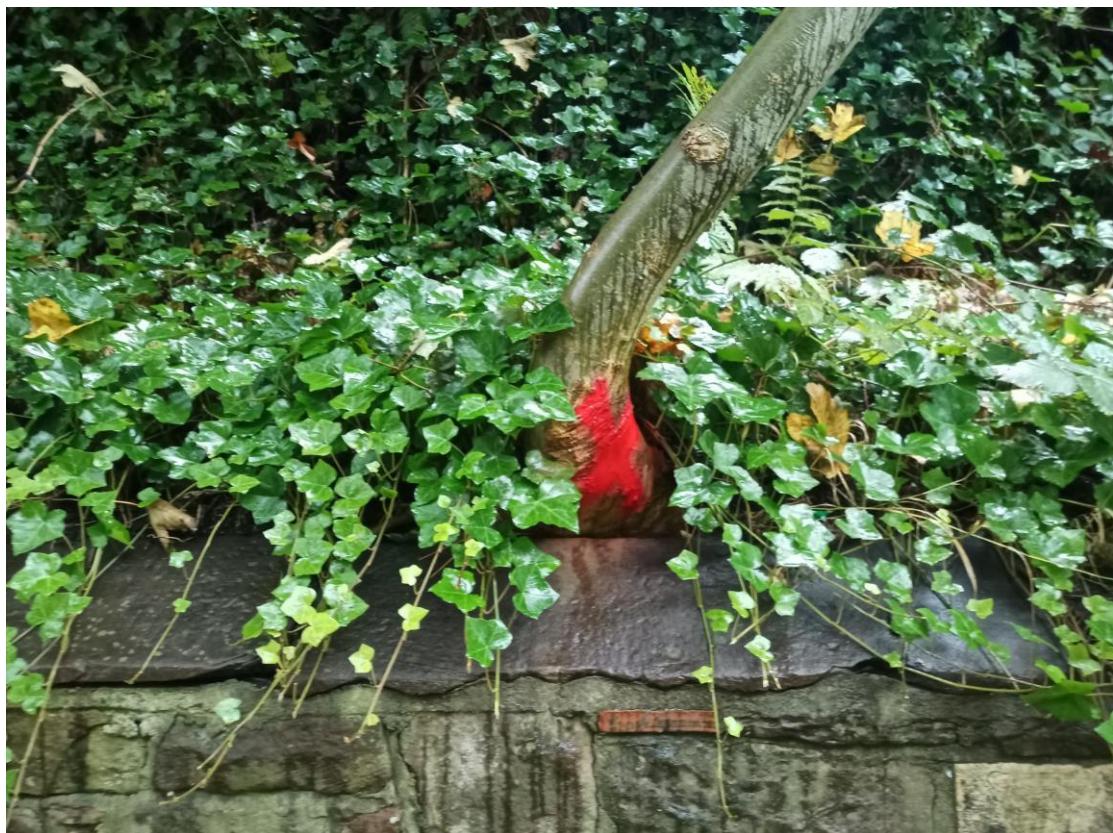
T106. Young specimen growing on top of retaining wall. Damage to retaining wall anticipated as a result. Fell recommended.

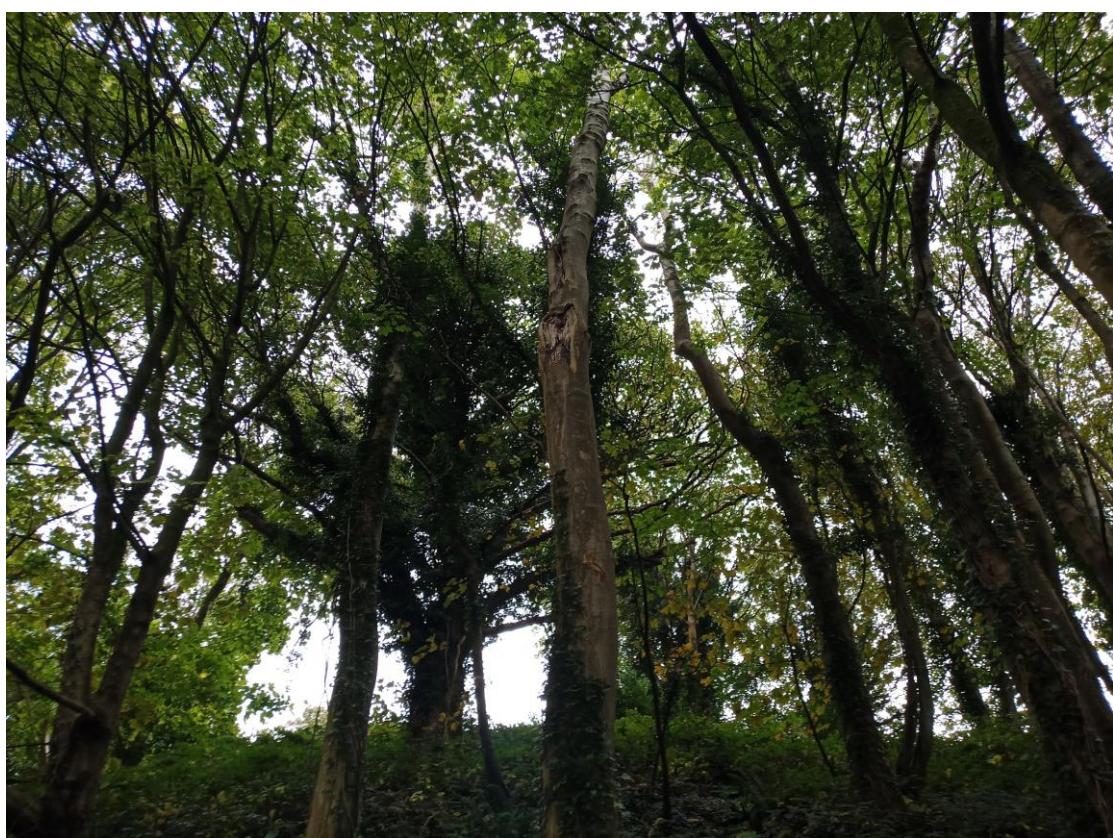
T111. Two areas of damage on west aspect of stem at 4 and 5 metres. Fell.

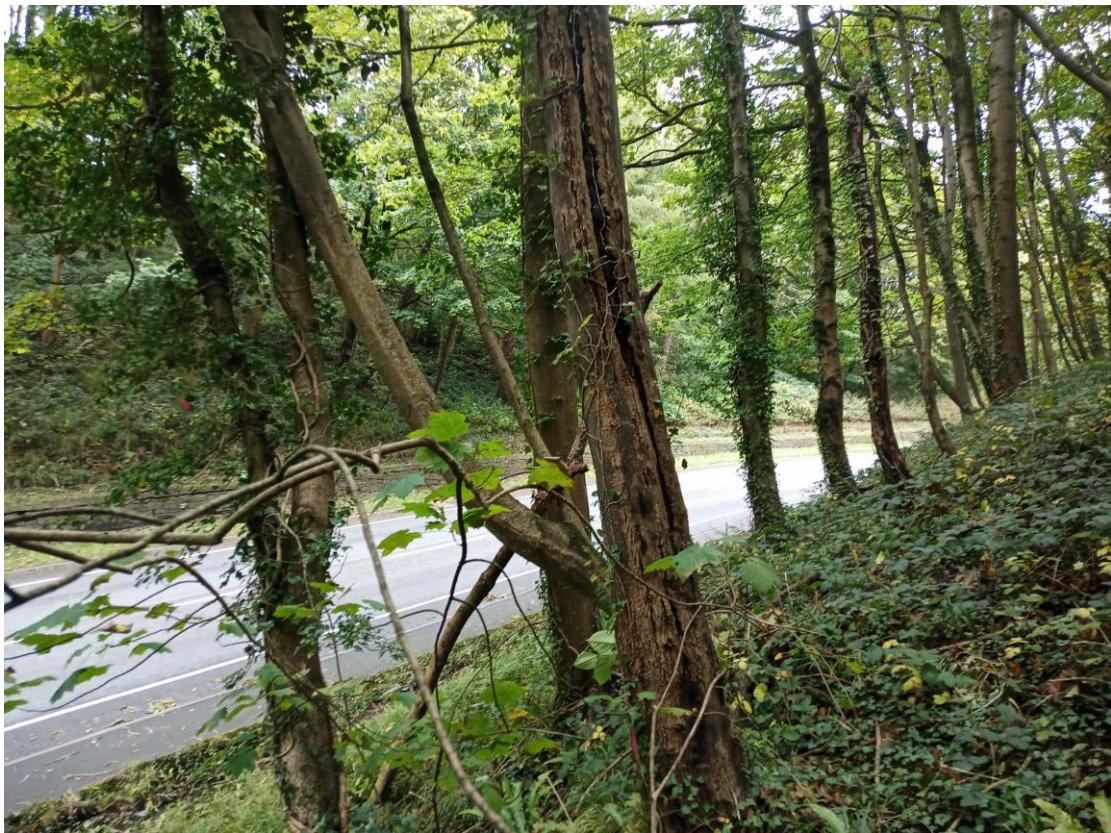
T122. Severe lateral fracture and decay developing throughout main stem from base to 8 metres. Fell recommended.

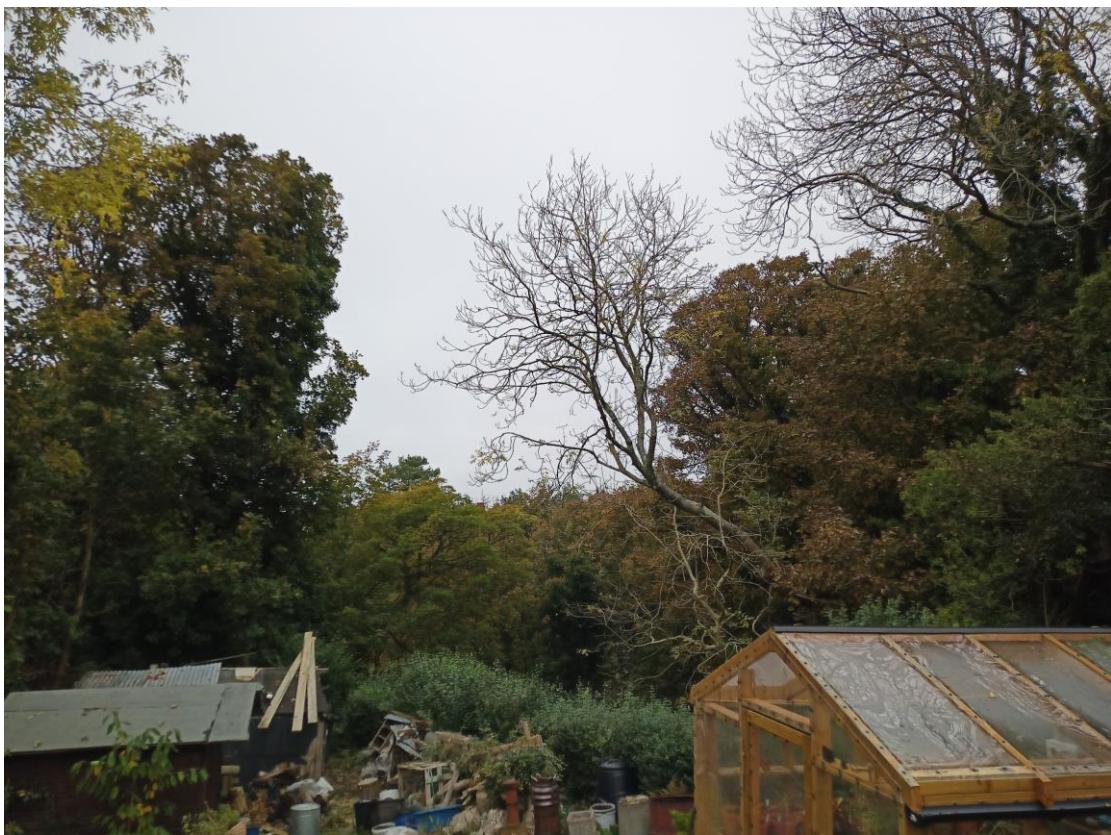
T138. Asymmetrical crown due south being within falling distance of allotment.

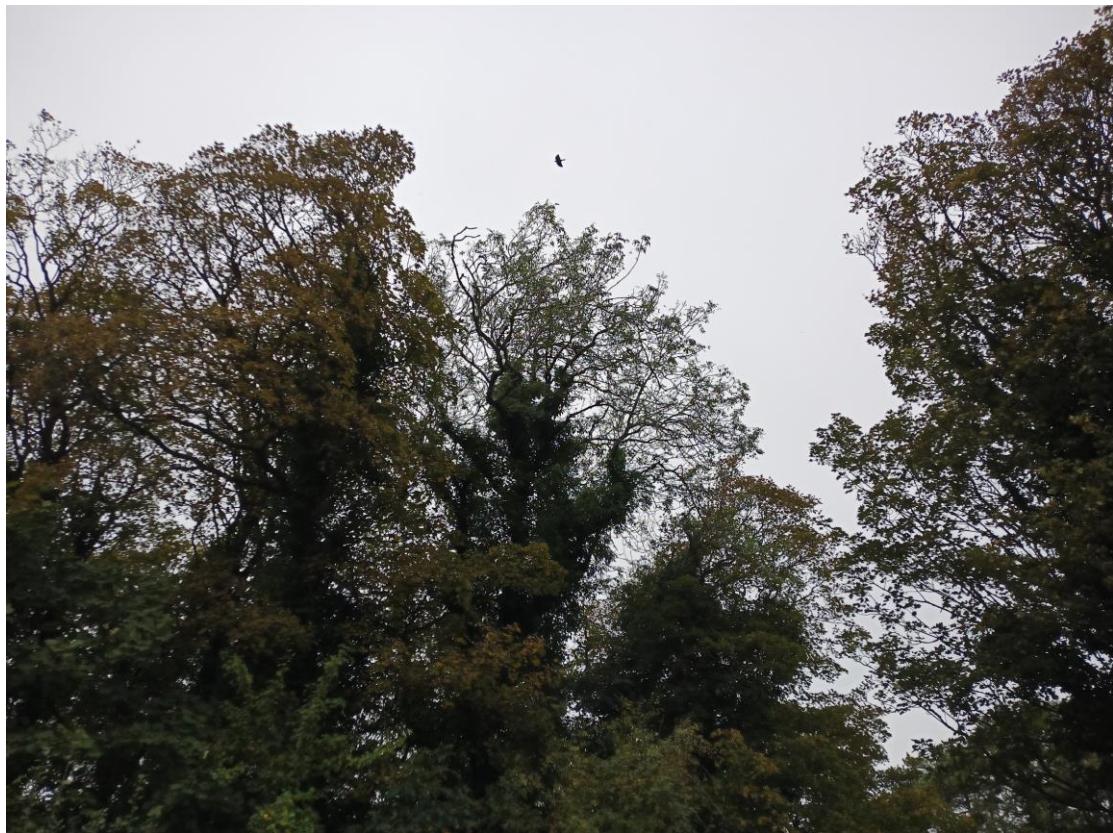
T139. Substantial mature specimen on embankment on boundary of garden.  
Extensive established Ivy on main stem and crown. Sever Ivy at base.

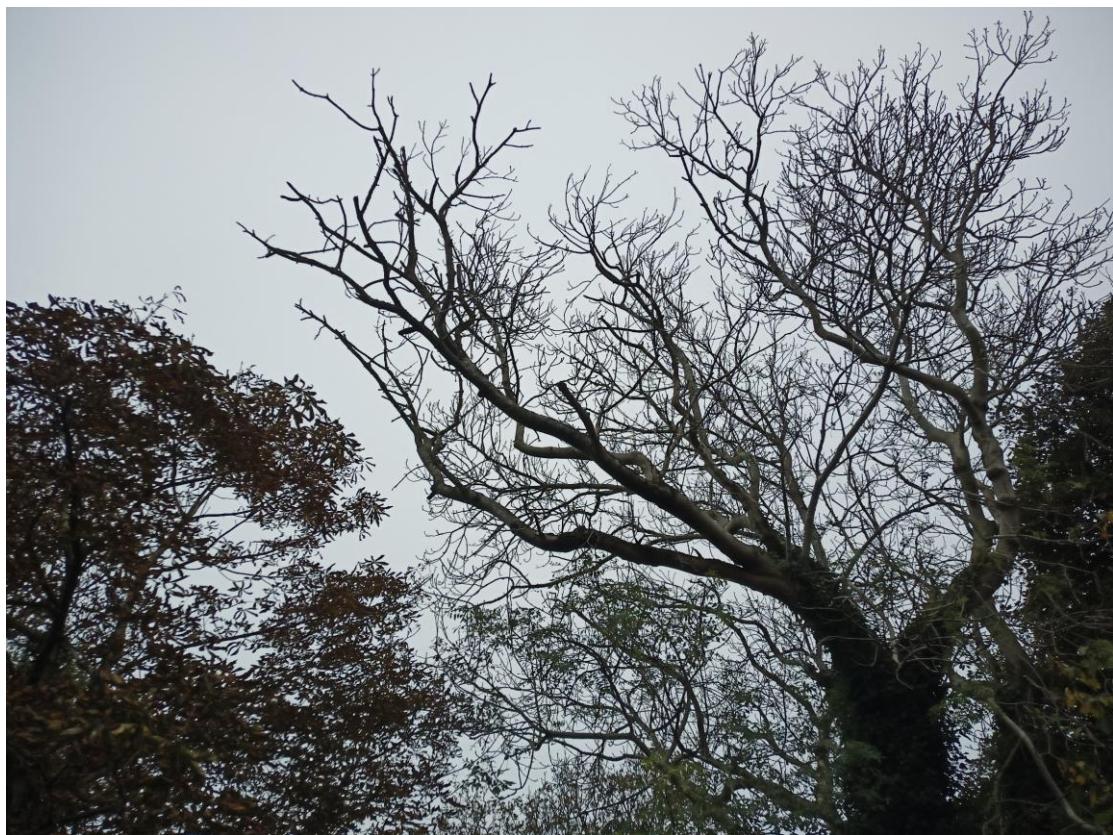
T141. Deadwood to south east aspect of crown over wooded area. Monitor.
